**Post Occupancy Evaluation and Internal Environmental Monitoring of the New BREEAM
“Excellent” Land Rover/Ben Ainslie Racing Team Headquarters Offices.**

Pasquale Ponterosso, Mark Gaterell, John Williams

School of Civil Engineering and Surveying
University of Portsmouth, United Kingdom

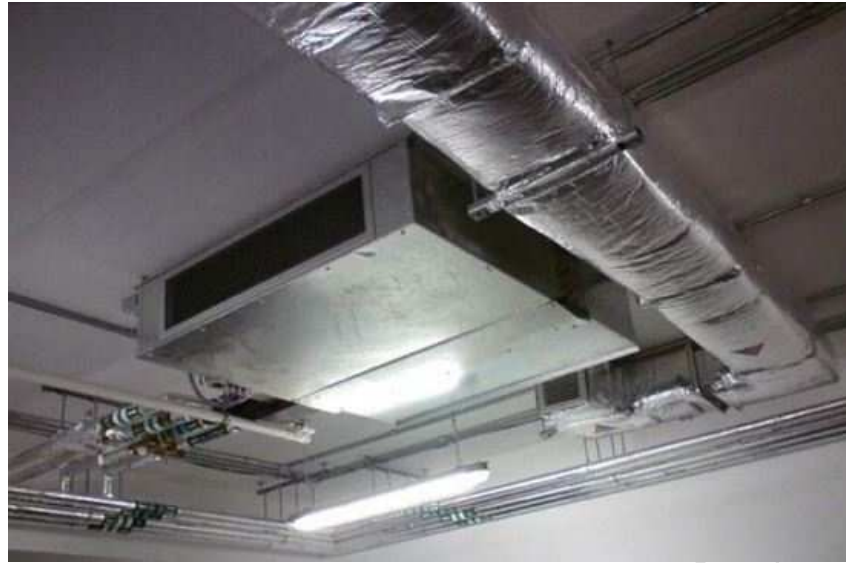
Figure 1. Typical Fan Coil Unit (FCU) as fitted at BAR Building and diagrammatic representation of FCU function and relationship to BMS

The building relies on natural ventilation and 64 fan coil units (FCU). The FCU are controlled via an extensive building management system (BMS) and occupants are not able to adjust heating themselves [18]. The FCU sample the air temperature, via their on-board sensors, relay this information to the central BMS which then adjusts the output of the FCU according to the environmental regime desired/organised by the operator/client, see figure 1. The BMS receives information regarding air temperature from the FCU on-board air intake temperature sensor and responds (if necessary) by adjusting the fan and heating/cooling coils while receiving feedback from the FCU on-board air output temperature sensor. The responses depend on pre-programmed criteria which can be “manually” overridden by the BMS operator.

Figure 1. Typical Fan Coil Unit (FCU) as fitted at BAR Building and diagrammatic representation of FCU function and relationship to BMS

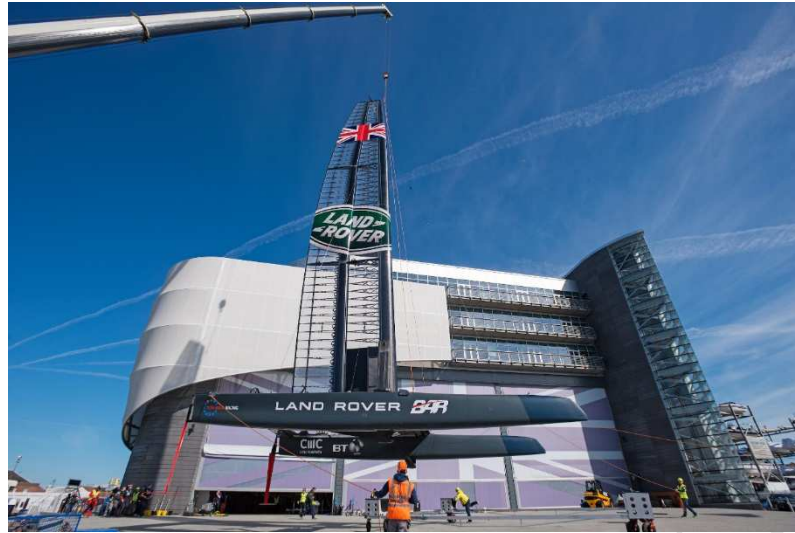
Figure 2a. External view of the new Land Rover Bar Team HQ building from the west. Showing yacht being craned out to the sea. The sea is on the immediate left of the photograph

Figure 2 shows several views of the new building, both externally and internally. All photographs courtesy of HarryKH/LandRoverBAR.

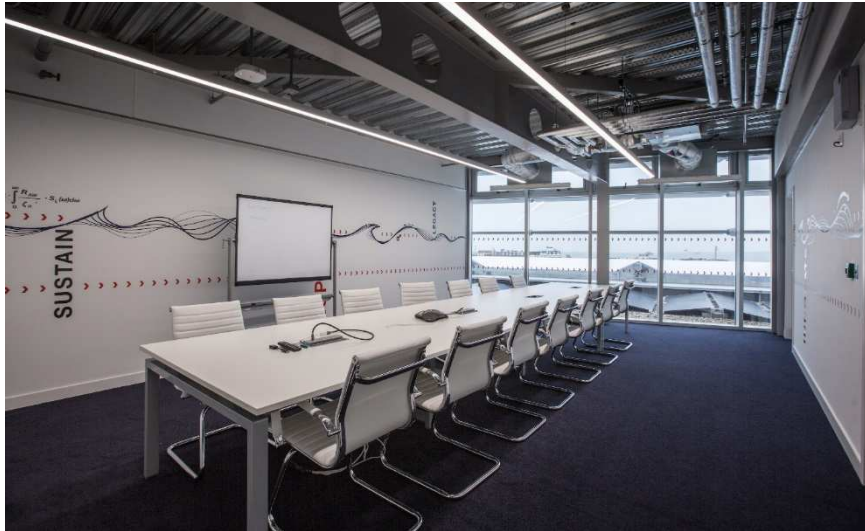
Figure 2c. One of the self-contained office spaces on the south face of the office floor.

These are discrete offices all located on the south most periphery of the floor. The southern façade of the office floor is entirely glazed and is not covered by the fabric shroud described in earlier.

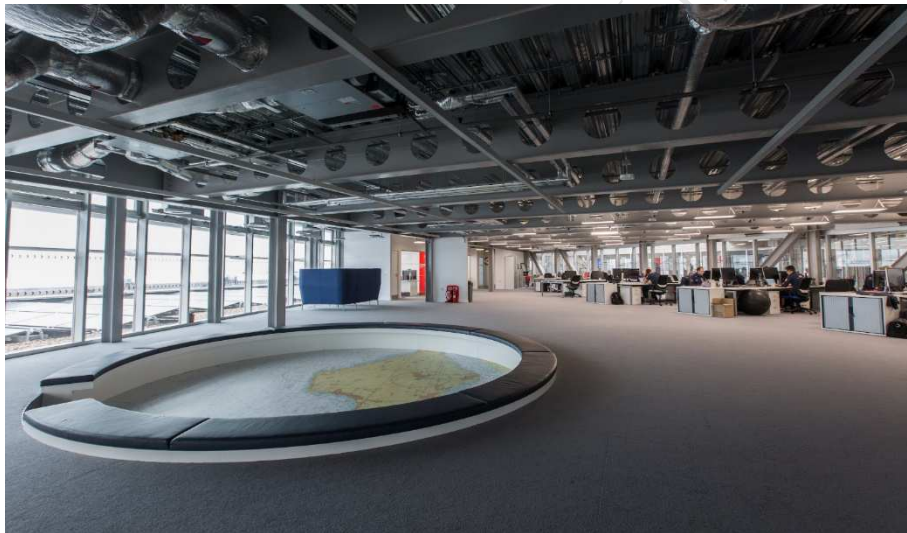
Figure 2d. View of the office floor taken from the south east corner

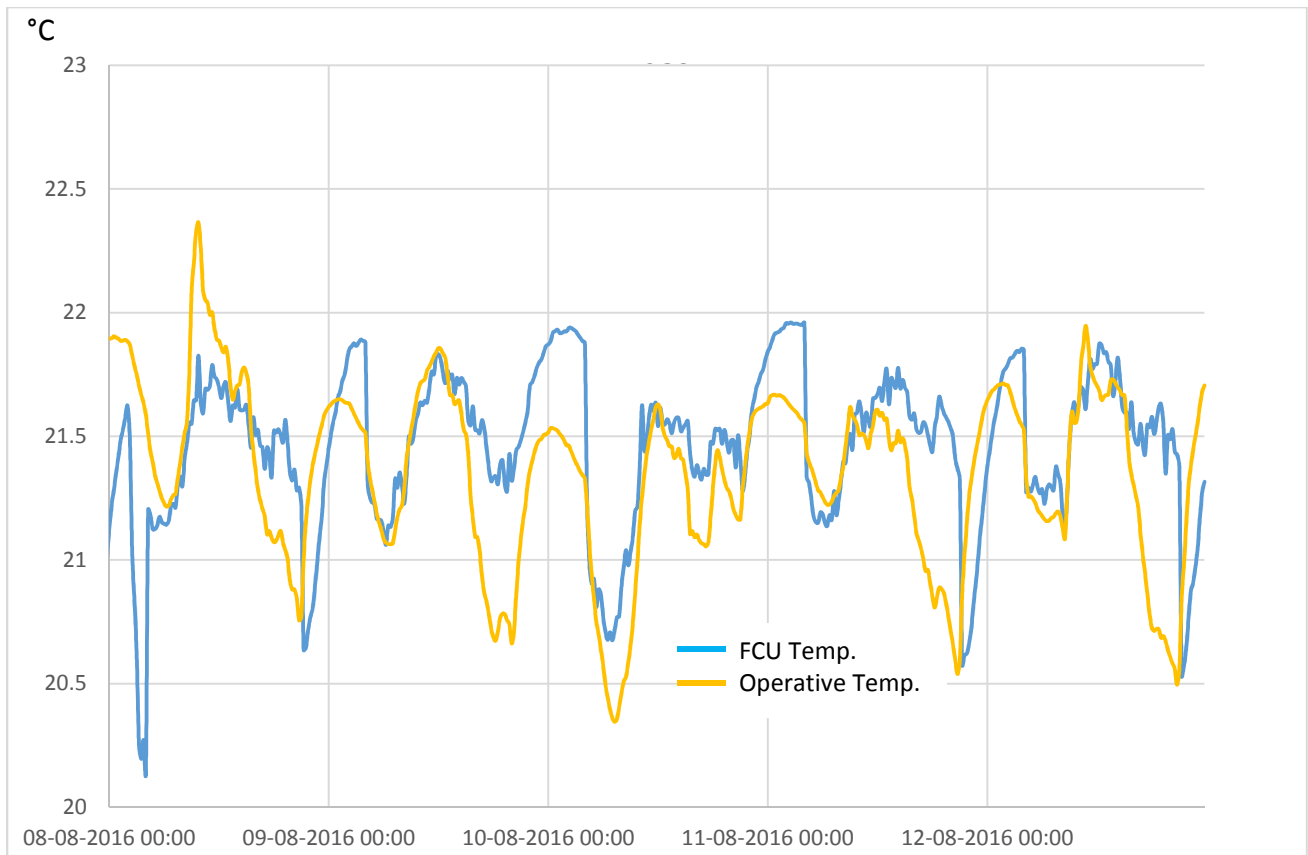
Fig 4. One typical set of FCU and operative temperatures in the office floor for the period 08 Aug – 12 Aug 2016

Figure 4 shows a graph of the first of these four weeks identified in table 2. For simplicity, only one FCU (and the operative temperature calculated from the installed UoP sensor located near to that FCU are shown). This analysis was done with all FCU and UoP data (so included data from the east, south, west and north faces of the building). Figure 4 demonstrates the general trend found.

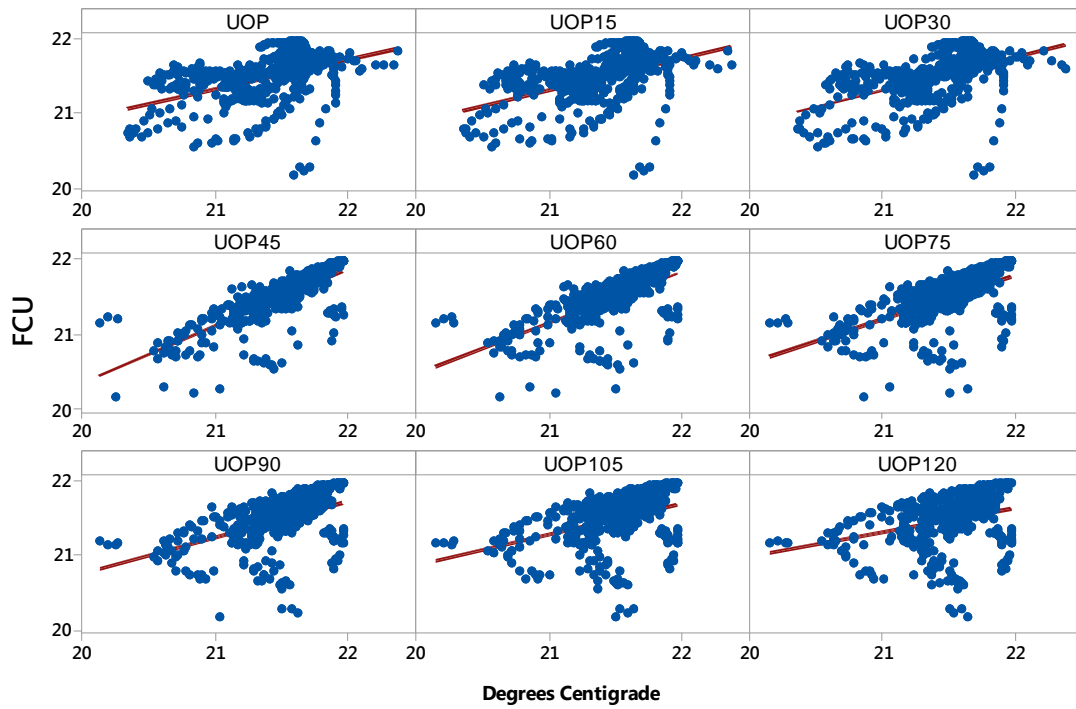
Fig 5. Graphs of regression analyses of FCU and UoP data (UoP data lagged sequentially every 15 minutes) for the period 08 Aug – 12 Aug 2016

In order to understand the correlation between FCU and UoP sensor temperature data, a series of linear regression analyses were carried out. The FCU and UoP data were compared directly and then in a series of 15 minute UoP lags i.e. at UoP + 15 minutes, UoP + 30 minutes and so on. Figure 5 and table 3 show the results of this analysis.

From table 3 and figure 5, it can be seen that the optimally correlated lag between FCU and UoP data occurs at UoP + 45 minutes. The regression equation for FCU v UoP+45 was found to be:

$$\text{FCU} = 4.887 + 0.772 * \text{UOP45}$$
