**Impact of Mineralogy, Texture and Fabric  
of the Maritime Canadian Sandstones on Deterioration of  
Ornamental Bridges in Central Park, NYC**

Submitted in partial fulfillment of the requirement for the degree  
Master of Science of Historic Preservation

Columbia University

May 2013

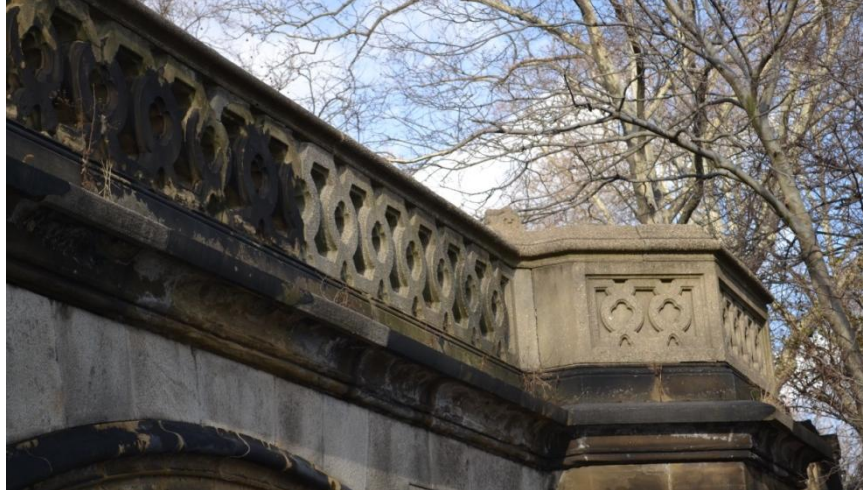
**Figure 1.12: Eastern balustrade of Balcony Bridge showing use of cast-stone for replacement**

The sandstone elements in the Park have also suffered damage by human activity and interventions that include graffiti, physical abuse and alteration, structural modifications, de-icing activity during snow and failed structural mechanics. The majority of the structures are frequently visited by transients, who use them as urinals and which can deposit harmful nitrates. Bird's heads and other finials at Bethesda Terrace, now repaired, were once knocked off completely. Vehicular traffic including snowplows caused significant damage to arches and balustrades in the past. Furthermore, inappropriate repair interventions have resulted in use of cast-stone with coarse aggregates for fine-grained sandstone as noticed at Balcony Bridge (Figure 1.12).

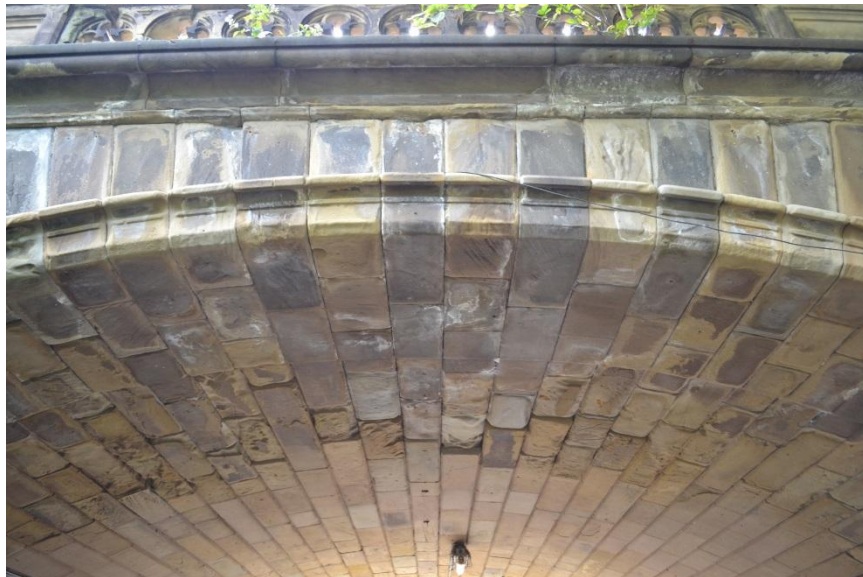
**Figure 1.14: Denesmouth Arch showing deterioration conditions**

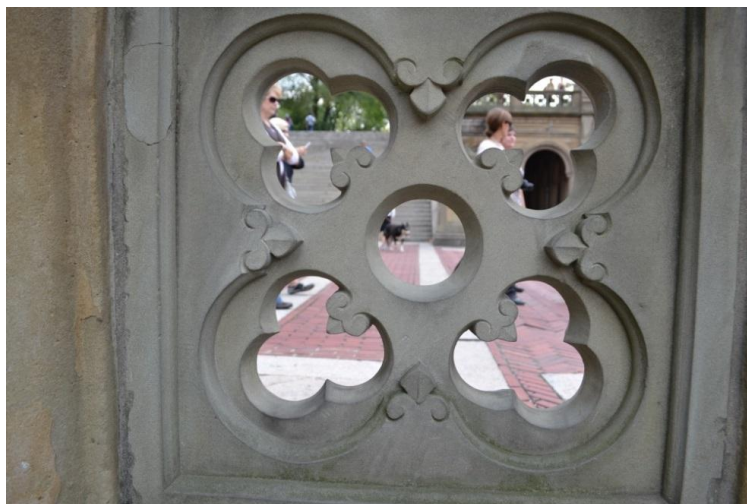
**Figure 4.1: Restored quatrefoil panel at Bethesda Terrace**

The Maritime Canadian sandstones used in Central Park are similar in their mineralogical composition but vary in texture with the original stones from the quarries in New Brunswick being coarser in grain size than the restoration sandstone from the Wallace quarries in Nova Scotia. The variation in the field samples taken from Central Park suggests that the original sandstones are not from the same quarry but are from multiple quarries in Shepody Bay area in New Brunswick and confirms the historic documentation. It is challenging, however, to identify a specific quarry source for all the samples that are studied due to overlap in textural and general descriptions of the rocks from different quarries and unavailability of fresh samples from the quarries that are closed now. On the other hand, the 1980s restoration stone from the Wallace quarries is easily distinguished from the original stones from New Brunswick quarries because the restoration stone either is of different color geologically or has not weathered to the same color as the original stones. In contrast, the Dorchester sandstone used for the restoration of some of the ornamental arches and bridges in the late 1980s is not easily distinguished from the original sandstones based on color. Therefore, it is more likely that the Wallace sandstone is of different color.

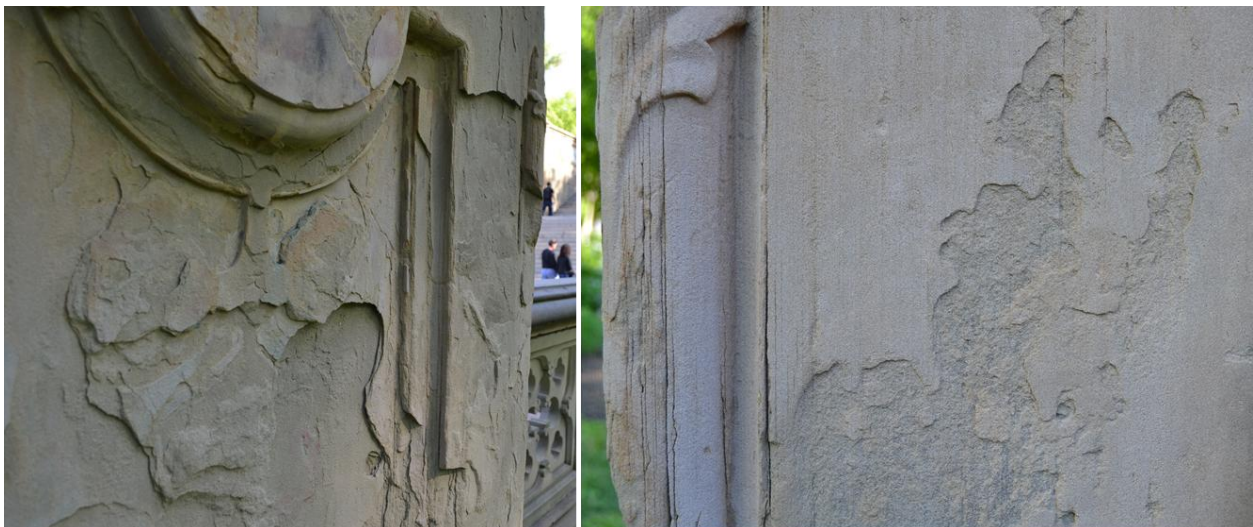
**Figure 5.1: Bethesda Terrace pier deteriorating through exfoliation on one side and flaking on the other side**

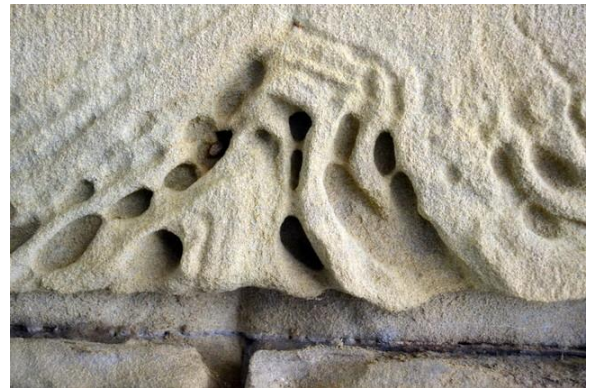
**Blistering** – It is a type of swelling that causes detachment of a thin uniform skin both across and parallel to the bedding planes of the stone.

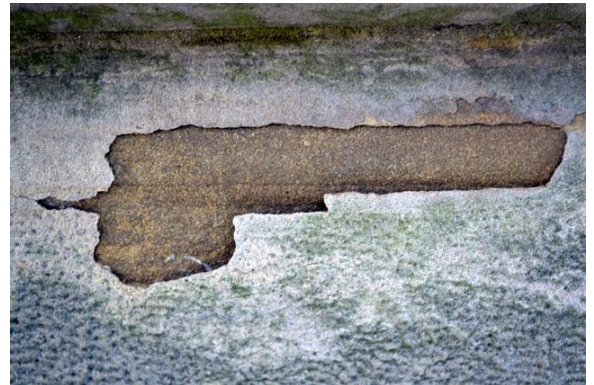
**Contour Exfoliation** – It refers to loss of the surface along the sectional contours of a profiled stone. A stone may lose between 1 to 20 mm of its surface in a single exfoliation.

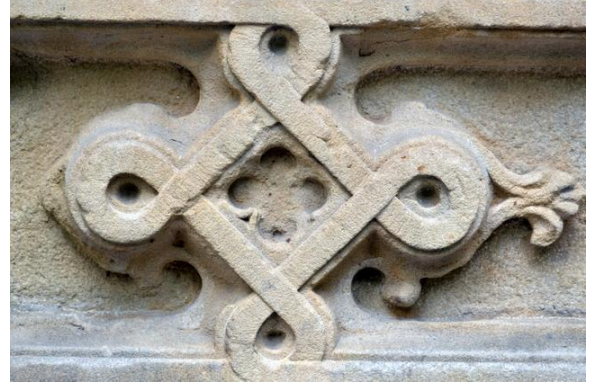
**Exfoliation** – It is a type of delamination that causes peeling, scaling or flaking of the surface of the stone into thin layers along its natural bedding planes. The layers may bend or twist in a way as book pages.

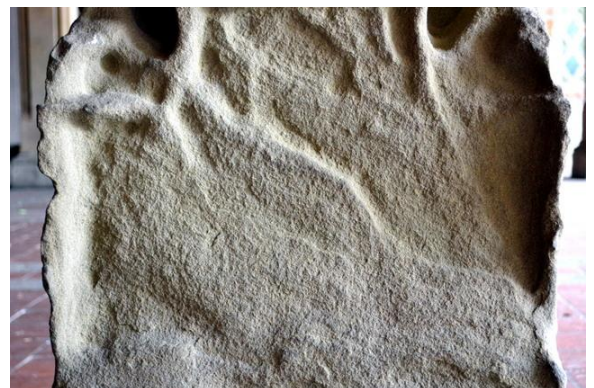
**Rounding** – Preferential erosion of originally angular stone edges to a distinctly rounded profile is referred to as rounding. It is observed on stones that tend to deteriorate through granular disintegration.

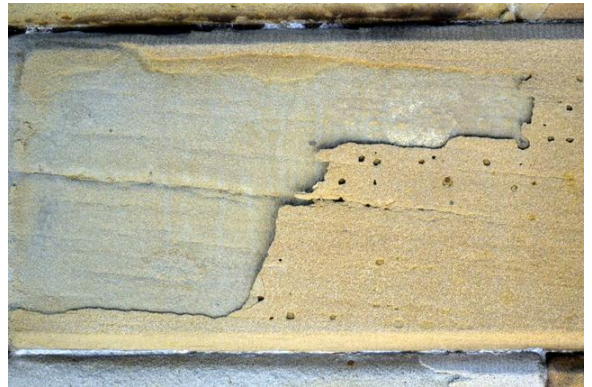
**Splitting** – It refers to the fracturing of a stone along planes of weakness such as microcracks or clay/silt layers.
