In Defense of Natural Cement:
A Critical Examination of the Evolution of Concrete Technology
at Fort Totten, New York

Submitted in partial fulfillment of the requirement for the degree
Master of Science in Historic Preservation

Graduate School of Architecture, Planning and Preservation Columbia University

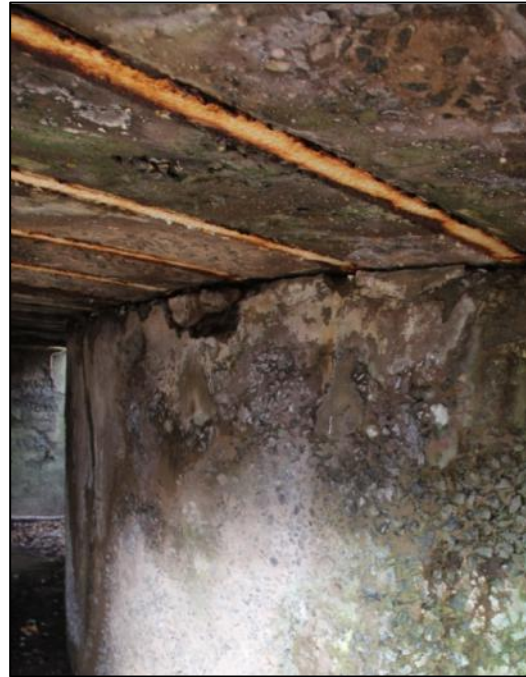
Figure 56: Battery Graham 1, ceiling showing rolled wrought iron beam and concrete infill ceiling surrounding the gun foundations. (2012)

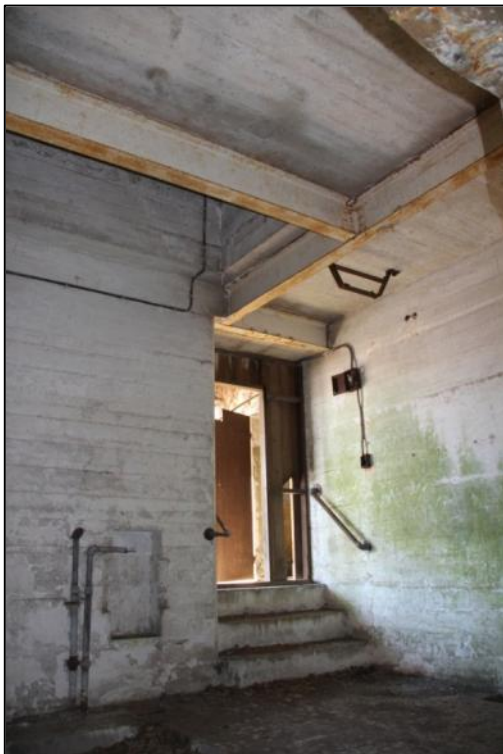
Figure 57: Extension of Battery Sumner 1 showing the rolled steel I-beam supports (2013)

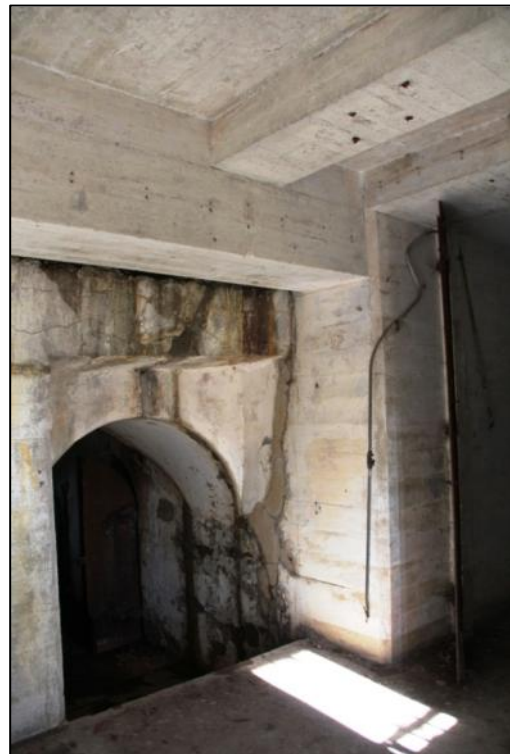
Figure 58: Battery Graham 1 showing the entrance to the original cast-in-place mass concrete magazines and the reinforced concrete columns and beams of the later extension (2012).

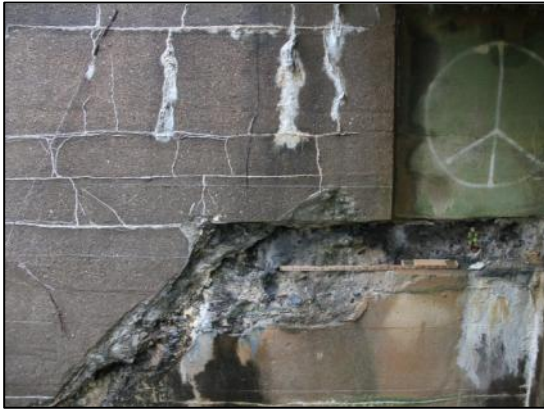
Figure 59: Battery Mahan 1, damage caused at the horizontal lifts (2013)

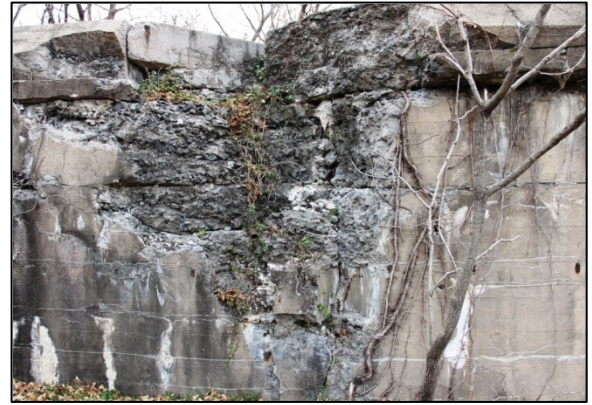
Figure 60: Freeze/thaw, calcite deposition and lateral movement of portland cement concrete in Battery Mahan 1 (2013)

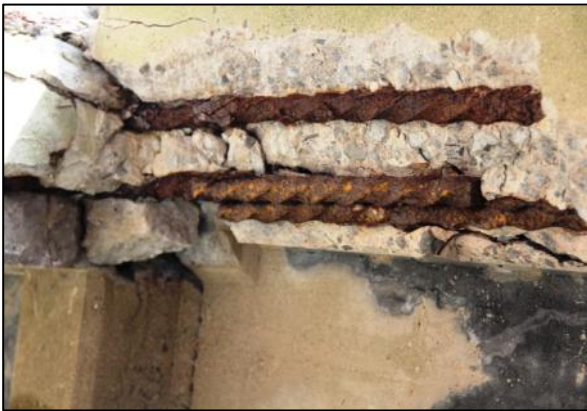
Figure 61: Failure of the reinforced concrete at the extensions of Battery Sumner 1 (2012)

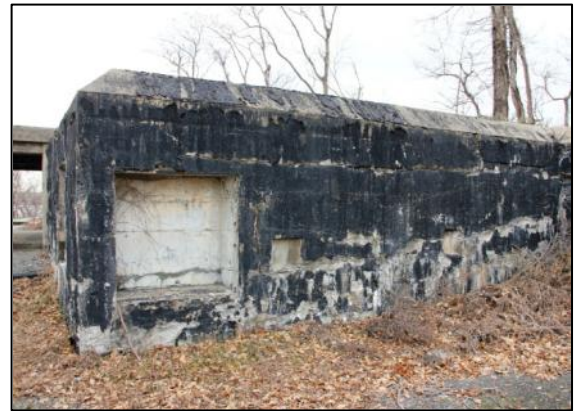
Figure 62: Bituminous coating at Battery Mahan 2 (2013)

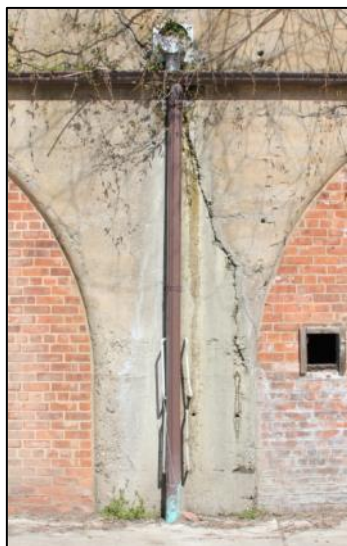
Figure 63: Crack between Torpedo Magazines 1 and 2 (2012)

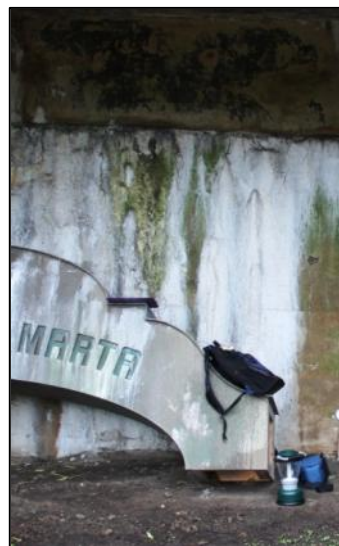
Figure 64: Horizontal cracking just below the second level at Battery Graham 1 with calcium deposits (2012)

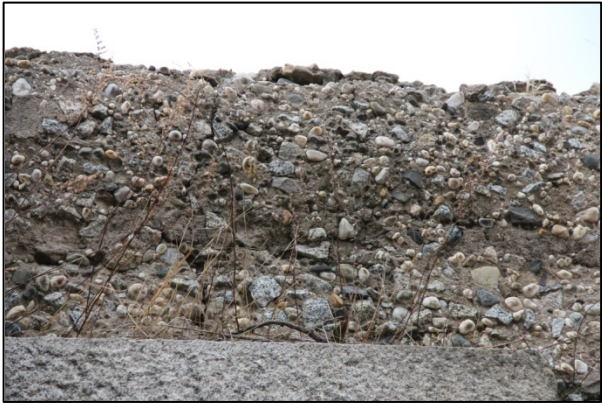
Figure 72: Coarse infill concrete used at the Water Battery (1862-67)

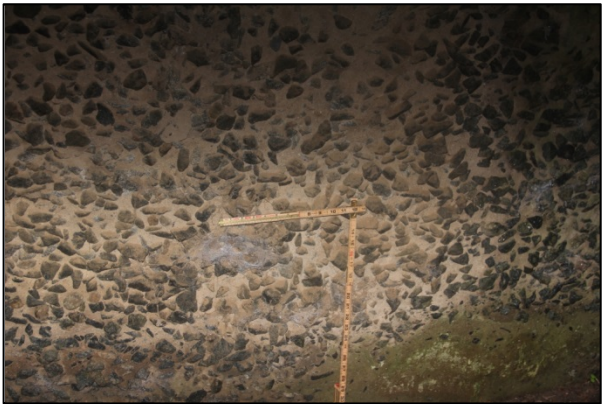
Figure 76: Coarse concrete foundations of Battery Graham 1 (1892-1897)

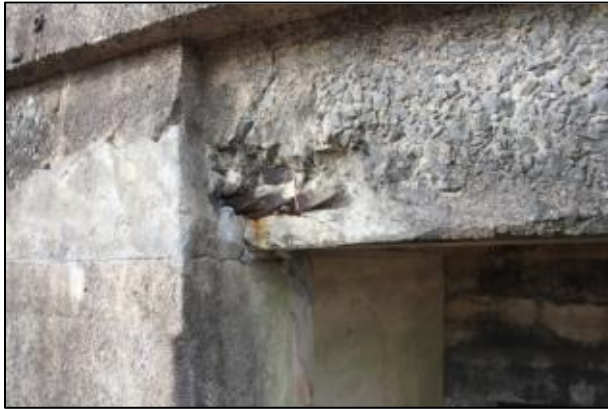
Figure 78: Battery Mahan 1 Upper, southern extension, showing reinforced concrete

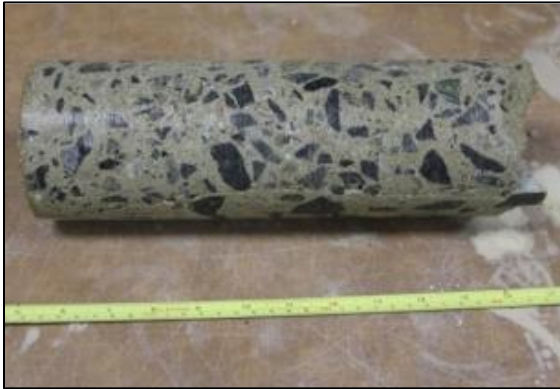
Figure 83: Battery Mahan 1 Upper Core (1898-1900), note the lift line

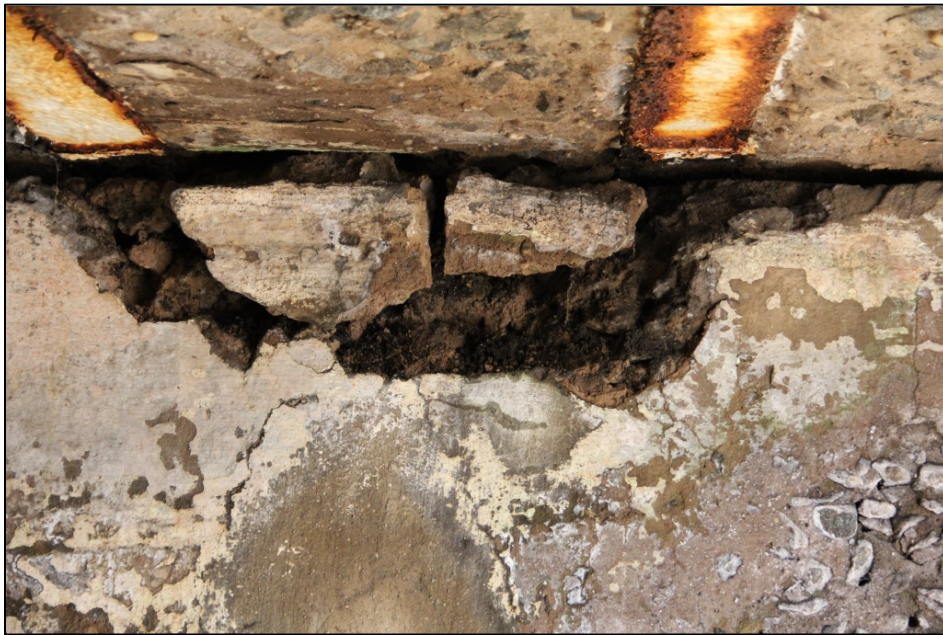
Figure 97: The gun emplacement foundations of Battery Graham 1 (1882-1897) with a slag cement coating
