CLADDING THE MID-CENTURY MODERN:
THIN STONE VENEER-FACED PRECAST CONCRETE

Submitted in partial fulfillment of the requirements for the degree
Master of Science in Historic Preservation

Columbia University
May 2016

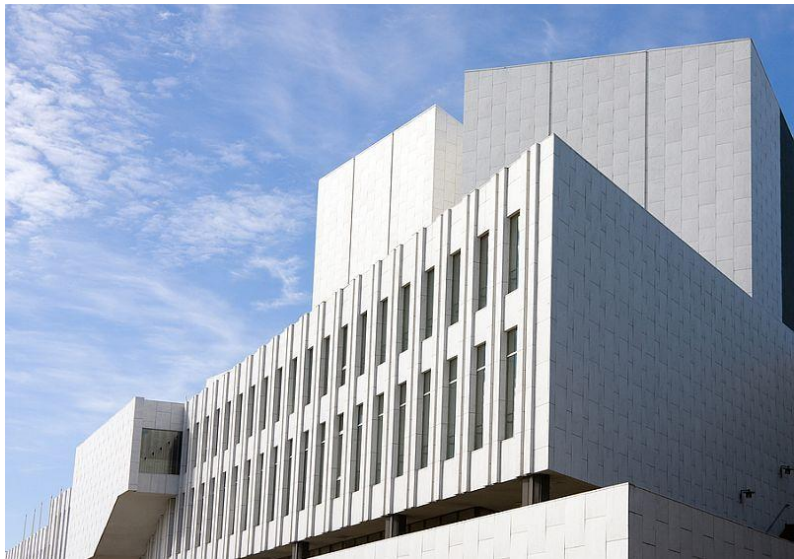
Figure 1.1 Finlandia Hall - Helsinki, Finland

Almost as soon as it was introduced, problems and failures regarding thin stone veneer and its response to the natural environment surfaced immediately. Some of the more well-known cases are Finlandia Hall designed by Alvar Aalto and the former Amoco building in Chicago. The thin stone Carrara marble cladding installed at Finlandia Hall started to show signs of failure six years after its completion in 1971. In 1997 the

decision was made to reclad the building with the same material with specifications that adjusted the thickness and anchor placements of the panel to address the deterioration and bowing that occurred. Despite the efforts, the marble panels, once again, began to bow as a result of hysteresis. In terms of historic preservation, it became a unique

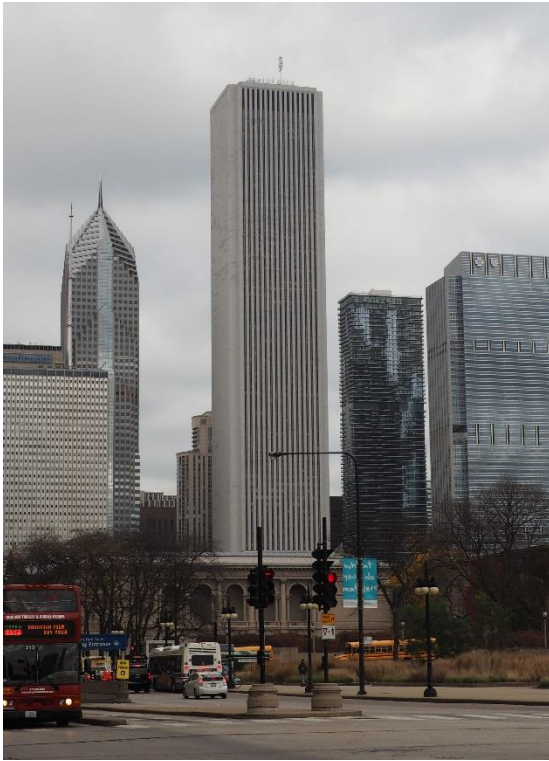
Figure 1.2 Aon Center- Chicago, IL

example of a failing building material and system on a significant piece of architecture.¹⁸ The former Amoco building, now known as the Aon Center, was another example of thin stone cladding failure, but this was on a building that rose up 83-stories, into the skyline of Chicago. Completed in 1974, this high-rise building was also clad in Carrara marble with a thickness of 1 inch. At the time of completion, the attention the project received was due to its innovative structural framing that used a chevron column system and the use of thin stone veneer cladding.¹⁹ However, an inspection of the building in 1985 revealed significant failures in the thin stone panels and further testing showed the impact of weathering in relation to strength. By 1988, 30% of the marble panels were bowing outwardly by 1/2 inch to 1-1/2 inch.²⁰ Due to

the public's previous interest in the building and the alarming issues of life safety that the bowing marble panels displayed, the project instigated changes in cladding design standards. The exterior of the building was completely recladded with a 2 inch thin stone granite. The legal responsibilities between the client and

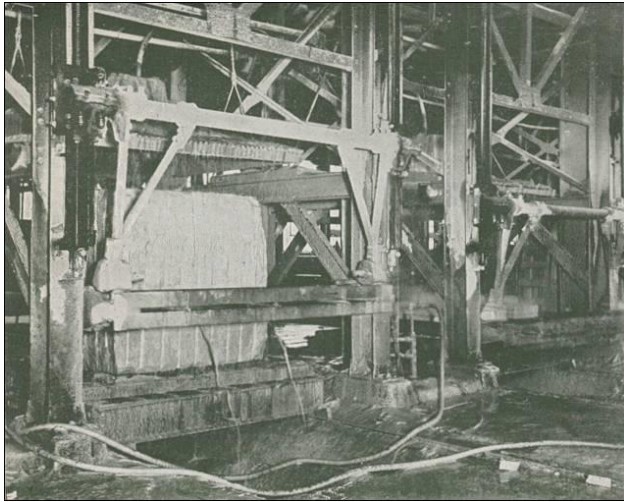
Figure 2.1 Gang-saws – Georgia Marble Quarries

1980s was the introduction of diamond-studded cables to slab blocks and frame saws with metal abrasives allowing stone to be cut down to 1/8" in thickness and used as facing material for developing composite building units.⁴¹ Even though the overall process is an ancient practice, new industrialized methods and equipment changed the way stone was quarried and finished. Stone was an old material but the change in thickness made it into a completely new product.

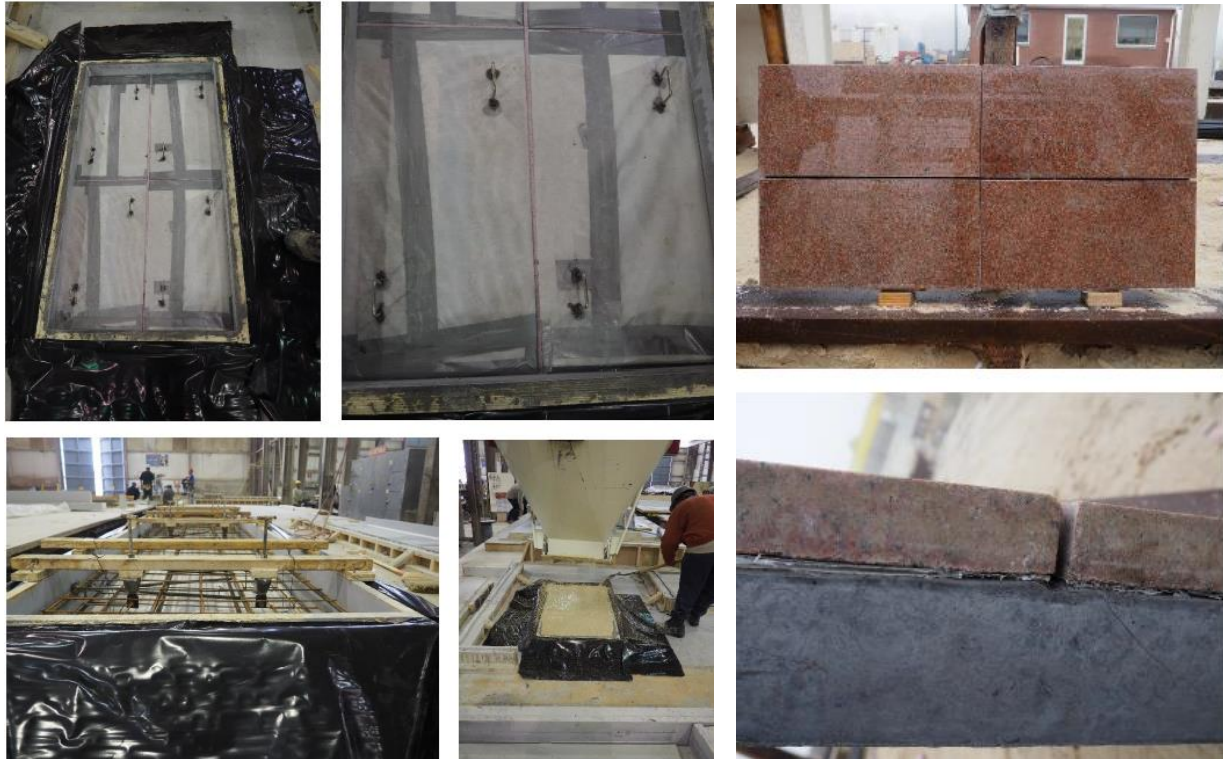
Figure 3.7 Gate Precast Demonstration: a.) stone and bondbreaker in wood mold b.) anchors and epoxy c.) secured rebar d.) pouring of concrete e.) finished panel surface with red granite f.) side view of precast concrete, bondbreaker, and granite

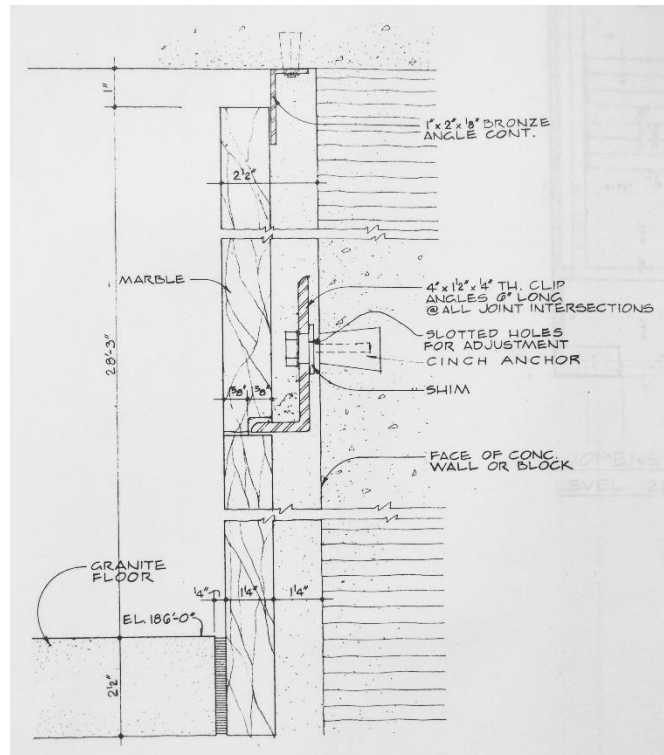
Figure 4.3 CEC – Typical Wall Section, 1966
(Source NYS Library)

exterior wall sections on sheet 64/4-54, 2” marble veneer anchored into 8” thick brick backup was specified.¹⁵¹ The typical wall section for the building was illustrated as a 1-1/4” thick marble casted to a floor fill cement with a thickness of 1-1/4” anchored into the backup concrete or concrete blocks. The detailed section does not show any use of dowels or pins to secure the connection between the marble veneer-facing. The drawings do indicate the cast in place clip angles that attaches to the backup with a chinch anchor.¹⁵² In terms of the section cut through the upper marble fins, the 1966

drawings show a marble veneer facing of 2-1/2” with a gap of 1-1/2” and the concrete surface to be treated with a damp proofing on the surfaces. These marble veneers are anchored into the 8” concrete back-up and only the coping on top had dowels.¹⁵³ When comparing these drawings with the copy at Avery Library the marble veneer has changed to marble faced-precast concrete panels from the marble veneer. The drawings at Avery Library are dated 1968. On sheet 64/4-104, the elevation illustrates the upper fins that surround the window openings as marble faced precast concrete panels. This is a change from the 1966 drawings

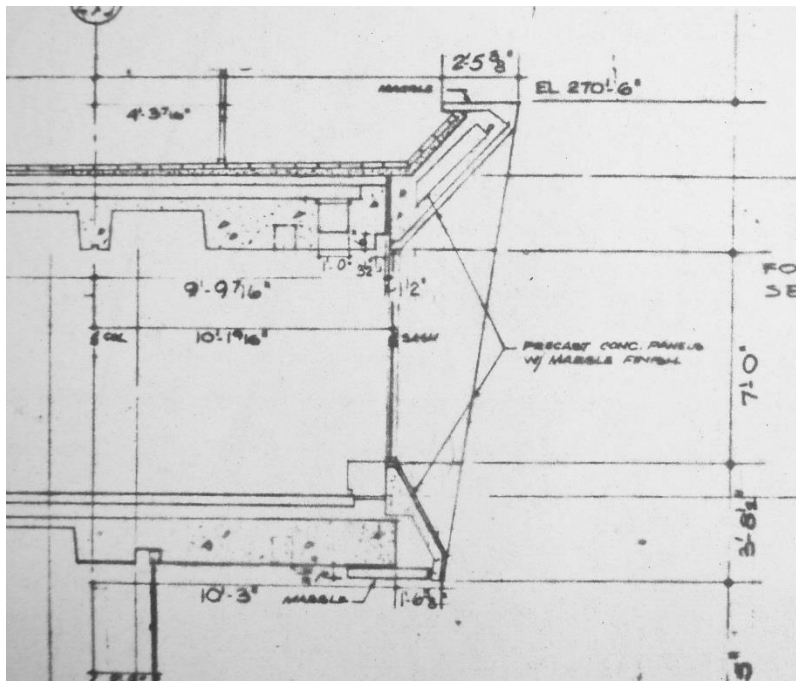
Figure 4.5 CEC – Section of Marble Fin, 1968 (Source Avery Library)

which specified them as marble. The section elevation thru the façade depicts the wall sections with details that indicate the facing material as precast concrete with marble. The 1966 façade section indicated a marble veneer facing attached to the back-up with anchors.

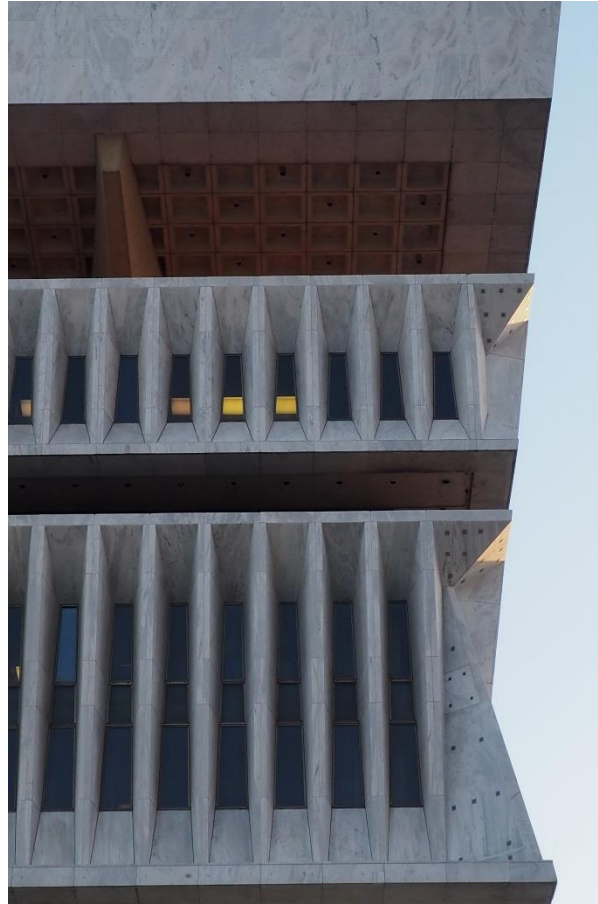
Figure 4.6 CEC – Bolting of Edge Panels

arranged in a vertical direction. The large panels have six bolts around the edges and the smaller panels have four bolts to secure them into place. Over the years, repairs have been done to the CEC building by a number of firms including Wiss, Janney, Elstner Associates, Inc. and Simpson Gumpertz & Heger. This case study depicts the early uses of *stone veneer-faced precast concrete panels* and how repairs have been handled over time. As an important government building that has a significant history, the repairs respond to this status.

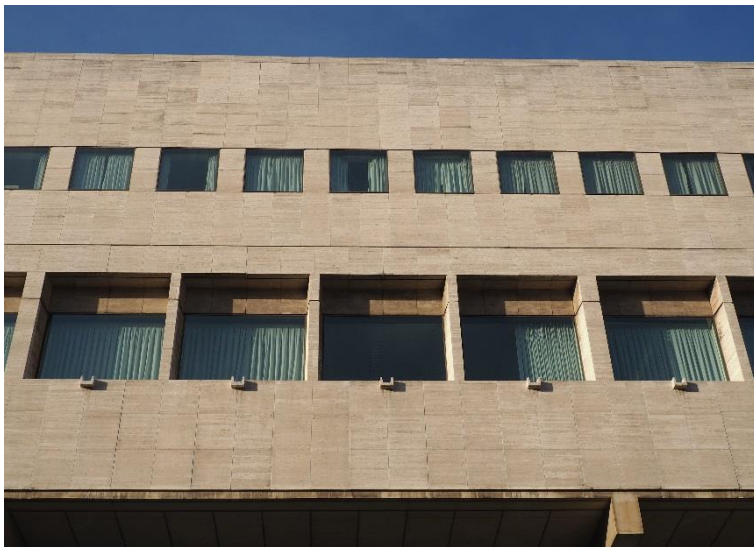
Figure 4.10 Juilliard School – Travertine Panels

and the Alice Tully Hall was 7/8” thick, attached to a precast reinforced concrete panel with a thickness of 3-6”.¹⁶⁵ Since the completion of the building in 1969, there have been a series of repair work done. In 1986 there was a stabilization program implemented at the Lincoln Center for the Performing Arts, which includes periodic on-site inspections and monitoring of the travertine exterior cladding.¹⁶⁶ Past surveys documented façade conditions that demonstrated multi-directional cracking of the travertine, predominately on the east and north elevations. Additional laboratory testing indicates deterioration is a result of cyclic freezing. There was water infiltration into the system, which accelerated the deterioration of the travertine. In some instances, the travertine veneer delaminated from the precast concrete substrate and there were signs of water intrusion and frost behind the travertine. Shims would slip in areas due to movement and panels would become offset from one another.¹⁶⁷

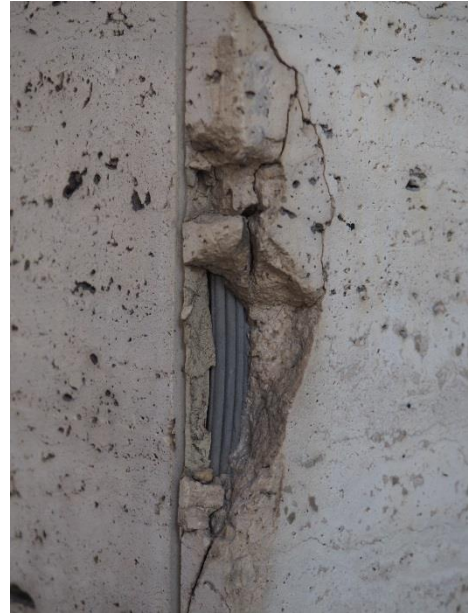
Figure 4.11 Juilliard School – Travertine Spall

During the site visit that was conducted on April 9, 2016 the façade of the Juilliard building was visually observed and photographic documentation was made. The south elevation, overall, does not show any signs of deterioration or severe discoloration. The panels all seem to be in good condition and visually, all the panels look rigid and flush. From a distance, there are panels of travertine that are lighter in color than the surrounding panels, which suggest it may be a replacement. There are indications of soiling on the surfaces of the travertine panels that are deeply recessed and on the surfaces of the exposed concrete underneath the panels. On the underside of the panels on the west elevation, cracking sealant and some rust color run-off is visible across the surface of a few panels. There are signs of dutchmen (indents) repairs on a couple of the parapets on the west elevation. There were also signs of horizontal and vertical cracking of the concrete slabs under the travertine faced panels along the crevice.

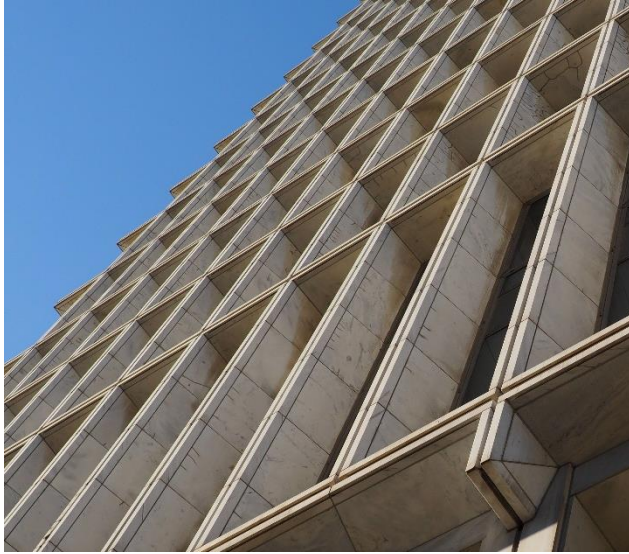
Figure 4.13 Former Life of Georgia Tower –
Panel Deterioration and Repairs

the city, the use of caulking as a repair method indicates a less rigorous concern of the building's aesthetic integrity.

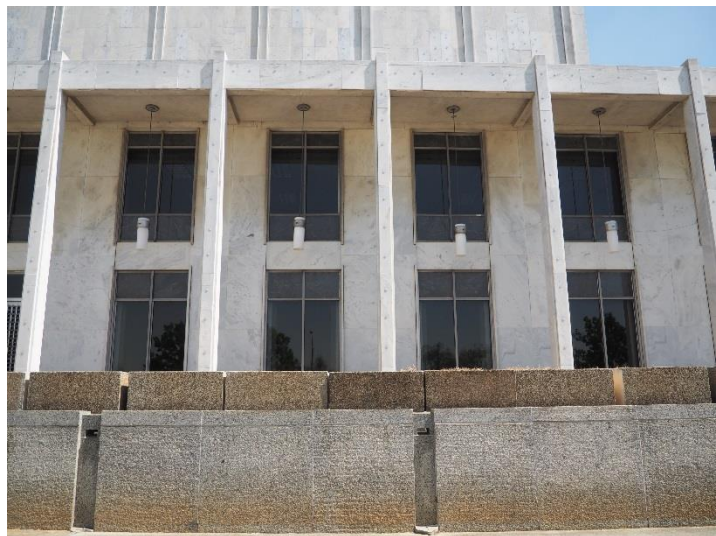
Figure 5.5 Exterior Detail – Bolted Panels

On the first and second floors the thin stone marble facings on the visible narrow surfaces of the columns are all bolted into the backup. The longer vertical pieces have three bolts (one in the center and the other two on either sides) and the shorter pieces have two bolts (one on either edge). The stone veneer marble facing on the flat surface where the columns meet the low roof is also bolted into the backup. There are three pieces of stone in between each column. The two smaller panels on the edges have two bolts and the center panel has three. These horizontal pieces also

conform to the same spacing as the vertical pieces on the columns. From the shadow castings on the surfaces, it is clear that the individual pieces of marble are bowing and do not meet flush with the pieces that they are butt up against. Although the bolting is following a certain principal, it is apparent that the work was done by hand due to the inconsistent locations of the bolts on the marble. The columns are sheathed with marble panels and the smaller panels are located on the west and east sides, which are bowing and warping significantly. The larger marble panels on the north and south side are not showing those properties. To address the bowing, every single marble panel on the west and east side of the columns are bolted into place. There is also significant soiling of the marble on the east side of the columns. The large marble panels on the exterior walls of the building look stable and show no significant signs of distress or bowing. These pieces of marble are placed in a way to show verticality; however, there are some areas where the jointing material changes from mortar to caulking. Some of the caulking was debonding from the surface of the marble around some of the joints. One of the vertical fins near the ground where it meets the precast paver near the south west end was sheared off. The underside of the extended low roof show signs of soiling and water damage that have caused the stone to change color, particularly at the corner joint on the far south west corner. Metal brackets have been put into place to keep the stone panels on the ceiling stationary and secure. The solid stone façades are bolted inconsistently. Some of the bolted marble pieces look like new replacements due to the lack of conformity in terms of color and marble veining. Each of the bolted panels have three bolts. The pieces with the bolts are also the ones that show signs of warping and bowing. They

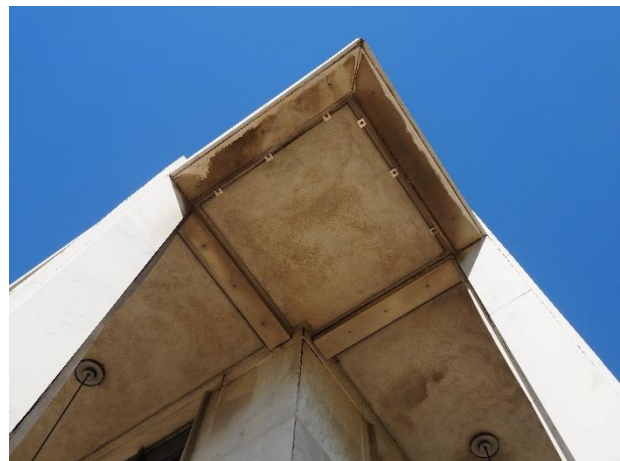
Figure 5.7 Exterior Deterioration – Metal Brackets

are not flush around the edges with the surrounding pieces. Upon closer observation the marble pieces, those with a yellow tint are most likely not replacement panels. They are the panels with small horizontal cracking. There are two areas on the upper right hand side of the façade where there are what looks like brownish circular rust marks on the surface of the replacement marbles. Both are not in the areas around the bolts but slightly to the bottom edges of the pieces. There are a total of 26 window openings on this façade. The aluminum sash seem to be the original sash. Although there is soiling on the vertical marble surrounding the windows, the marble slabs are all in its proper location. The main doors have a decorative aluminum grill element that appears to be clean and in working order. There is a total of 14 hanging light features that are all present. Finally, the base of the building is built up in a granite and has precast concrete pavers that make up the staircase from the sideways up to the platform surrounding the entrance of main entrance. The precast concrete pavers also have planters that surround the edges of the platform made of

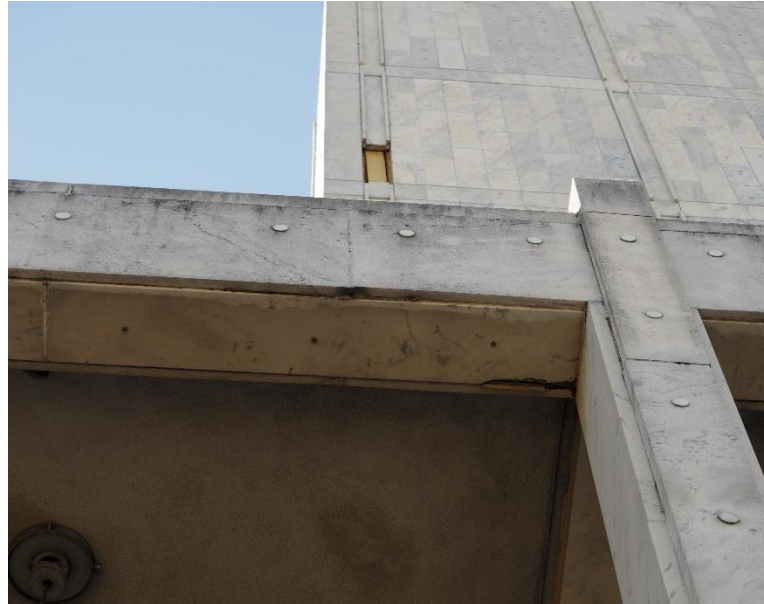
Figure 5.10 Exterior Deterioration – Missing Marble Fin and Bolting Repairs

corner piece was replaced and then bolted into the backup. All of the edge panels along the horizontal piece of the lower roof is bolted and the vertical pieces of the columns are also bolted in from bowing outwards. These same edge pieces around the extruding interior space has also been bolted. The horizontal marble elements that face the top of roof surfaces show soiling patterns in the form of back streak

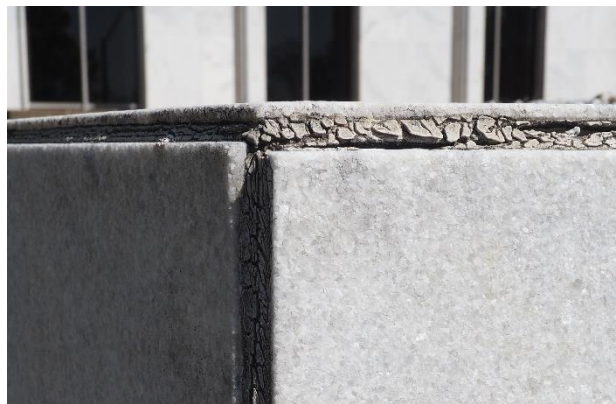
Figure 5.11 Exterior Deterioration –
Moisture in Foundation

The two fountains near the main entrance of the building are a part of the original design. The failing caulking and mortar between the joints of the marble has caused the stones to pull apart from one another. The stress in movement has also chipped corner of the marble off and exposed interior shims and shelf angles that are now open to moisture and additional corrosion. Some of the openings measured at nearly 1-3/4" in height and 4" in length. The deteriorating caulking is cracking and flaking off allowing moisture to penetrate and corrode the structural systems. The marble cladding that makes up the fountains have mechanical damage as well as serious deterioration leading to delamination and sugaring of the marble. The grains are visibly loose and the stone panel no longer meet with flush edges.

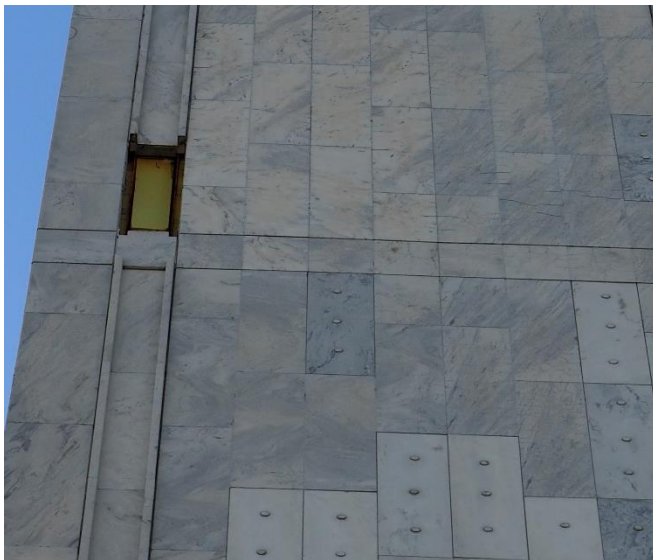
Figure 5.13 Exterior Deterioration – Exposed Façade Systems

The building owner decided to address the issue by bolting any loose or bowing panels with white color bolts. This decision addressed the danger of falling marble pieces; however, did very little to address or understand why the marble was delaminating from the precast in the first place. Also, looking at the variety of colors and striations of the bolted marble, it makes one question if these pieces are replacements. On top of this issue, the flexural cracking of the marble is another concern. Flexural cracks, in this instance, can be caused by the materials relationship with the backing material of different thermal expansion qualities or hysteresis; however, the reasons for the horizontal cracks cannot be confirmed without of testing. There may be a correlation between water absorption and freeze-thaw that is causing the observed conditions for this building. The following is not an example of marble faced precast, however, marble veneers are located on the interior areas underneath the covered ceiling demonstrated severe bowing. Also, along the covered ceiling below the low roof, most of the veneer pieces have been bracketed and bolted into place; however, there are a number of pieces that have either spalled, cracked, or gone missing. Overall, the damage is quite extensive and visible to the attentive eye.
