# Inherently Flawed: Carbonation-Induced Cracking in Reinforced Concrete Structures

Submitted in partial fulfillment of the requirement for the degree  
Master of Science in Historic Preservation  
Columbia University Graduate School of Architecture, Planning and Preservation

May 2017

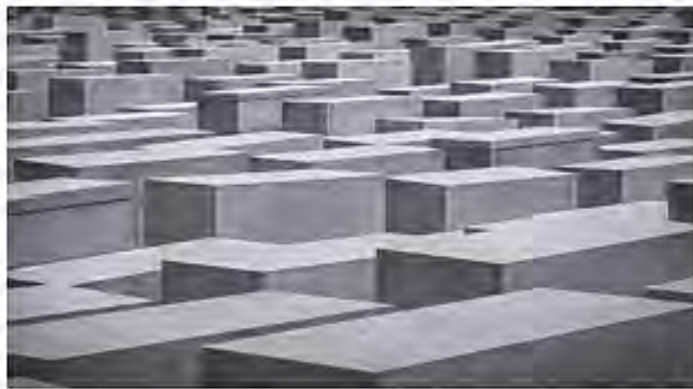
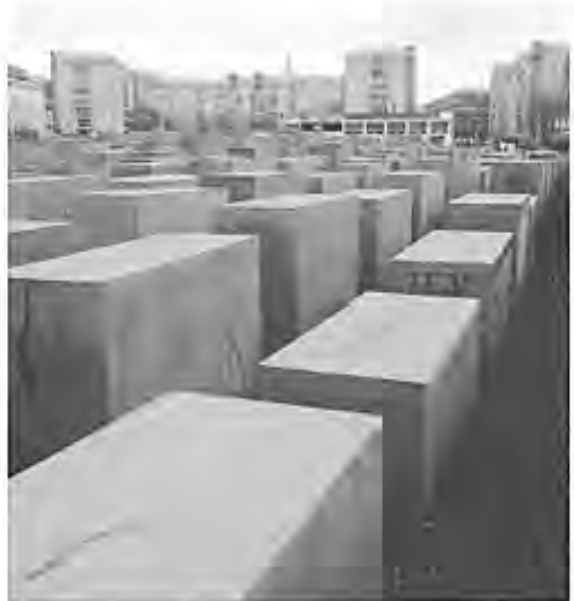
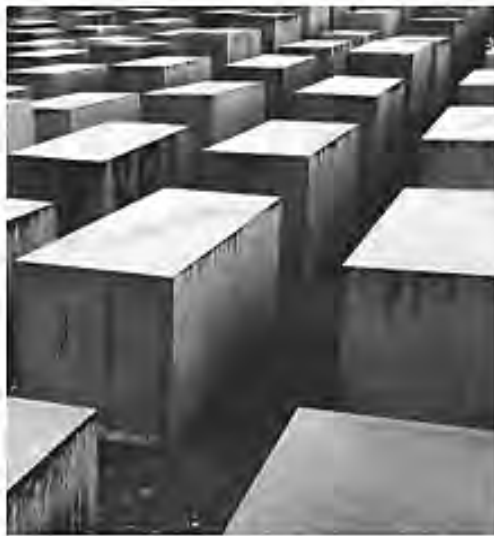
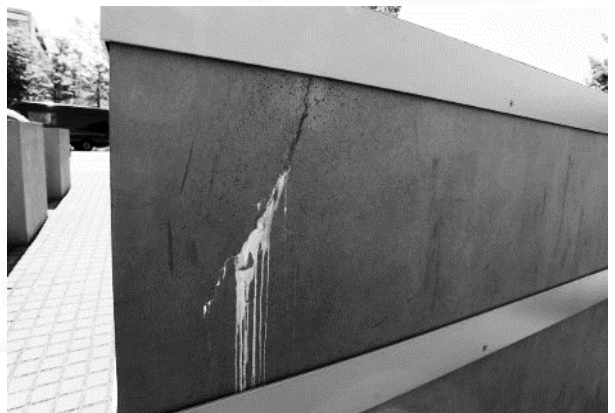
*Figure 1: Images of the Memorial to the Murdered Jews of Europe, 2015, student photos. Photos show signs of cracking; the image on the bottom right shows steel collars reinforcing the concrete pillar.*

to the public in 2005. Today 80% of the 2711 concrete stelae are cracked. Cracks were recorded on the stelae as early as seven months after the memorial opened to the public. The smooth concrete surface of the blocks is central to Peter Eisenman's design for the memorial, but the cracking of the concrete makes the site unsafe for visitors, who enjoy the interaction with the monument. By 2014, 420 of the stelae were secured with steel ties to prevent expansive cracking. The memorial encouraged me to research philosophical questions posed by conservators; such as how do we preserve sites of recent and modern heritage? And, what is the difference between a construction defect and a conservation issue?

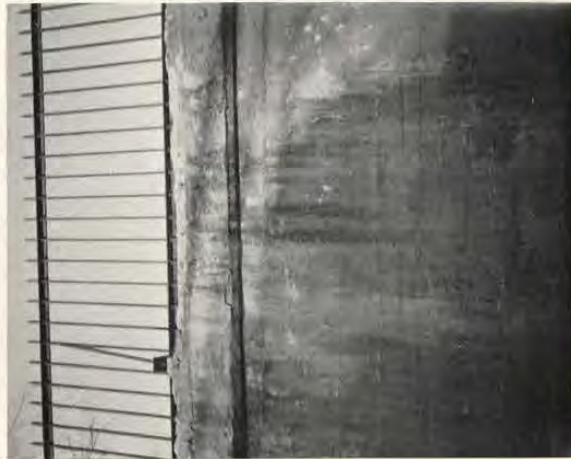
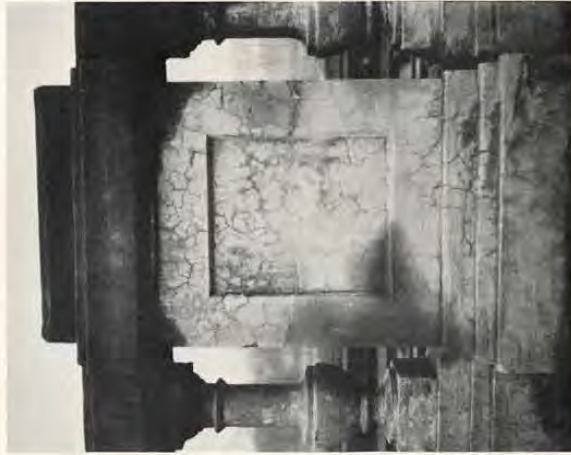
Figure 4: David Levi Snader, 1937.: "Plate VIII, Fig. 1, shows part of a retaining wall several hundred feet in length, at a section where disintegration has occurred in particular in the top of the wall. Fig. 2 shows part of the balustrade of a bridge in a large city. The structure is of modern design, has pleasing lines, and probably was built under modern engineering conditions.

In both structures a characteristic network of veins and cracks has developed, which are more than simply surface cracks. They show a condition of the concrete which usually leads to the breaking up and falling away of the outer, harder, more carbonated shell, variable in thickness, and thereby exposing the interior mass to further attack both from within and without."

material, requires a careful consideration of both its structural characteristics and properties as well as its resistance to deterioration. All materials have certain inherent qualities and characteristics, and unless these can be modified or changed through improved methods of preparation or manufacture, these qualities become limitations to proper use if desired results are to be obtained.<sup>19</sup> (Figure 4)

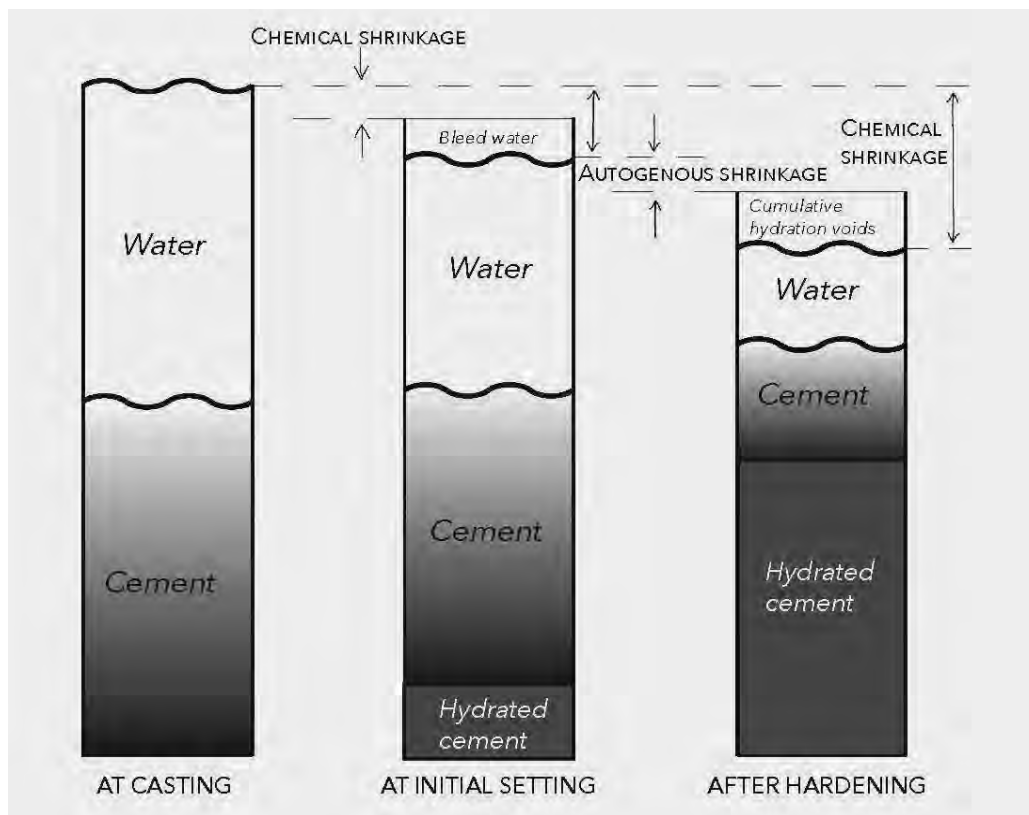
Figure 6: Schematic drawing showing various stages of shrinkage and the correlation to the volume of the concrete.

Other immediate construction defects are autogenous shrinkage, the dimensional change of the paste caused by chemical shrinkage, and self-desiccation of the paste. Shrinkage and self-desiccation create tensile stress in the paste and lead to the development of cracks (Figure 6).

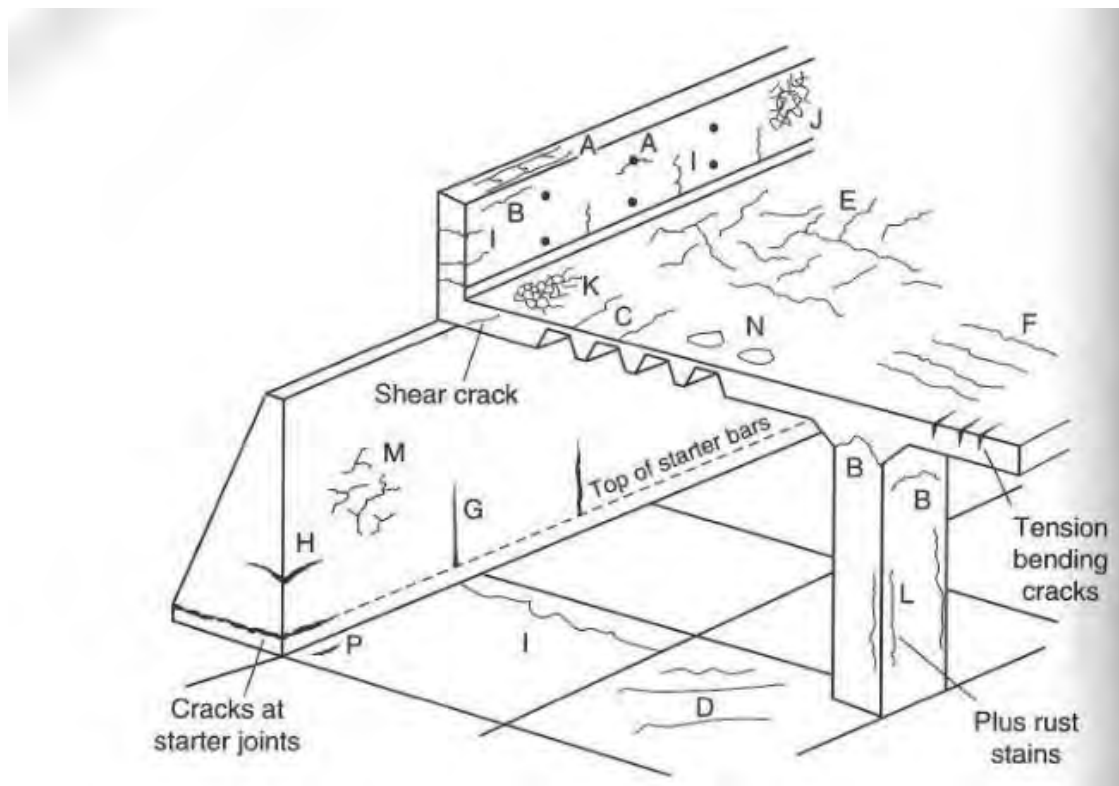
Figure 8: Schematic representation of the various types of cracking which can occur in concrete (See table ). From Concrete Society Report, *Non-structural Cracks in Concrete*, Technical Report 22.3. (Concrete Society, London, 1992), 48.

In-service defects include a broader range of problems including external contamination or surface deposits, moist or wet conditions, surface texture, cracks or crazing, corrosion of steel and rust staining.<sup>36</sup> The severity of a crack can be visually characterized by crack direction—longitudinal, transverse, vertical, diagonal, or random—and width. Crack widths can easily be measured with a crack gauge or ruler. Cracks as small as 0.05mm can be seen on the dry surface of concrete. Table 7 is a useful reference for type of cracking, location, causes, and time of appearance. Table 7 corresponds with Figure 8, which is a diagrammatic representation of common crack locations.

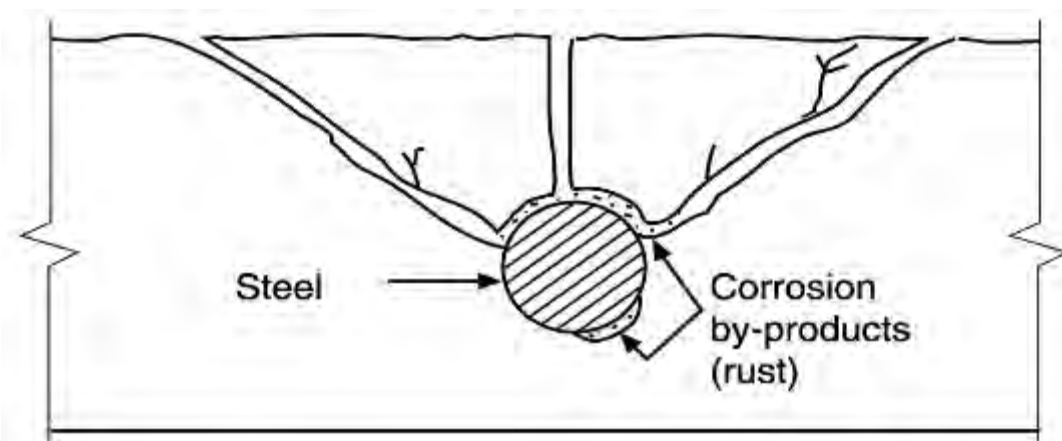
Figure 10: The expansion of corroding steel creates tensile stresses in the concrete, which result in cracking, delamination and spalling. Source, "Types and Causes of Concrete Deterioration", PCA Portland Cement Association 2002.

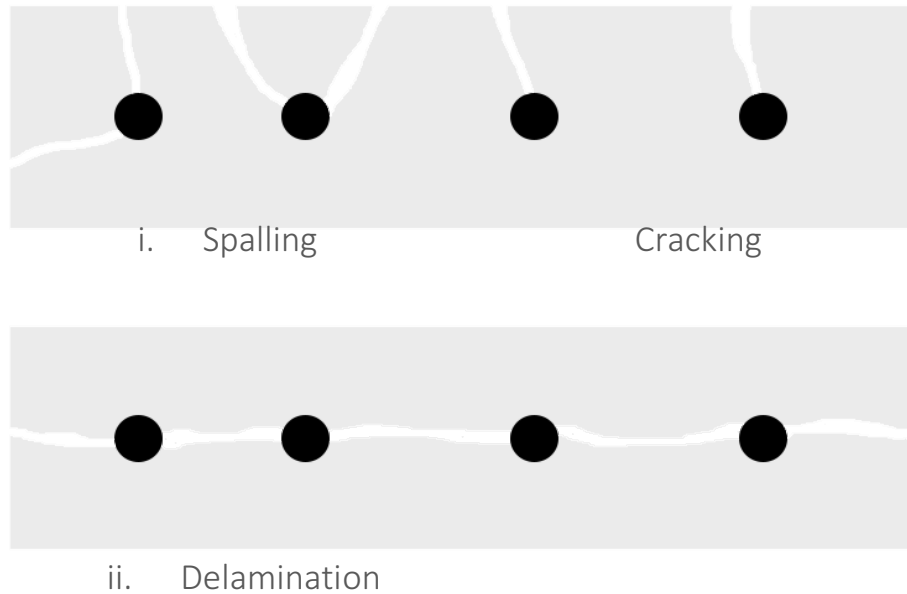
*Figure 11: Description of Defects, Source: Rendell. Spalling and delamination are considered types of cracks in this schematic. Spalling describes small pop-outs of concrete due to corrosion of the reinforcement, and delamination describes total loss due to what we can describe as internal cracking.*

Rebar embedded in the hydrated cement paste forms a passivating oxide layer, protecting the steel from the reaction with oxygen and water. To maintain the passivated oxide layer, the pH of the cement paste must remain high. During carbonation, when calcium hydroxide reacts with carbonic acid, partial neutralization of the pH of paste (from about 13 to 8) results, destroying the passivating layer on the steel. Subsequent corrosion causes a net expansion of steel and corrosion (Figure 10). If the rebar is too close to the surface, or if the concrete is too porous, carbonation will reach the reinforcement in a shorter amount of time, and the concrete will crack (Figure 11).

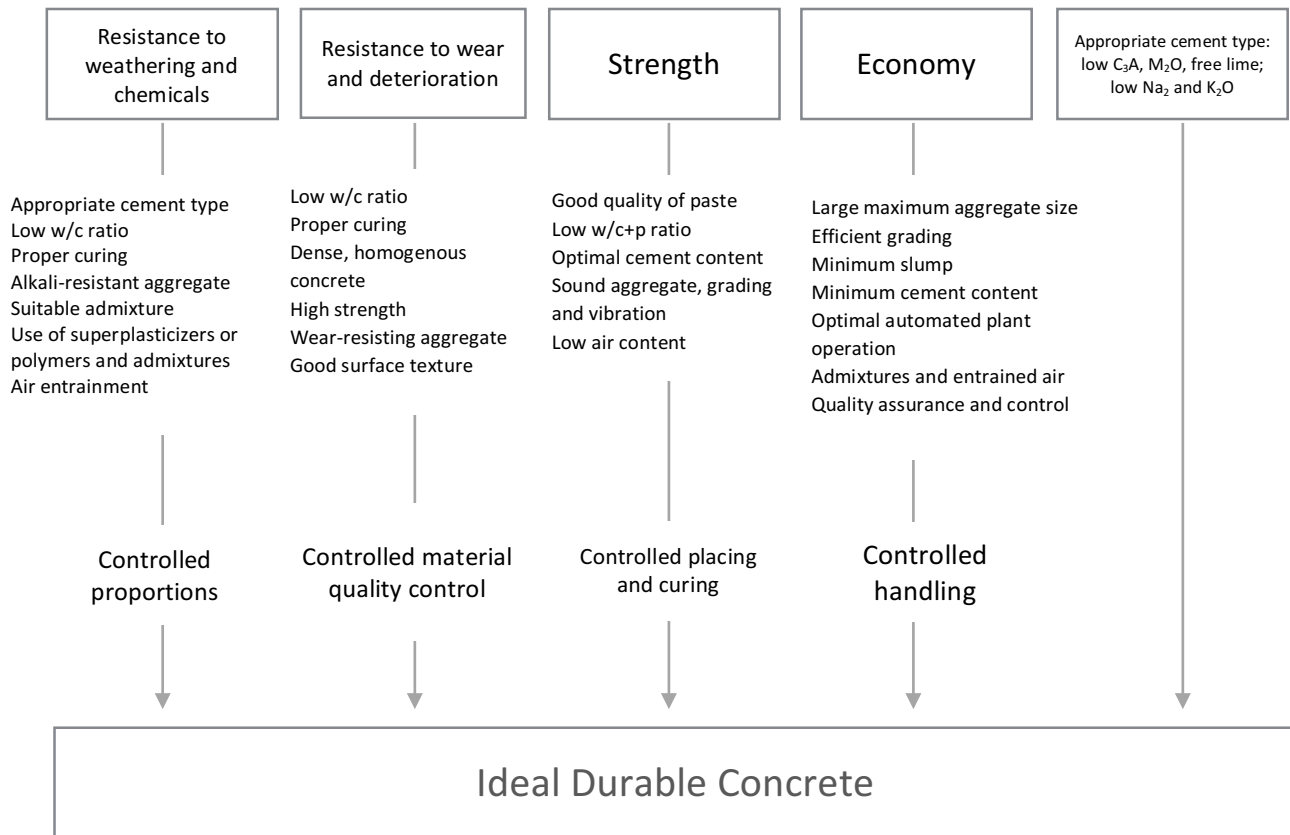
Figure 12: ACI 211.1 "Ideal Durable Concrete", representation of the principle properties considered during the mix design for "good concrete".

water-cement ratio, density, and generation of heat.<sup>45</sup> Figure 12 is a representation of the principal properties considered to establish the mix design for "good concrete".

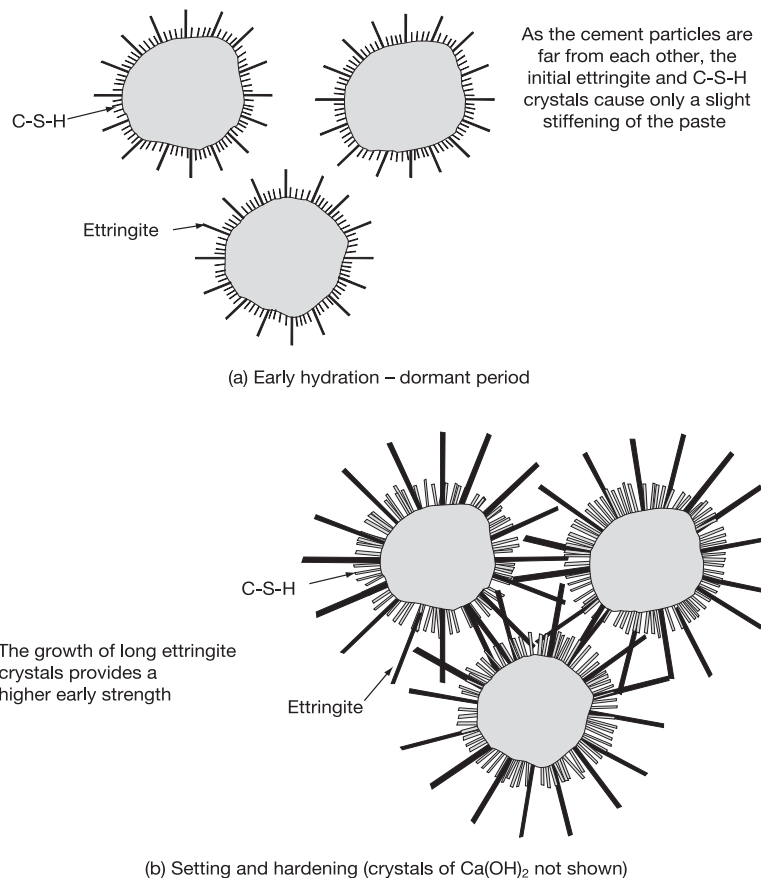
Figure 14: Schematic representation of the hydration of a paste with high w/c made with Portland cement with a high content of C3A. Schematic source: A.M. Neville, *Properties of concrete*, John Wiley & Sons, Inc., Malaysia, 1997.

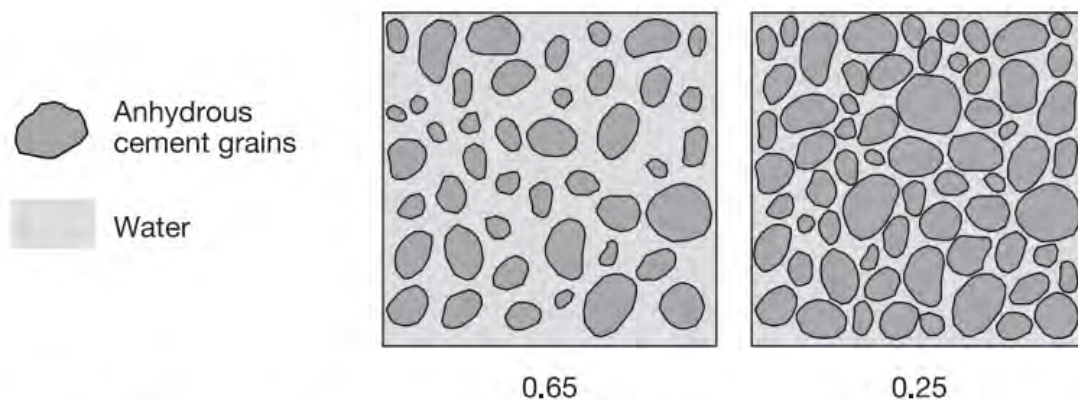
Figure 15: Diagrammatic representation of fresh cement paste with a w/c of 0.65 and 0.25. The ratio of the areas of water and cement is equal to the W/C by volume. from Adam Neville, *Concrete: Neville's Insights and Issues*, Thomas Telford, 2006.

During hydration, the rapid formation of hydration products (C-S-H and CH) occurs in the space occupied by the mix water (Figure 15). This results in a decrease in total pore volume and an increase in strength. Several early studies connect porosity to strength of the concrete. Moncmanová wrote, “Strength of concrete, whether compressive or bending, is also indirectly proportional to w/c ratio as porosity severely diminishes the strength of all materials.”<sup>58</sup>

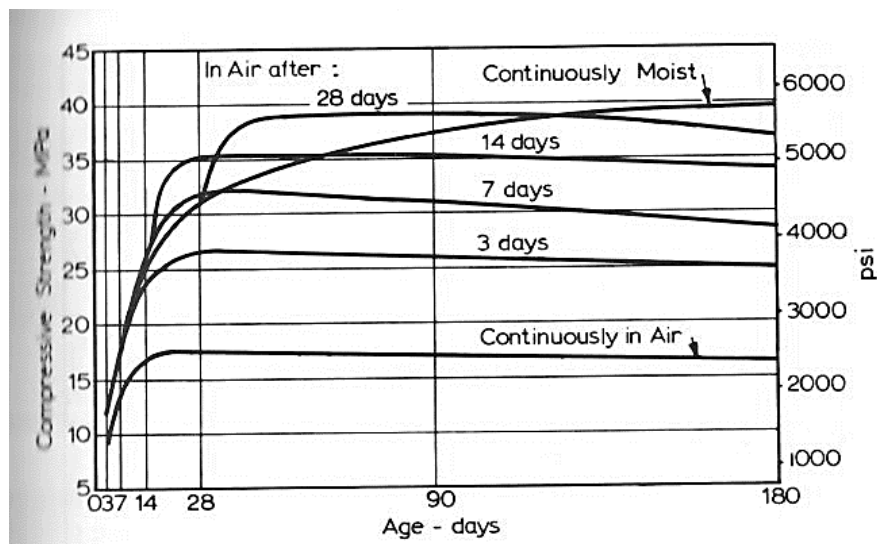
Figure 17: Influence of moist curing on the strength of concrete with a water-cement ratio of 0.50.

Curing influences the manner in which the cement hardens, and the quality of the concrete microstructure. Proper curing is evaluated by considering time, temperature, and ambient humidity. Curing must start after placing to avoid autogenous shrinkage and cracking within the body of the concrete mass. Its influence on strength is directly related to w/c ratios, inadequate curing affects strength at high w/c ratios, and high w/c ratios also show a lower rate of development of strength<sup>61</sup> (Figure 17).

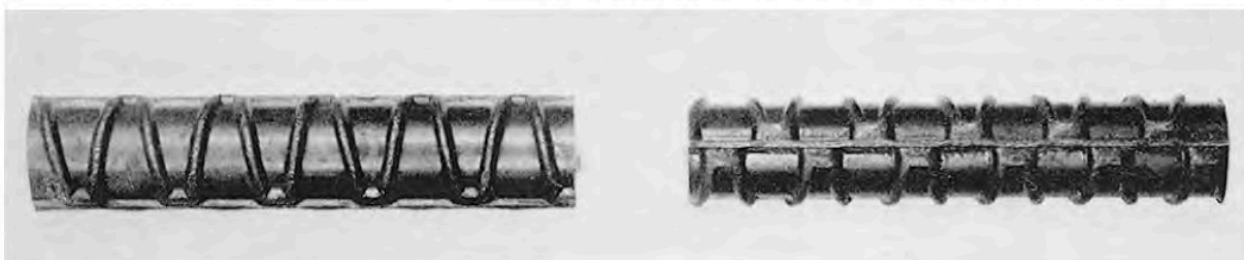
Figure 22: Deformed bars used to better bond the steel to the concrete, distribute strain and limit crack width. National Bureau of Standards, "Control of cracks in reinforced concrete", Publication #C561010, The Aberdeen Group, 1956.

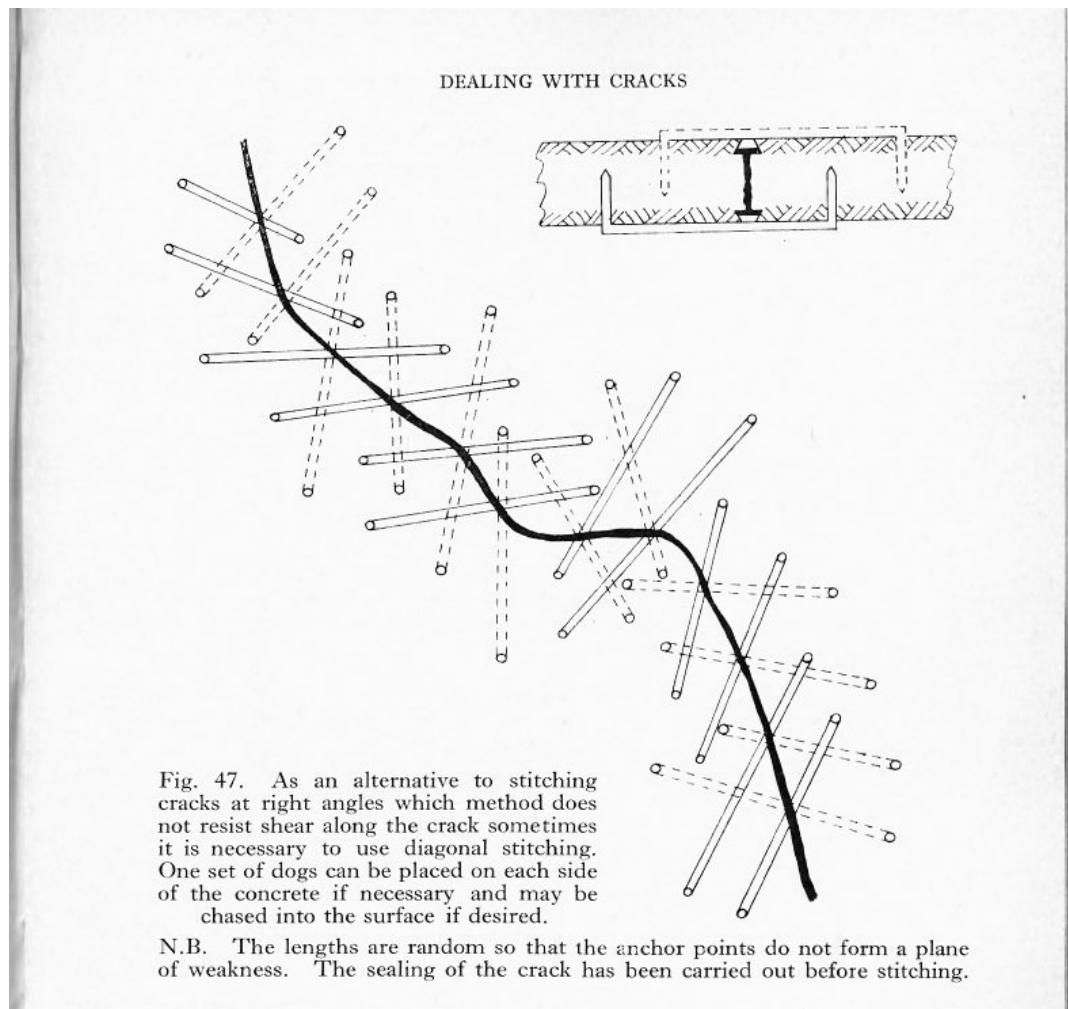
Figure 23: Crack Stitching, S. Champion, *Failure and Repair of Concrete Structures*. Contractors Record Limited, London. 1961.

In 1961, S.Champion wrote *Failure and Repair of Concrete Structures*. The text critically analyzed concrete failure as either chemical or mechanical deterioration, and detailed several methods for repairing concrete, notably crack stitching. (Figure 23)

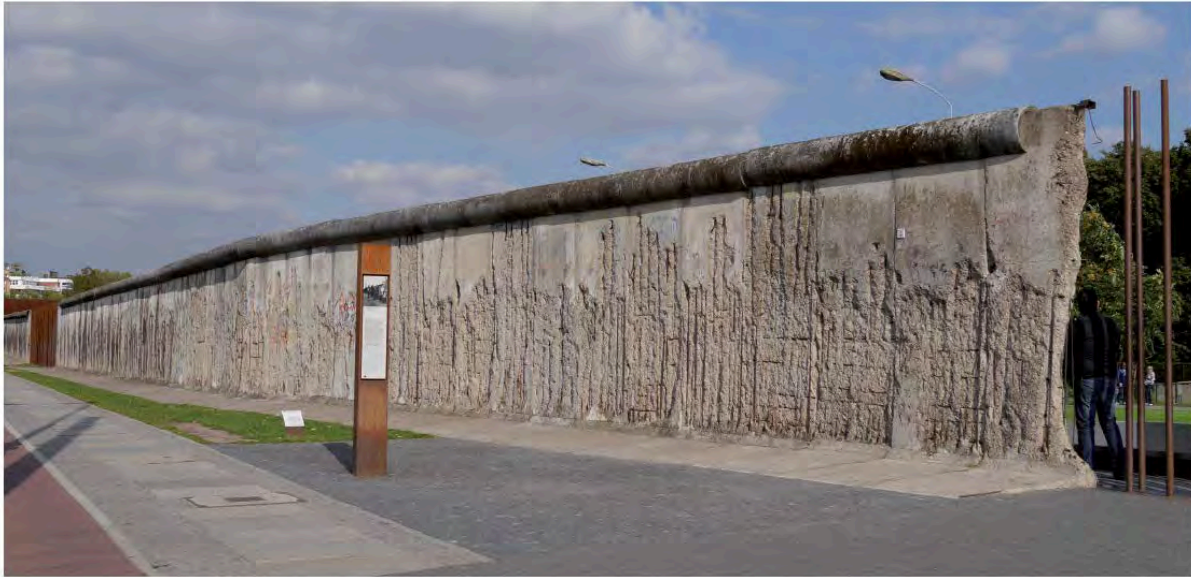
*Figure 1: Section of the Berlin Wall at the Berlin Wall Memorial, Photo Number P1040262. Image Prof.Dr.phil. Leo Schmidt FSA , Anja Merbach MA, Sophia Hoermannsdorfer MSc. Concrete is has been chipped by relic-scavengers.*

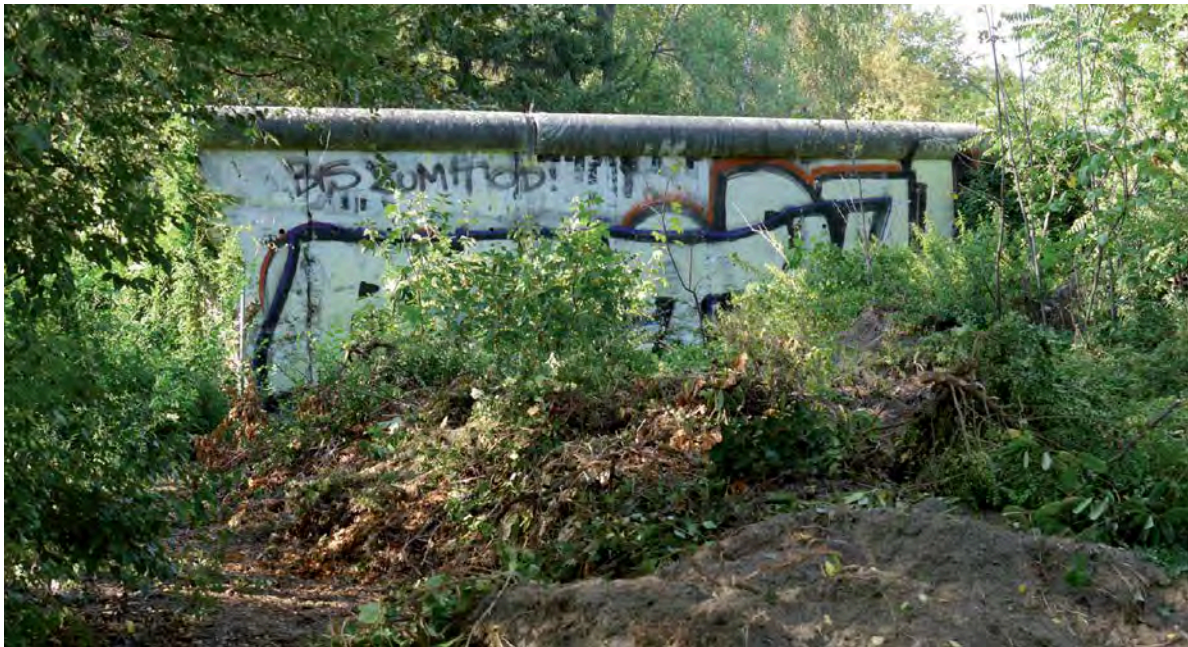
Figure 2: Section of the Berlin Wall, Photo Number P1050279. Image Prof.Dr.phil. Leo Schmidt FSA , Anja Merbach MA, Sophia Hoermannsdorfer MSc.

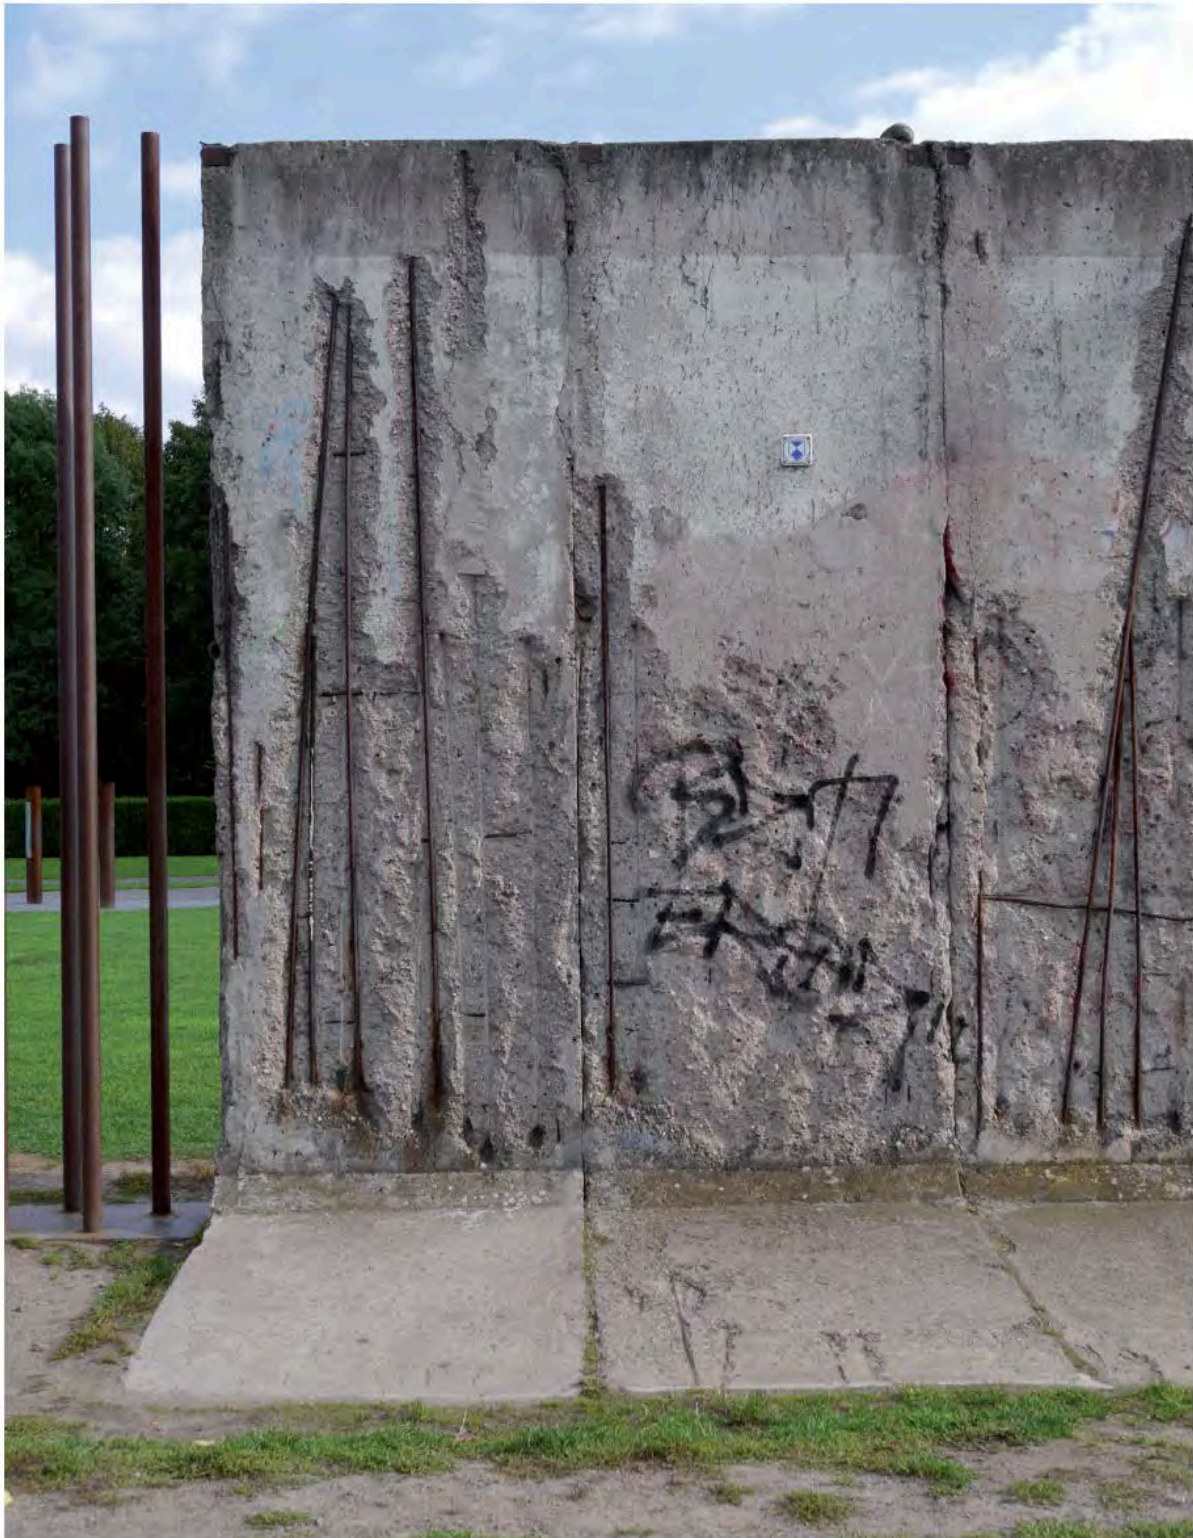
*Figure 4: Section of the Berlin Wall, Photo Number P1050229. Image Prof.Dr.phil. Leo Schmidt FSA , Anja Merbach MA, Sophia Hoermannsdorfer MSc.*

Remaining sections of the wall Berlin are severely deteriorated due to corrosion of the reinforcement, which was placed close to the surface during construction of the prefabricated panels. In 2015 Dr. Leo Schmidt led a project to document the remaining sections of the wall. The documentation report will aid in conservation of the Wall, already begun at the Berlin Wall Memorial.

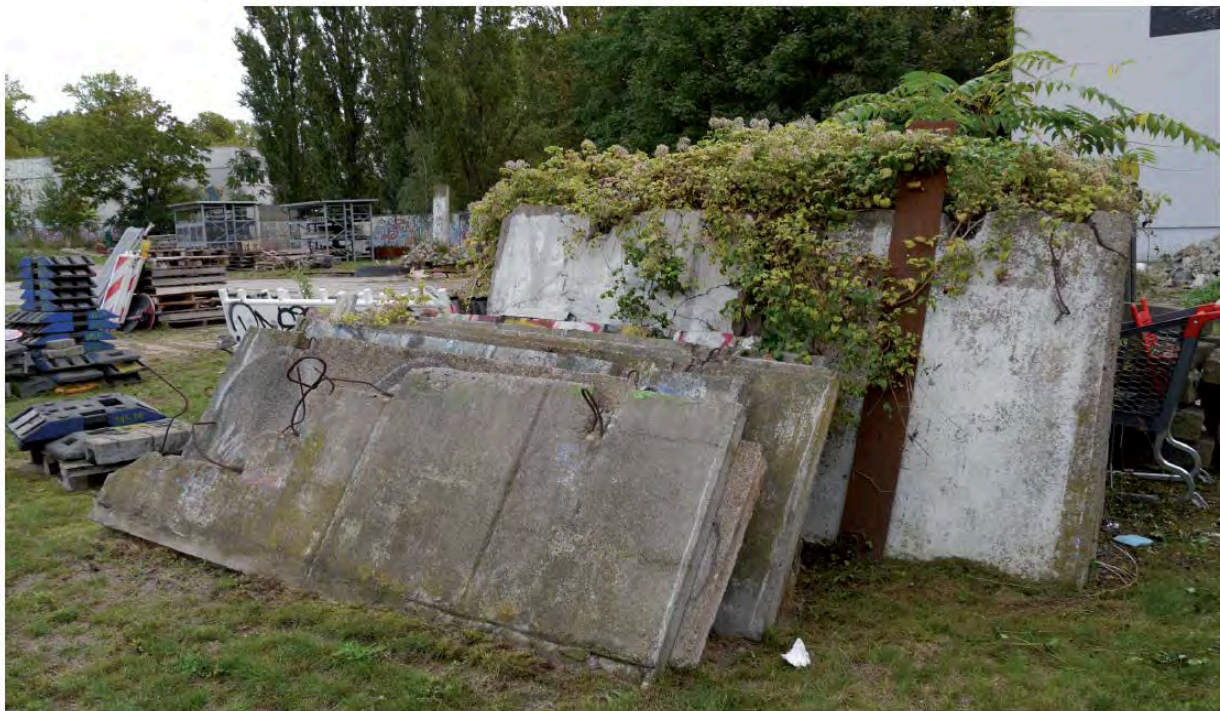
*Figure 3: Figure 3: Section of the Berlin Wall, Photo Number P1040890. Image Prof.Dr.phil. Leo Schmidt FSA , Anja Merbach MA, Sophia Hoermannsdorfer MSc.*

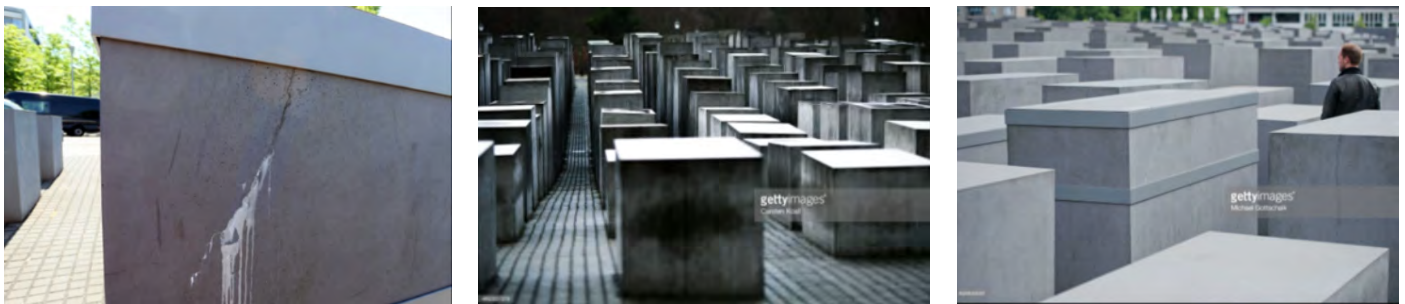
images: deterioration of concrete slabs/ Physical Conditions affecting the site, photos from Getty images

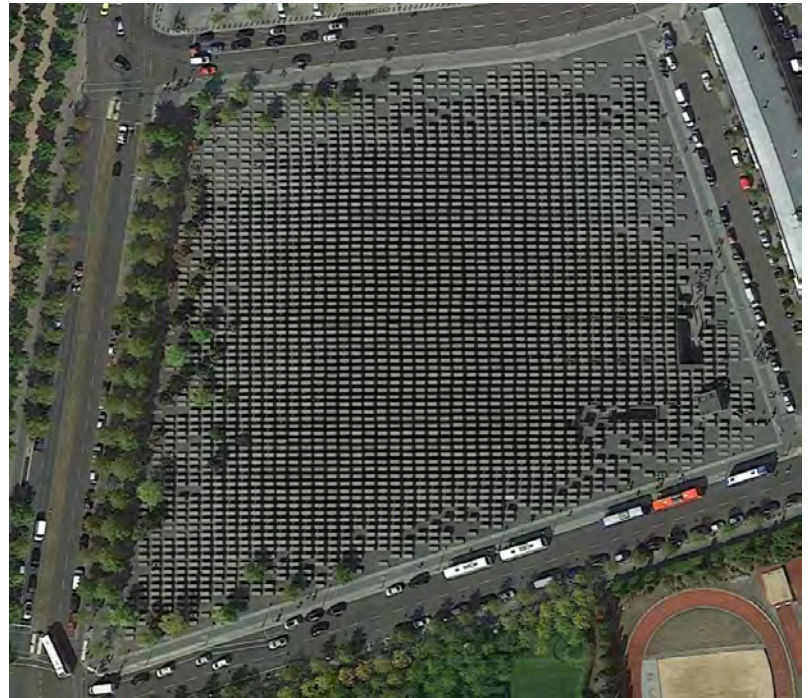
The memorial opened to the public in 2005, but today 80% of the concrete slabs are severely deteriorating. The hairline cracks, the largest 4.7 meters long, began after the field had been open to the public for just seven months. The cracks caused lime run and further deterioration in the stones, which the German media described as "undulating gravestones".<sup>5</sup> The aesthetic appearance of the stones is central to Eisenman's design concept, but their deterioration makes it additionally unsafe for visitors, who enjoy

The reason for the deterioration of the stones is not known, and there is an inconclusive battle of blame between the Foundation, the architect, and the Firma Geithner (Wilhelmshaven/Joachimsthal plant), who developed the specific mixture of “the best concrete Berlin has ever seen”.<sup>8</sup> The concrete stelae were developed by the Firma Geithner to meet particularly high requirements for color and durability as set by the architect Peter Eisenman and the German Senate prior to construction in 2003. Each stone had to be meticulously checked against one of ten reference stones individually approved by Eisenman, and the process only saw the creation of 16 stelae per day, 60 per week. But, in 2014, Eisenman accused the Firma Geithner of changing the material composition of the concrete to cut costs.
