# Contact Analysis and Simulation of Rolled Plastic Film Used for Roof Ventilation in Japanese Greenhouses

N. A. Noda, L. Wang, H. Nagatomo, Y. Sano, Y. Takase

**ABSTRACT.** Greenhouses are capable of producing a variety of high-value crops year-round. A novel Japanese greenhouse design is gaining popularity because of its automated roll-up ventilation system that is integrated into the roof. However, due to the frequent movement of the roll-up system, the plastic film deteriorates rapidly and typically lasts for only three or four months. In order to better understand the film deterioration, we studied the mechanics involved at the point of contact between the film and the metal greenhouse frame. We found that film deformation and failure were closely related to stretching and creasing, and these processes were observed at the microscopic level. An experimental device was developed to further study the damage to greenhouse film due to the roll-up movement. We concluded that the reduction in film thickness due to static loading or rolling contact was the best predictor of future film damage.

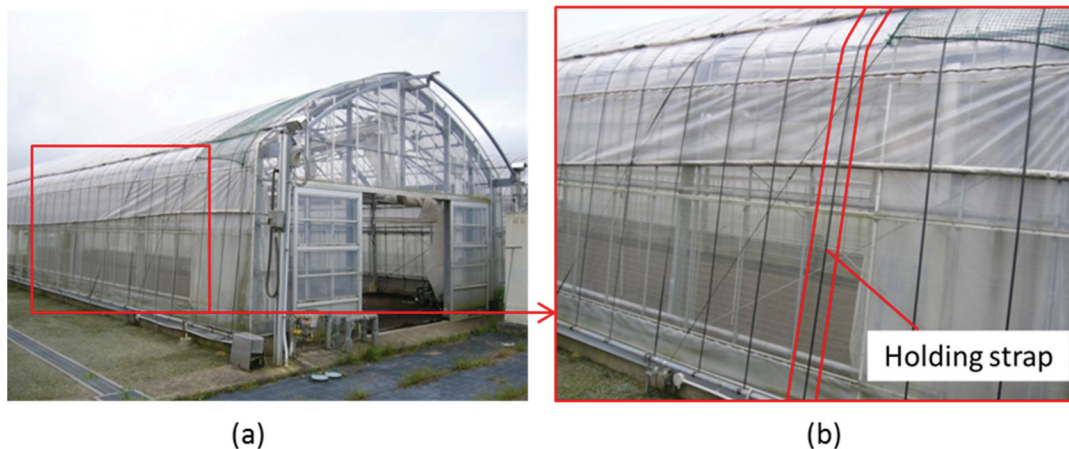
Figure 2. (a) Greenhouse with fully opening roof and (b) straps used to hold the plastic film and roll-up system in place.

actual load increases when the support pipe deflects. Greenhouse roofs are also subject to additional forces imposed by hard wind and rain and exerted by the holding strap (fig. 2). Therefore, we assumed that loads up to 75 N could be applied to the support pipe.

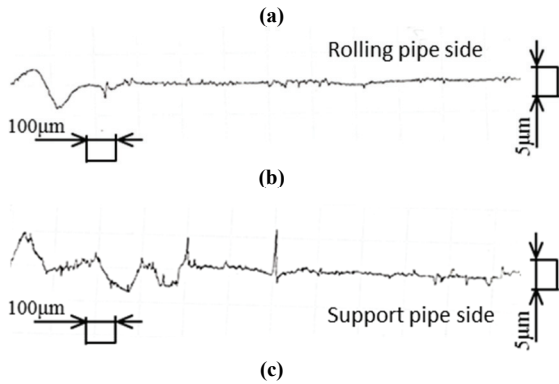
Figure 5. (a) Roughness testing machine used to measure surface roughness of film (type B) after 300 cycles of pipe rolling perpendicular to the rolling direction, (b) maximum roughness ( $R_y = 5.1 \mu\text{m}$ ) measured on the outside surface of the film, and (c) maximum roughness ( $R_y = 11.6 \mu\text{m}$ ) measured on the inside surface of the film (Japanese Industrial Standards, 1994).

Figure 5 shows a roughness testing machine that can measure the surface roughness along a direction perpendicular to the rolling direction. Figure 5b shows the roughness measured on the outside surface of the film, and figure 5c shows the roughness measured on the inside surface of the film (Japanese Industrial Standards, 1994). It was found that the maximum roughness, as defined in JIS-B0601 (Japanese Industrial Standards, 1994), on the inside film surface ( $R_y = 11.6 \mu\text{m}$ ) was approximately twice as large as the maximum roughness on the outside film surface ( $R_y = 5.1 \mu\text{m}$ ). From figures 4 and 5, it can be concluded that film damage first occurs on the inside film surface due to contact between the film and the pipes of the greenhouse frame.

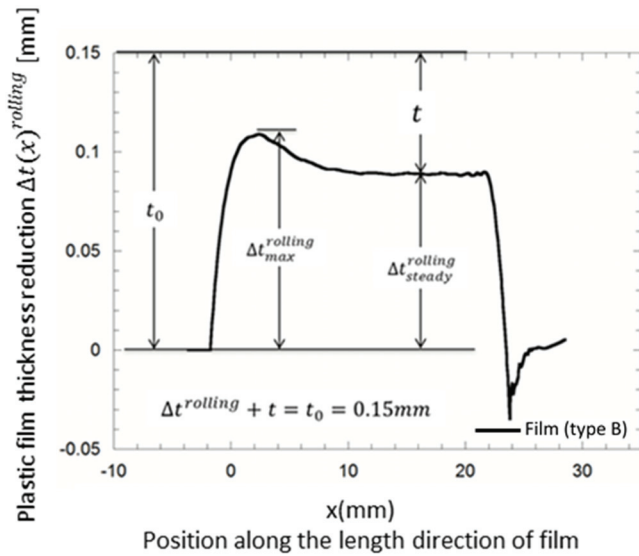
Figure 20. Plastic film thickness reduction ( $\Delta t_{rolling}$ ) along the length direction of film type B ( $P = 75 \text{ N}$ ,  $\mu = 0.15$ ,  $T = 70^\circ\text{C}$ , and  $d_1 = d_2 = 38 \text{ mm}$ ).

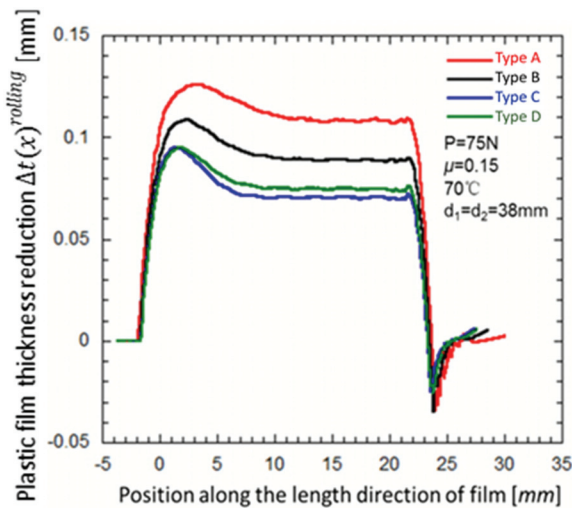
Figure 21. Thickness reduction ( $\Delta t_{rolling}$ ) of four kinds of plastic film along the length direction ( $P = 75 \text{ N}$ ,  $\mu = 0.15$ ,  $T = 70^\circ\text{C}$ , and  $d_1 = d_2 = 38 \text{ mm}$ ).

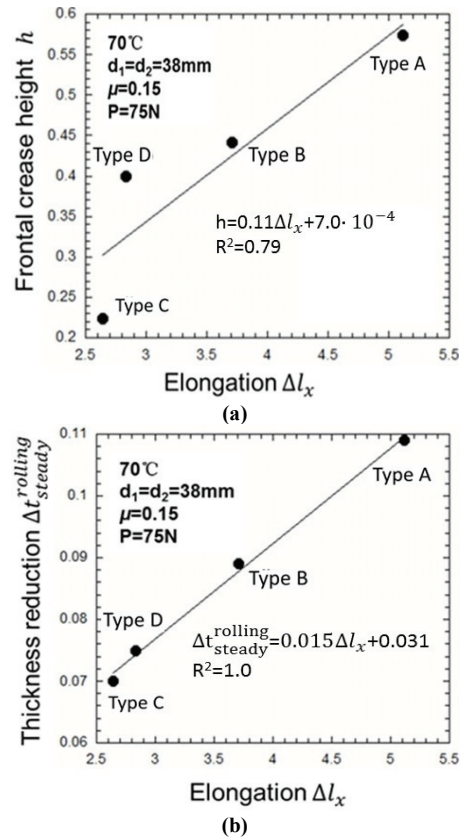
Figure 24. Relationship between (a) frontal crease height ( $h$ ) and elongation ( $\Delta l_x$ ) and (b) thickness reduction ( $\Delta t_{\text{steady}}^{\text{rolling}}$ ) and elongation ( $\Delta l_x$ ).

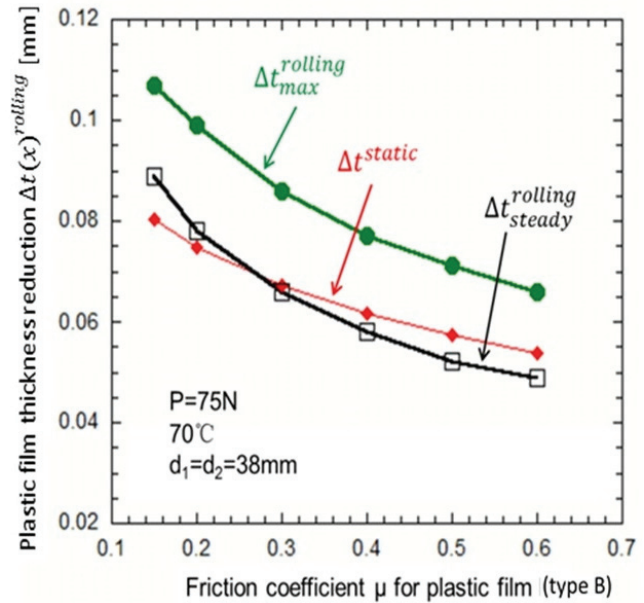
Figure 28. Effect of friction coefficient  $\mu$  on  $\Delta t^{static}$ ,  $\Delta t^{rolling\_max}$ , and  $\Delta t^{rolling\_steady}$  defined in figure 26.
