Using Unmanned Aerial Vehicles to assess the rehabilitation performance of open cut coal mines

To appear in: *Journal of Cleaner Production*

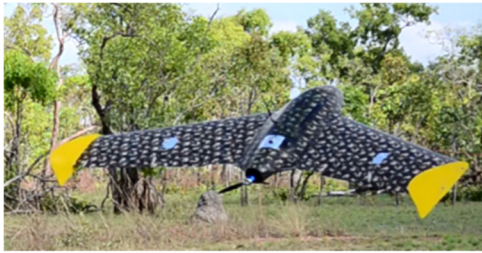
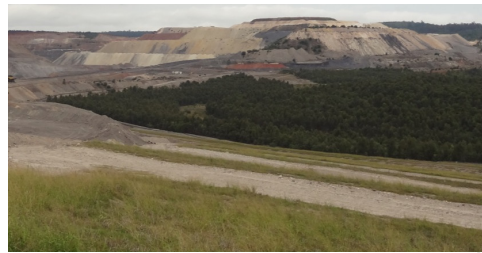
UAV Imagery

Land-Cover Map

Rehabilitation Quality Indicators

Mine Safety

Mine Stability

Mine Sustainability

Status Map

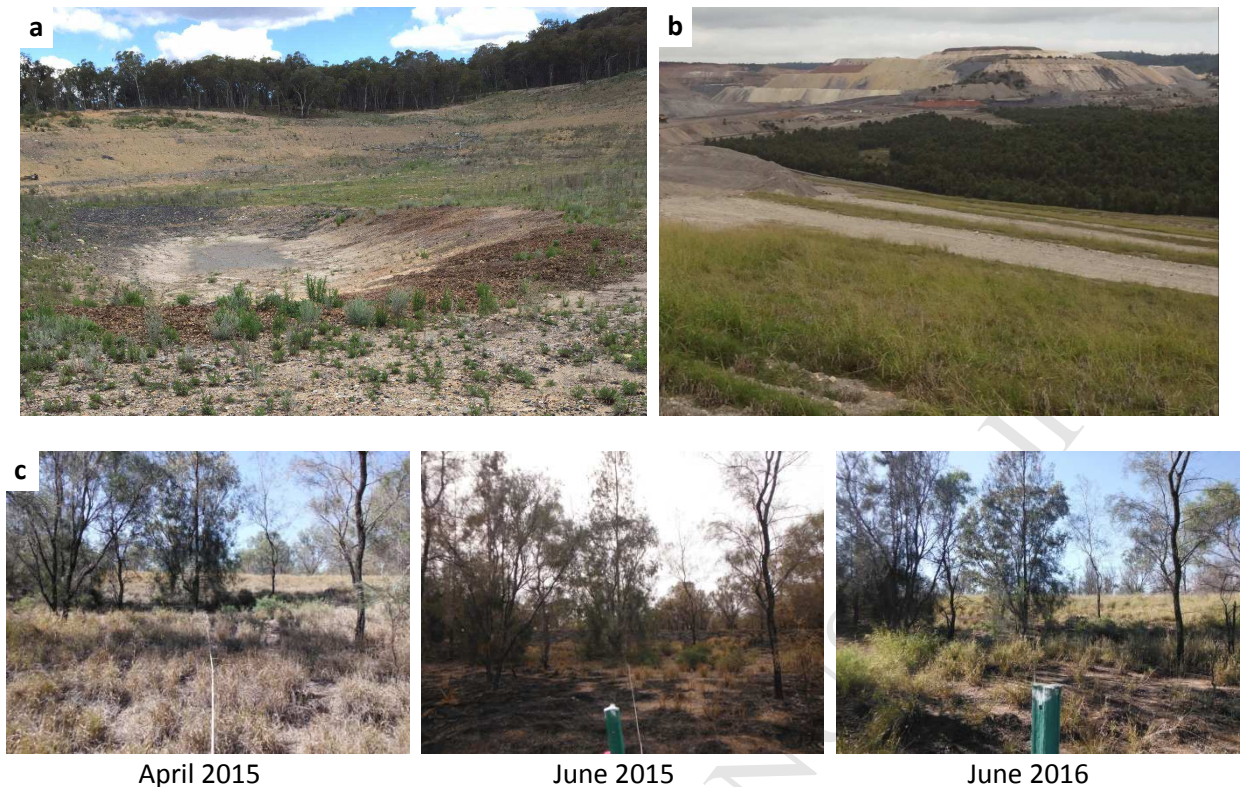
**Figure 2.** (a) The eastern side of Ivanhoe North rehabilitation; (b) dense tree cover in the south-west Meandu rehabilitation area; and (c) three photos from Curragh mine, showing change in the vegetative cover of a 20 year old rehabilitation site exposed to a controlled burn on 28 May 2015, prior to the June 2015 image collection (McKenna and Glenn 2016).

The Ivanhoe North project was a small three-year open-cut mining operation that ceased production in March 2012. Centennial Coal, the mine operator, recovered more than 600,000 tonnes of coal over this time and progressively undertook rehabilitation activities. The main areas that required rehabilitation included the open-cut floor, the angle of repose of overburden (spoil) dumps, coarse reject dumps and abandoned high walls. This area included approximately 23 ha. Ivanhoe North's remedial works included backfilling the open cut, land contouring, soil spreading, broadcast seeding and fertilising, drainage works and the removal of buildings and pit top infrastructure. This work was completed in late 2012. The rehabilitation aims to restore the mined area to match the natural surrounding areas within the next 20 years, subject to government approval (see Figure 2a).

Overburden has been progressively rehabilitated at the Meandu open-cut coal mine since 1985. Rehabilitation processes have included the reshaping of spoil piles to defined landform criteria and the replacement of stockpiled topsoil. Topsoil and spoil are deep ripped along the contour, sown with improved pasture and native grass, native shrubs and trees and NPK fertilizer. The seed mixes and timing of application, equipment used, stockpile age and depth of topsoil (< 400 mm), the amount and type of fertilizer, plus the depth of ripping (300–1000 mm) have been somewhat variable over time (Gravina and Vickers 2010). For this research the southwestern areas (Figure 2b), which were rehabilitated from 1998 to 2010, were the primary areas assessed with the UAV and covered approximately 200 ha (Figure 2b).

The Curragh site has undergone a significant program of rehabilitation activities since the late 1980s, with more than 1100 ha rehabilitated. The main site assessed for this project was established in 1994 and is a large 180 ha landform reconstructed using the topsoil-spoil-strip method (McKenna et al. 2017a) of alternate strips (10 m wide) of bare overburden and freshly placed topsoil (to 20 cm depth). The block is an undulating landform. Seeding was carried out at the time of ripping and included a mix of introduced pasture grasses and legumes. On overburden strips, a range of woody *Acacia* and *Eucalyptus* tree and shrub species were sown. Over the course of this project, the landform was subjected to a controlled fire to examine the response of the rehabilitation to this type of disturbance. The progressive change of selected sites on the landform before and following the fire are illustrated in Figure 2c.

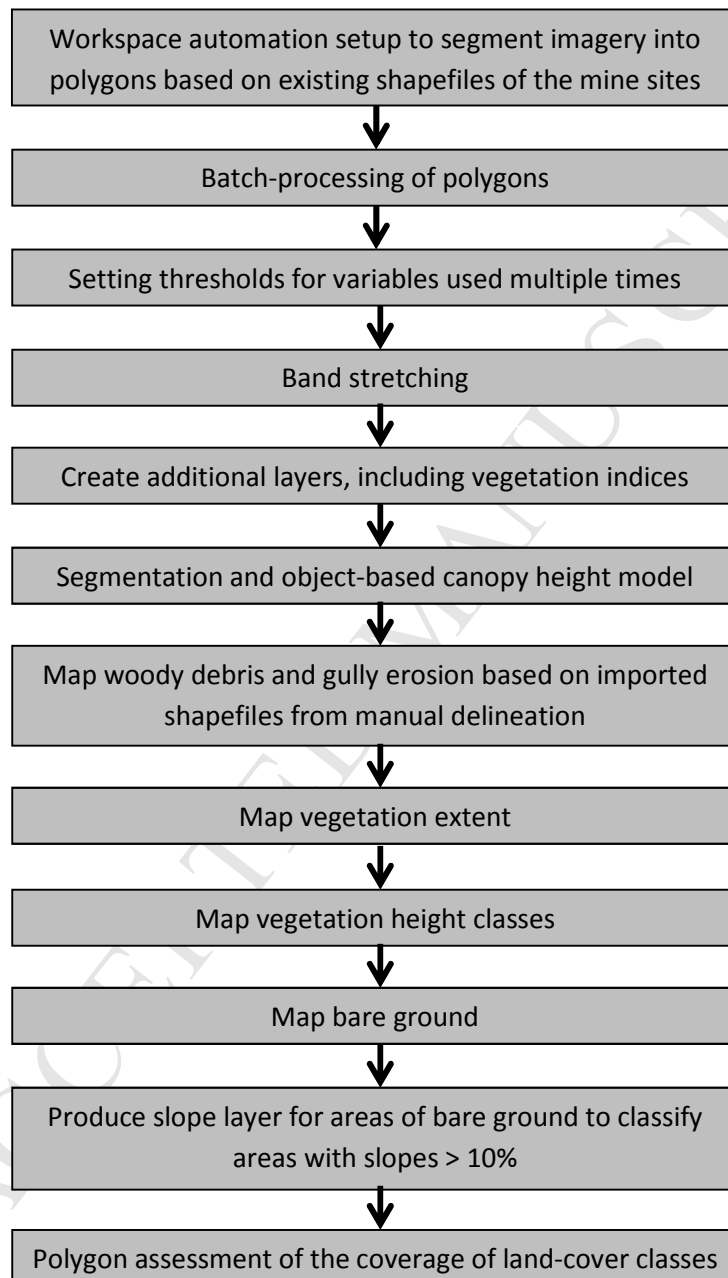
**Figure 3.** Flowchart of the image processing approach used to convert the UAV imagery into a land-cover map.

The automated mapping approach was designed as a rule set in the eCognition Developer 9.2 software. The overall workflow of this process is presented in Figure 3. As none of the UAV image data sets were radiometrically, vignette or BRDF corrected to at-surface reflectance (to reflect an “applications” based usage of UAVs, as opposed to research purposes), consistency in spectral reflectance of the same features could not be expected. Hence, some threshold values used several times in the rule set were specified as a “variable”, representing a set value specified only once in the rule set, rather than each time this threshold was used within the rule set. Hence, a change in

As the spectral bands of the UAV imagery did not cover the full range of the digital number range, each spectral band was stretched to cover the full range. These stretched bands were subsequently used in the remainder of the rule set. The next step produced various vegetation indices, such as the

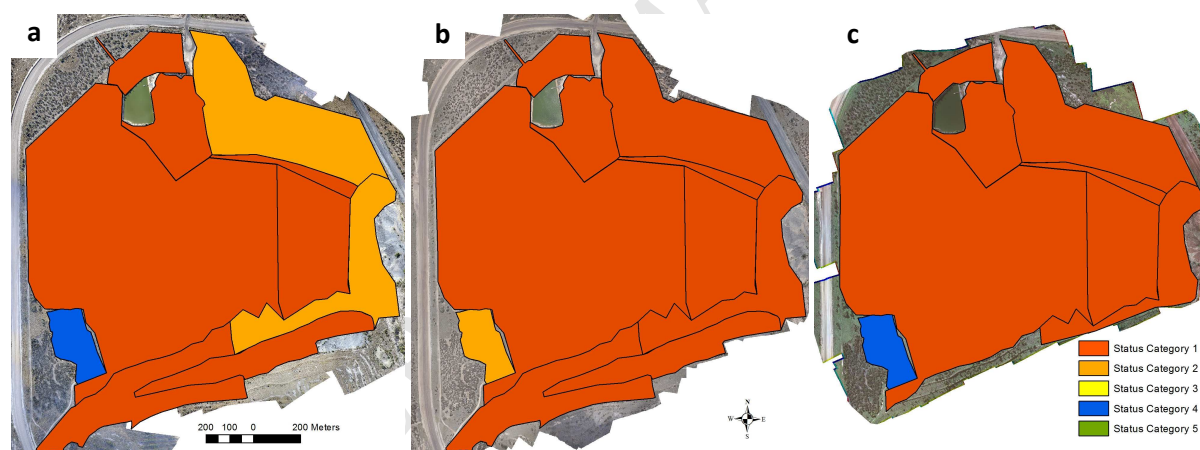
**Figure 8.** Polygon based status maps of the Curragh site for images 1 (a), 2 (b) and 3 (c).

The maps generated for the Curragh site produced polygons with poor status in most cases (i.e. Category 1), due to the presence of gully erosion, indicating a lack of safety, stability and sustainability (Figure 8). Most of the areas of bare ground had gully erosion and showed signs of rill development. Some of the areas with rills developed into gullies between the acquisition of images 1 and 3, following exposure of the site to a controlled fire. Without the fire and gully erosion, most of the polygons would have been categorised with a status score one to three categories higher. The Category 4 polygon in the south-western part of image 1 changed to Category 2 in image 2 (Figure 8) due to the presence of mapped bare ground patches  $> 1000 \text{ m}^2$ , but went back to a Category 4 in image 3 due to a reduction in mapped bare ground. Both of the two Category 2 labelled polygons in image 1 in the north-eastern and south-eastern parts of the imaged area were reduced to a Category 1 status because of gully development within these two polygons in the subsequent images.
