Mundell, C, McCombie, PF, Heath, A, Harkness, J & Walker, P 2010, 'Behaviour of drystone retaining structures', Proceedings of the Institution of Civil Engineers-Structures and Buildings, vol. 163, no. 1, pp. 3-12. <https://doi.org/10.1680/stbu.2009.163.1.3>

## Behaviour of drystone retaining structures

**Drystone walling is an ancient form of wall construction, used worldwide wherever there is an abundance of raw building materials. However, very little research has been conducted on these structures, making their analysis difficult. As part of an ongoing investigation, four full-scale drystone retaining walls were built and tested to failure in a bespoke outdoor test laboratory. Through the course of the testing, the distinctive bulge patterns that are found in many in situ walls were successfully recreated. This paper describes the set-up of the test laboratory and instrumentation used, in addition to the proceedings of each wall test. Initial findings of the project tests and a discussion regarding the underlying reasons behind bulging in drystone walls are presented.**

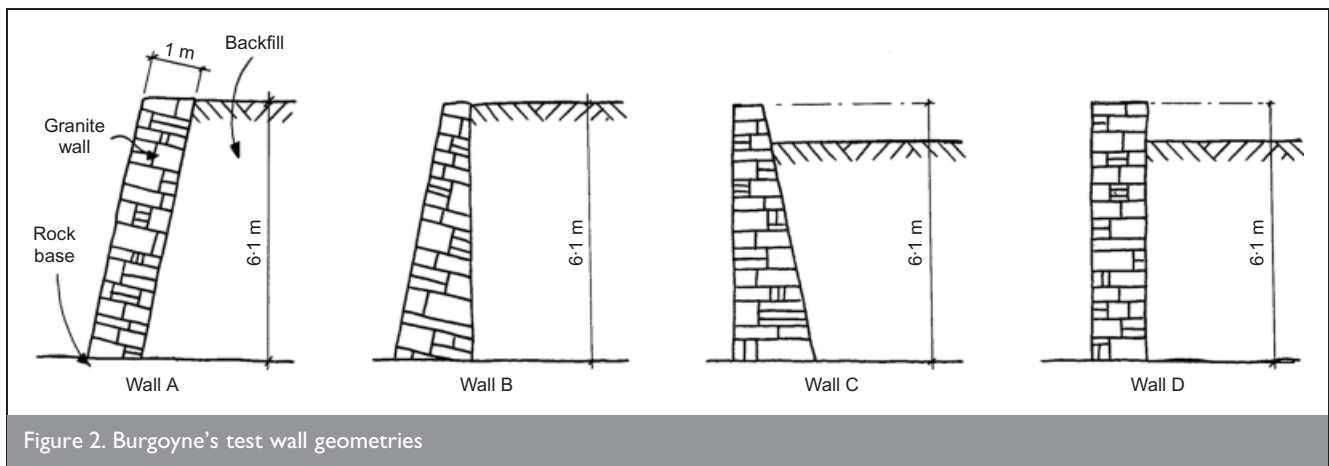
Figure 2. Burgoyne's test wall geometries

The work was conducted as scientifically accurately as possible for the time and, although dated, is still used for verification of several current drystone analysis techniques. Burgoyne proved that geometry has a very important impact on stability (Table 1), although it may be questionable how representative his

walls were of traditional drystone constructions; the walls were constructed of well-cut and tightly packed granite blocks, displaying a generally monolithic behaviour unrepresentative of most existing walls. In addition, and perhaps more importantly, each wall was built between bay walls, introducing the problem of end effects at these junctions. These end effects may have caused both the earth pressures and the walls themselves to behave differently; however, in terms of Burgoyne's aims of validating geometrical proportions, this would have little effect.

Fill height attained	Failure mode	Observations
Wall A	Full height	N/A	No signs of distress
Wall B	Full height	N/A	Slight fissuring
Wall C	5.2 m	Bursting at 1.7 m	Bulging at 1.5 m, significant fissuring
Wall D	5.2 m	Toppling from base	0.45 m overhang prior to failure

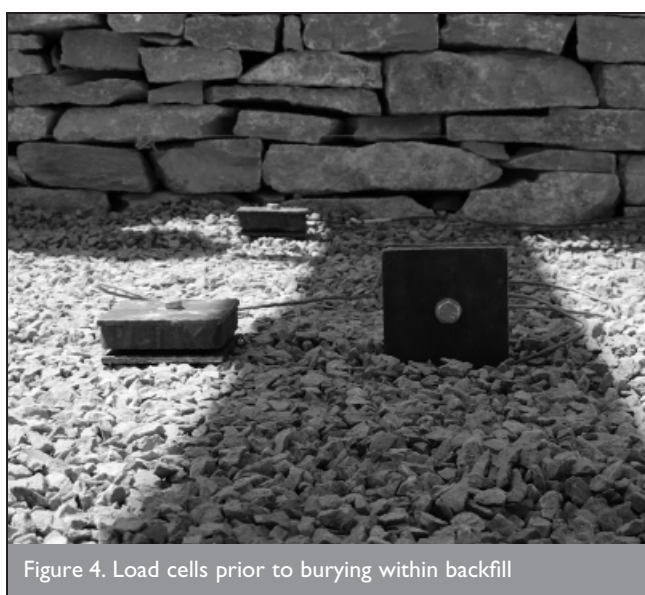
Figure 4. Load cells prior to burying within backfill

As previously mentioned, load cells attached to the platform monitor the overall forces being applied to the wall. The first two tests augmented this information by using small load cells within the backfill. These load cells were sandwiched between 100 mm × 100 mm steel plates and placed at critical locations within the backfill, orientated to record either horizontal or vertical pressures (Figure 4). The aim was to use these data to help determine the distribution of stress within the gravel arising from the surcharge loading. This form of monitoring was discontinued after the second test wall as the results were often inconsistent and erratic, mainly due to the small scale of the steel plates in relation to the size of the gravel. Larger plates were considered, which would give more reliable readings, but these would have a greater impact on the test itself and possibly affect wall behaviour.

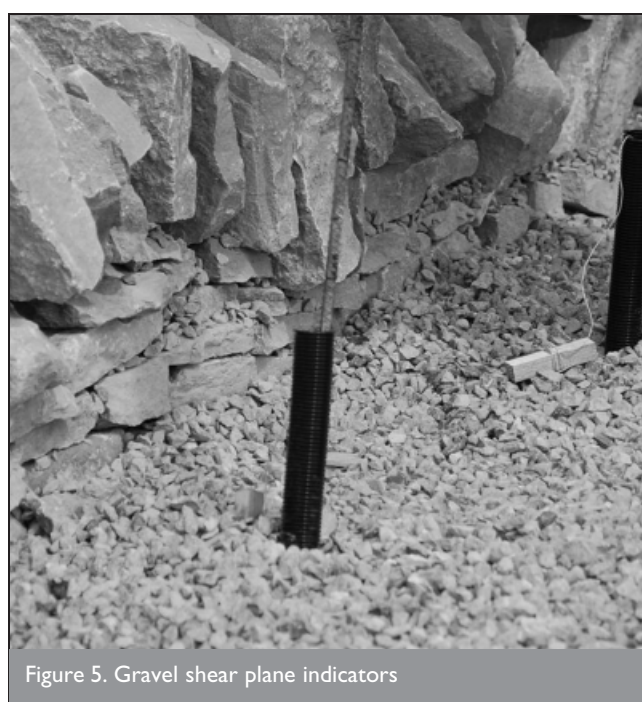
Figure 5. Gravel shear plane indicators

moves during testing, and in particular where failure planes develop. Two methods were used to assess this, beginning with the placement of ball bearings within the gravel. Each ball bearing was numbered and its position determined using a total station. Upon destruction of each wall, the gravel was carefully unearthed and the ball bearings located using a metal detector. Using the total station to determine their final positions, the overall movements of the ball bearings were calculated and from these data the location of the gravel's failure plane found.

For the third and fourth walls, the ball bearings were replaced with long, very flexible plastic tubes placed vertically into the gravel using a mandrel. Throughout the tests, long marker poles were lowered down the flexible tubes until either the end or an obstruction (such as kinks caused by developing shear planes) occurred (Figure 5). With similar data obtained from several locations, this method identifies the failure plane quickly and easily during the test and so was adopted in favour of the time-consuming ball bearing approach.

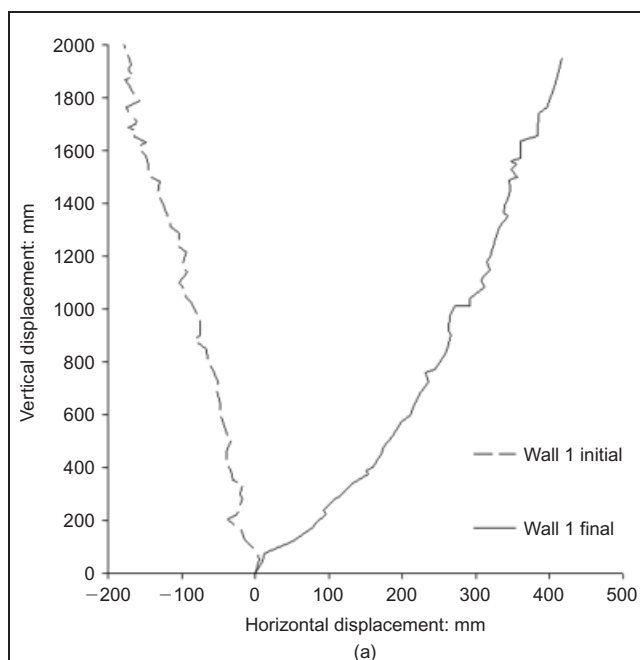
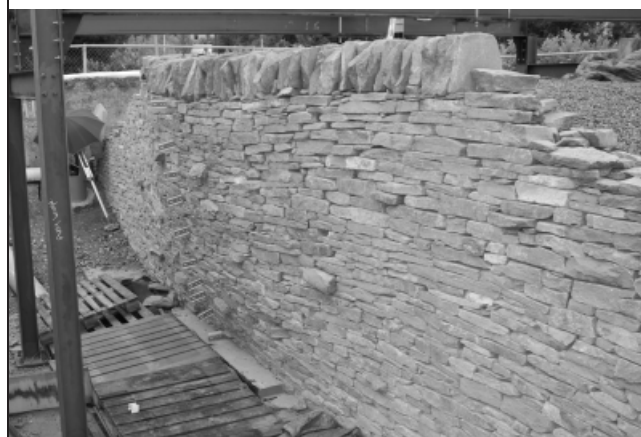
Figure 6. Test wall 1: (a) survey readings; (b) prior to failure

Testing of this wall (Figure 6(a)) was carried out a month after construction in July 2007. The wall was regularly monitored using the surveying equipment to identify any settlement or deformation in this period. Backfilling took place in tandem with wall construction, ensuring that the fill height was approximately 0.5–1.0 m below the wall height, allowing a comfortable working position for the masons. The fill was introduced in layers of 300 mm and compacted with a 1 kN vibrating plate compactor until the full height of 2.2 m was achieved, leaving the top 300 mm of coping stones uncovered. Plate loading tests on the gravel indicated an initial angle of friction of  $50.1^\circ$ . As this is likely to be significantly higher than generally found behind walls of this nature, this issue was addressed for subsequent walls. The voidage of the wall was approximately 28%.

Prior to failure, the wall had substantially deformed, having moved forwards over 650 mm at the crest, overhanging the wall toe by some 500 mm (Figure 6(b)). Although there was evidence of bulging within the structure, the primary failure mechanism was toppling, encouraged by both the rotation and the initial surcharge location.

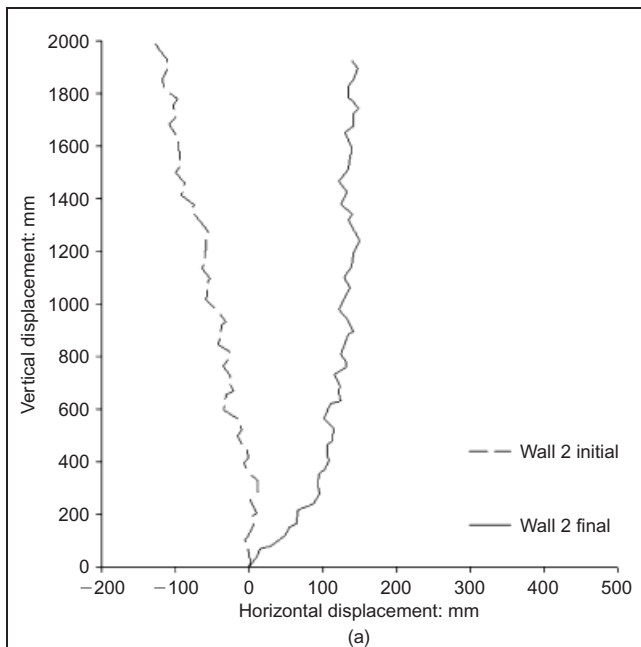
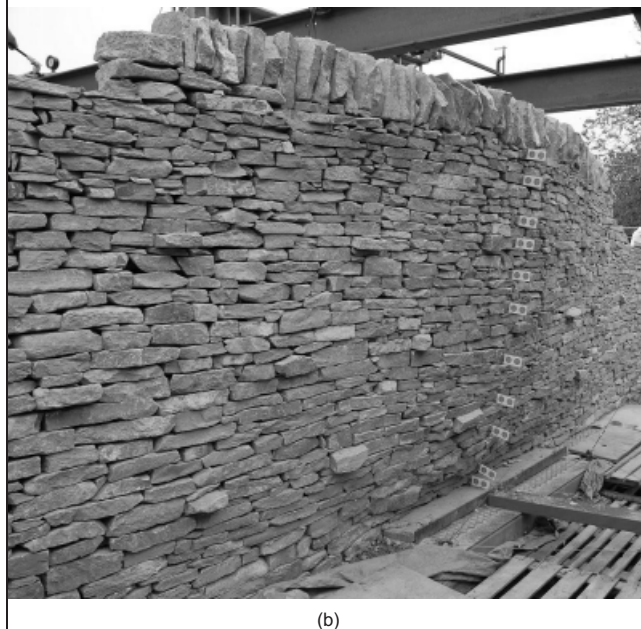
Figure 8. Test wall 2: (a) survey readings; (b) prior to failure

Final deformations were less severe than in test wall 1; the coping moved 300 mm in total, with some 250 mm overhang over the toe (Figure 8). The manner of movement was also much closer to the mechanisms found in many existing retaining walls. Instead of monolithic toppling of the first wall, the second wall displacements were non-linear with respect to vertical height. For example, an hour prior to failure an overhang of 100 mm was measured at a third-height of the wall, followed above by a gradual reduction in overhang, ending with the coping stones being 50 mm in front of the toe line.

Although test wall 2 also eventually failed by toppling, the manner in which this toppling was achieved was different to that of the first test wall. In this instance, it was found that the lower blocks of the wall were sliding over one another,

eventually allowing one or more to freely rotate and fail locally. These key blocks created a cascade effect, causing the area directly above to become destabilised, in turn initiating rotational failure of the central portion of the wall and ending the testing process.

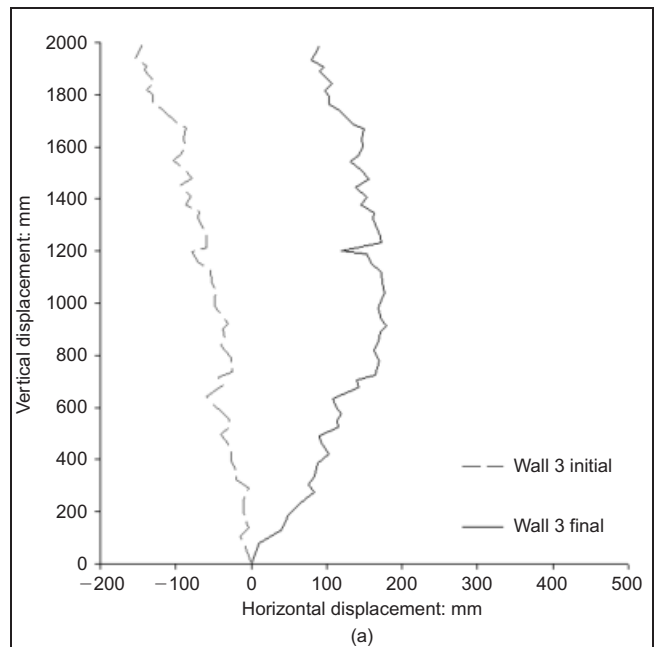
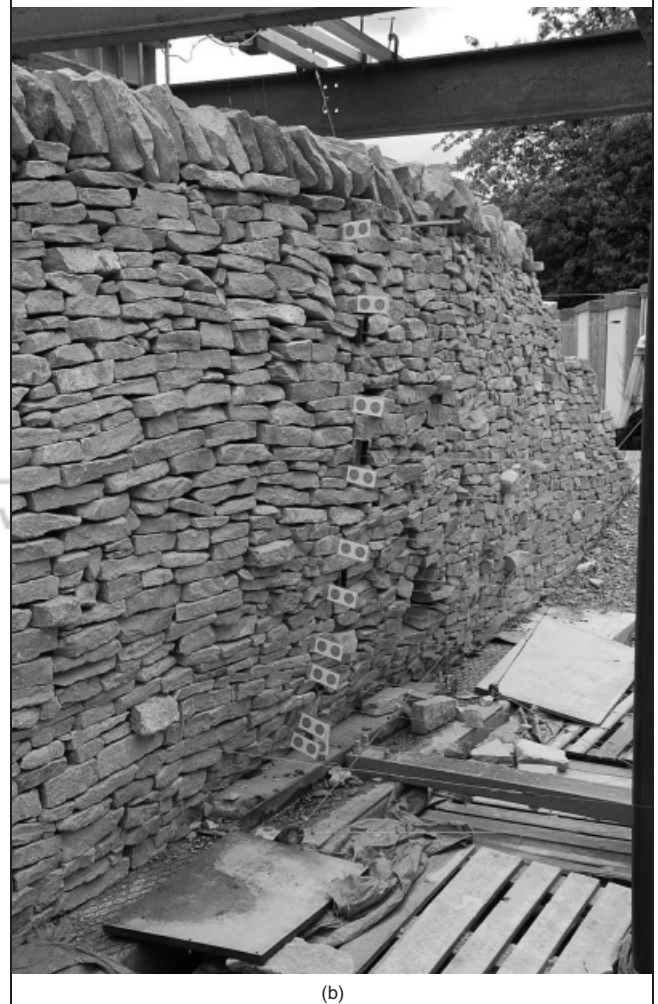
Figure 9. Test wall 3: (a) survey readings; (b) prior to failure

After the initial platform movements, the applied loads to the structure caused definite bulging to occur within the wall. Monitoring of the flexible tubes within the backfill indicated that the failure wedge was developing at a relatively shallow angle, beginning directly behind the surcharging plate and terminating at the face of the wall some 500 mm above the toe. As a consequence, the bulge's centre was slightly higher than that produced in test wall 2, occurring roughly 1 m above the base and overhanging the toe by over 350 mm before failure (Figure 9). The extremely pronounced nature of this bulge, combined with the large internal void spaces due to the roughness of construction, caused significant cracks to open along the face of the wall. In addition, large amounts of material were able to drop both through internal voids within the wall and out of the wall face itself (Figure 10(a)).

Eventual failure was again because of bulging, driven by the continuous displacement of the backfill. However, there was also a visible bursting at various sections during the failure, as the areas below the main bulges were unable to resist the horizontal forces of the sections above (Figure 10(b)). As a result, a large amount of material slipped forwards rather than toppling from the toe as failure progressed.

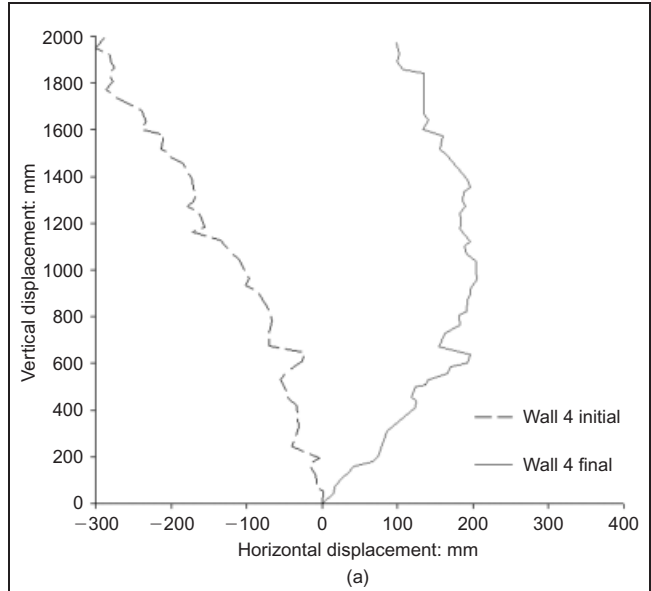
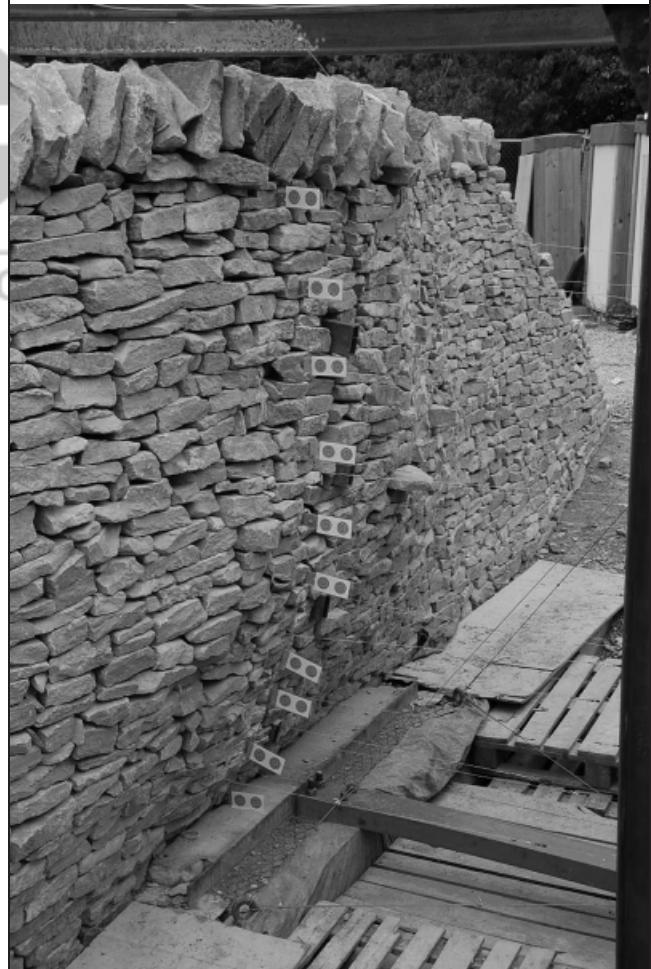
Figure 11. Test wall 4: (a) survey readings; (b) prior to failure

Maximum displacements, while remaining stable, were slightly lower than those in test wall 3, bulging outwards some 200 mm

at a vertical height of 1.1 m from the toe (Figure 11). However, the crest of the wall moved a comparatively smaller amount, giving a more visually obvious bulge. From the fixed mount camera images, it is also apparent that this wall contained a higher number of running joints with large vertical cracks opening approximately every 500 mm along the face of the wall. Collapse initially began over the central 4 m of wall as a

topple. However, once this failure was under way a large portion of the adjacent wing walls was destabilised and similarly collapsed.
