# Monitoring of the moisture content of straw bale walls

#### Mike Lawrence, Andrew Heath, Pete Walker.

BRE Centre for Innovative Materials, Dept of Architecture & Civil Engineering, Bath University, UK

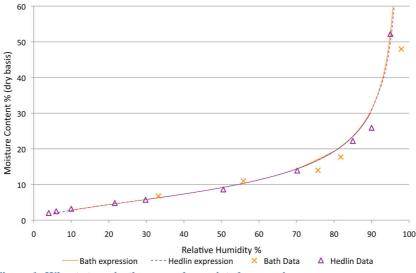
The data gathered by Hedlin and those gathered by the authors are shown in Figure 1 together with the line described by the above expression and that described by the more complex expression developed by Hedlin.

Figure 1: Wheat straw isotherms and associated expressions

It is clear that both expressions give very similar results, and that both have a slight tendency to overstate the moisture content as measured by experimentation for a given RH%. Further refinement is required to the expression, but is its considered that the current expression offers a factor of safety at higher RH levels where moisture content is most critical.

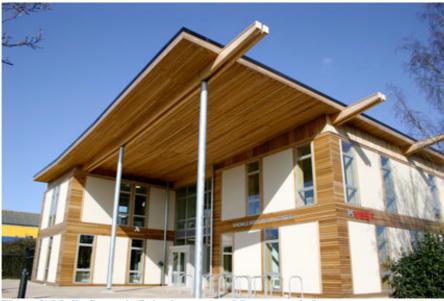
Figure 2: Media Centre in Bristol constructed from straw bales

Rendered straw bale walls have been monitored in a newly constructed media centre in Bristol, UK (Figure 2) since August 2008. The sensor used was a Hu-

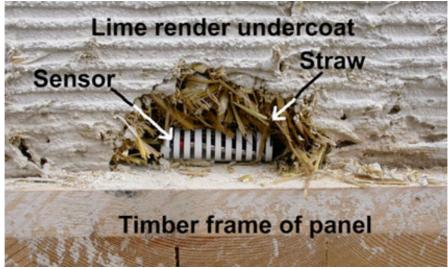
Figure 3: Sensor inserted just below the external render (prior to final rendering)

The sensors were inserted into ventilated 20mm ø polypropylene tubes and installed into the straw bale panel during construction (Figure 3). Sensors were positioned at the centre of the base of the panel just behind the render at both the exterior and the interior of the panel. Instrumentation was inserted into one panel on each elevation of the building (Figure 4), although subsequently it was found that the wiring to the sensors in the 'West' elevation was damaged during construction, and data from these were not accessible.

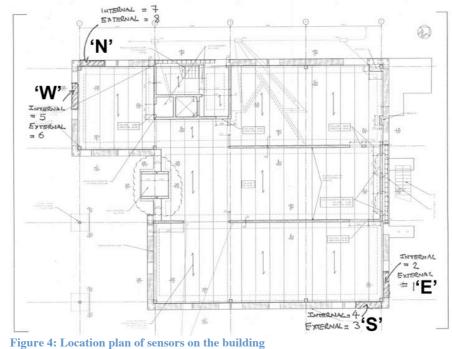
Wiring from the sensors was taken to a central point in the building and connected to the data logger, where data were logged at 60 minute intervals. Daily temperature and rainfall information were recorded from a publicly available weather station 500m from the building.

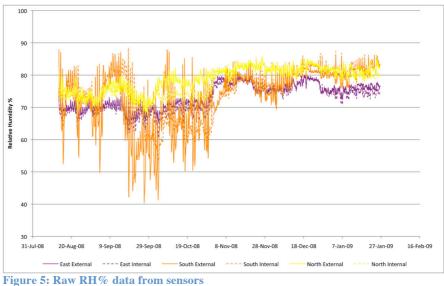
rigure of Run Rif / untu from sensors

The raw RH% data are presented in Figure 5

It can be seen that the curve does not show the large individual variations seen in the RH data from Figure 4.

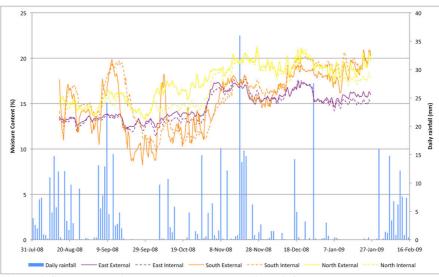
The expression described above was then applied to these raw data to produce moisture content (MC) data. In order to smooth out the hourly variations and obtain a curve which is more readily able to be interpreted, the resultant MC data were averaged using a rolling 24 hour average. For a given point the previous 24 hourly measurements were averaged. This produces a curve which takes out significant individual variations to produce a smoother curve which is more readily interpreted. It was decided to use a rolling average based on a 24 hour cycle because this was felt to best represent the diurnal pattern of external humidity. The rolling average of the previous 24 hours resulted in a figure which was 12 hours out of phase (earlier) than the time point on the x axis. Resultant data were therefore moved backwards by 12 hours in order to be in phase, and therefore directly comparable, with any weather events. These data are presented in Figure 5 together with daily rainfall from a nearby weather station.

Figure 6: Smoothed moisture content data and daily rainfall data

There appear to be two distinct phases to the moisture content data. The first phase runs to about 8<sup>th</sup> November. In this phase the moisture content of the straw oscillates over a wide range of values from 8% to 20%. The moisture content increases relatively rapidly about 8 days after a rainfall incident and then reduces about 6 days after the rainfall ceases. The prevailing wind is from the South West and the most exposed face of the building is the Southern elevation. It can be seen that the data from the South elevation varies by the greatest amount with the internal MC slightly out of phase and behind the external MC. This is likely to be due to the wind driven rain increasing moisture content more rapidly than on the other two elevations. When the rainfall ceases, drying will occur more rapidly on the exposed southern elevation. The East elevation is the most protected of the three elevations, and it can be seen that there is much less variation in moisture content, both internally and externally.

Between 1<sup>st</sup> November and 15<sup>th</sup> November there was a general rise in moisture content, but subsequently the MC varies over a lower range than in the first phase, varying between about 14% and 21%, a range of 7% compared with 12% in the first phase. The moisture content during the second phase appears to be less associated with external rainfall, and appears to be buffering the moisture in the build-
