Fujii, Y, Fodde, E, Watanabe, K & Murakami, K 2009, 'Digital photogrammetry for the documentation of structural damage in earthen archaeological sites: the case of Ajina Tapa, Tajikistan', *Engineering Geology*, vol. 105, no. 1-2, pp. 124-133. <https://doi.org/10.1016/j.enggeo.2008.11.012>

**DIGITAL PHOTOGRAMMETRY FOR THE DOCUMENTATION OF STRUCTURAL DAMAGE IN
EARTHEN ARCHAEOLOGICAL SITES: THE CASE OF AJINA TEPA, TAJIKISTAN**

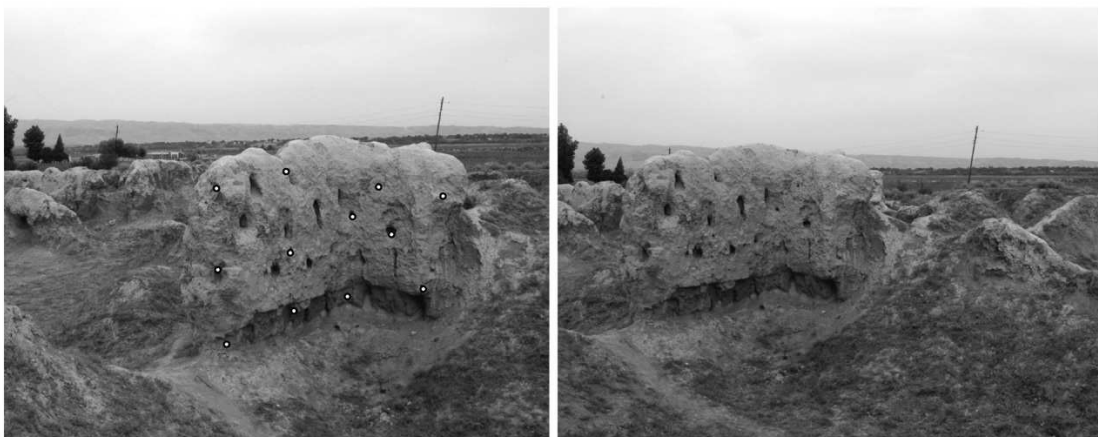
Fig. 2. A pair of stereo-photographs of a damaged wall (Wall A in Fig. 8). White circles on the left photograph show control points.

Using a pair of overlapping digital images (Fig. 2), the three-dimensional (3-D) morphology of a wall can be reconstructed. The information of camera positions and directions, in which the pair of stereo-photographs were taken, are needed to get the three-dimensional co-ordinates. However, it is very difficult to get the accurate positions and directions at the same time when taking the photographs. Coordinates of control points which must be included into photogrammetric evaluation were determined by the use of a geodetic Total Station (TS). The camera positions and directions can be inversely calculated from the control points by means of least-square adjustments (Schenk, 1999, Linder, 2003). A 3-D digital photogrammetric software was employed to calculate the camera positions, and to get 3-D information on the surface topography. After the calculation of camera positions and directions, the software can give matching of the same positions on a pair of digital images due to the difference of color and contrast, and generates 3-D coordinates of the points. Those points are connected with lines, and the surface morphology of the wall is constructed as Triangle Irregular Network (TIN; Fig. 3). It is called Digital Terrain Model (DTM; Fig. 4a). The great advantage of digital photogrammetry is to connect the photo images to a DTM. The result is a texture mapping model, which can be viewed from arbitrary directions (Fig. 4b).

In the site of Ajina Tapa, two benchmarks were settled as reference system on both margins of the boundary between stupa and monastery area (Figure 6). Relative positions of those two benchmarks were measured by TS in the accuracy of less than 15 mm. Coordinates of control points, which were included into stereo-photographs, were determined by TS. At the same time of measuring the control points, the benchmarks were also measured by TS. Therefore, the 3-D coordinate of the position of TS could be calculated by triangulation. Two distances from the benchmarks, one horizontal angle between the benchmarks, and two vertical angles to the benchmarks are measured by TS. Therefore, the position of TS can be calculated by means of LSM. The residual from the calculation of LSA by means of TS, which is called as R_{ts} for convenience, was 92 mm for the southwestern side of Wall-A (Figure 2).

distance from the cameras to the object. B: the distance between two cameras. C: focal length of the camera (lens). In the case of the southwestern side of Wall-A (Figure 2), H is about 14 m, B is about 4.4 m, C is about 18 mm, and δ_{CCD} is 0.0079 mm. So σ_{xy} is about 6.2 mm, and σ_z is 20 mm. The residual from the calculation of LSA for camera positions and directions, which is called as R_{ph} , was 98 mm, and it is much larger than σ_z . The R_{ph} is almost as same as the R_{ts} .

Four damaged walls (refer to the frames in Fig. 7) were mapped in 3D with digital photogrammetry. Two pairs of photographs of each wall were taken to make DTMs of both the sides, except for the Wall-A. As to the Wall-A (Fig. 7), which is in reversed L-shape in ground plan, pairs of photographs of the northeast and southeast sides were taken from the northeast and southeast directions respectively, and another pair of photographs of the L-shaped wall

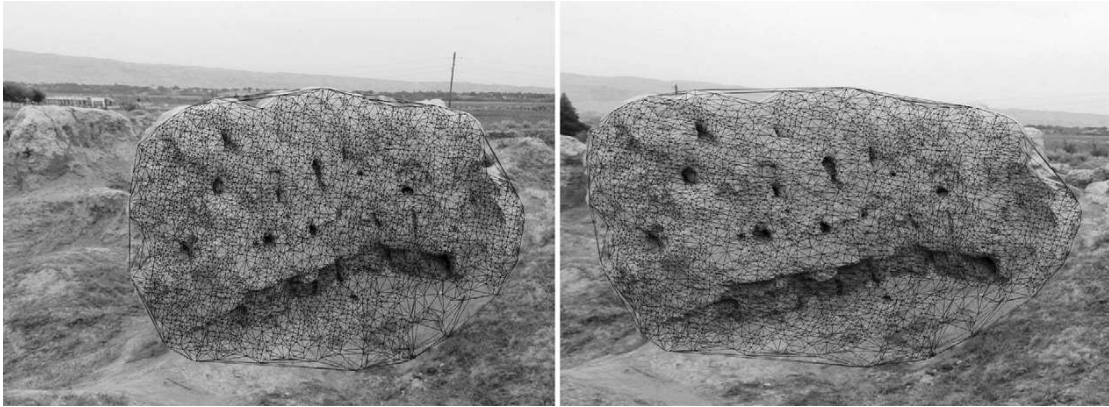
Fig. 3. Triangle Irregular Network (TIN) on a stereo-pair of photographs (Fig. 2).

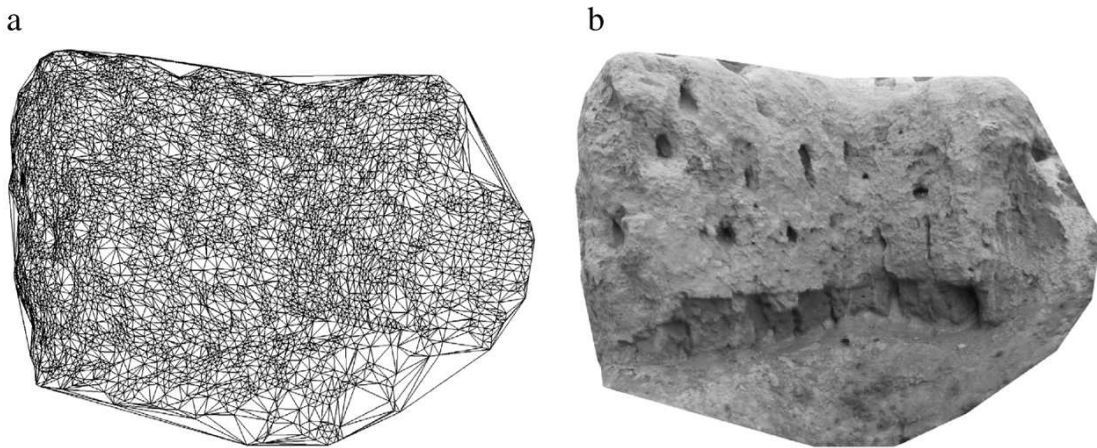
Fig. 4. Digital Terrain Model (DTM) of the damaged wall (Figs. 2 and 3). a: DTM constructed by means of TIN. b: Texture mapping model. Photo images are put on the DTM.

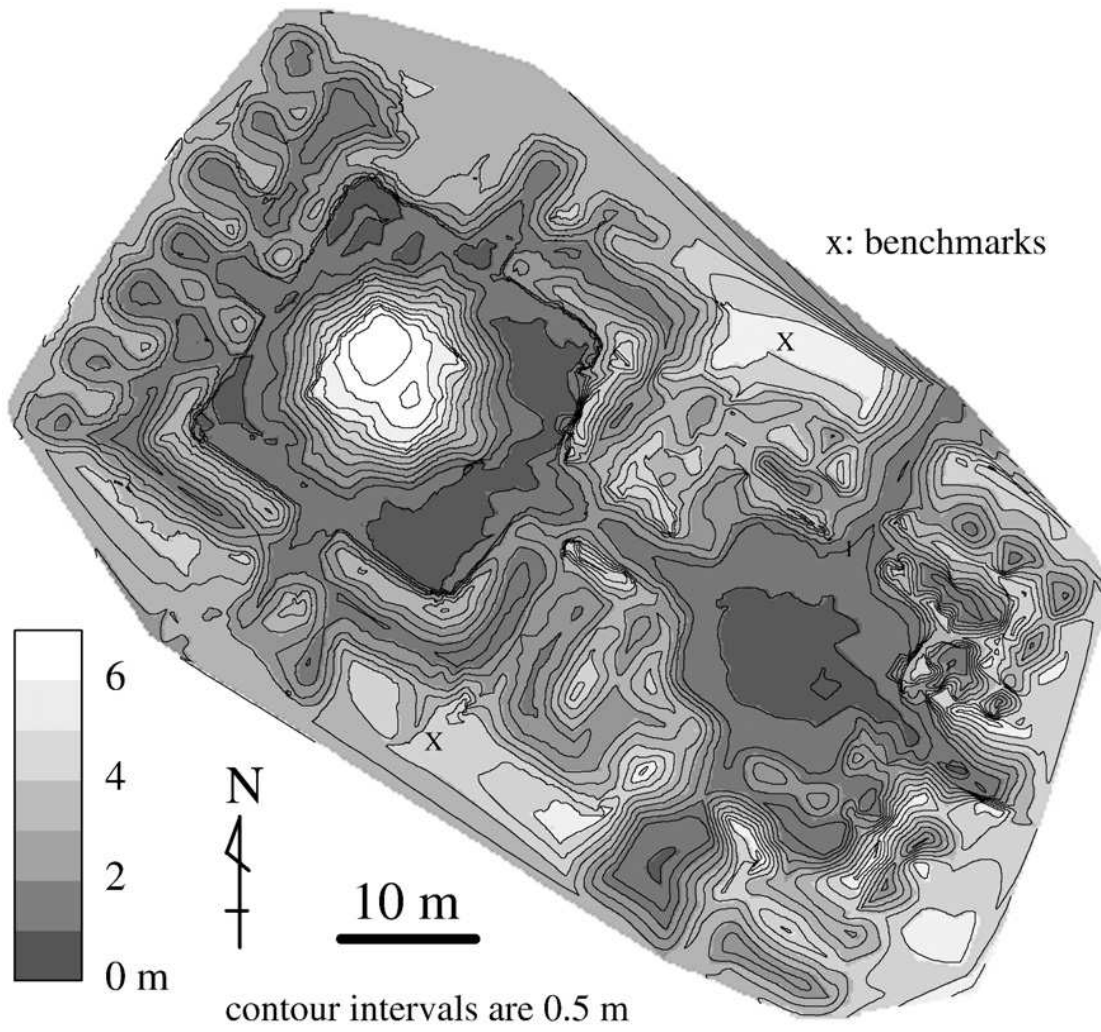
Fig. 6. High resolution map of Ajina Tepa. Topographic coordinates were gained from each pair of photographs

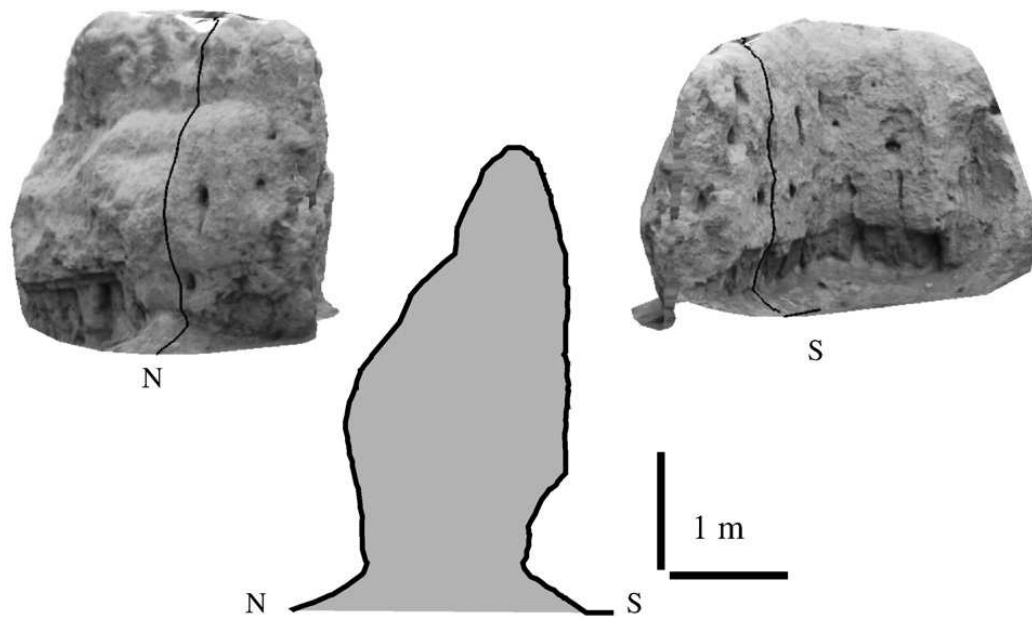
Fig. 8. A section of Wall A in north–south direction. Upper two photos show the positions of the section on texture mapping models.

was taken from the southwest direction (Fig. 2). The control points for each pair of stereo-photographs have 3-D coordinate, which were defined by the bench marks . Therefore we could establish the original mutual position of each DTM, and complete sections of each wall could be obtained. Fig. 8 shows a north-south section of the Wall-A (Fig. 7). The massive wall had been constructed with *pakhsa* blocks or mud bricks on *pakhsa* base, and the original shape of the section might be rectangular. The original thickness of the wall was 2.4 metres, which is recorded in Litvinskij and Zejmal' (2004). The original height of the wall is not clear for Wall-A, but the walls of the monastery area had average height of 2.5 metres with maximum of 5 metres (Litvinskij and Zejmal, 2004). Maximum width of the remained wall is about 2 metres (Fig. 9). In fact, the wall is largely eroded as seen in the sections. The current shape of the wall is much different from the original rectangular one due to erosion. First, upper part of the wall was strongly eroded and looks rounded. Both sides (north and south) are eroded deeply. The erosion of the north side is a little bit harder than the south side. Second, basal part was undermined to make shallow coves, and was eroded asymmetrically. Its south side was more deeply eroded than north side of the wall.

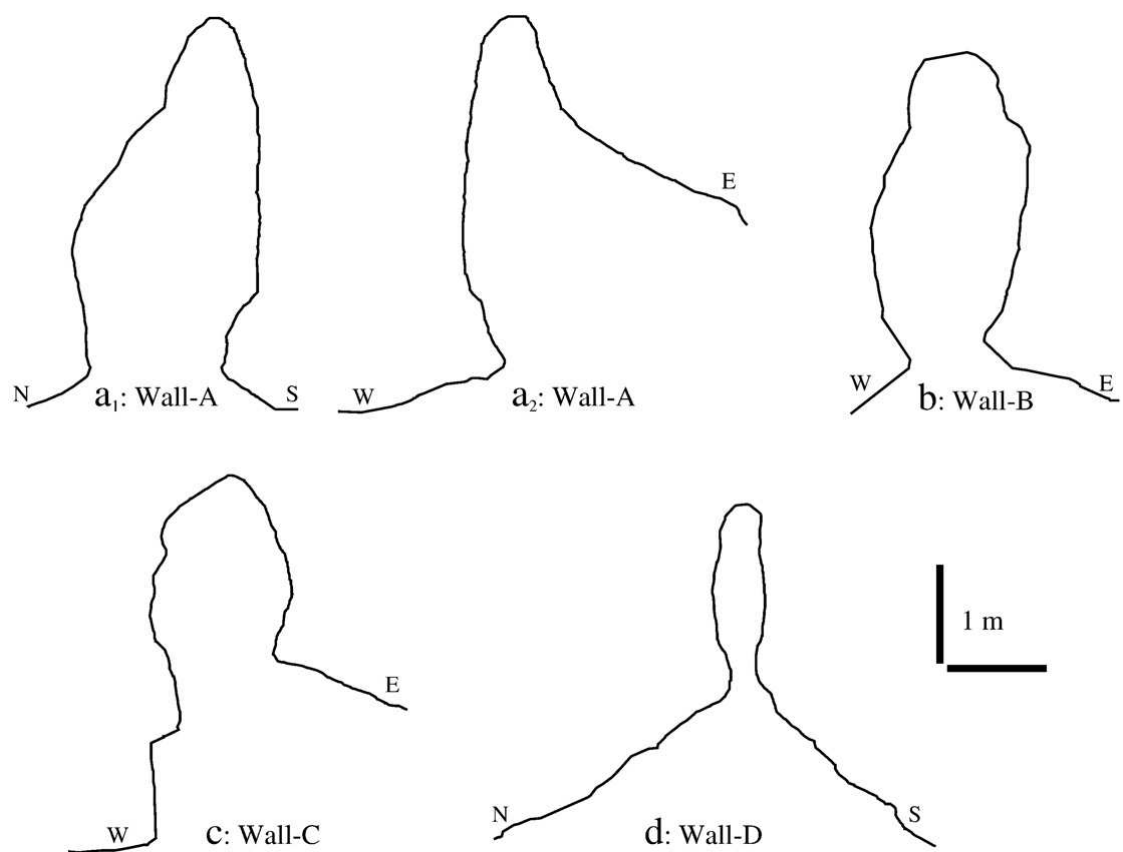
Fig. 9. Sections of the damaged walls. See Fig. 7 for locations of the walls.

Some measured sections of damaged walls are shown in Fig. 9a-d. Fig. 9b shows an east-west section of the Wall-B, which is situated at the southern monastery area and oriented in north-south direction (Fig. 7). Upper part of the wall is eroded, and the top is rounded. Both the sides (east and west) are equally eroded. Maximum width is about 1.5 metres, and it's thinner than the original thickness of 2.4 metres. The basal part is more deeply eroded than the middle part of the wall. Other damaged walls show more or less similar features, indifferent to their positions and orientations. Common characteristics of the erosion are as follows:

1. The walls are largely eroded compare to the original outlines.
2. Top of the walls is eroded and rounded.
3. Basal part is more or less undermined and thinner than middle part of the walls.

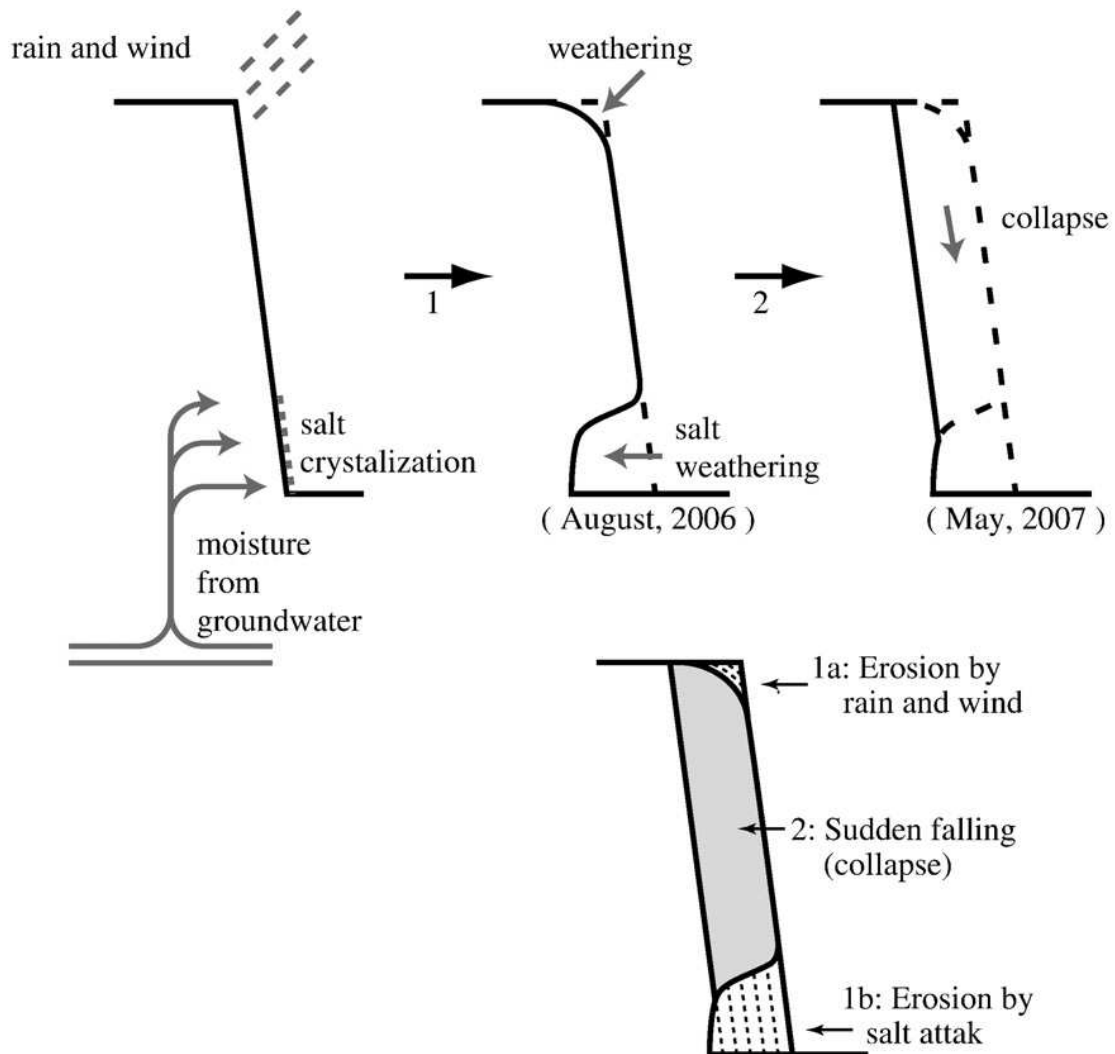
Fig. 11. Schematic erosional process of the wall. 1: Soluble salt is transported with capillary groundwater, and crystallized on the surface of the wall. Salt crystallization attacks and erodes the basal part of the wall. The top part of the wall is also eroded by rain and wind. 2: The upper wall, which lost support due to the thinning of the basal part, collapses suddenly. The wall surface becomes planar, and the erosion will continue to decay the wall.

Before the former excavations, the site was totally covered with sediments and formed as topographic mound (Litvinskij and Zejmal, 2004). After the excavations, appropriate preservation or protection work has not been done for the buildings in the site of Ajina Tepa. Therefore, the building walls have been exposed since 1975. The erosion test shows slow for mud brick and medium for *pakhsa* compare to the other earthen materials in central Asia. In contrast, the wetting and drying test shows very slight failure for both historical materials. Therefore, rain and wind might have been main erosive causes to the top of the walls for about 30 years. Winter is the rainy season in the area of Ajina Tepa, so the walls are progressively eroded by rain water in such season. The building wall was lost by the erosion, resulting to rounding of the top of the buildings (Fig. 11-1a).

halite, calcite and gypsum are the major salt minerals crystallized on the walls. Mud brick and *pakhsa* contain soluble salt, so these salts might be transformed by groundwater. Vertical profiles of evaporation rate were measured on the surface of the walls (Watanabe et al., 2008), demonstrating that the rate is maximum at the ground, and gradually decreases with the height. It indicates that the moisture is essentially supplied from the groundwater. On the height of 1 metre from the ground, the evaporation rate is small enough compared to the ground. The erosion of the basal part for each wall has less than 1 metre height. Therefore, it is clear that soluble salts were transported to the surface with capillary groundwater, and crystallized on the basal part of the walls accompanying by evaporation of groundwater as moisture. The current floor of the site is lower than the around topographic field and close to the groundwater table. Therefore it's easy for groundwater to evaporate on the floor in the site. The salts cause damage on the wall (Goudie and Viles, 1977), and combination of the wind and windblown silt strengthen the power of erosion. With the repetitions of the above process, the basal part became thinner and thinner than the middle part of the walls (Fig. 11-1b).

Due to the thinning of the basal part by salt attack, the upper wall lost support from the lower basal part. Eventually, protruded part of the wall was collapsed (Fig. 11-2). The collapse can be caused by structural weakness especially in rainy winter season, because earthen materials contain more moisture and have less strength. However earthquake or other exterior efficiency might affect the sudden failure of the wall. The thickness of the wall becomes thinner and the surface is planar after the collapse, but the erosion by soluble salt attack, rain, and wind continues to decay the wall (Fig. 11).

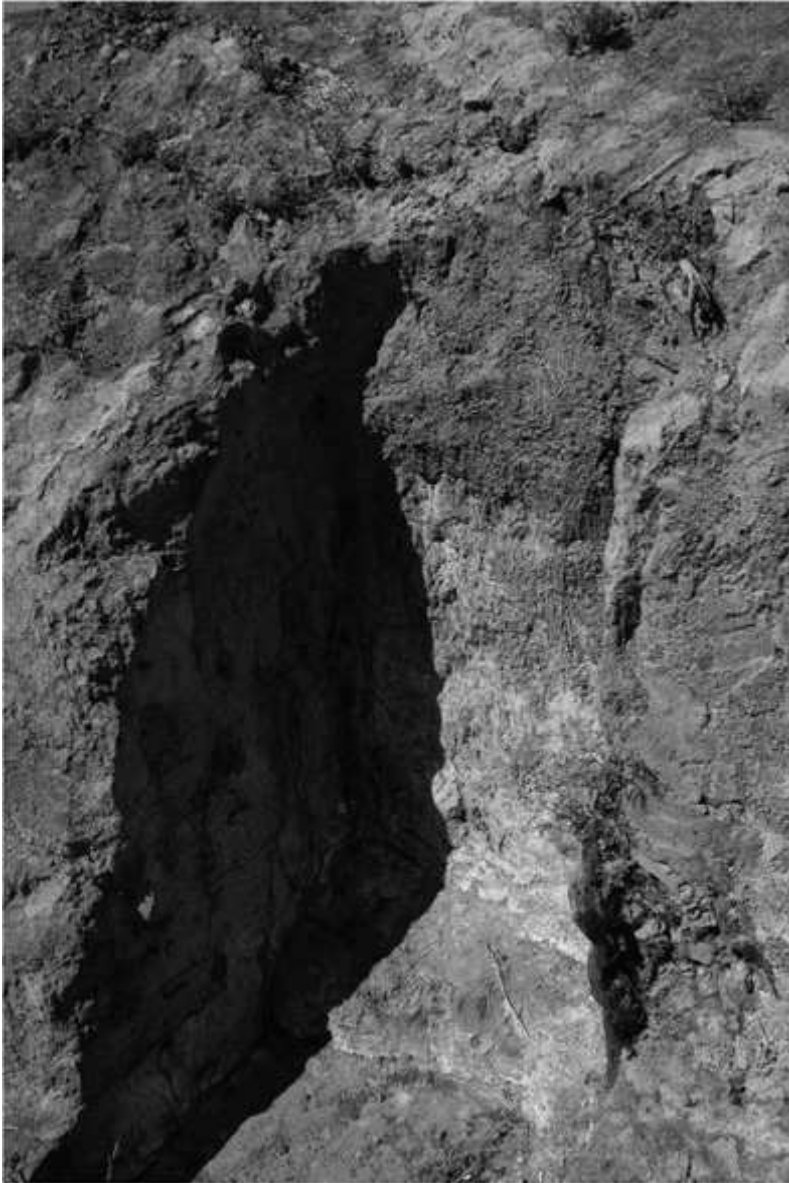
Fig. 12. Salt precipitation on an excavated surface of the building wall. The excavated height is about 1 m.

In central Asia and thereabout, salt crystallization or salt attack is an important erosion agent that causes the decay of the basal part of walls in earthen archeological sites. Average soluble salt content of historic earthen material was calculated in three central Asian sites: 4.7% in Ajina Tepa, Tajikstan (Fodde, 2008), 3.8% in Krasnaya Rechka, Kyrgyzstan (Fodde, 2007c), 5.6% in Otrar Tobe, Kazakhstan (Fodde, 2007b and 2008). In the site of Ajina Tepa, salt is actually crystallized on the excavated surfaces of the walls (Fig. 12). It was analyzed by XRD, and

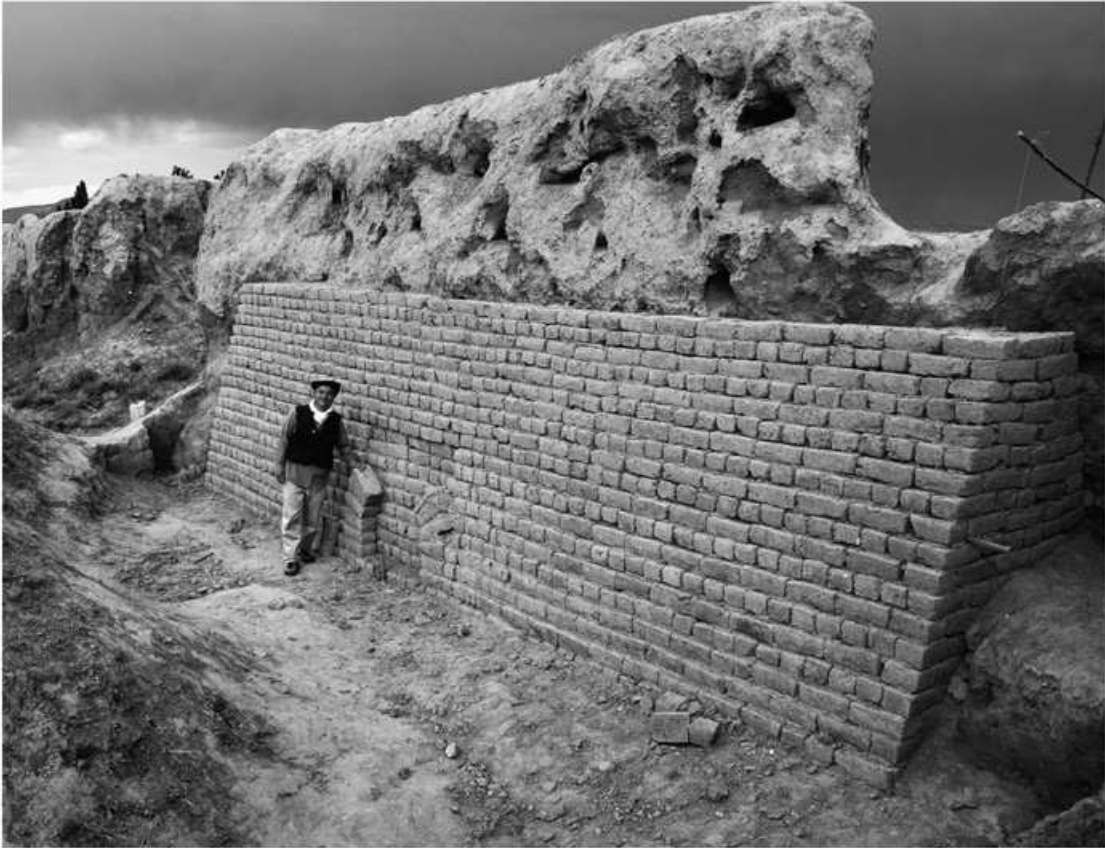
Fig. 13. An example of conservation work. Wall-B is supported by buttresses made of new mud bricks.

Conservation works have been done by this project (Fodde et al. 2008a, in print). Some unstable walls had been already supported by buttresses made of new mud brick and plaster (Fig. 13). The design of the wall is not vertical and the bottom is thicker than the top. This is to
