THE INFLUENCE OF SOLUBLE SALTS ON THE DECAY OF MOENJODARO, PAKISTAN

Enrico Fodde

Purpose The World Heritage site of Moenjodaro, located in the Indus flood plain and dating to the early Bronze Age, is believed to be the most important urban centre of the Indus valley culture. The purpose of the paper is to discuss the main conservation threats and the mechanisms of decay affecting the site and to understand the influence of soluble salts on materials such as fired brick and soil. Furthermore, the paper describes the repair methods employed against salts attack and provides a scheme for site management.

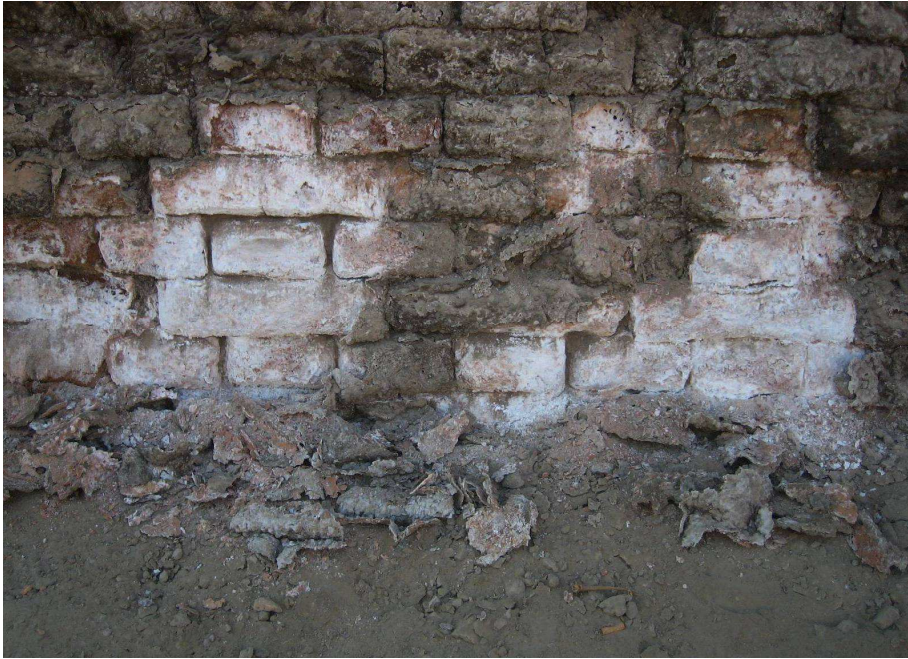
Plate 5

In the cool season lower brick courses show a thick layer of salts efflorescence up to 1-1.5m (Plate 5). The process through which the phenomenon occurs was explained by Boekwijt (1979, 6): 'The bricks of the remains have a high salt content estimated per brick at about 20gr sodium chloride, 20gr sodium sulphate, and a minor amount of carbonates and bicarbonates of calcium, sodium and magnesium.' And again (Various Authors 1987-1988, 4): 'Excavated brick structures at Moenjodaro are deteriorating at an unacceptable high rate because of crystallization and hydration of the mineral thenardite (sodium sulphate). Its destructive effect is mainly attributed to a volume increase of 315 percent resulting when

Take in Plate (No. 5)

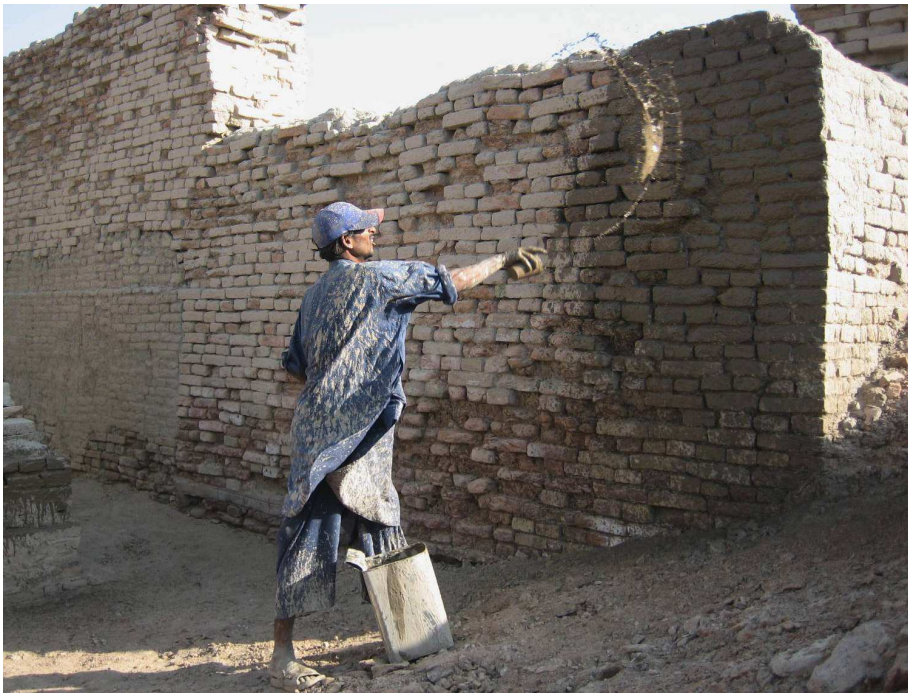
Plate 6

At middle level the application of the mud slurry is advised only after the structural condition of single brick is checked (Plate 6). If necessary, repointing or resetting with new mortar should be carried out as first consolidation measure. At upper level it is suggested that structures be coated with mud slurry application, whilst the top be capped with two mud brick courses.

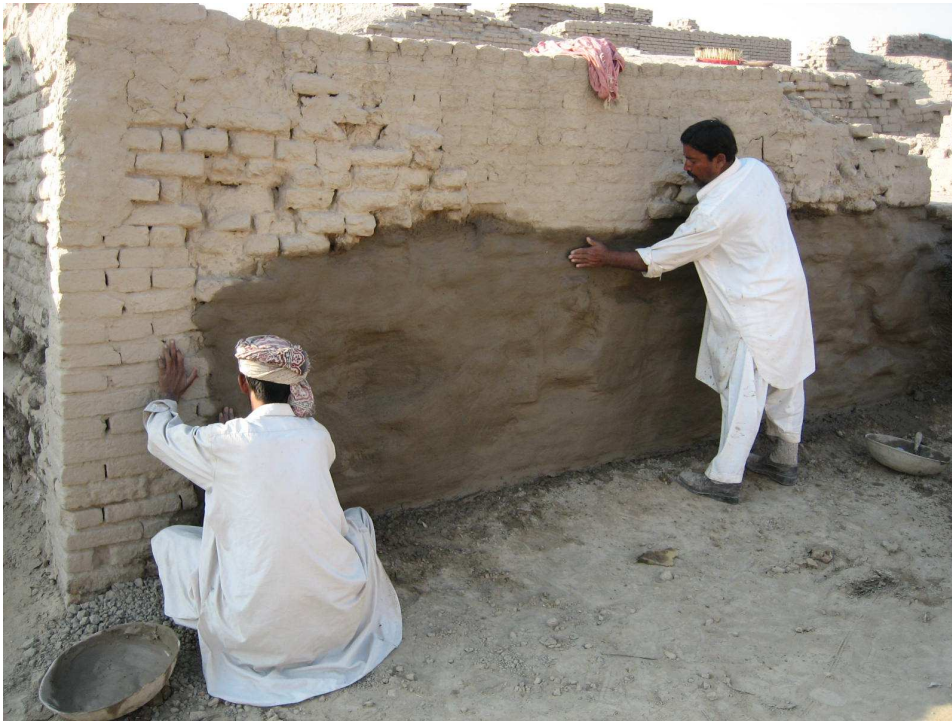
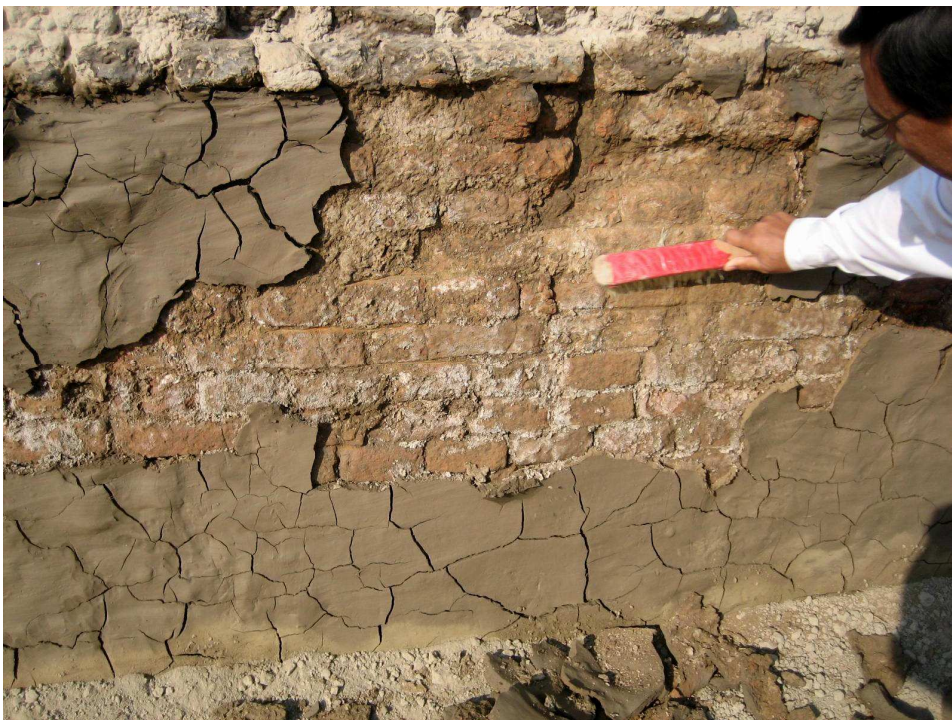
Heavily affected structures are cleaned from salts attack with mud poulticing (Plates 7-8). This is carried out in several steps: brushing of wall portion and disposal of salts, wetting, application of mud slurry, immediate application of thick mud plaster, packing in order to make sure that the plaster adheres to the wall, waiting until plaster is semi dry, removal of plaster, and brushing of hydrated salts and disposal. The process is repeated several times until complete cleaning of the affected portion.

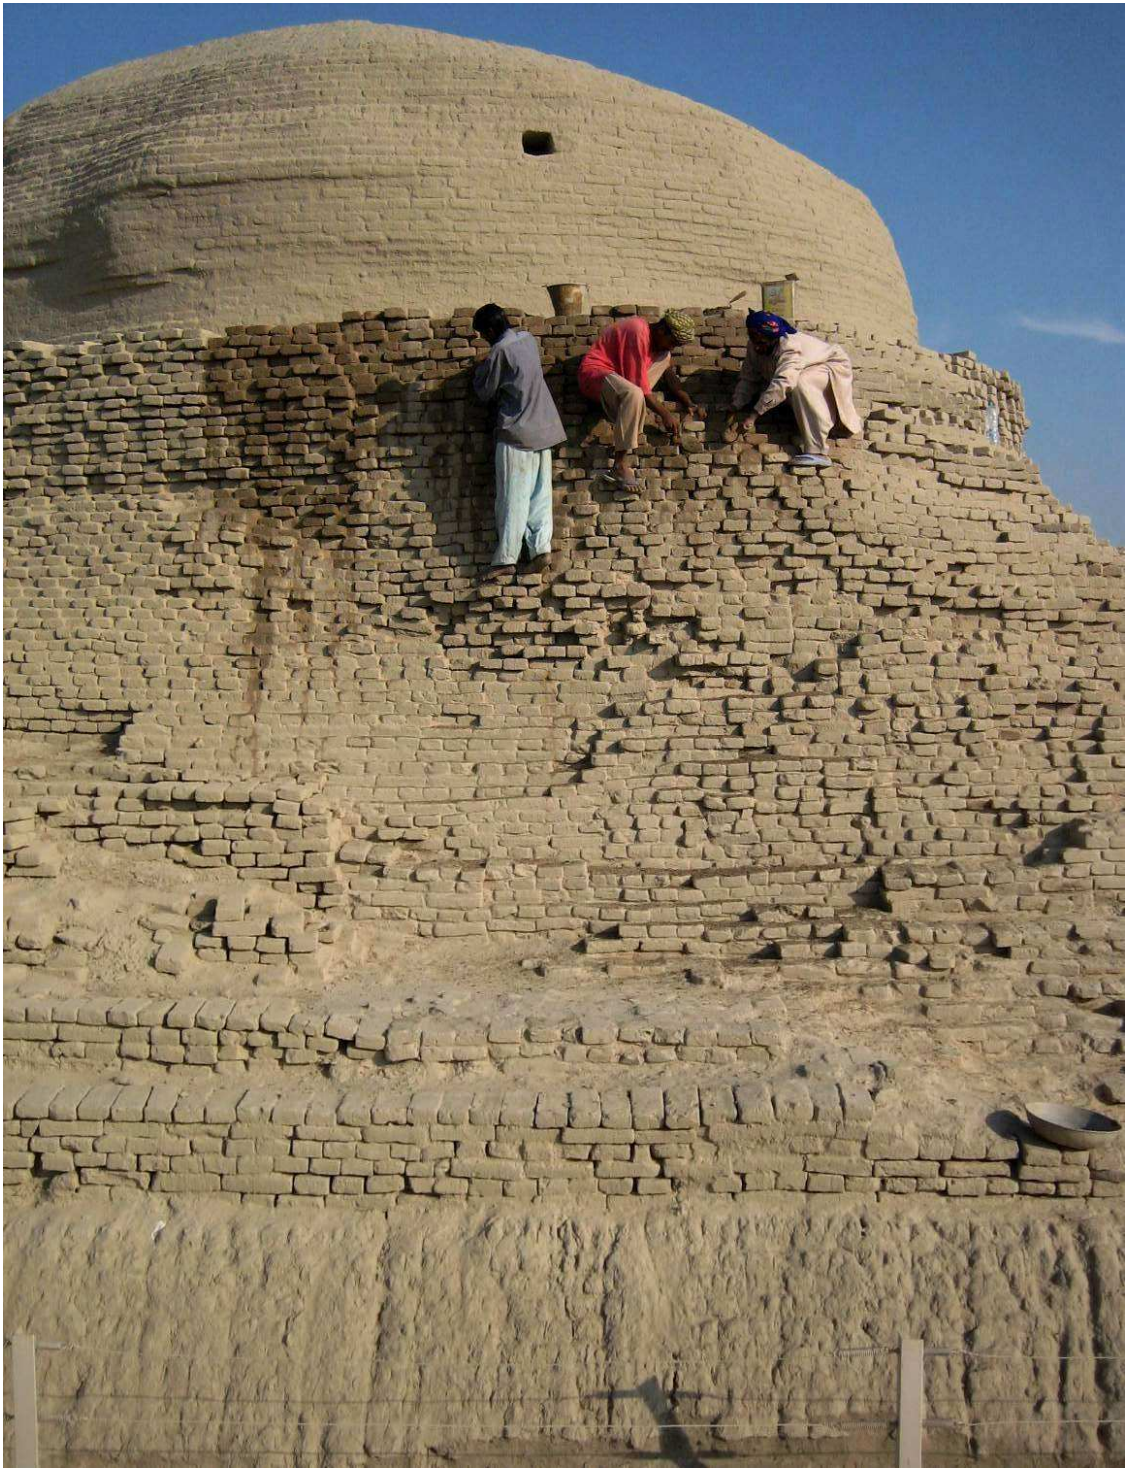
Plate 9

The monsoon season falls between June and September. Preparation work concentrates mainly on drainage improvement by reinforcing gullies, treating drains, and protecting wall bases). Wall capping is maintained or provided where lacking so that to improve the structural stability of structures, prevent water penetration and collapse. Repointing and grouting is also provided to the most endangered structures (Plate 9).

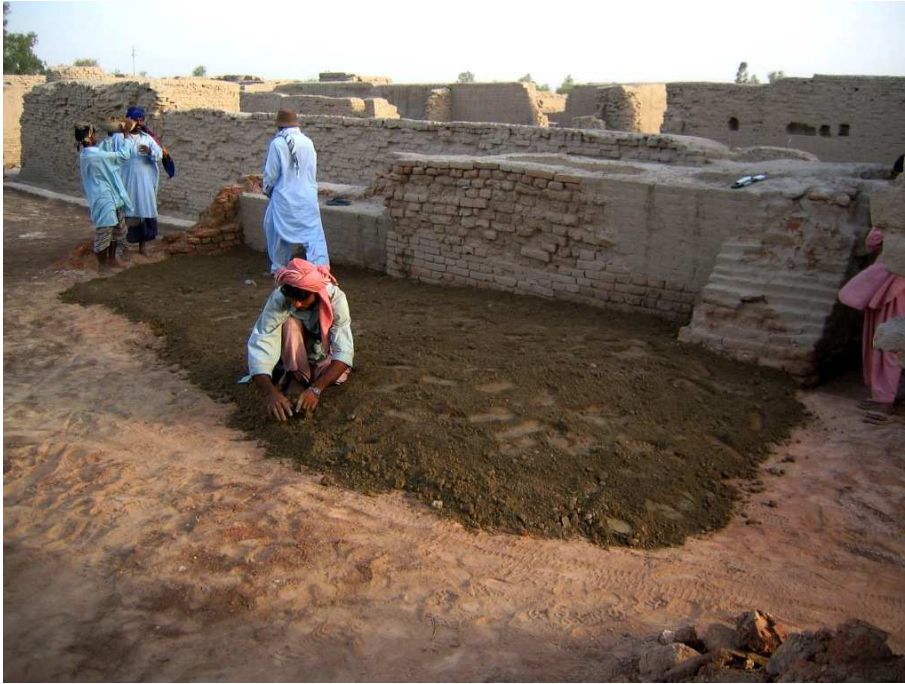
Plate 10

It is proposed here that topographic remodeling to control surface water flow and ponding is essential for proper drainage. This should be provided by employing the following method (Plate 10): drainage survey and plan to be undertaken with total station before and after any intervention is carried out, scraping and disposal of 10-20 cm of salty soil, creation of slopes by importing sweet soil, laying of a bed of mud bricks (paving system) so that to channel water towards the centre of the area or of corridors, and finally it is advised that no sand bed is applied between the ground and the mud brick so that to allow proper crystallization of salts on the mud brick surface. Leaning walls to be consolidate with fired brick buttresses following what explained in Plate 11.

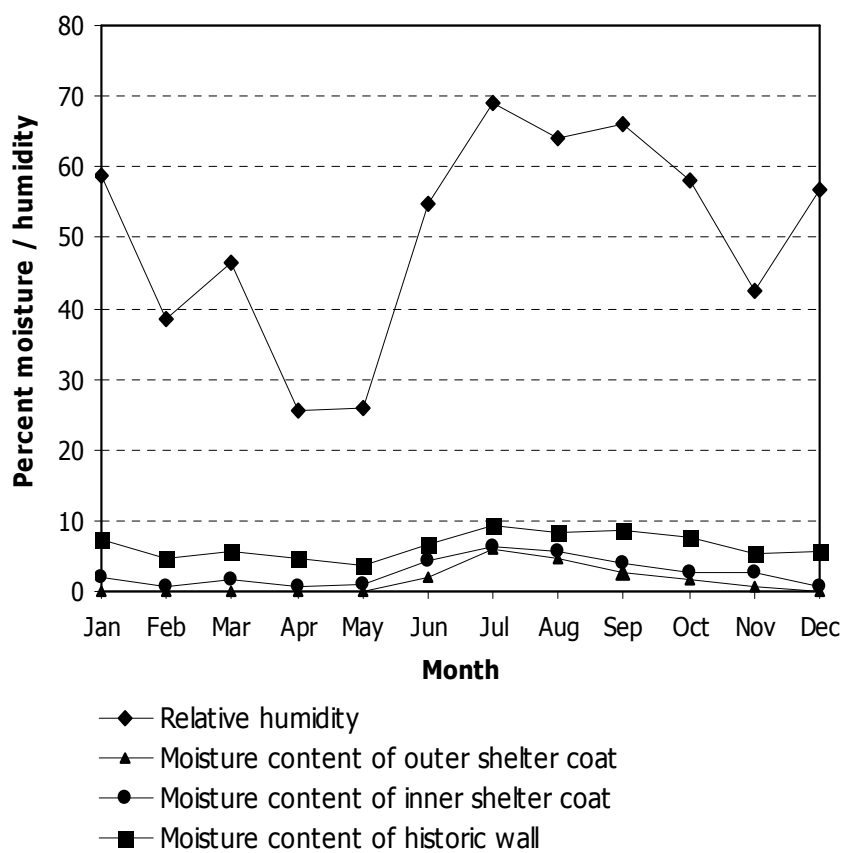
Figure 1

At present only the stupa is monitored (see Figure 1), but it is suggested here that structures of individual significance are examined in terms of moisture and soluble salts content following this simple method: drilling of inspection holes in the joints (5cm depth and max 1cm diameter), collection of samples in air-tight plastic bags, inserting new cotton (use same type) in the holes and compacting, sealing with tape and plastering with mud, laboratory analysis of moisture and soluble salts content to be repeated monthly. The scope of such experimental monitoring programme is to understand the flow of water in the structure and to use the data as a basis for future conservation. It is very clear from simple visual analysis that water patches are affecting the structures at lower level and that proper conservation measures should be taken to minimize decay. A quantification of humidity
