The corrosion of metal matrix composites

THE CORROSION OF METAL MATRIX COMPOSITES

for the degree of PhD

School of Materials Science

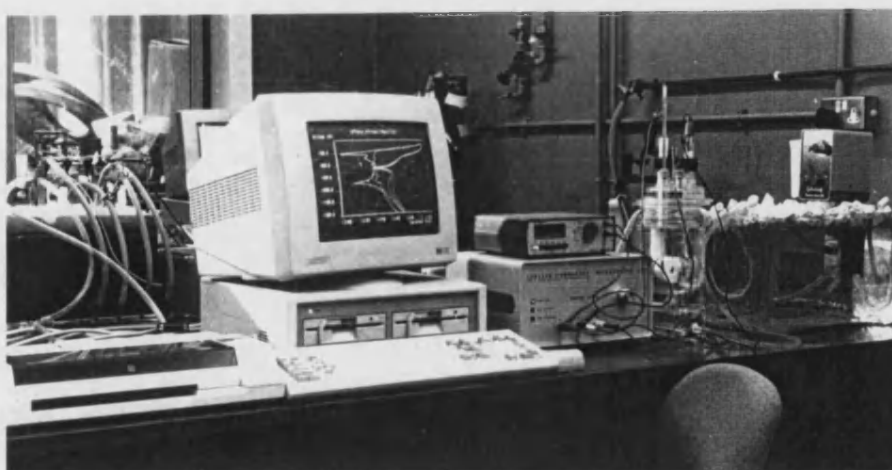
Fig.3.4 The computer-controlled polarisation equipment

The equipment used for polarisation tests is illustrated in Fig.3.4. It consisted of an ACM RS-232 Computerstat (Applied Corrosion Monitoring Ltd) which was controlled by an Amstrad PC-1512 computer. The ACM-232 Computerstat was a potentiostat which could be controlled via a computer to measure current-potential or current-time relationships for a variety of materials. The results were plotted out during the course of the test and stored on floppy disc. The choice of sampling interval (potential and current) was dependant upon the method of polarisation since it is a function of the memory of the computer. Typically data were sampled at 5mV intervals during potentiodynamic polarisation experiments.

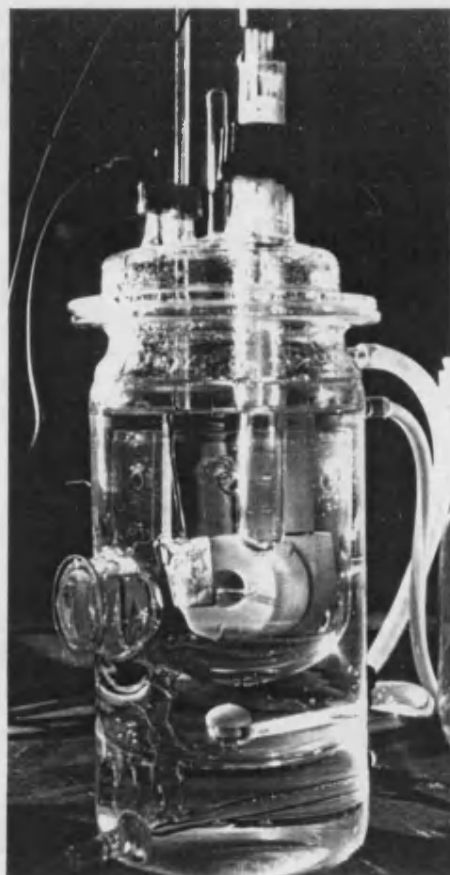
Fig.3.6 The glass cell equipped with the working, reference and auxiliary electrodes

which the nitrogen was bubbled to minimise turbulence in the inner compartment. The inner compartment, also filled with test solution, contained a working electrode, a counter electrode and a standard reference electrode. Holes in the walls of the inner compartment allowed interchange of the solution with the middle compartment. Fig.3.6 shows the polarisation cell fitted with the three electrodes.

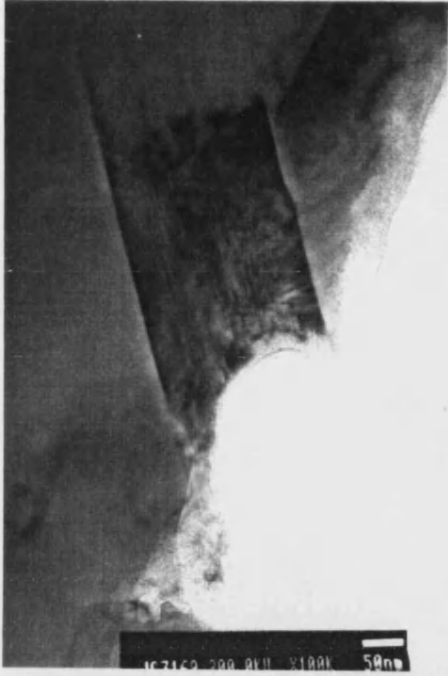
Fig.4.17 (a) TEM micrograph of crystals at the fibre/matrix interface in Al-C
(b) SAD pattern of carbon fibre
(c) SAD pattern of aluminium matrix

Analysis of the fibre/matrix interface was carried out in the transmission electron microscope (TEM). Fig.4.17(a) is a transmission electron micrograph of the specimen showing the carbon fibre, the aluminium matrix and a reaction zone containing lath-like crystals situated at the fibre/matrix interface. The crystals, which appeared to have grown into the matrix in a variety of directions, were found to have lengths of up to ~300nm long and widths of up to ~100nm. Analyses of the fibre, matrix and the interfacial crystals were made by selected area diffraction (SAD). The carbon fibre gave a SAD pattern of diffuse rings, Fig.4.17(b),

One such factor concerns the presence in some MMC, of a layer of aluminium carbide between the fibre and matrix. Indeed evidence has been presented showing that the incorporation of carbon fibres into an aluminium matrix by squeeze casting frequently results in the formation of aluminium carbide (Figs.4.17 & 4.18), as shown by Yang and Scott (1991a) in their studies on 357-C fabricated by liquid metal infiltration (LMI). Thus 2124-C and 357-C_S, both fabricated by squeeze casting, are also likely to contain aluminium carbide. This phase readily hydrolyses and accelerated corrosion at the fibre/matrix interface would be anticipated, giving more extensive attack than that indicated by measurement of the galvanic current between fibre and matrix.

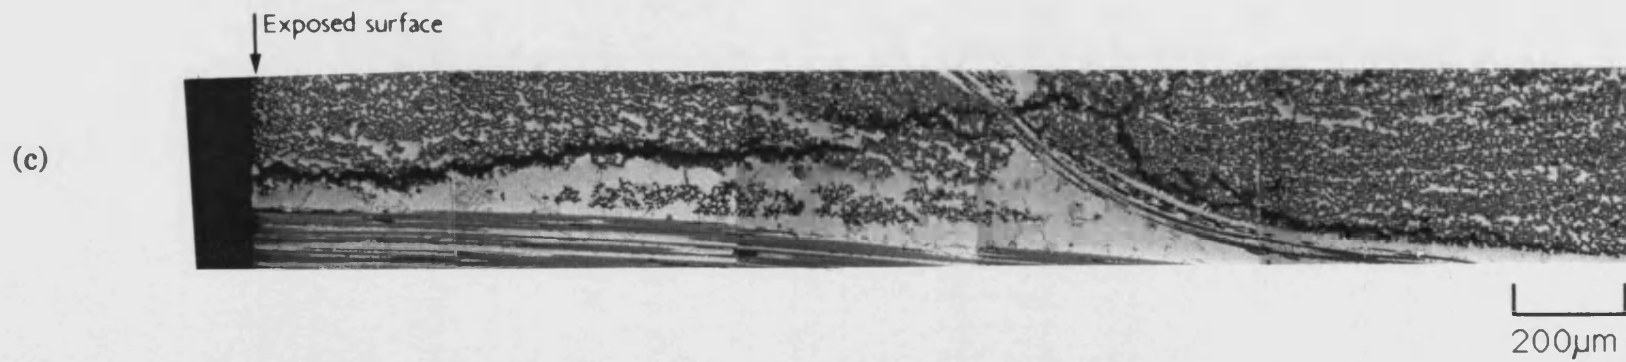
Fig.4.29 The results of DCP tests on 357-C_L (2mV/min scan rate)
 (a) DCP curve
 (b) Optical micrograph taken after the test
 (c) Cross-section through the specimen

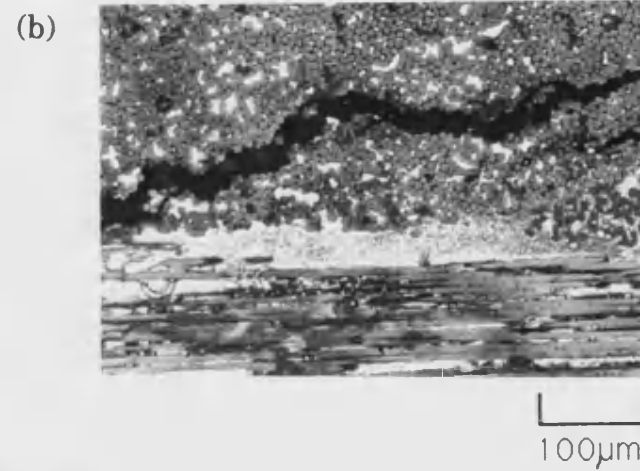
Fig.4.32 Corrosion morphology of 357-C_I after 3 weeks corrosion
 (a) Corrosion around carbon and weft fibres
 (b) Crack running through fibre tow
 (c) Cross-section through the corroded specimen
 (d) Cross-section showing complete penetration of corrosion through the specimen

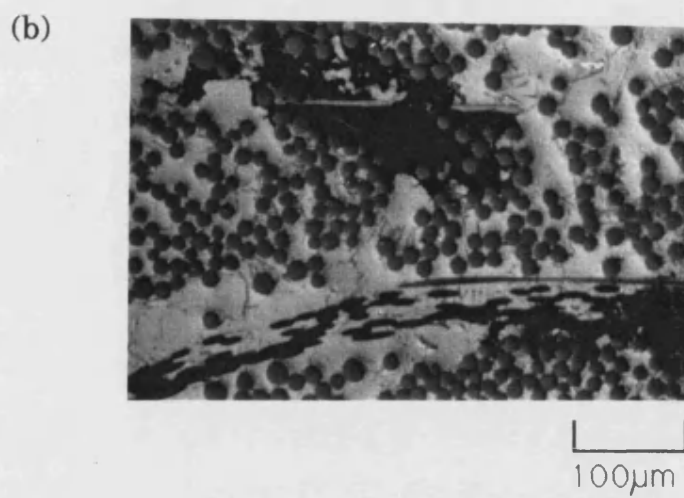
Fig.4.37 Corrosion morphology of 357-Nic (type A) after DCP test (20mV/min scan rate)
(a) Corrosion around the glass weft
(b) Corrosion pit at FeSiAl₅ intermetallic

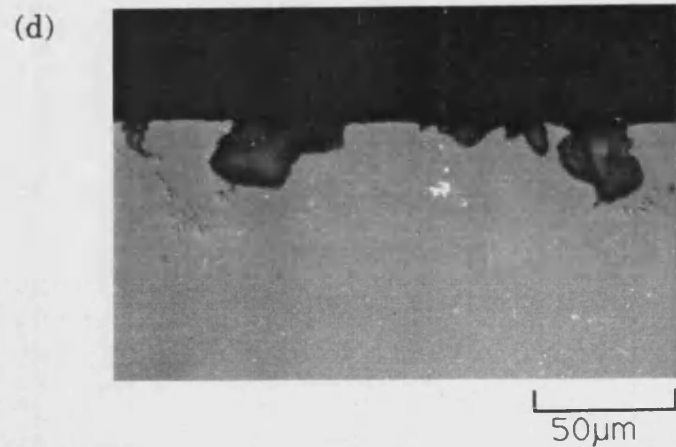
Fig.4.47 Corrosion morphology of 2124 alloy
(a) After 3 days immersion, illustrating corrosion around the $(\text{CuFeMn})\text{Al}_6$ phase
(b) After 1 week immersion
(c) After 3 weeks immersion
(d) Cross-section through a specimen after 3 weeks corrosion

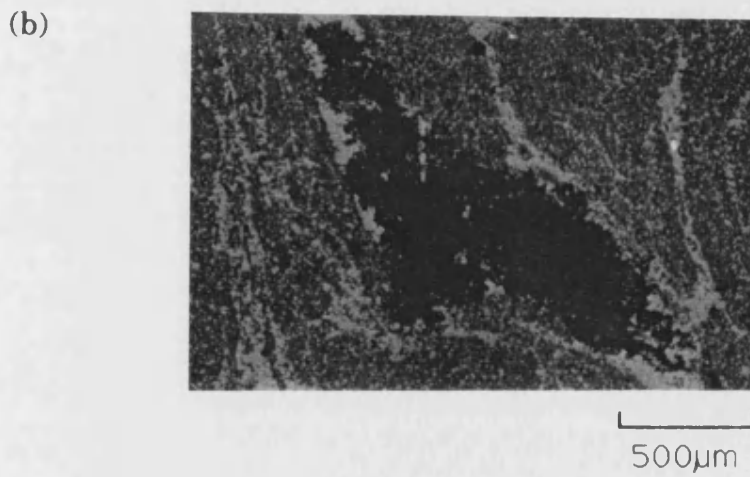
Fig.4.58 The results of DCP tests on Al-C (20mV/min)
 (a) A DCP curve
 (b) Optical micrograph of a corrosion pit taken after the test
