**Characterisation of thermal sprayed hydroxyapatite coatings for use as a biological attachment system for prosthetic devices**

# Characterisation of Thermal Sprayed Hydroxyapatite Coatings for use as a Biological Attachment System for Prosthetic Devices

Submitted by Steven R Brown for the degree of Doctor  
of Philosophy of the University of Bath.

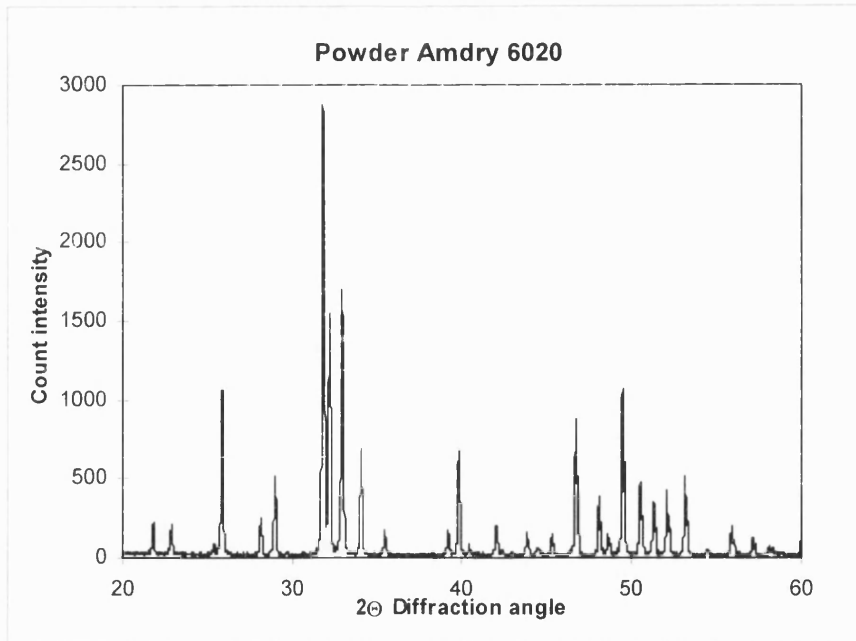
Figure 3.1.1. XRD pattern of powder Amdry 6020.

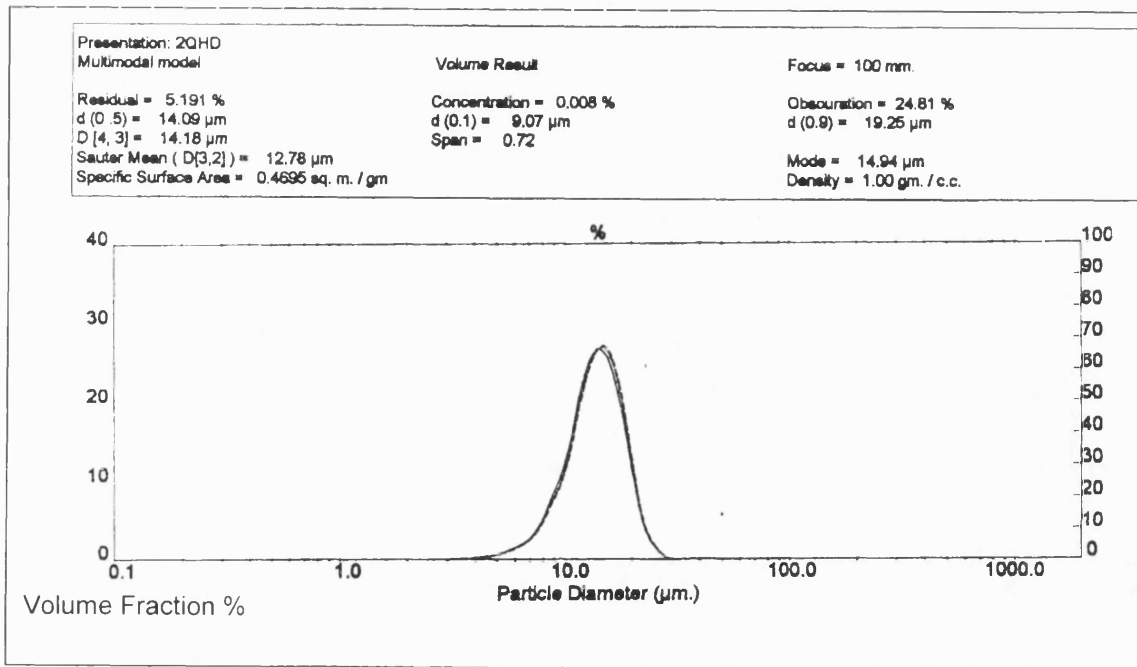
Figure 3.1.5. Particle size distribution for powder HA 044.

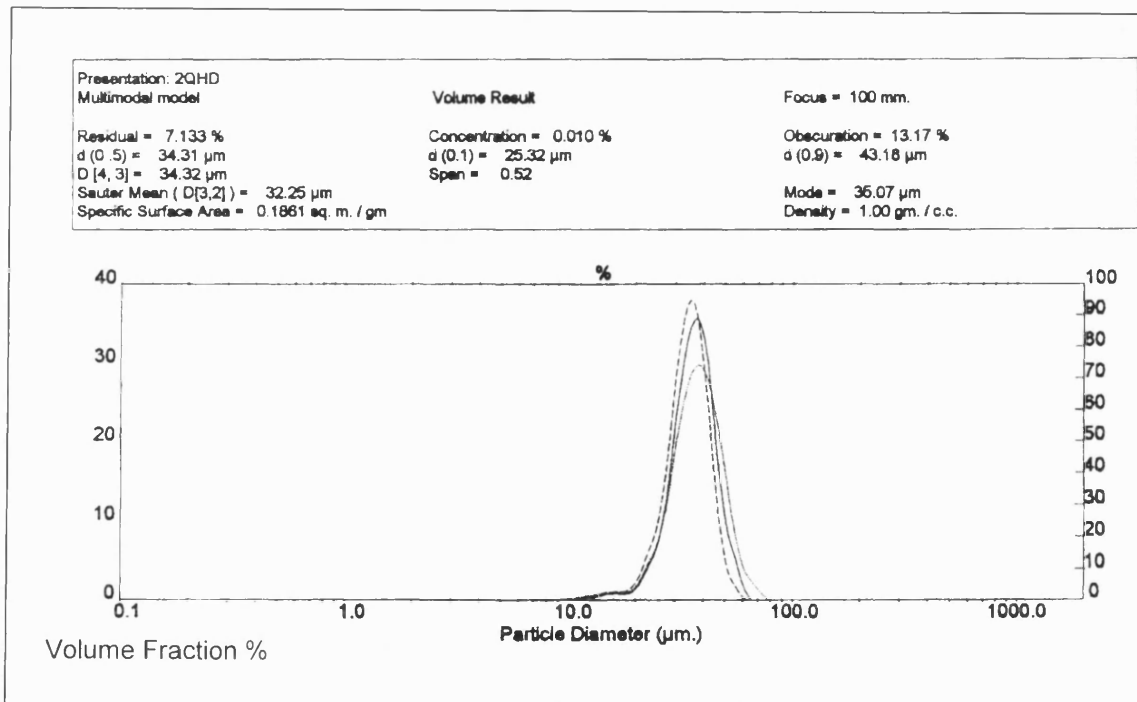
Figure 3.1.6. Particle size distribution for powder XPT W 601.

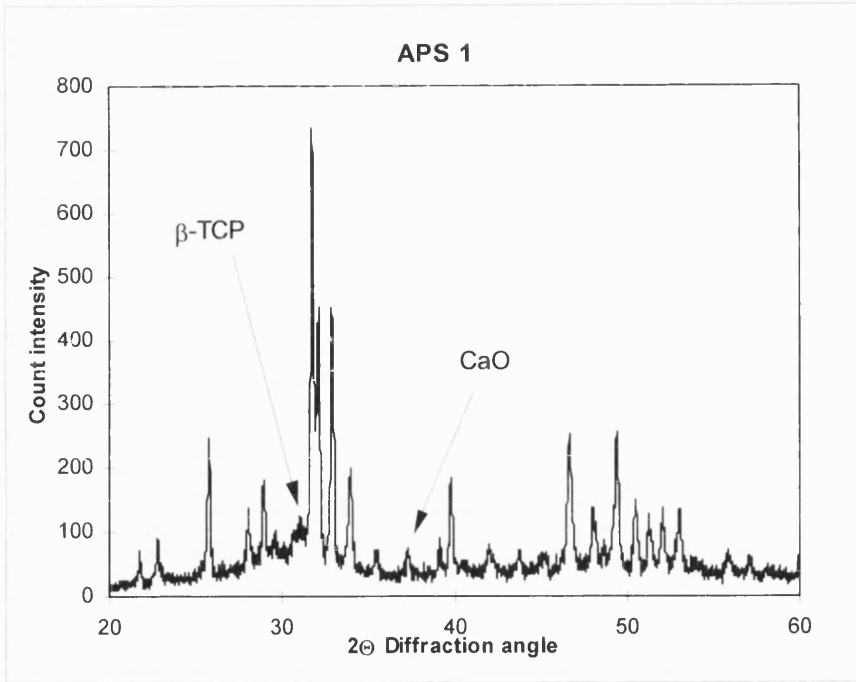
Figure 3.2.1. XRD pattern of APS1 coating.

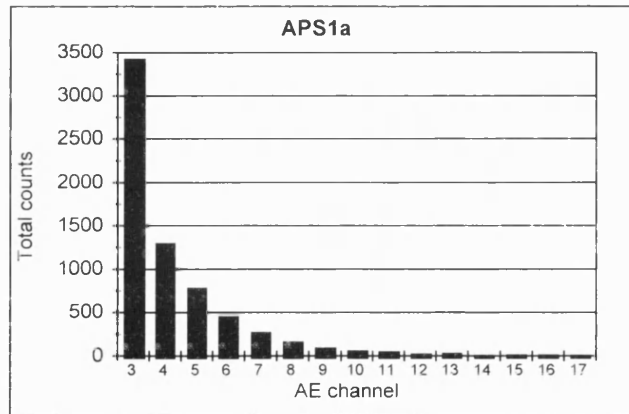
Figure 3.5.1. Cumulative event count per channel for HA coating APS1.

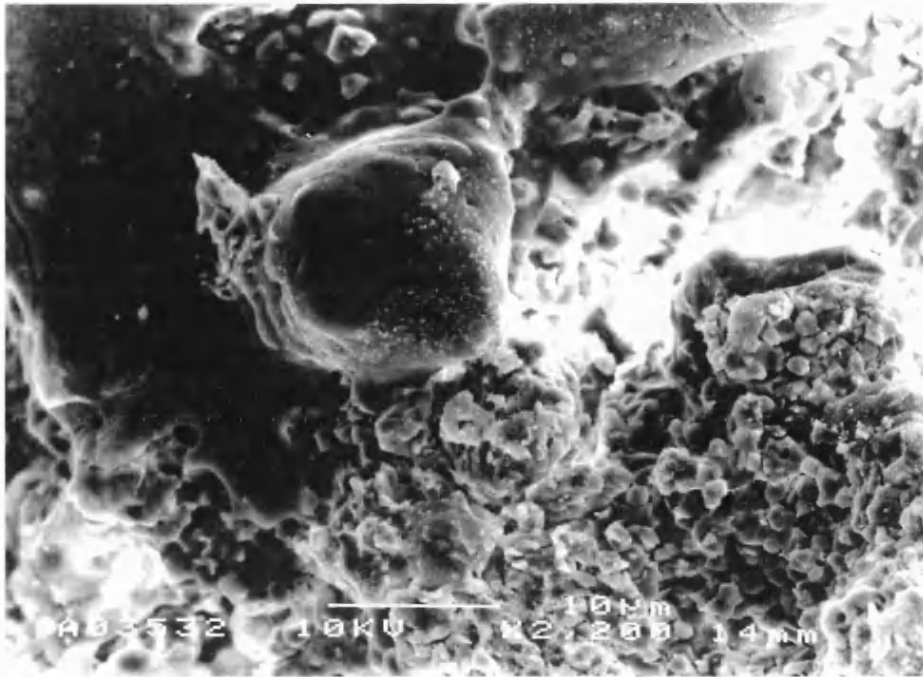
Figure 3.7.31. SEM micrograph of the HA coating APS3 aged for 1 week at pH4.5, showing etched and unetched areas. mag.  $\times 2200$ .
