**The effect of transient overloads on the stress-rupture of glass fibre reinforced polymers**

Rawles, J. D.

*Award date:*  
1990

The Effect of Transient Overloads on the Stress-rupture  
of Glass Fibre Reinforced Polymers.

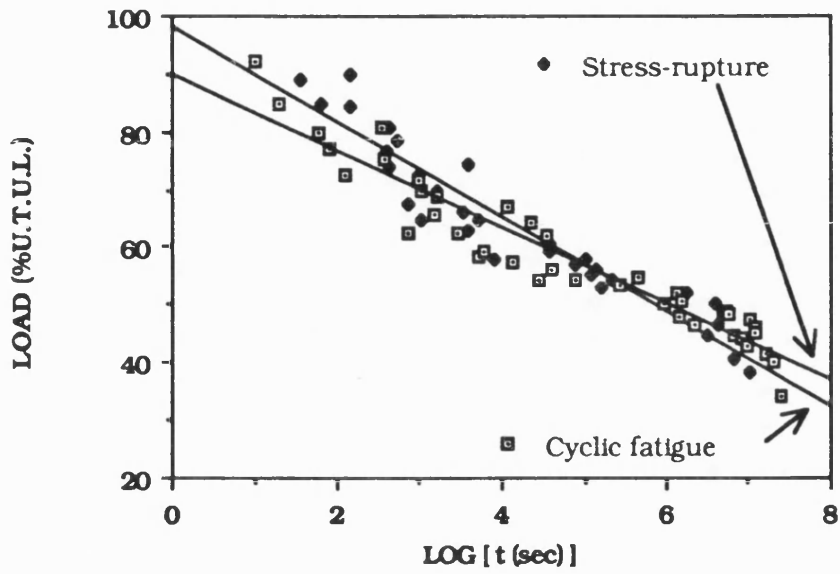
FIGURE 3.1 (from Ref. 34)

Test life as a function of applied load for GRP under two loading regimes, static and cyclic fatigue.

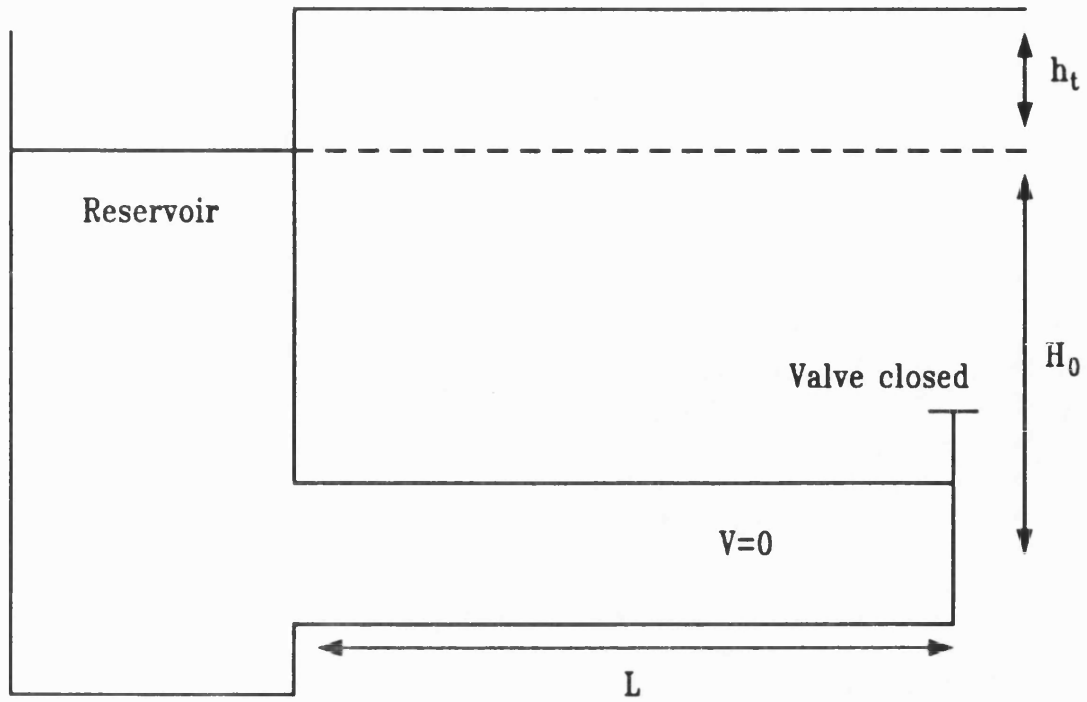
FIGURE 4.3 System conditions after  $L/a$  seconds.

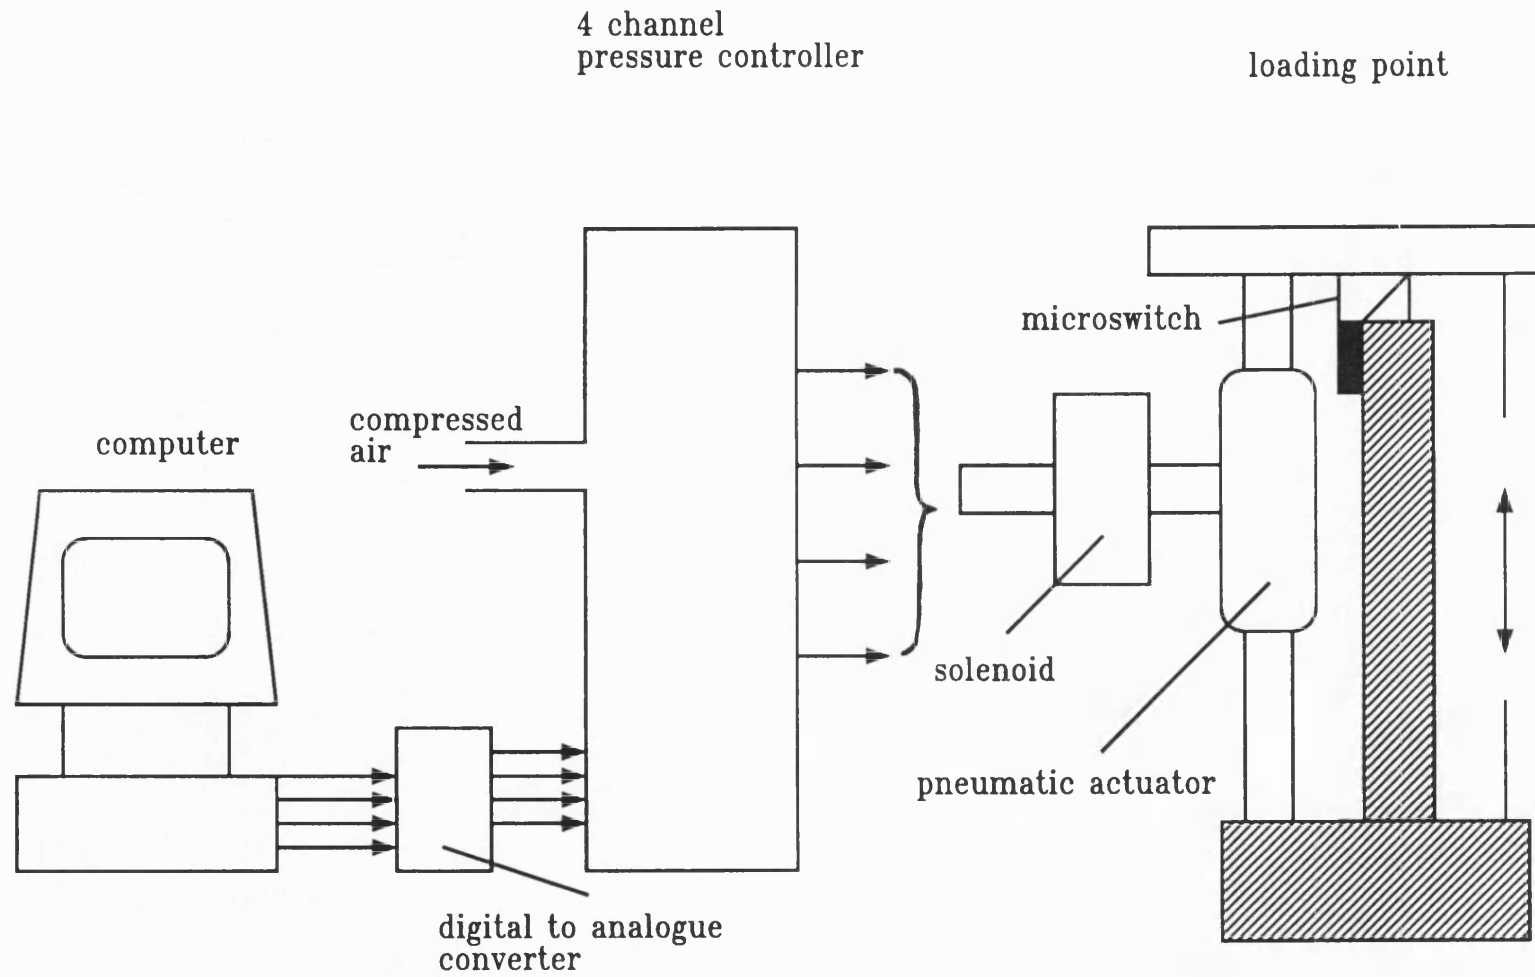
FIGURE 7.6 Schematic representation of pneumatic loading rig.

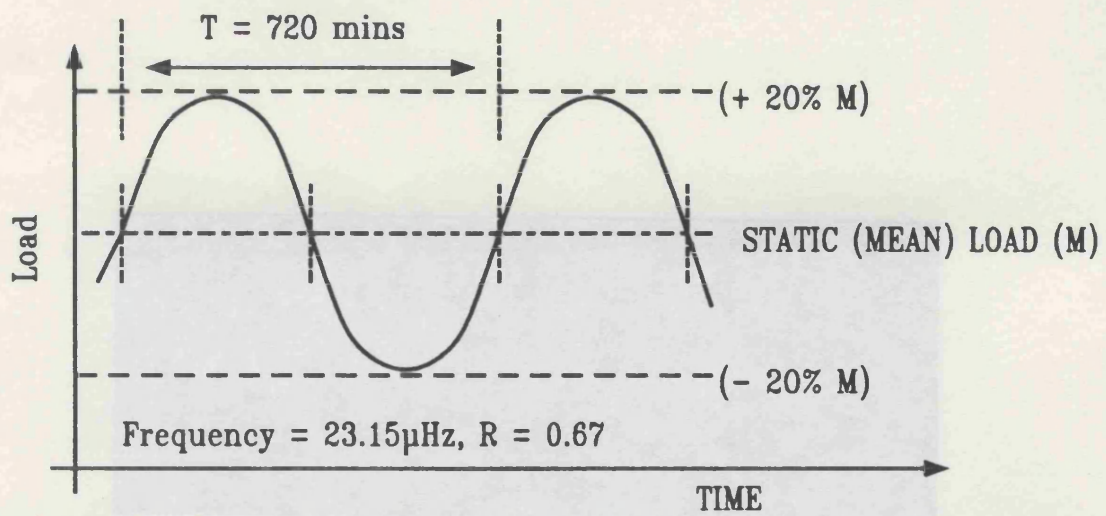
FIGURE 7.7

Load profile for stress-rupture with superimposed sinusoidal load.

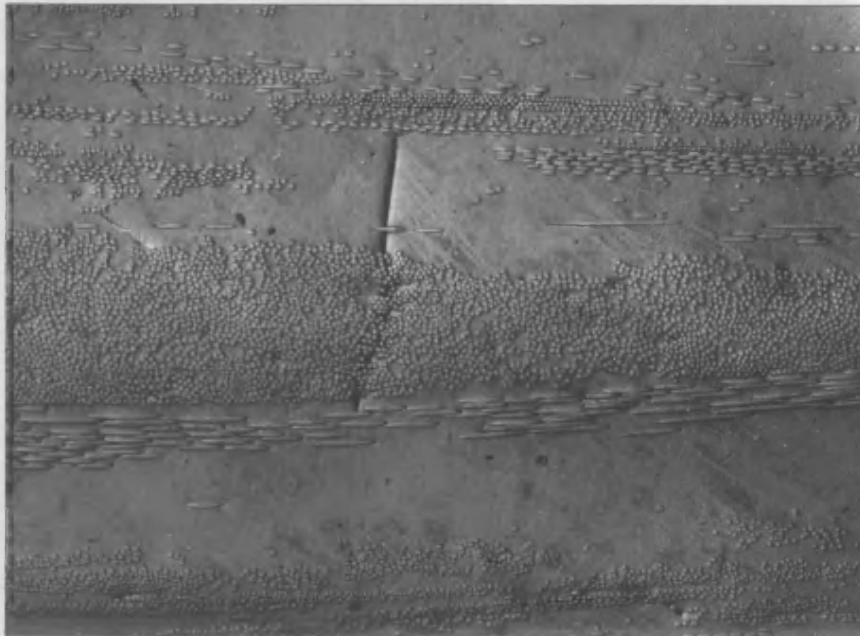
FIGURE 8.6

Optical micrograph showing resin cracking originating from a transverse roving bundle after one 60% UTUS overload cycle. Magnification: 50.

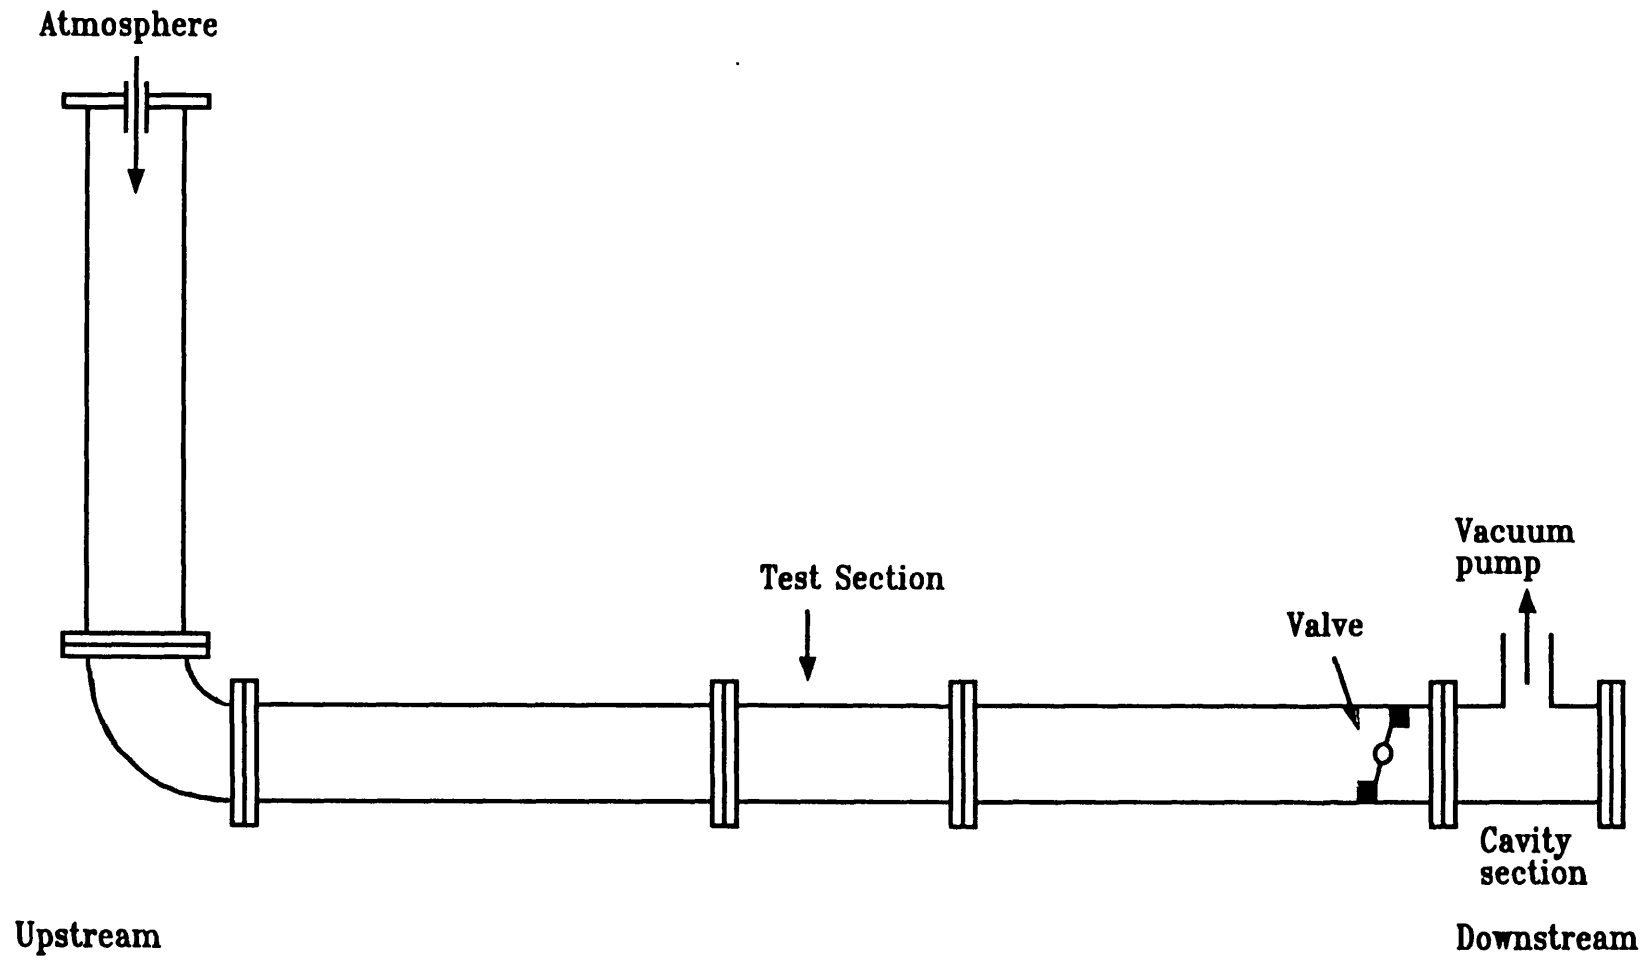
FIGURE 10.5 Rig used for the application of controlled water hammer event to pipes.

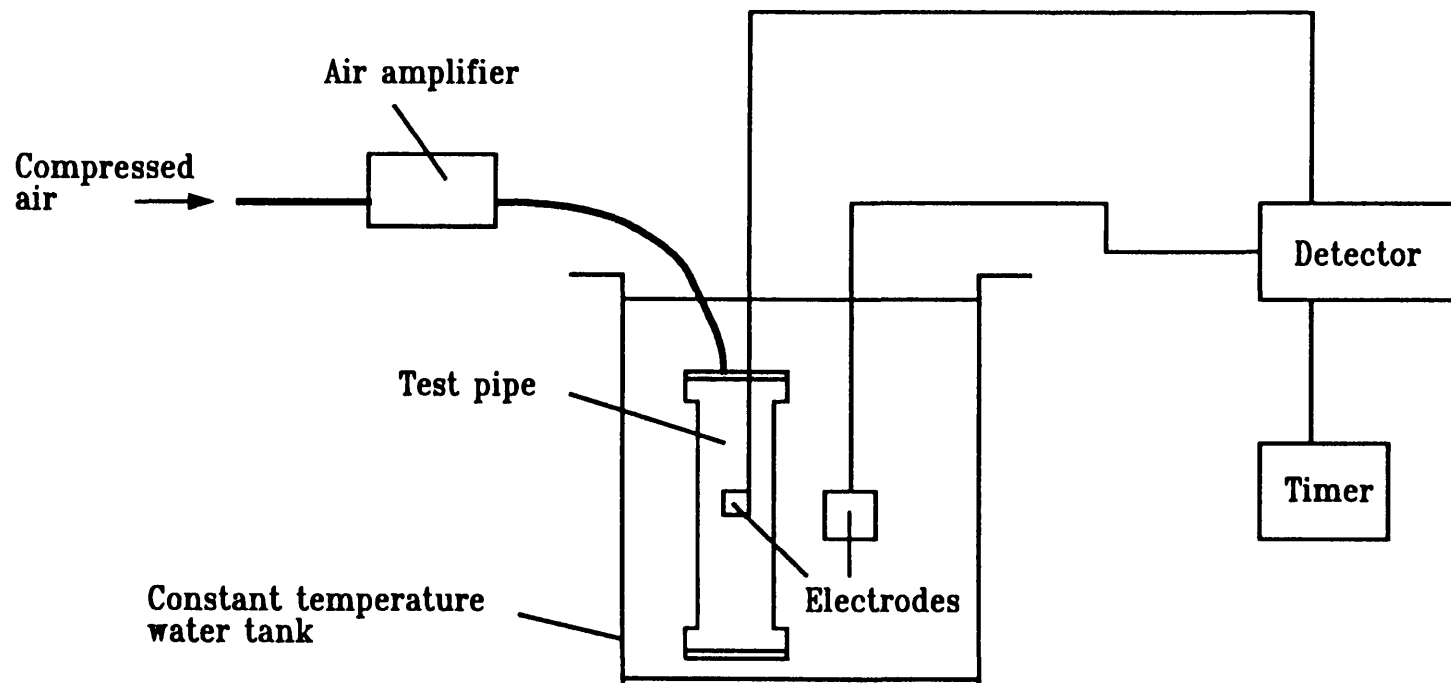
FIGURE 10.26 PIPE STRESS-RUPTURE APPARATUS.

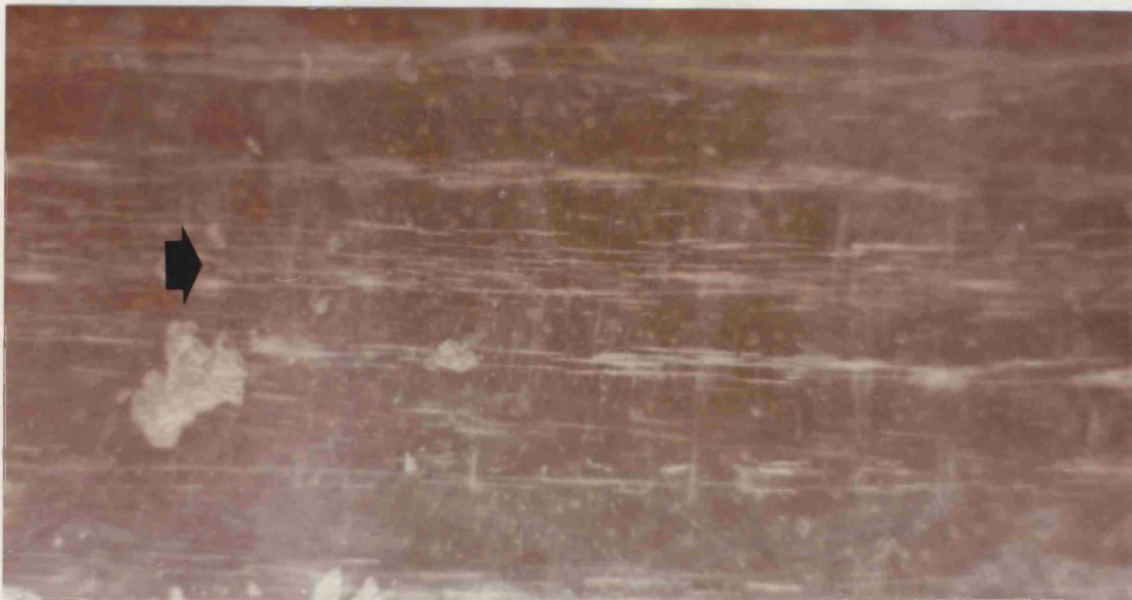
FIGURE 11.4

Band of axial debonding/resin cracking.

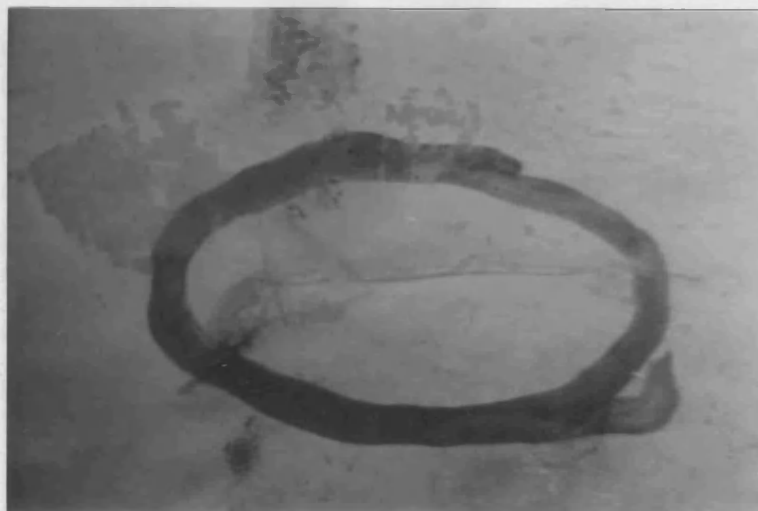
FIGURE 11.10

Point of leakage in a failed virgin pipe.
