Full-scale shaking table tests on a substandard RC building repaired and strengthened with Post-Tensioned Metal Straps

(Short Version: Shake table tests on PTMS-strengthened RC frames)

Abstract

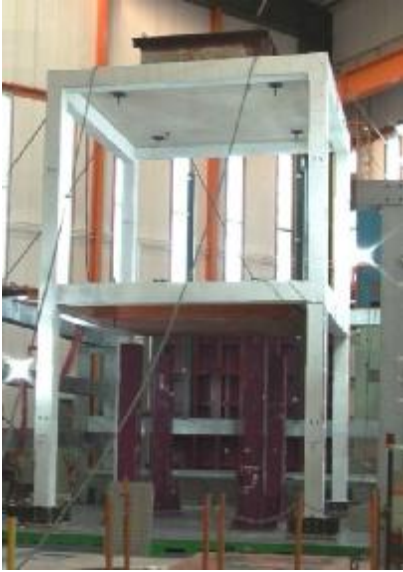
Fig. 2. General view of BANDIT building in bare condition

The tested structure (see Fig. 2) was a one-bay two-storey frame building regular in plan and elevation, similar to a building tested as part of the EU ECOLEADER programme [Chaudat et al., 2005; Garcia et al., 2010] and built according to substandard construction practices of developing countries. Fig. 3(a) to (c) show details of the general geometry of the building, cross sections of

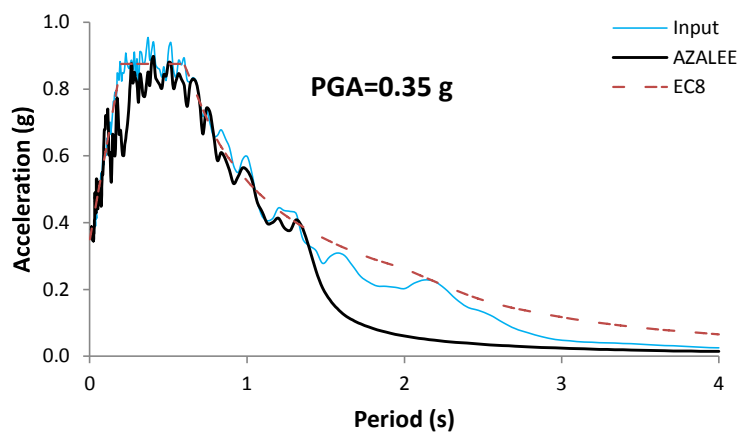
Fig. 5. Matching of response spectra input record and response of shake table (PGA=0.35g)

An artificial ground motion record based on Eurocode 8 (EC8, EN 1998-1:2004) soil type C spectrum [CEN, 2004] was used as horizontal input. The matching of the input record and EC8 spectra was performed analytically using commercial software (SignalStar by Data Physics). The record length was 30 s, with a frequency range of 0.7-30 Hz. The ground motion record was scaled to apply different levels of peak ground acceleration (PGA). In general, a good matching between the input record spectrum and the table response spectrum was observed for the range of frequencies of interest at all excitation levels. For instance, Fig. 5 compares the spectra for the “EC8” for 5% of critical damping, the “input” record, and the “AZALEE” actual response recorded on the shaking table at PGA=0.35g.

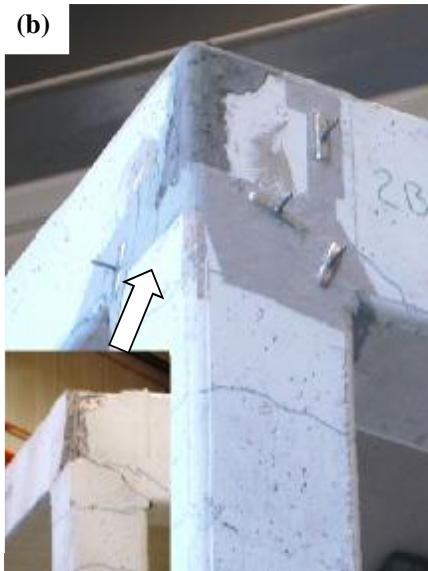
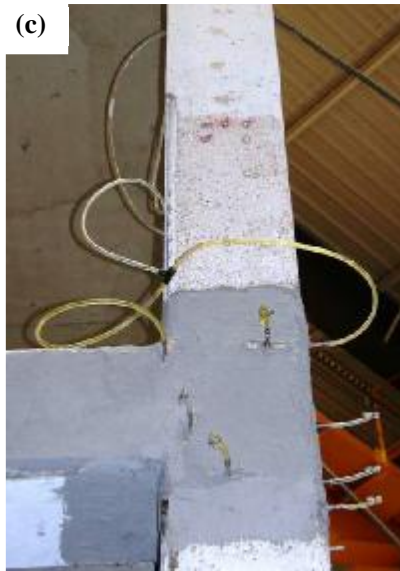
Fig. 9. Repairs after Phase 1: (a) welding of external beam bars to column bars, (b) mortar repair at J2B-2 and injection ports for crack injection, (c) crack injection in progress

b) Replacing damaged and spalled concrete with high-strength repair mortar (Fig. 9(b)), and

c) Injecting cracks with epoxy resin (Fig. 9(c)).

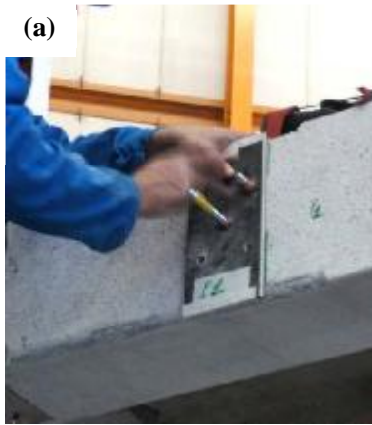
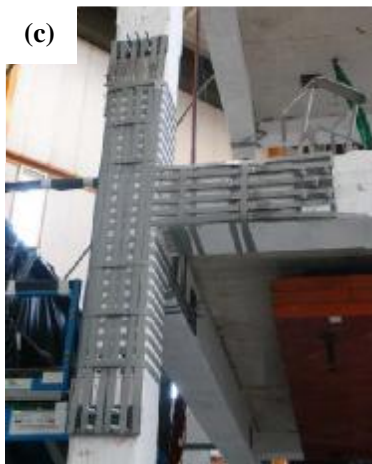
Fig. 11. PTMS strengthening of beam-column joints: (a) fixing of steel plates, (b) additional anchorage plate at interior face of beams, (c) final view of 1st floor joints, (d) final view of 2nd floor joints.

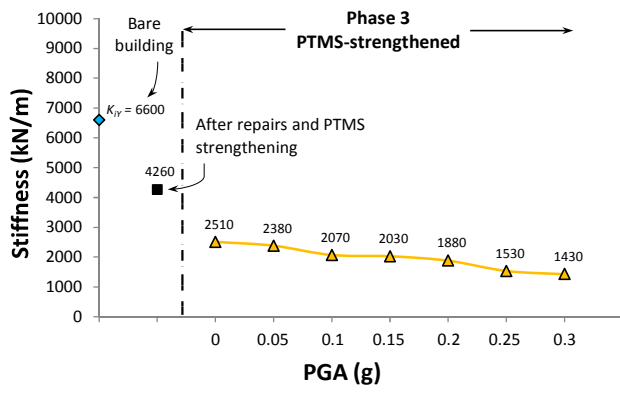
Fig. 13. Lateral stiffness degradation, Phase 3 (Y direction)

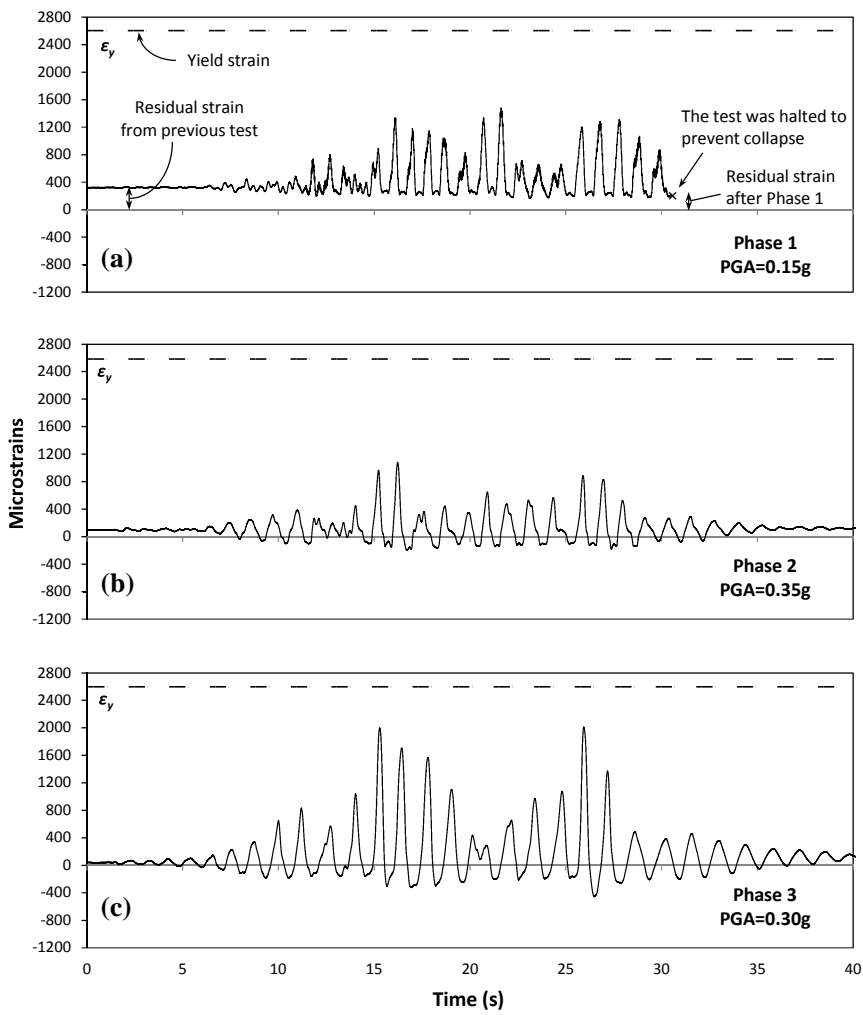
Fig. 15. Strain time-histories of bottom beam reinforcement at joints, last test of Phases 1 to 3

Fig. 15 compares strain time-history readings from gauges fixed on the bottom beam reinforcement of the 1st floor (gauges marked with an asterisk in Fig. 4). As shown in Fig. 15 (a), elastic strains of 300-400 $\mu\epsilon$ accumulated during the initial tests in Phase 1 due to damage at the bar-concrete interface. In comparison, very small strains (120 $\mu\epsilon$) accumulated during Phases 2 and 3, which indicates that most of the seismic force demand was taken by the metal straps rather than by the internal reinforcement. The readings from the strain gauges fixed on the reinforcing bars indicated that no yielding occurred in beams or columns.

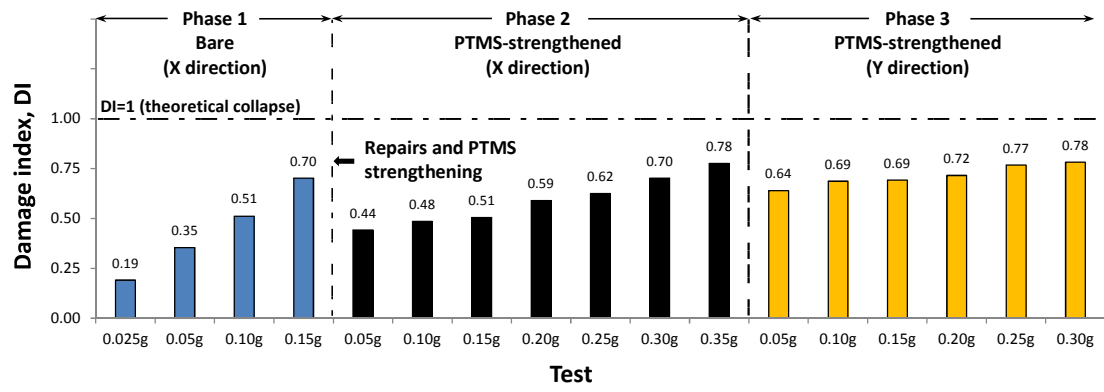
Fig. 16. Global damage indices, Phases 1 to 3

Phase 2. Fig. 16 shows that at a $PGA=0.15g$, the PTMS-strengthened building exhibited a DI of only 0.51, which indicates a damage reduction of 27% compared to the bare building (Phase 1). It is also shown that the damage of the strengthened building at $PGA=0.30g$ ($DI=0.70$) was identical to that obtained at a considerably lower $PGA=0.15g$ in the bare building and no local damage was observed. Although the tests in Phase 2 were stopped at a relatively high $PGA=0.35g$, the DI value only reached 0.78 (without severe local damage) and could potentially resist higher PGAs.

Phase 3. Despite the significant damage accumulated at the start of this testing phase ($DI=0.64$) due to shaking in the X direction, the PTMS-strengthened building in the Y direction (Phase 3) showed similar levels of damage as the bare building at $PGA=0.15g$ ($DI_s=0.69$ and 0.70 , respectively) tested in the X direction (stronger direction).

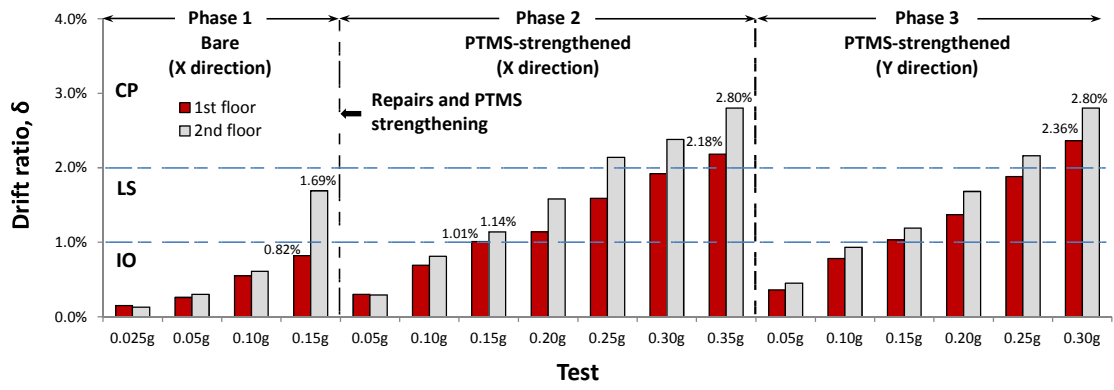
Fig. 17. Inter-storey drift ratio of 1st and 2nd floors, Phases 1 to 3

Phase 1. Fig. 17 shows the maximum inter-storey drift ratios (δ) of the 1st and 2nd floors obtained for each shaking table test. The results indicate that the 1st and 2nd floors of the bare building had similar drift ratios at PGA levels of 0.025g, 0.05g and 0.10g. However, when the building was subjected to a PGA=0.15g, the 2nd floor drift value was 100% higher than that of the 1st floor ($\delta=1.69\%$ vs 0.82%). This sharp increase of the drift ratio can be attributed to the significant local damage of the beam-column joints at the 2nd floor, as observed in the experiments.

Phase 2. It is shown in Fig. 17 that the drift ratios of the bare and PTMS-strengthened buildings were very similar at a PGA=0.05g (0.29% vs 0.30%). At a PGA level of 0.10g, the drift ratios of the 1st and 2nd floors of the strengthened building (Phase 2) were respectively 33% and 25% higher than the corresponding ratios measured on the bare building (Phase 1). While the 2nd floor of the bare structure was within LS level at a PGA=0.15g ($\delta=1.69\%$) due to the local damage, the critical drift ratio of the strengthened building was very close to the IO performance level ($\delta=1.14\%$), which is consistent with the experimental observations. In general, the local repairs and PTMS strengthening of the joints were very effective at reducing the critical drift of the 2nd floor (i.e. critical storey). As discussed in Section 4.1, this led to a more uniform distribution of damage in the structure.

Phase 3. The effectiveness of the PTMS strengthening is emphasised by comparing the maximum inter-storey drifts of the strengthened building in the X and Y directions (Fig. 17). Although no rehabilitation was done after Phase 2, similar maximum inter-storey drifts were observed during the shaking table tests in the X and Y directions up to PGA=0.25g (Phases 2 and 3, respectively).
