## THE SILTING OF LAKE CHAUTAUQUA

Havana, Illinois

J. B. Stall and S. W. Melsted

STATE WATER SURVEY DIVISION

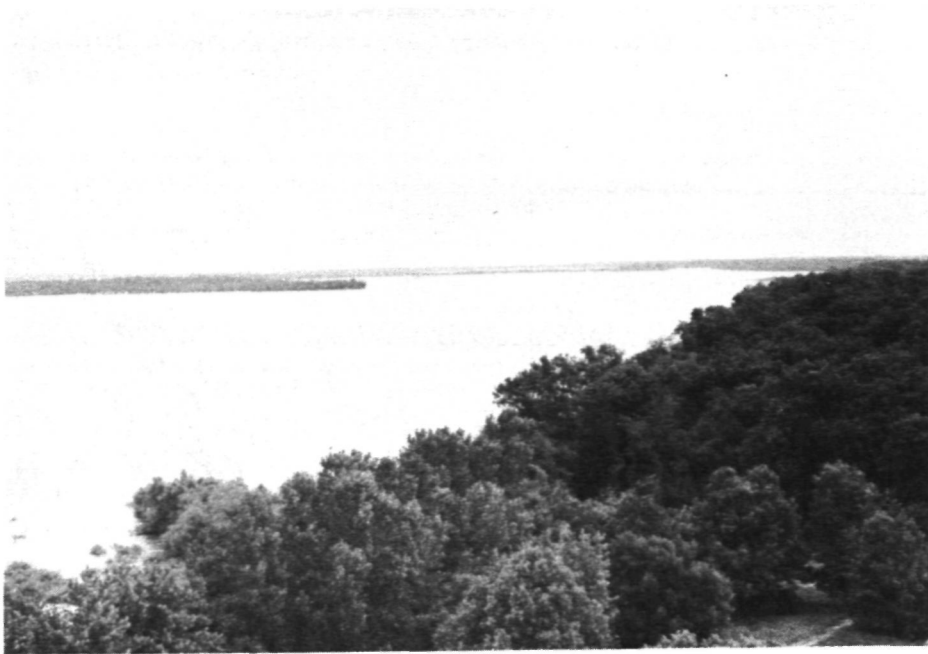
Figure 1a. View of Lake Chautauqua Looking North

pletely different from conditions found in most artificial lakes studied to date within the state. General views of the lake are shown in Figure 1.

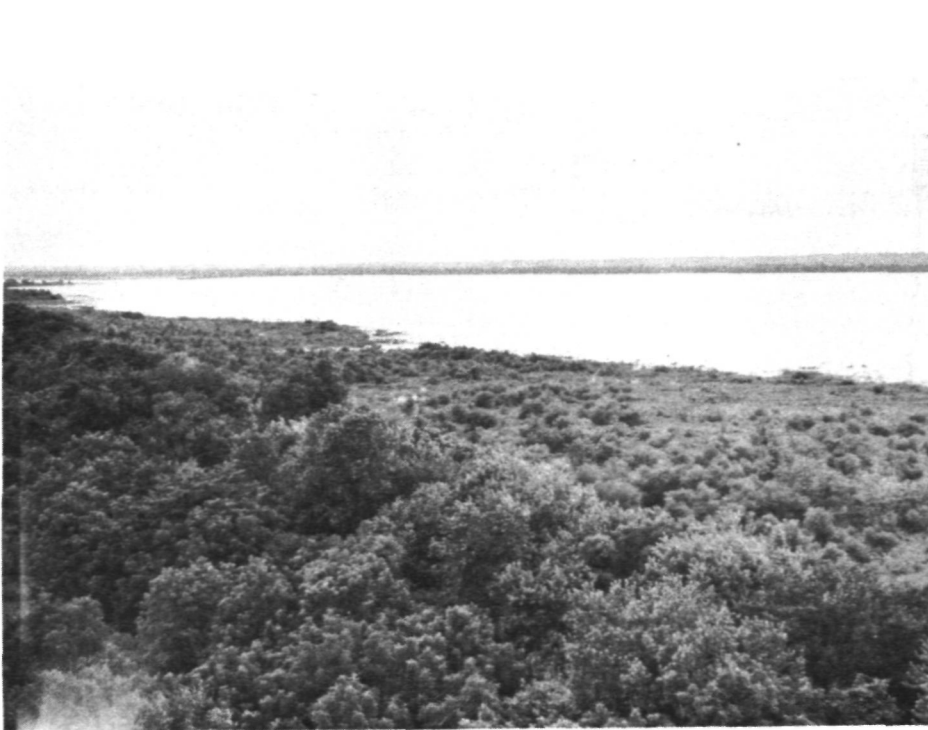
Figure 1b. View of Lake Chautauqua Looking South

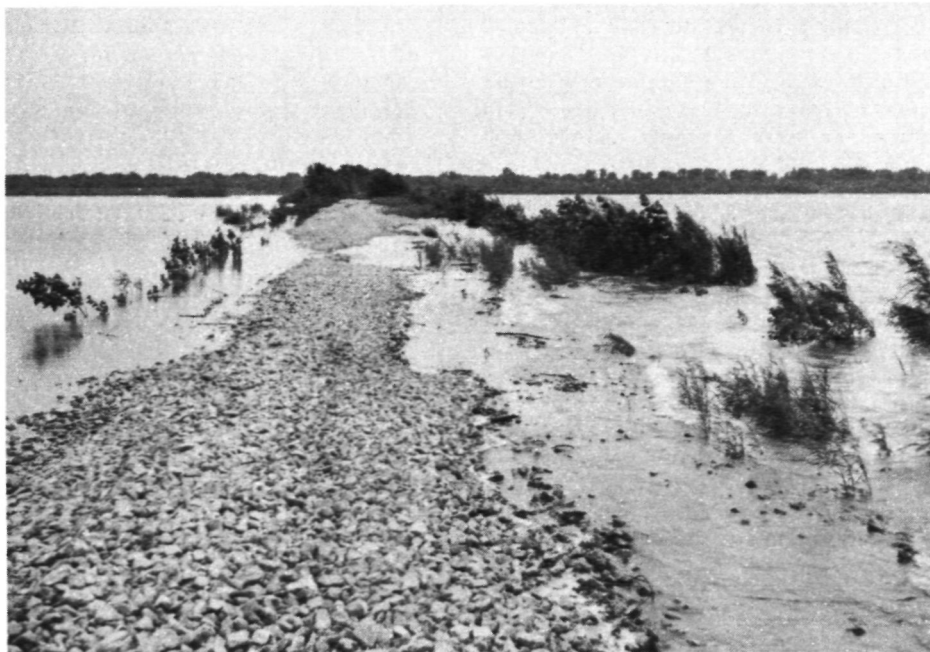
Figure 5. View Along the Top of the South Levee Looking Westward on July 20, 1950  
Note flow into Lake Chautauqua from Quiver Lake (at left).  
Water level 439.1 Mean Sea Level

On May 25 to 27, 1943, flood waters broke across and damaged the north levee. The damage was repaired. In Figure 5 is shown the south levee during high water in 1950.

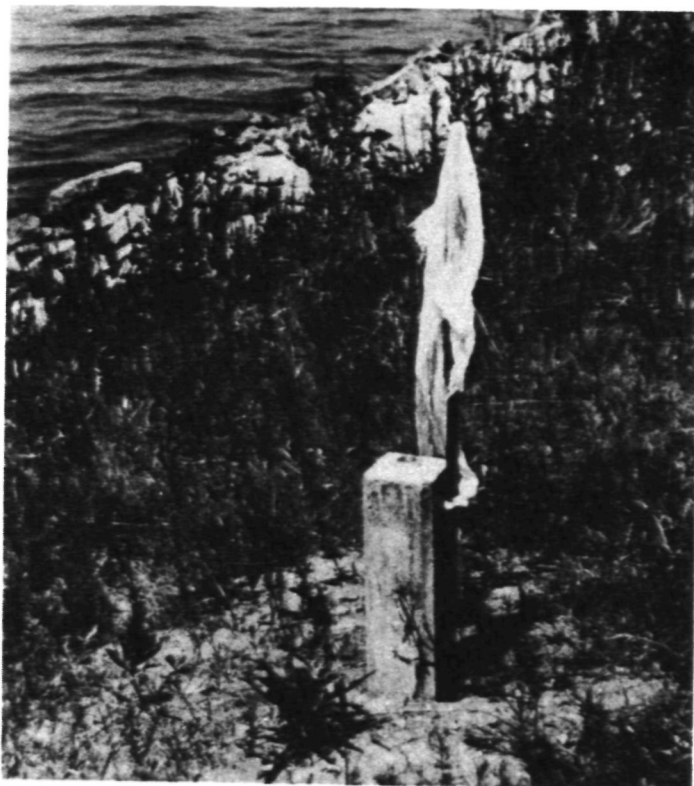
Figure 7. Concrete Post Installed as a Permanent Survey Marker

All triangulation stations and range ends were marked permanently in the field with concrete posts 4 1/2 inches square and 4 1/2 feet long. As shown in Figure 7 these posts were set into the ground with about one foot exposed. These permanent markers will be of value in the future when it becomes desirable to make a re-survey of Lake Chautauqua along these same silt ranges.

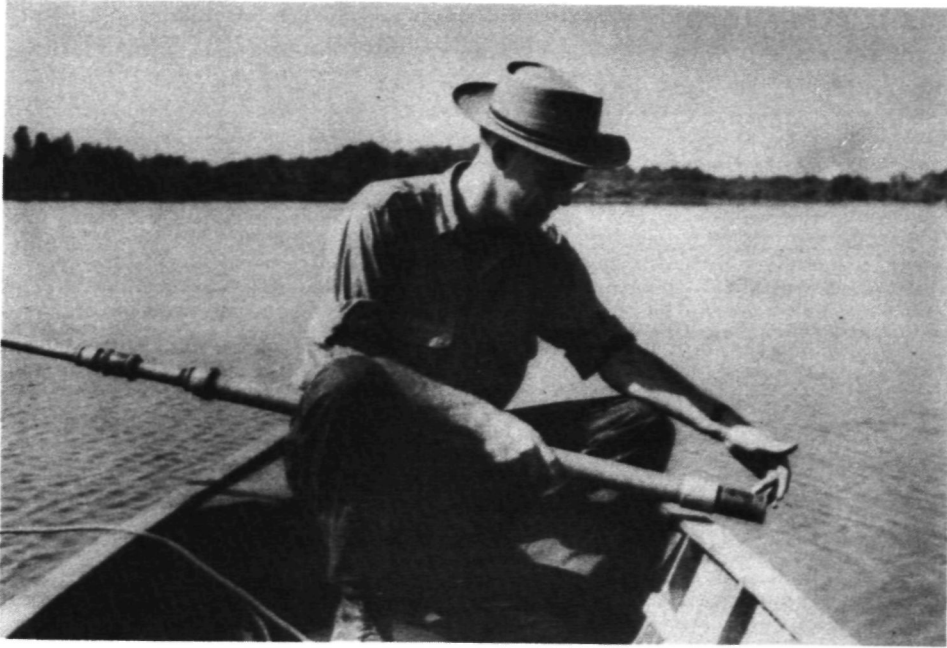
Figure 9a. Sediment Sampler Ready for Use

During the course of the survey a series of seven samples of the deposited material were obtained at locations shown in Figure 3. These samples were taken with a pipe-nipple sampler as shown in Figure 9. This sampler consists of a 3-foot section of galvanized iron pipe, 2 inches in diameter with a check valve at the top. Above the check valve is an additional 2-foot section of 1-inch pipe with an open "T" fitting at the top for securing the sampler to a line. A 2-inch nipple 4 inches in length is attached on the bottom of the sampler. The entire sampler, with the nipple in position, is shown in Figure 9a. From a boat the sampler is lowered into the water on a line and sinks into the sediment deposit of its own weight. As the sampler is retrieved, the 2-foot column of water above the check valve holds the sample of sediment in the nipple and in the 3-foot length of pipe. In the boat the excess sediment on the extreme lower end of the pipe nipple is struck off at the edge of the nipple and a pipe cap is attached. The nipple is then removed from the sampler and the upper edge is struck off and capped. Usually the sample is immediately transferred to a glass jar as is shown in Figure 9b, and hand-sealed for later laboratory analysis.

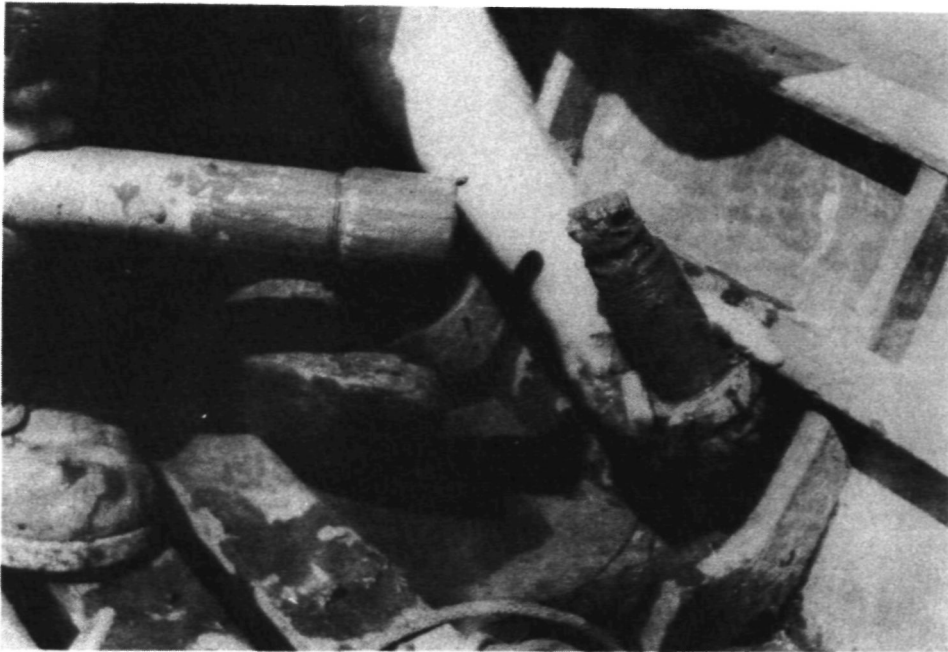
Figure 9b. Sediment Sampler in Position for Removal of Sample
