# PROPORTIONS - DISPOSITION RELATIONSHIP ANALYSIS OF A HISTORICAL TRUSS IN A RURAL HOUSE IN VÁPENNÁ VILLAGE, CZECH REPUBLIC

## Abstract

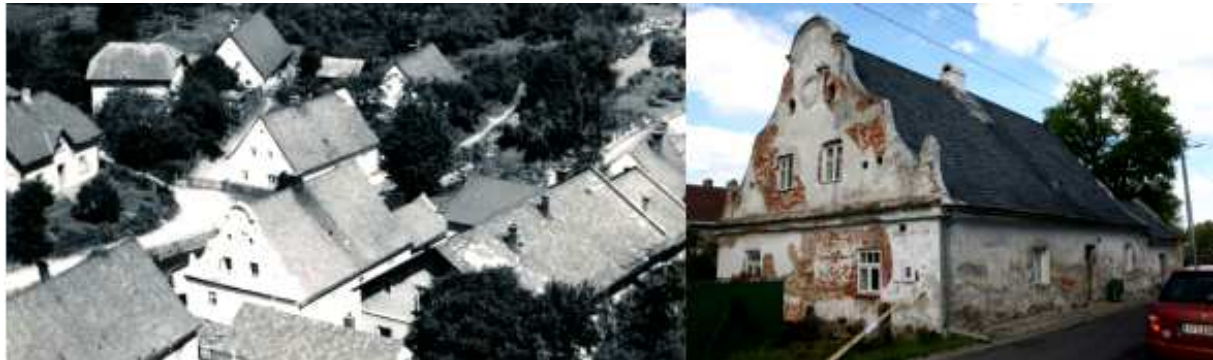
Fig. 1: The researched object – a rural house No. 98 in Vápenná.

House No. 98 in Vápenná, Jeseník region, Czech Republic (Fig. 1) was built in the 2<sup>nd</sup> half of the 18<sup>th</sup> century as a reflection of establishment's aims to raise the numbers of tax-paying subjects [3]. The first written note originates in 1786, when Michal Hauke sold the house to his son, Michal [1]. Dendrochronological analysis of the ceiling - after 1775 is also an evidence for the house being built in the 2<sup>nd</sup> half of the 18<sup>th</sup> century 70s. The building is a typologically common rural house with a central room and a hood kitchen, but has been richly designed to contain decorations in form of painted red frames, which have been preserved in the western attic area. Despite the ceiling parts being largely preserved above the ground floor, the truss was newly built (1974/75 according to dendrochronological dating) with an inclusion near the southern gable. The living room was partitioned in the southern section on the verge of the 19<sup>th</sup> and 20<sup>th</sup> century, which relates to the muring of the window in the southern wall. The kitchen hood in the central tract was under-arched and a stove was set up in the south-eastern room.

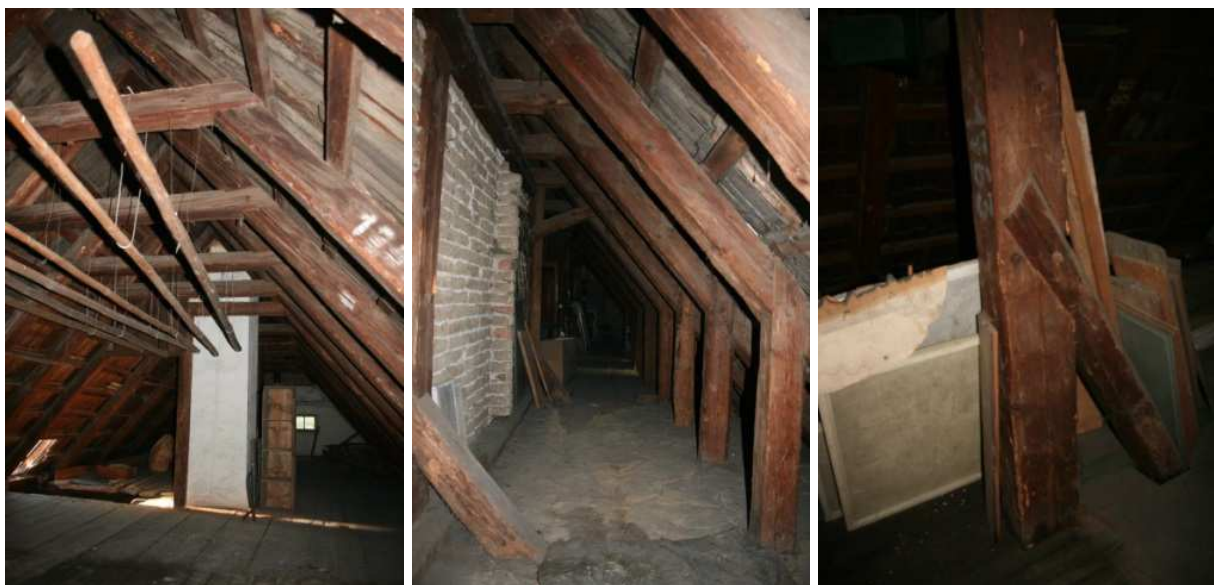
Fig. 2: The inner view of the truss.

The truss over the southern part has a rafter – collar tie structure and consists of two collar tie levels and base struts located at the base of the rafters. Lateral stools, whose posts are placed on the threshold beams, were later incorporated into the design. Central binding rafters bearing the collar beams are tenoned to the posts. The posts are also stabilized using single-sided outer bracing structures clad together into binding beams. The posts in the marginal joints are longitudinally wind-braced by struts (three views of the truss are on the Fig. 2).

The truss over the northern part is also of a rafter - collar beam structure with two collar beam levels, positioned at the same height as in the southern part. Unlike the southern roof its central posts are located in the marginal joints, which are placed on the threshold beam. The posts are stabilized by base struts. The truss itself is longitudinally secured by inclined bracing structures passing through the anchor post into the columns and the anchor posts below the lower collar beams.

Most of the joints used are dovetail joints fixed by wooden stakes. Tenon joints are used in case of the anchor posts and rafters with binding beams.
