Article

# Characterization of Corrosion Products on Weathering Steel Bridges Influenced by Chloride Deposition

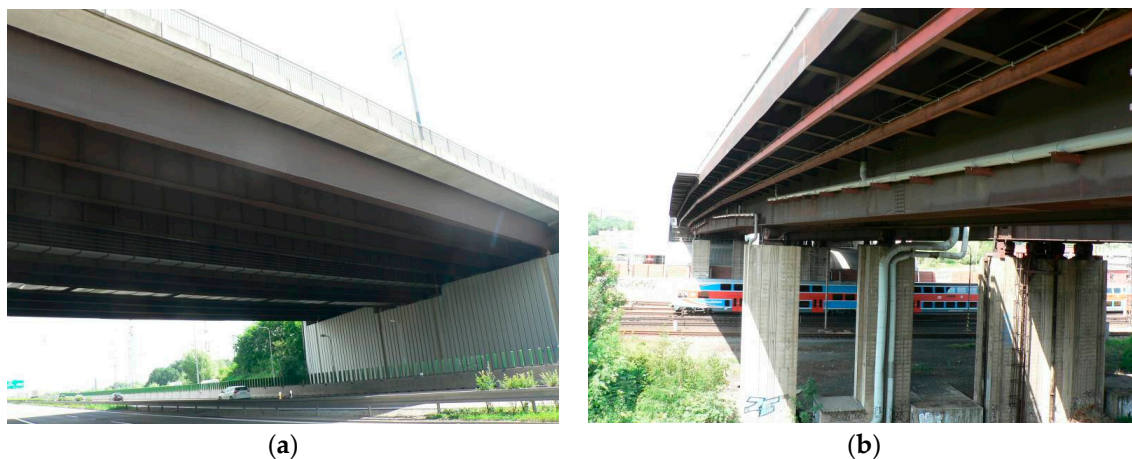
**Figure 3.** View at selected bridges for experimental testing: (a) Bridge No. 1 and (b) bridge No. 2.

Bridge No. 1 takes the road No. 479 across the busy highway D1. The composite bridge is designed with a reinforced concrete slab and I-shaped main girders. Bridge No. 2 brings the same road across a railway line and is designed with an orthotropic deck and main box girders. Both bridge constructions are designed with Atmofix B [11] weathering steel and are located in Ostrava-Svinov, Czech Republic. The site can be characterized as an urban environment with a degree of atmospheric corrosivity categories C2 to C3 for steel complying with EN ISO 9223 [12]. The distance between the centers of both bridges is approximately 200 m. Figure 3 shows a view of both bridges.

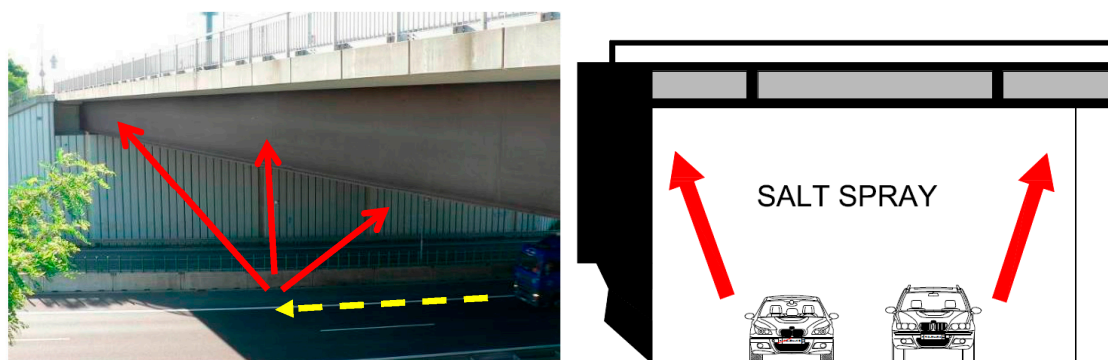
**Figure 4.** Bridge No. 1—Environment under the bridge is similar to the environment in the tunnels.

The general conditions for the development of corrosion products on typical surfaces of the bridge constructions are very similar—the bridges are situated in the same location, with just minimal differences in orientation. The design solutions are not too different from one another, either—both bridge constructions are designed as girder road bridges with upper deck. Any significant variations in the development of corrosion products on a particular typical surface of each individual bridge are thus conditioned primarily by the specific local microclimate surrounding the bridge. The decisive factor within those microclimates is the impact of road traffic under the bridge. Only bridge No. 1 is exposed to intense road traffic underneath. In addition, the abutments of bridge No. 1 stand in close proximity to the highway, which makes it somewhat similar to the so-called “tunnel-like conditions” and the associated increased deposition of chlorides on the structure [13–15], see Figure 4.

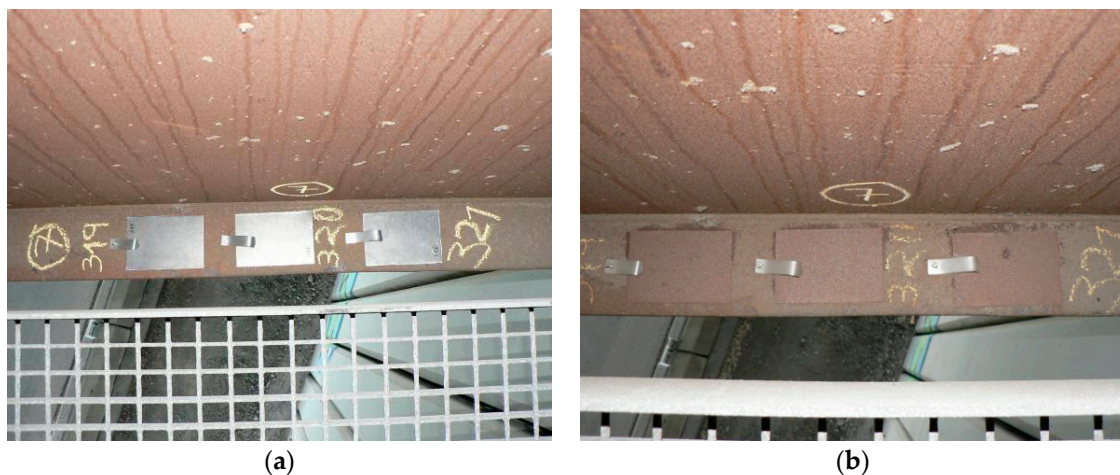
**Figure 5.** Corrosion samples on the upper surface of the bottom flange at the time of installation (a) and after 1 year of the exposure (b).

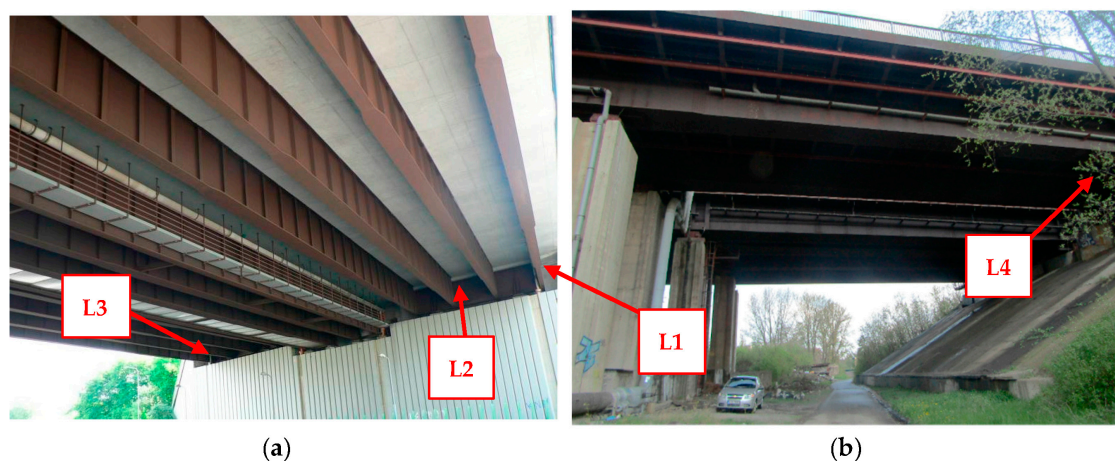
**Figure 6.** Position of the measuring devices on the selected bridge structures—bridge No. 1 (a) and bridge No. 2 (b).

The location of the sampling device is shown in Figure 6. Each position includes a sampling device both for wet candle method and dry plate method in a horizontal and a vertical direction, simulating the deposition of chlorides on the vertical and horizontal parts of the structure's surface. The individual positions are shown in Figure 7. The sampling devices were installed on 1 December 2016. Samples are replaced after one month of exposure; the sample is removed from the sampling device and an analysis is performed according to the procedure set out in [19] to determine the amount of chlorides stored in the wet candle solution and on the dry plate. The wind direction and velocity were not monitored within the research.

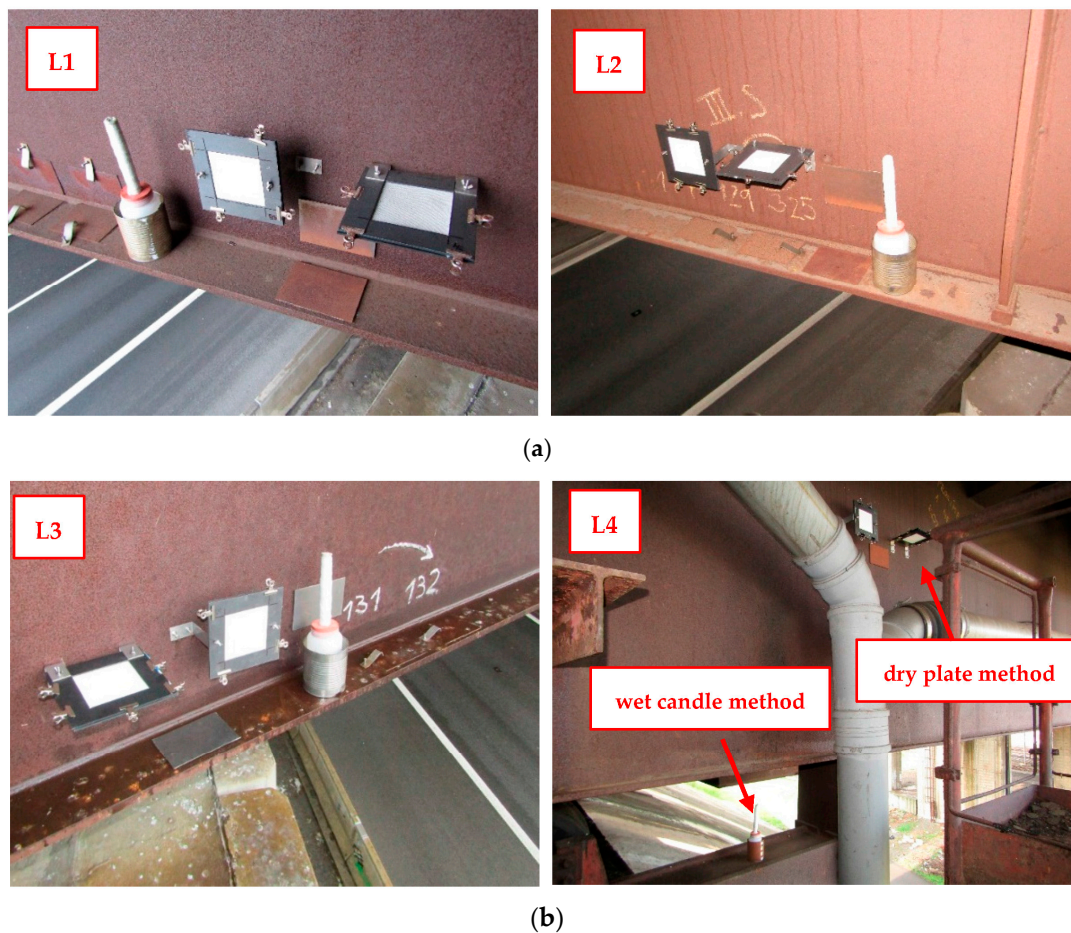
**Figure 7.** (a) Individual positions of the measuring devices on the selected bridges; (b) Individual positions of the measuring devices on the selected bridges.

- L1—bridge No. 1—external girder, north orientation (corresponds to surfaces P1 and P5);
- L2—bridge No. 1—internal girder, south orientation (corresponds to surfaces P3 and P6);
- L3—bridge No. 1—external girder, south orientation (corresponds to surface P2);
- L4—bridge No. 2—external girder, north orientation (corresponds to surfaces P1 and P5).

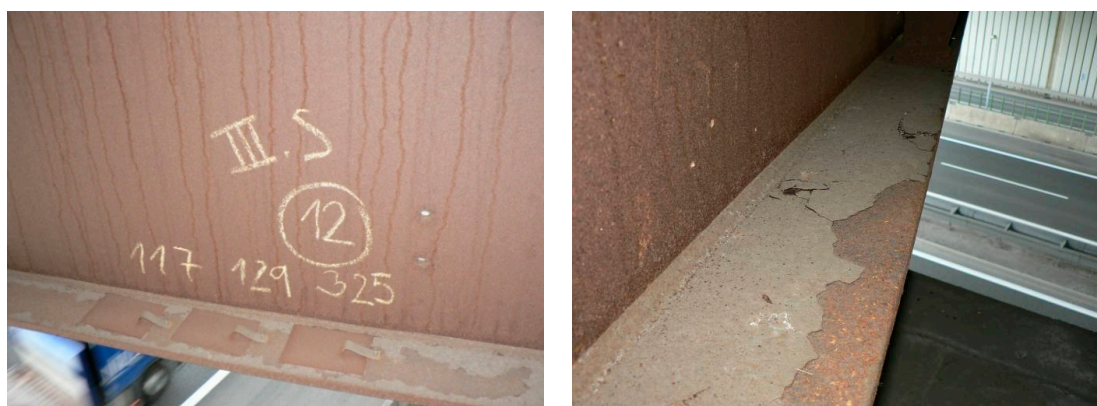
**Figure 8.** Bridge No. 1—unfavorable development of corrosion products on the internal upper surface of the bottom flange (surface P6).

<sup>1</sup> The internal surfaces of the bottom flanges of the main girders have not developed a sufficiently protective corrosion layer. Non-adherent corrosion products are formed which gradually fall off the surface of the flange, see Figure 8.

The values of thickness of corrosion layer measured on bridge No. 1 exceed the values of thickness measured on bridge No. 2. The impact of intensive road transport under the bridge and of the design creating a partial “tunnel-like effect” was most pronounced at the upper surfaces of the bottom flanges. The increased occurrence of dust deposits (including chlorides) has had a very negative influence, especially so in the case of non-ventilated internal surfaces of the bottom flanges, which do not develop a sufficiently protective corrosion layer, see Figure 8.

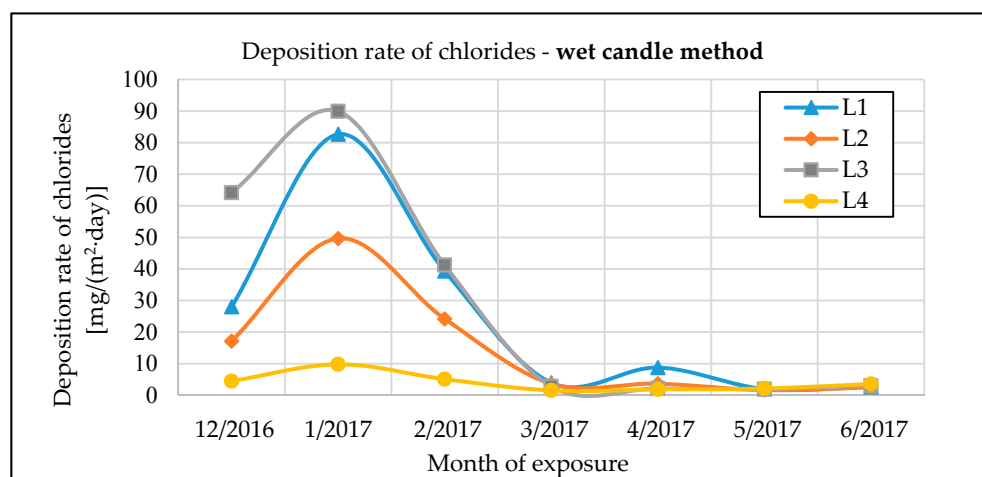
**Figure 9.** The deposition rates of chlorides determined by the wet candle method.

At present, experimentally measured chloride deposition rates are available for the period from December 2016 to June 2017, see Figures 9–11. Chloride deposition values are measured using wet candle method and dry plate method. The results include three months (December 2016 to February 2017) during which the winter maintenance with de-icing salts was performed on the roads concerning the bridges under evaluation.

- There is a clear link between the amount of deposited chlorides and the winter maintenance using de-icing salt. The chloride deposition rates during the winter maintenance period (December 2016 to February 2017) significantly exceed the values measured during the spring months. The difference is evident especially with bridge No. 1, which is affected by the intense traffic on the D1 highway underneath. The drop in deposition rate at the end of the winter maintenance period is rather steep. The chloride deposition rate during the winter period amounts to  $5 \text{ mg} \cdot \text{m}^{-2} \cdot \text{day}^{-1}$ . The gradual decline in the deposition rate over approximately two months after the end of winter maintenance, reported in the literature [9,10], has not been observed.

- Comparing the results from sampling devices located at bridge No. 1 (positions L1, L2, and L3) with results from bridge No. 2 (position L4) shows the significant influence of the specific microclimate found under the bridge structure. It is quite evident that the road traffic under the bridge structure is the main source of chloride deposition upon the bridge's supporting elements. The results from bridge No. 2 show, on the other hand, that a suitable design of the bridge (girder bridge with an upper deck and sufficient overhang over the external main

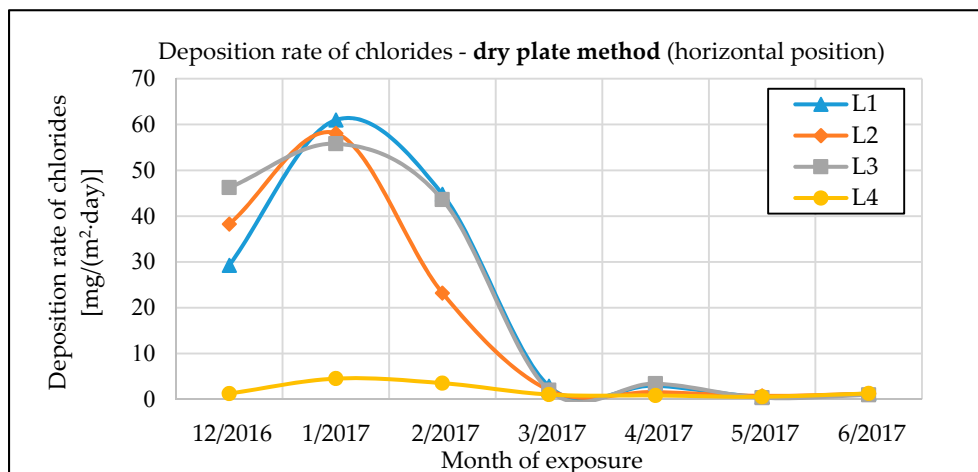
**Figure 10.** The chloride deposition rates determined by the dry horizontal plate method.

- The method used for measuring the dry deposition of chlorides significantly affects the resulting values. For most measurements, the highest chloride deposition rates are obtained using the wet candle method (maximum deposition rate measured was  $90 \text{ mg}\cdot\text{m}^{-2}\cdot\text{day}^{-1}$ ). In some cases, however, the highest chloride deposition rate was measured with a dry plate method in a horizontal position. Dry plate vertical measurements provided in all cases significantly lower values when compared with other measurement methods (approximately four times less than the dry plate in the horizontal position).

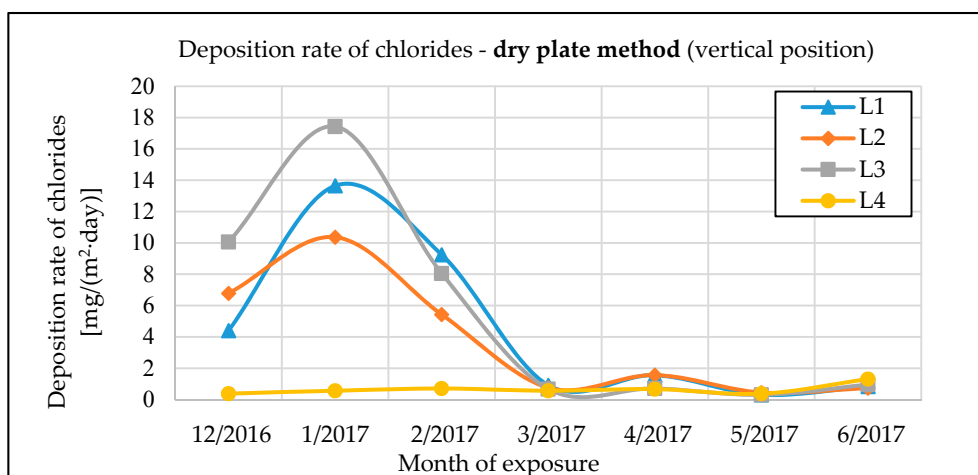
**Figure 11.** The chloride deposition rates determined by the dry vertical plate method.

- The results indicate that the external surfaces of the supporting steel structure are exposed to higher levels of chloride deposition when compared to internal surfaces (this observation is in line with the results presented in [9,10]). However, dust deposition (including chlorides) on the external surfaces of bridge No. 1 is regularly washed by rainfall or wind. Non-protective corrosion products only form on the internal flanges, despite the fact that the chloride deposition rate on the internal surfaces is lower compared to the external ones.
