# Sustainable Hydraulic Barrier Design Technologies for Effective Infrastructure Engineering

**Abstract.** Migration of liquids lead to embarrassing post construction scenarios such as that of leaks from roofs, potable water leaking from water tanks/ reservoirs, rising damp in walls with groundwater seeping into basement structures, leakage of water from ornamental lakes and ponds or leachate leakage into the environment from MSW landfill sites. Such failures demand immediate and expensive maintenance. A stringent control on structural and waterproof stability is deemed necessary for long term service life of structures and in particular underground and near surface structures. On a micro scale and over a longer time scale, the phenomenon of rising dampness occurs in older buildings with the groundwater rising up through walls, floors and masonry via capillary action. Even slower rates of contaminant fluid migration occur through landfill base liners. In this paper a variety of hydraulic barrier technologies is critically discussed against a backdrop of relevant case studies. The choice of an appropriate hydraulic barrier technology for a given scenario will depend also on the sus

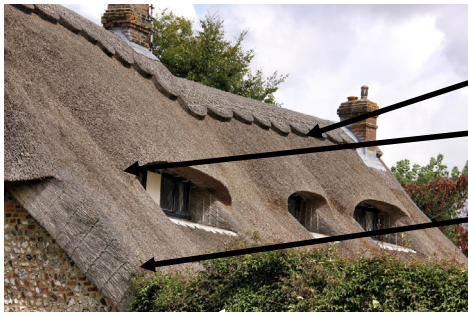
**Fig. 1.** Thatched Roofs – (modified [8])

Capping / Ridging

Valley sections – intersection of two or more roof slopes

Corners – subject to wind / storm damage – need carefully hex net reinforced thatching

Discourage easy access to the roof by animals

Thatched roofs (Fig. 1) are greatly admired architectural splendour and an outcome of past ‘Biotechnology’. Water migrations in any leaking roof is gravity induced and result from; leaking capping / ridging (cracking of the cement mix; absence of expansion joints, punctured plastic sheeting), leaking valley sections (premature rotting from moisture concentrations and delayed drying), Wind damaged corners (thin weakly compacted thatching unable to restrain lifting by wind), Inadequately compacted thatch ( require 35-50 kg/m<sup>3</sup> density to reduce fire risk, Animal or bird damage ( deter the animals having access to the roof) and alike.

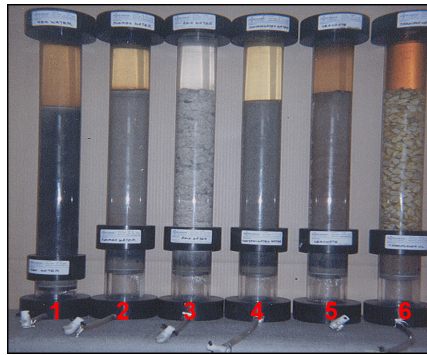
**Fig. 5.** Long-term Test Cells of Prehydrated GCL when permeated with non-standard liquids. (1) Mine Water, (2) Contaminated Water, (3) Rain water with Limestone Chip, (4) Sea Water, (5) Synthetic Leachate, (6) Transformer Oil

conventional laboratory testing and focused specifically on the long term hydraulic performance of GCLs when subjected to permeation that are representative of actual and commonly met hostile geo-environment conditions (Fig. 5). The overburden stress on the specimen was made up of a 300mm thick selected material appropriate to the respective field condition. Each specimen was placed between two porous plates and a free flow condition with a hydraulic head of 25 kPa maintained at the base and applied to the leachate at the testing times. Fig. 6 illustrates the variation in hydraulic conductivity (observed via a modified constant head test) during the reporting period of ten years. There is evidence of a marginal increase in hydraulic conductivity with time, but it is not detrimental to the performance criteria, even after 10 years' time.

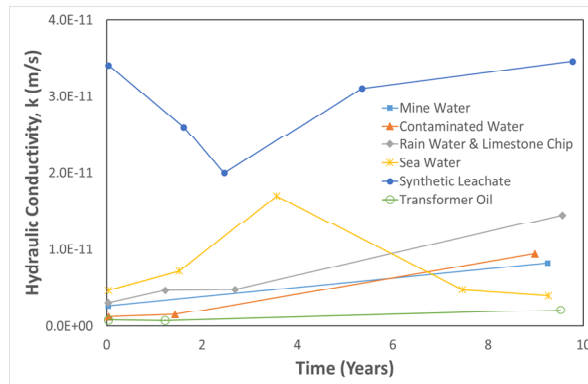
**Fig. 6.** Long term hydraulic conductivity results for Prehydrated GCL when permeated with non-standard liquids
