Waste Rock Dilution in Stoping of Steeply Dipping Narrow-Vein Deposits

School of Engineering

Master thesis
Espoo 26-11-2018

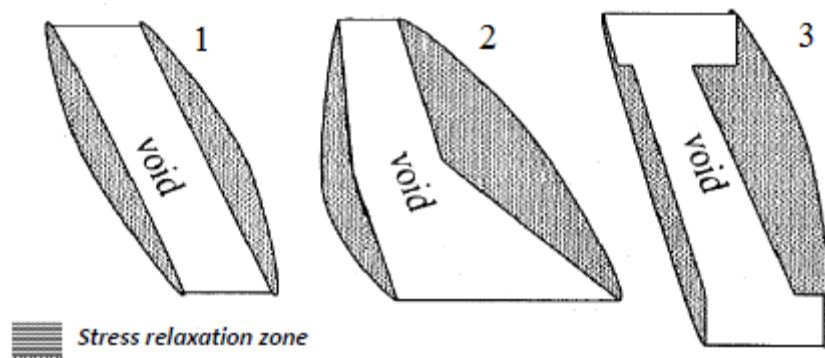
Figure 3.2: Under and Overcutting and its Effects on Stope Stress Relaxation Zones after Hutchinson & Diederichs (1996).

Hughes et al. (2010) performed a case study on unplanned dilution at the Lapa Mine in Canada and found that unplanned dilution in narrow-vein mining can be reduced significantly when the length of the stope strike is being decreased. Diederichs & Kaiser (1999) studied the effect of undercutting and overcutting stopes. They found that undercutting and overcutting significantly increases the stress relaxation zone of a stope, which results in instability of the stope. Stope instability can in its turn cause enormous amounts of dilution. Figure 3.2. displays the increase in stress relaxation zone at different levels of under and overcutting. Situation 1 in Figure 3.2. depicts the normal stress state when a stope has been excavated. However, whenever a stope is being undercut or overcut the stress relaxation zone increases significantly as being shown in situation 2 and 3.

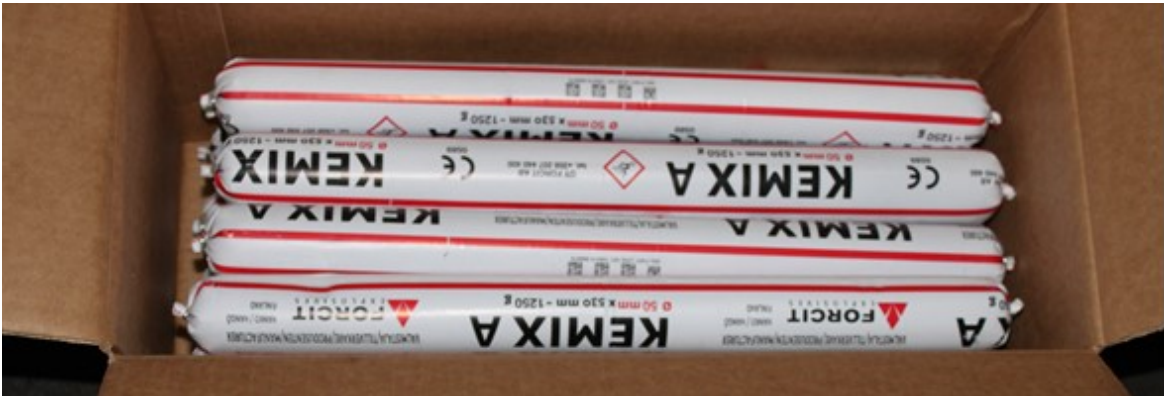
Figure 5.5: Kemix A emulsion cartridges (\varnothing 50mm) used during production blasts.

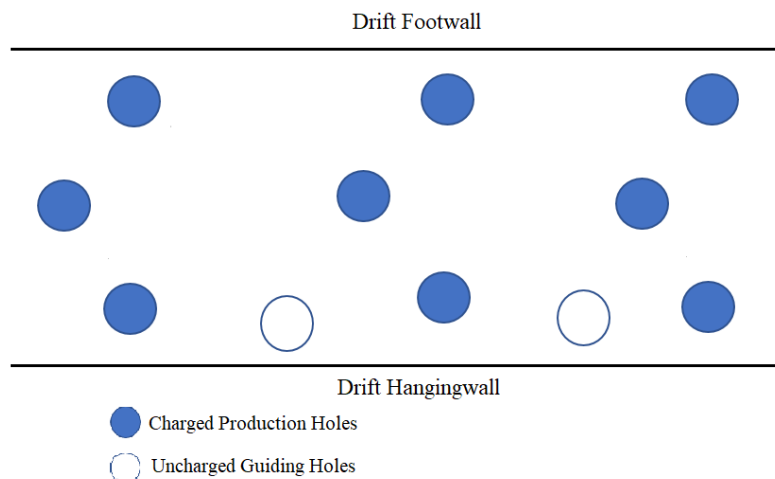
Figure 5.6: Illustration of the use of guiding holes.

The aim of this thesis is to not only allocate causes of waste rock dilution, but also to minimize it. Therefore, in addition to designing drill and blast parameters according to past experiences, two additional measures have been undertaken to pursue this goal. The first measure has been designed to improve the condition of the hangingwall of the stope. To achieve this, an additional hole is being drilled in between each ring on the hangingwall side of the stope. This hole is drilled with average length and angle of the hole on the hangingwall in the preceding and following ring. This hole will remain uncharged but will be a guiding hole for the crack-formation and propagation at the hanging wall during the blast (Figure 5.6.).

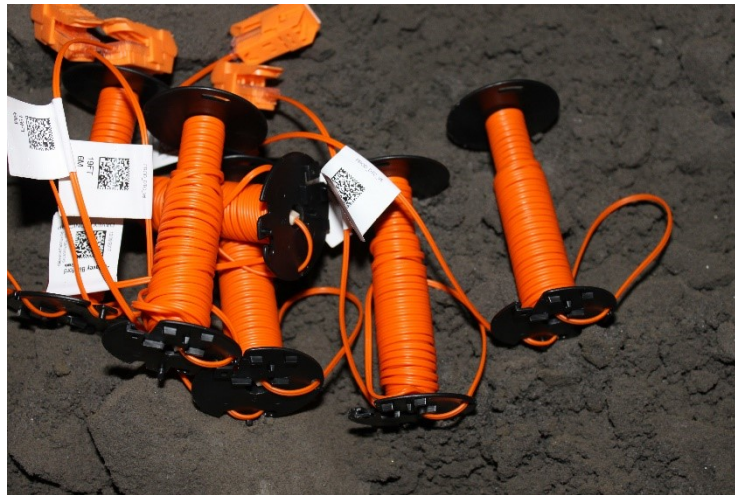
Figure 5.7: Daveytronic® OP electronic detonators used for this research

The second parameter that will be added in this research is the use of electronic detonators (Figure 5.7.) rather than the previously used, shock tube detonators. The electronic detonators being used are the Daveytronic® OP detonators. The use of electronic detonators will control the time delay between initiation of rings more precisely than before and therefore ideally, optimize the initiation sequence. Generally, optimizing the initiation sequence has been proven to be an effective measure in reducing stope wall damage and therefore waste rock dilution.

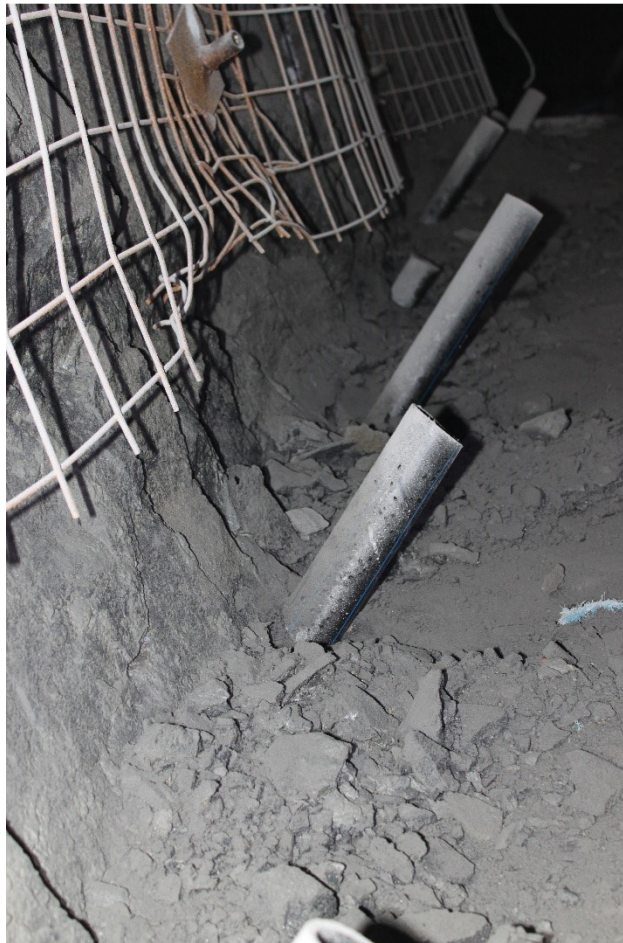
Figure 5.8: Polyethylene tubes installed at drillhole collars.

without driving on top of the polyethylene tubes which are installed at the drillhole collars to prevent the holes from getting blocked by small rocks or clogged by sludge (Figure 5.8.).

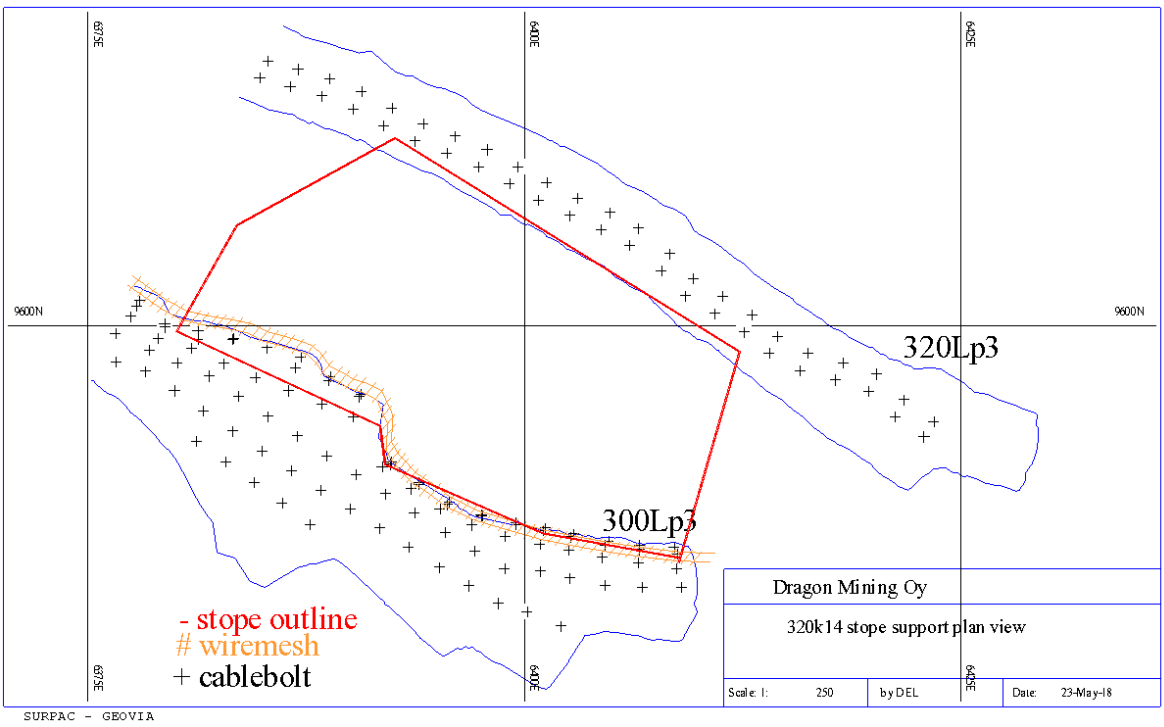
Figure 5.10: 320K14 Stope support plan view.

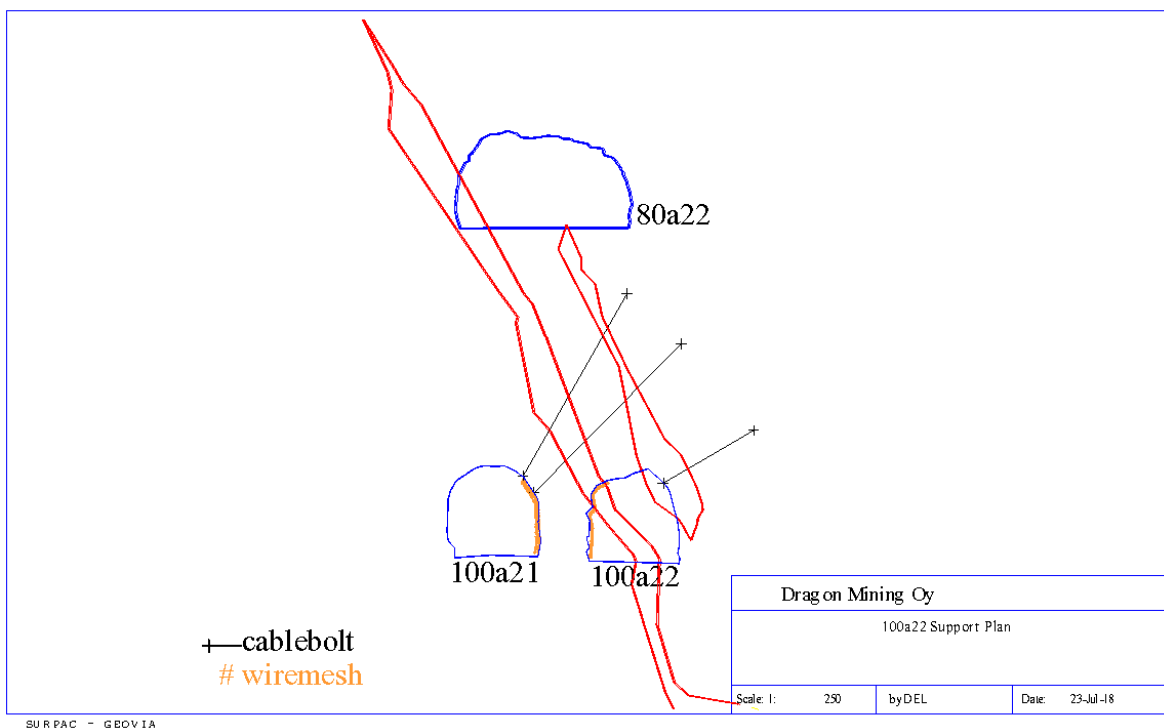
Figure 5.11: 100A22 Stope support cross section.

Contrary to the 320K14 stope, the 100A22 stope has a parallel drift situated next to the lower level of the stope, separated by a pillar. This parallel drift offers the convenience to drill cablebolt support perpendicular to the dip of the stope to provide anchorage and maximal support to the rock mass in the stope hangingwall. The pillar which separates the two drifts is supported by wire-mesh to mitigate the ravelling to some extent. In addition to the two bolts per fan that are drilled in the parallel drift, there is another cablebolt installed in the ore drift, to provide support to the lower part of the stope hangingwall. The cablebolt fans in the 100A22 stope are designed with a spacing of 1.8 metres. This spacing is equal to the spacing of the drillholes of the DL 421-7C production rig. This will make it easier for the operators to not intercept the installed cablebolts while drilling the stope. Figures 5.11. and 5.12. give an overview of the designed and installed rock support in the 100A22 stope.

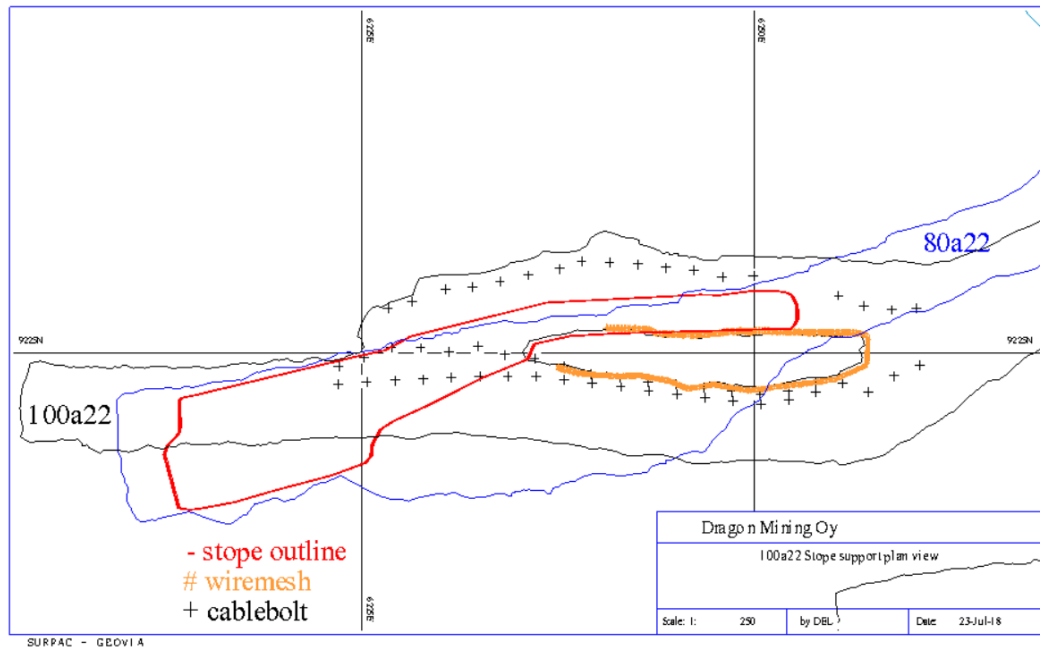
Figure 5.12: 100A22 Stope support plan view.

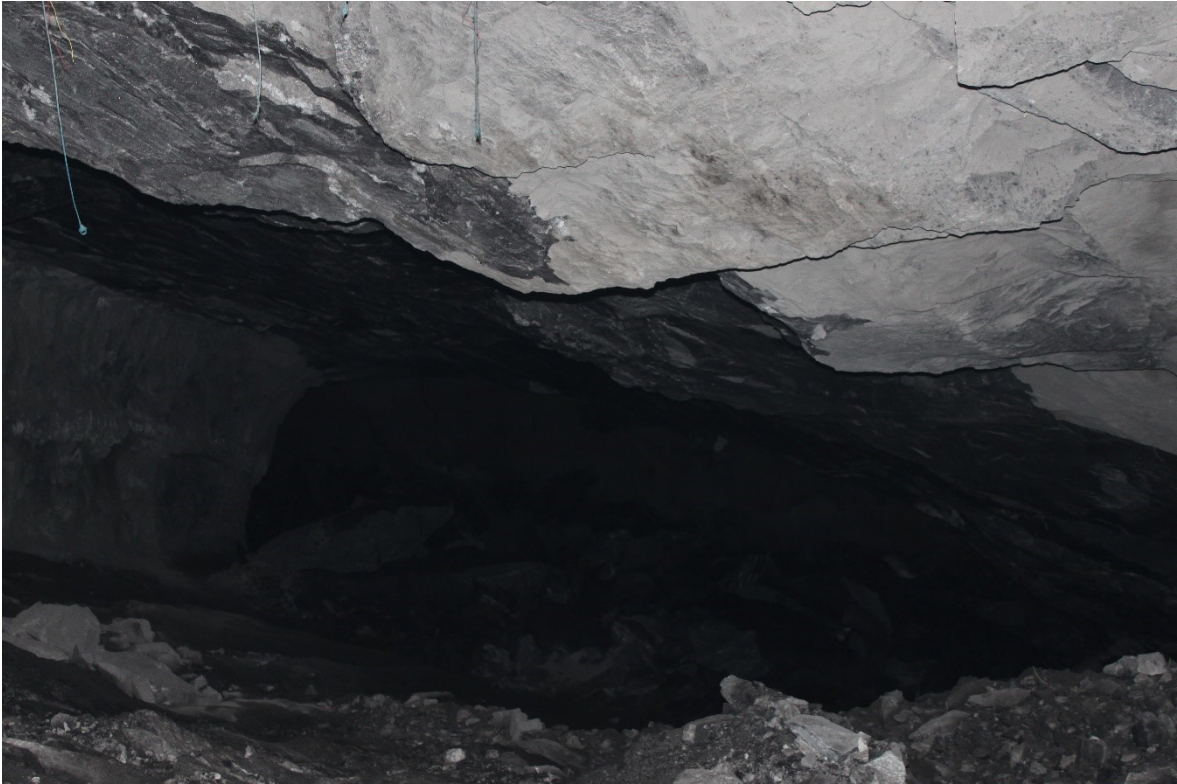
Figure 6.1: 320K14 Exposed surface (black) after hangingwall collapse rings 1-7.

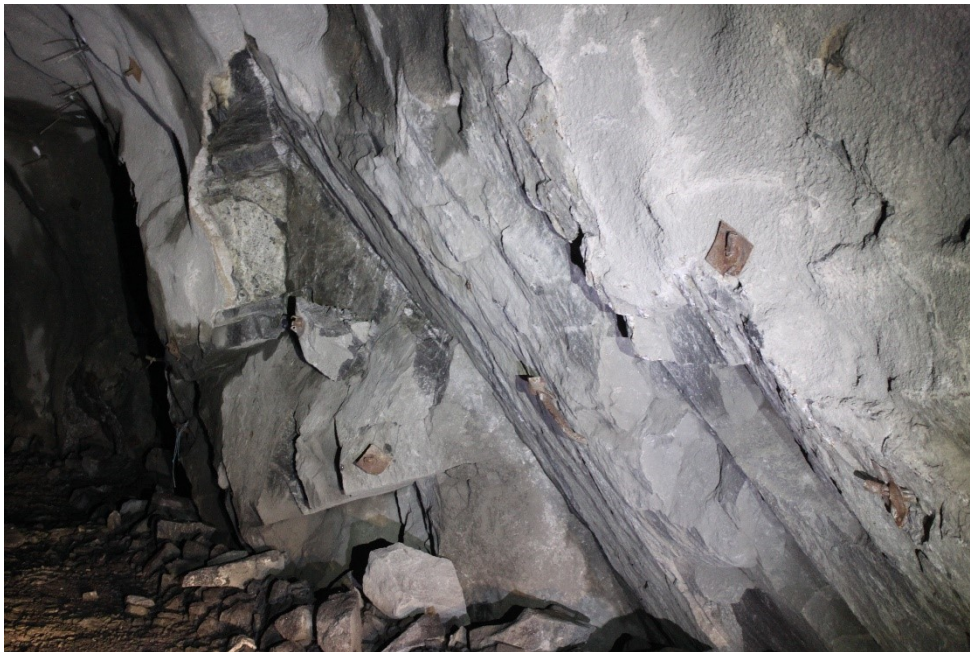
Figure 6.8: 100A22 Hangingwall present fault plane and joint structure before production commenced.

Before production started, a set of parallel joints and a small fault plane was observed on the hangingwall side within weak pegmatite rock. These structures were expected to continue throughout the full extent of the stope. This joint set became visible on the hangingwall during production, between rings 8 to 18. These joints resulted in a heavily fractured hangingwall and local caving of 1.5-2 metres thick slabs. Figure 6.8. depicts these present structures before production and Figure 6.9. illustrates the caving plane, photographed from the 100 level.

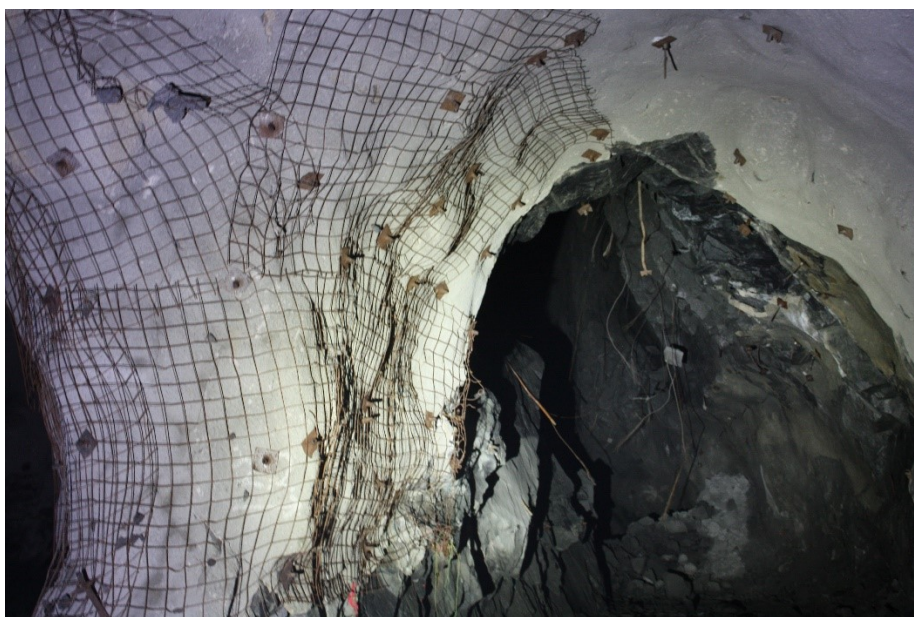
Figure 6.10: 100A22 Pillar after the stope has been mined out.

The rock support that has been designed and installed for the 100A22 stope performed exceptionally well. The installed cablebolts and the mesh around the pillar on the 100 level kept the majority of the pillar intact, while allowing the gold mineralization at the pillar contact to be mined successfully (Figure 6.10.). The cablebolts penetrating the ore-bearing zone also anchored a large part of the jointed rock slabs on the hangingwall side. Together with the steep dip angle, the cablebolts prevented extensive caving of the hangingwall.

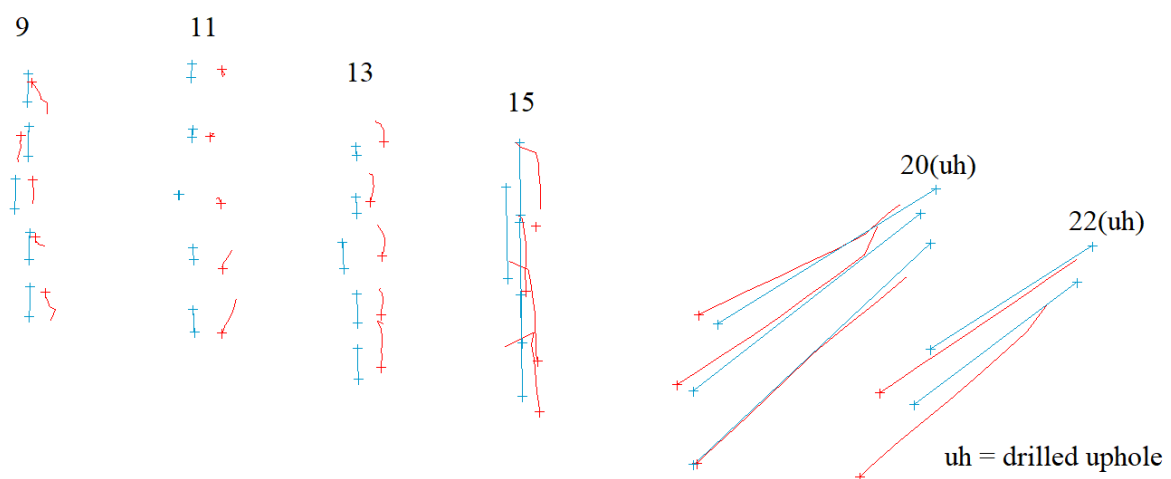
Figure 6.11: 100A22 Designed drillhole collar location (blue) vs. actual drillhole collar location (red).

Drillhole deviation measurements were carried out for a part of the 100A22 stope. The results are depicted in Figures 6.11. and 6.12., where the numbers indicate the ring number of the 100A22 stope.

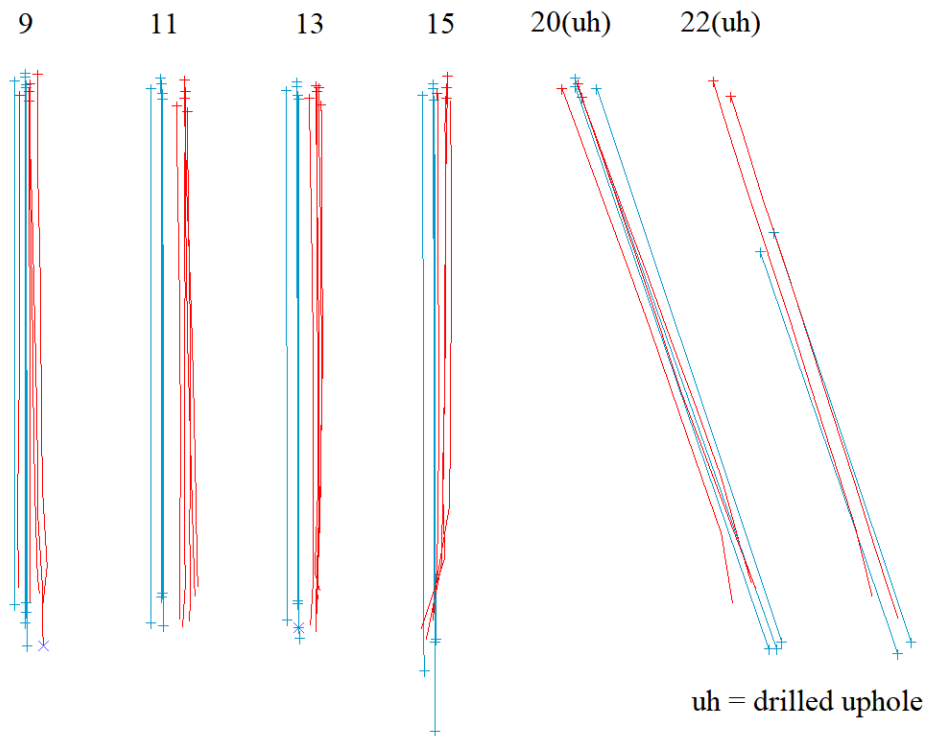
Figure 6.12: 100A22 Designed drillhole trajectories (blue) vs. actual drillhole trajectories (red).

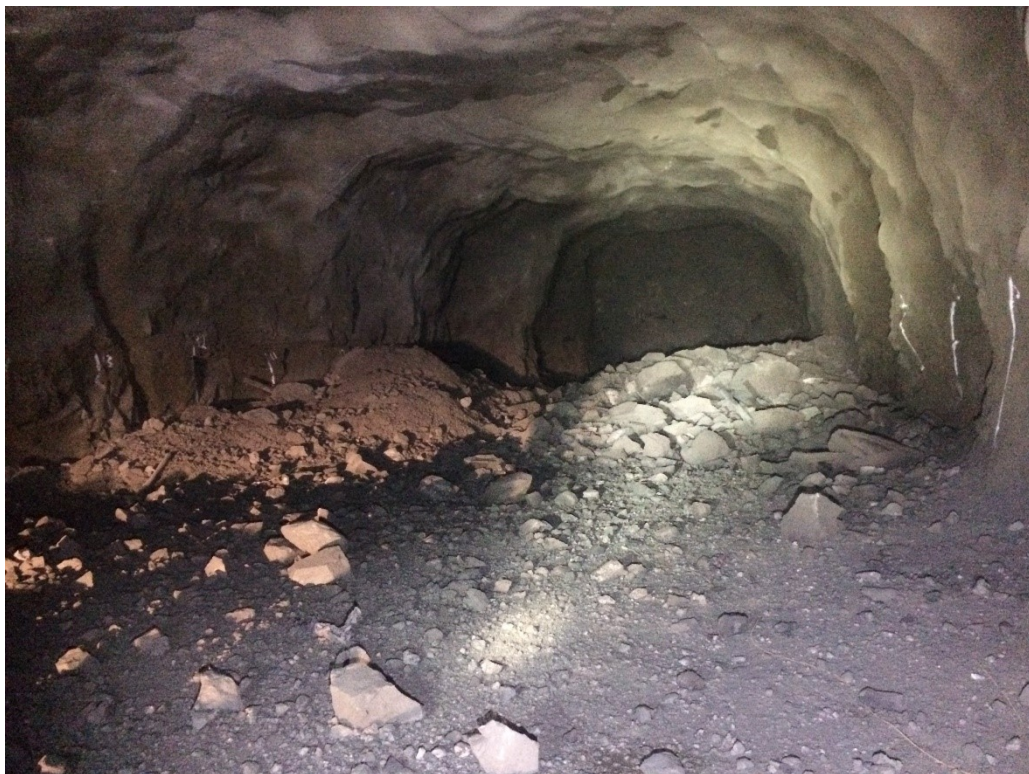
Figure 6.13: 80LpA22 Drift after blasting of rings 1-6.

Opposite to the 320K14 stope, the blasting of the 100A22 stope encountered only little complications. The blasting of the opening raise (rings 5-6) and ring 7 was executed. Hereafter, rings 1 to 4, behind the raise were blasted. Because the expansion factor of the rock had not been fully considered during the blast design, the opening (rings 4-7) did not offer enough space to host the blasted rock in. Consequently, this resulted into some rock being thrown in the 80LpA22 drift (Figure 6.13.) as well as parts of the charged column not breaking. This, in combination with a risky design resulted in approximately 500 tonnes ore loss. In Appendix F., the ore loss is visualized by comparing the designed stope outline in a cross section, with the resulting stope outline, obtained from scanning the stope.

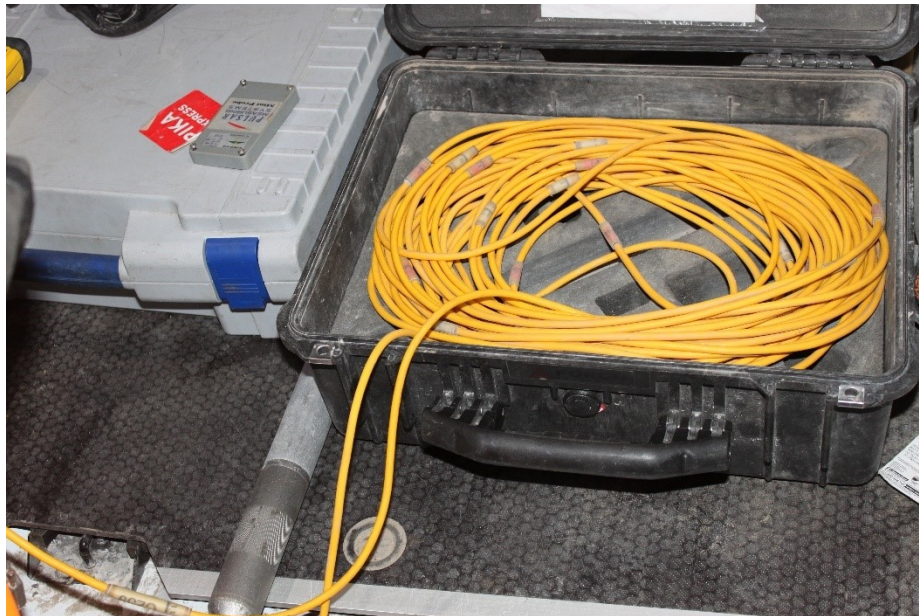
Figure 7.2: Drillhole deviation measurement probe and cable.

The actual (true) length of a drillhole that is being used in Equation (5) to determine the drillhole deviation, has been obtained by the total metres of cable that enters the hole, until the probe reaches the toe of hole. The cable is marked with a label each metre (Figure 7.2.) and does not have any markings in between metres. This resulted in the true length of the drillhole being reported within an accuracy of only 0.5 metres.

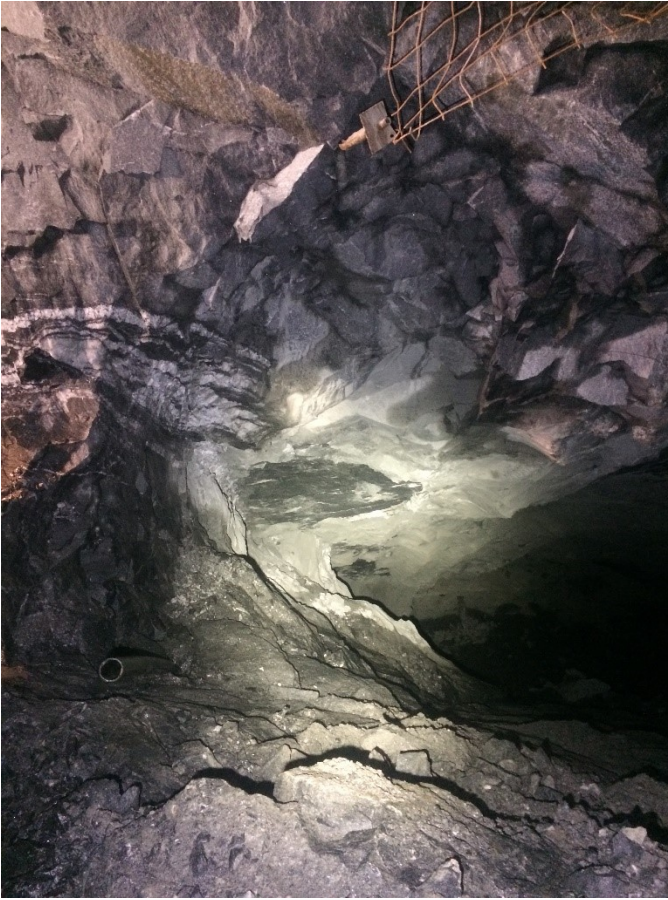
Failed detonation of footwall hole in 320K14 ring 15 as described in section 6.3.

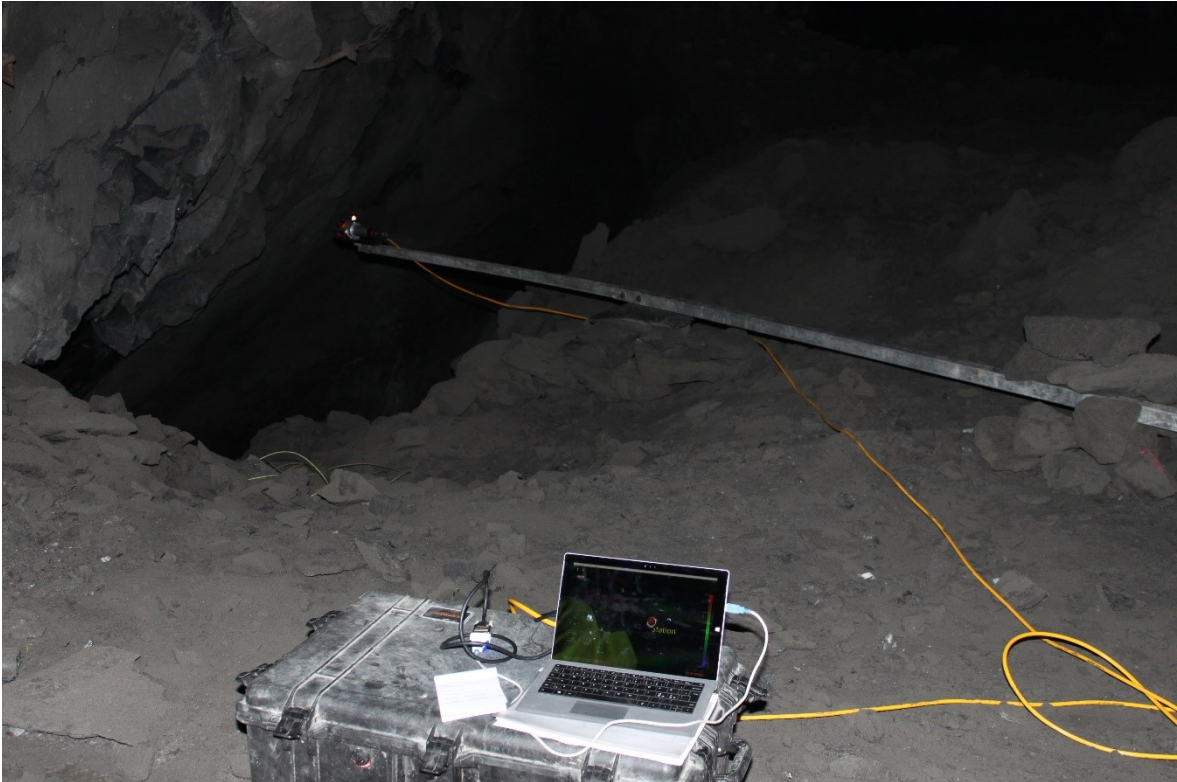
320K14 Stope scanning rings 14-20 post pillar.

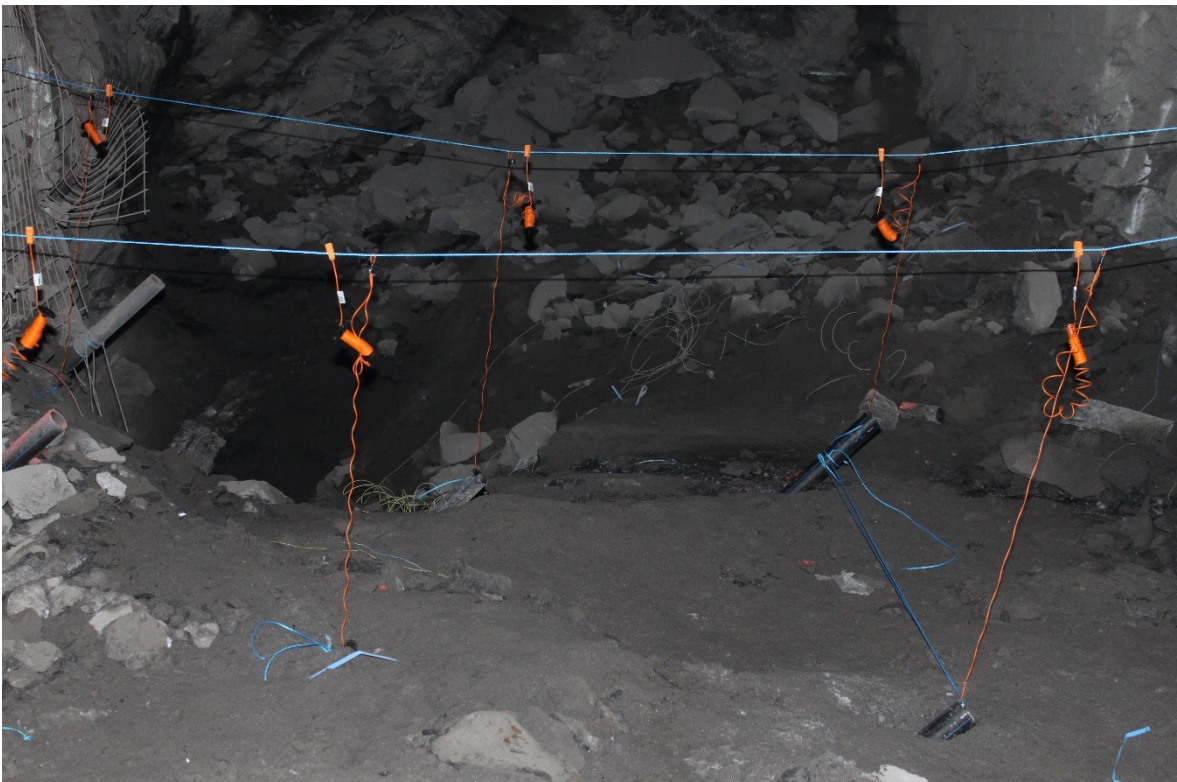
320K14 Stope rings 4-5 charged holes with programmed electronic detonators in place.

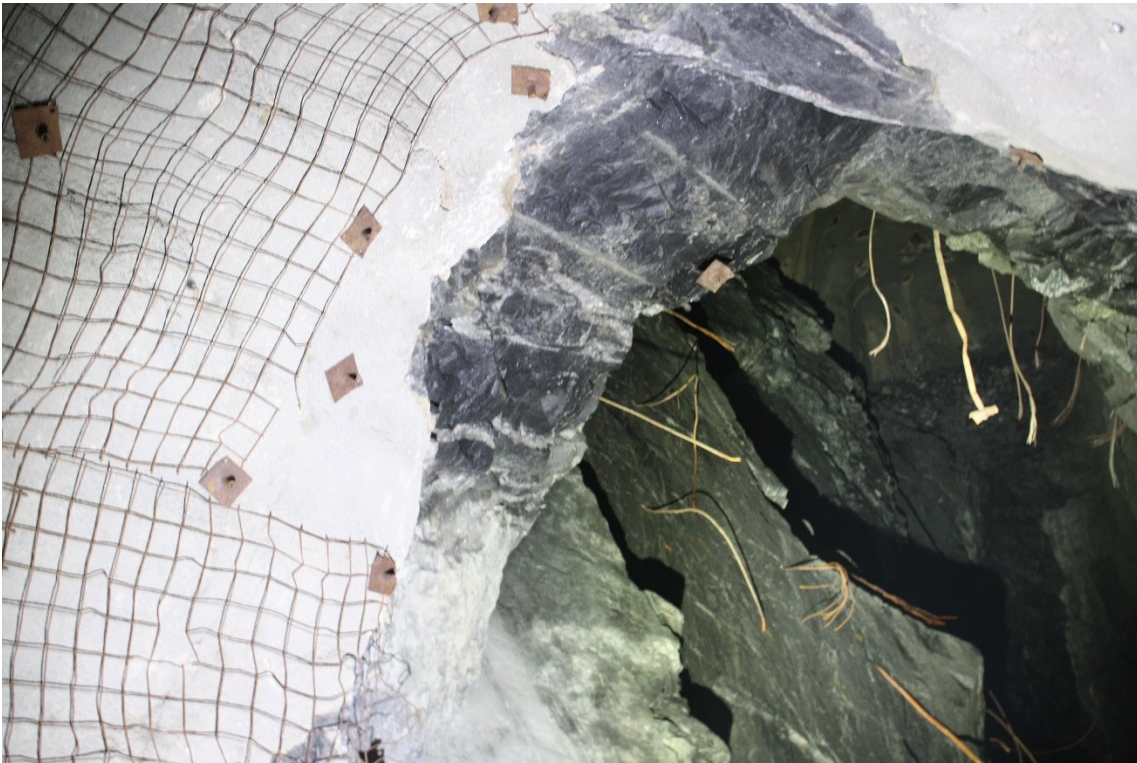
100A22 Footwall fault plane between rings 11-15 (on the right of the picture) next to the pillar (left) as described in section 6.5

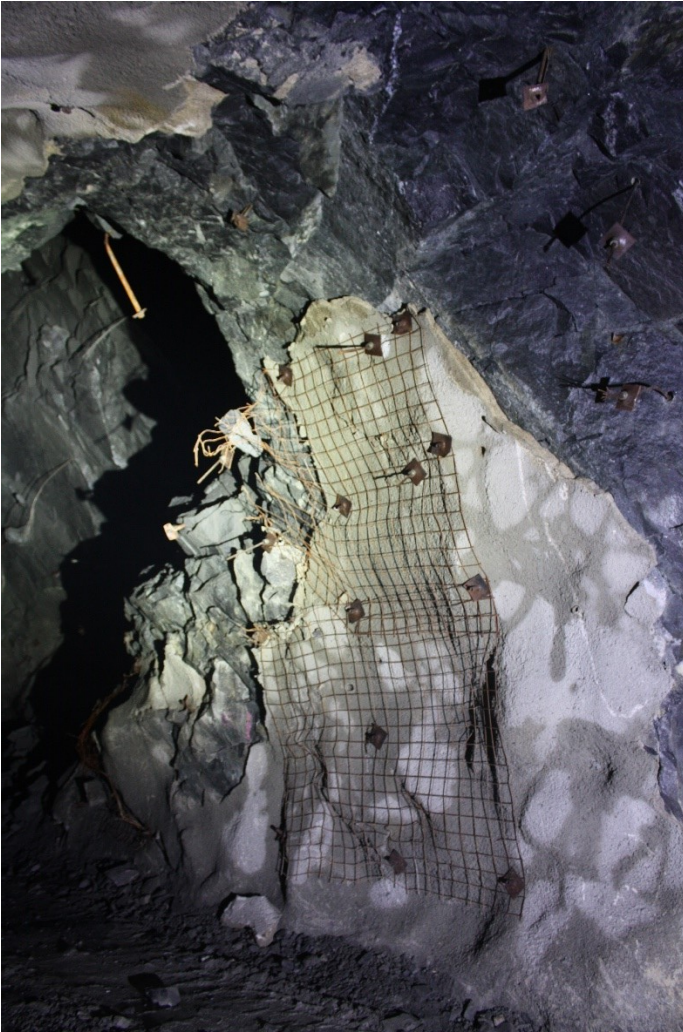
100A22 left hand side of pillar. Surprisingly intact, as part of it was designed to be mined, due to ore contact.

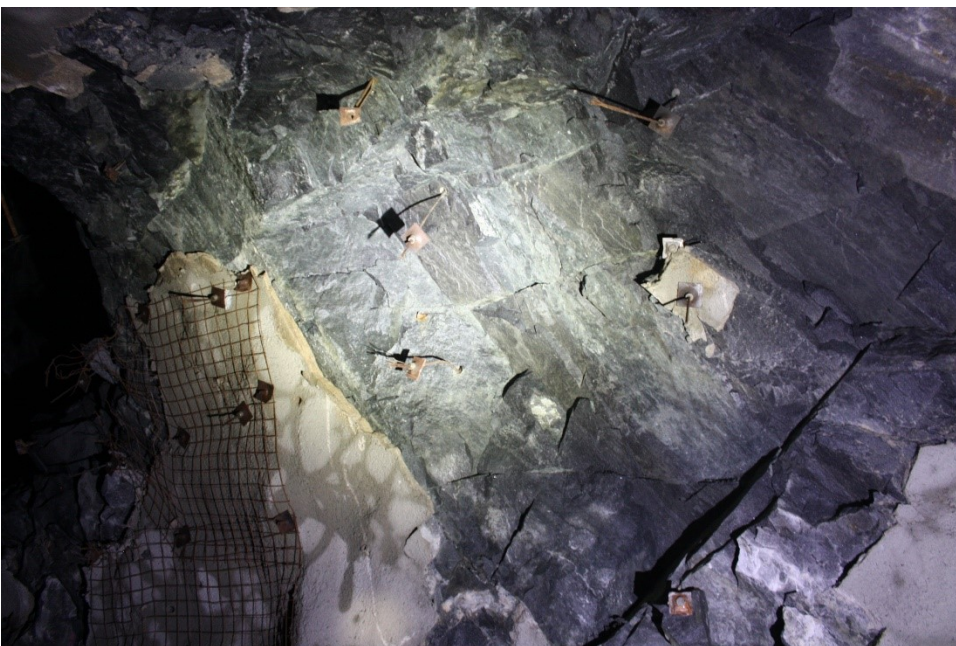
Large overview of 100A22 pillar left hand side. Installed cablebolts keeping the pillar in place.
