Monitoring of subtidal reef biota off Motuotau Island in relation to dredge spoil dumping by the Port of Tauranga Ltd

2014-2018

ERI Report no. 118

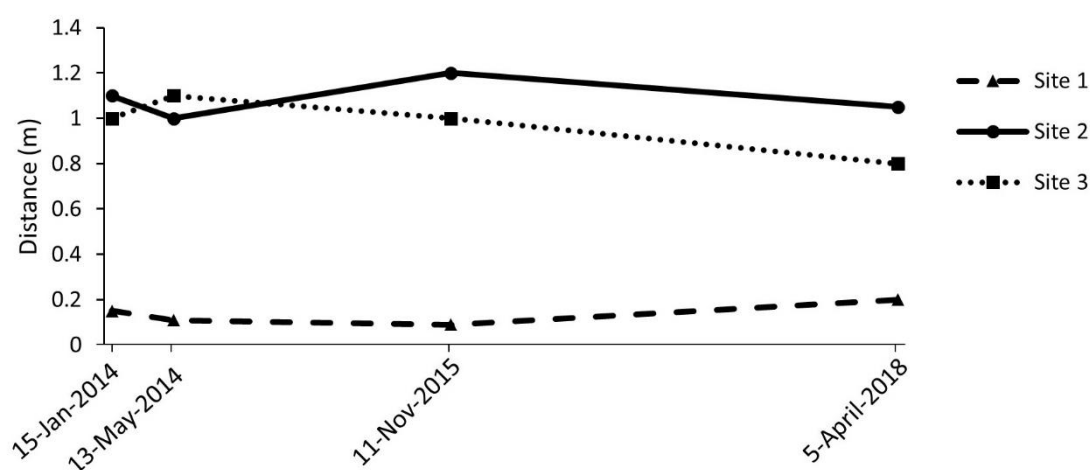
Variations in seabed elevation are presented in table 1 and in figure 2. At site 1, the distance to the reef-sand boundary varied between 0.2 m and 0.09 m with no trend of either increasing or decreasing seabed elevation at this site. At site 2, the distance to the reef-sand boundary varied between 1.2 m and 1.0 m. Again, there was no trend of either increasing or decreasing seabed elevation at this site. At site 3, formerly the control site, distance to the reef-sand boundary varied between 1.1 and 0.8 m. Since May 2014 the pin to boundary distance has decreased by 0.3m indicating a small increase in seabed elevation at this site. The increase in seabed elevation recorded at site 3 and the variation recorded at sites 1 and 2 are within the scale of fluctuations that would naturally occur given the reef aspect and energy environment. Images showing the positions of the bottom pins at the three sites are shown in figures 3-5.

Figure 2. Tape distance (m) from the bottom marker pin to the reef-sand boundary over time. For site locations refer to figure 1.

Measurements of the distance between the bottom marker pin at each site and the reef-sand boundary indicate some fluctuation in the elevation of the seabed at all sites. At sites 1 and 2 measurements since 2014 indicate both the rise and fall of the reef-sand boundary. At site 3, formerly monitored as a control site, the seabed has risen over two successive surveys, but only by 30 cm. The levels of fluctuation observed for the 2014-2018 period are similar or less than the changes previously reported for the Motuotau reefs (Ross and Pilditch 2009). Greater fluctuations in seabed elevation are known to occur in this area (P. Ross *pers. obs.*) but may not be captured by this approximately bi-annual monitoring programme. The data presented here indicate that the reefs around Motuotau are not being inundated by the dredge spoils dumped offshore of Mt Maunganui.

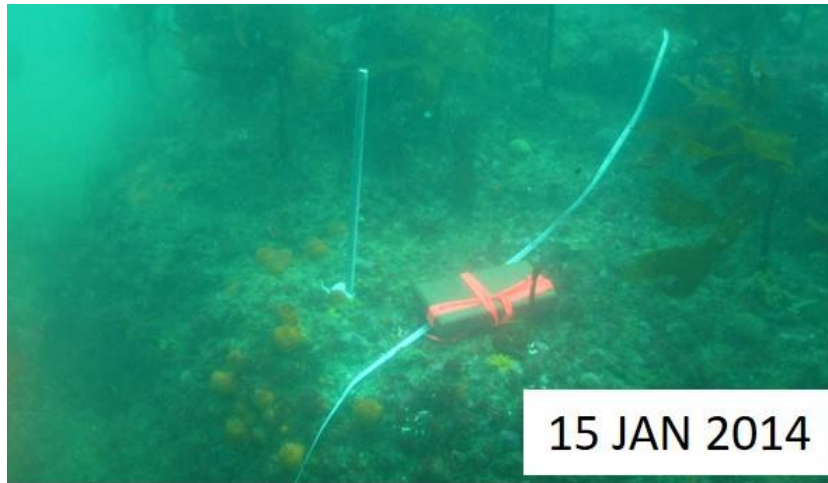
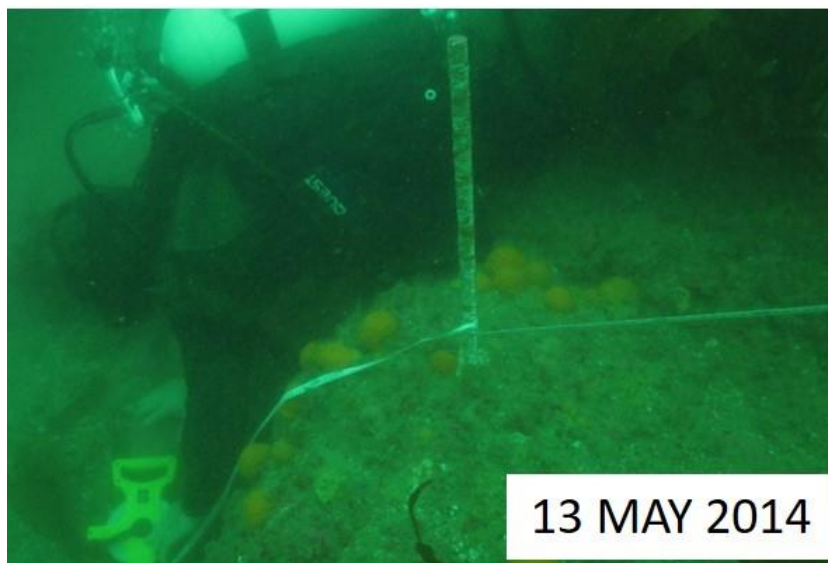
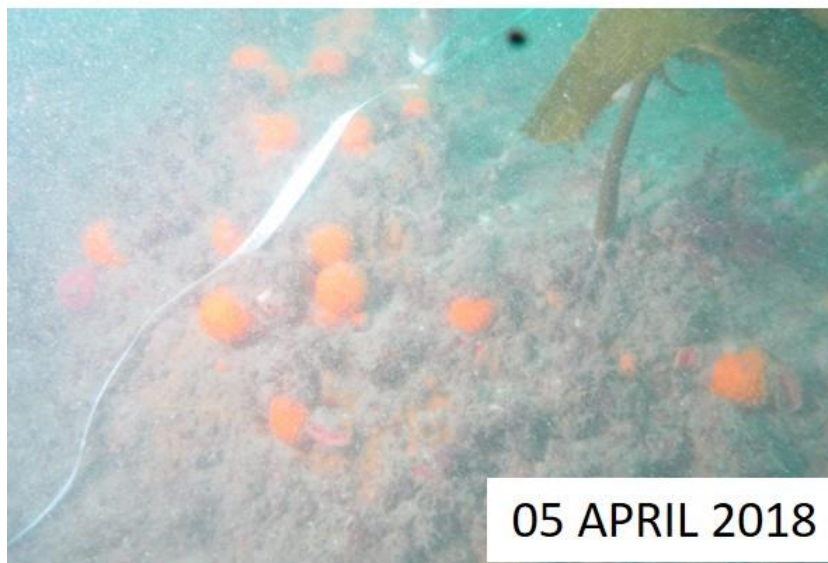
Figure 3. Images of the bottom pin at site 1 in January and May 2014 and April 2018. Visibility during the 2018 survey was very limited and only close up photos were able to be taken.

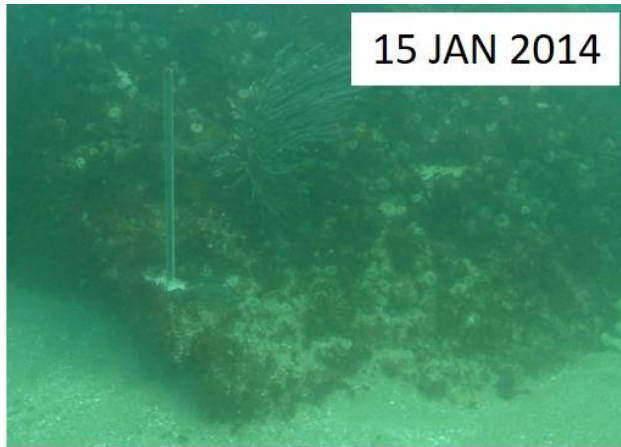
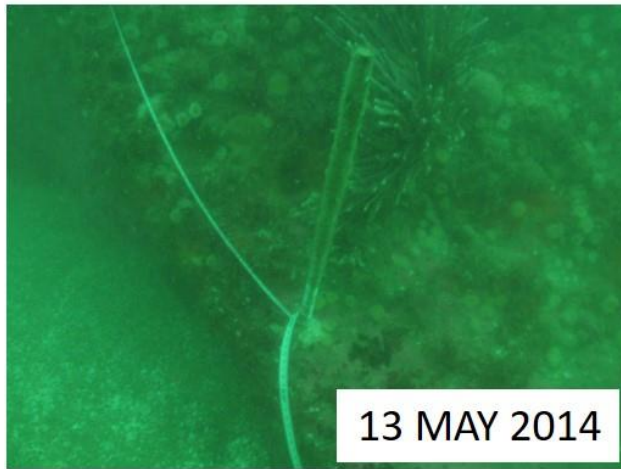
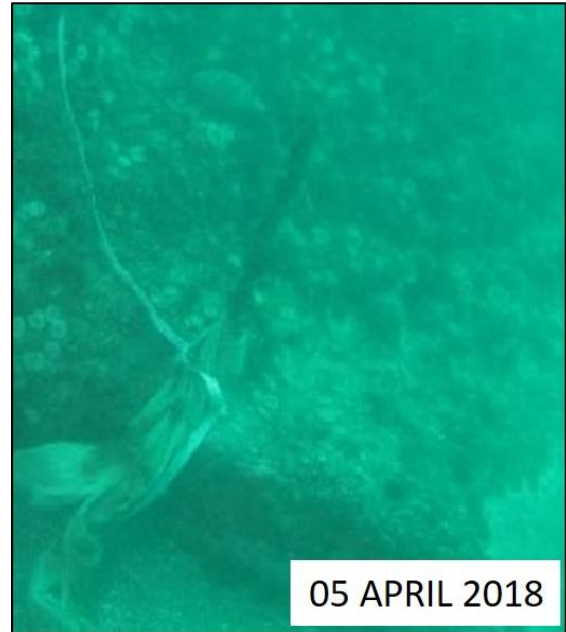
Figure 4. Images of the bottom pin at site 2 in January and May 2014 and April 2018. Visibility during the 2018 survey was very limited and only close up photos were able to be taken.

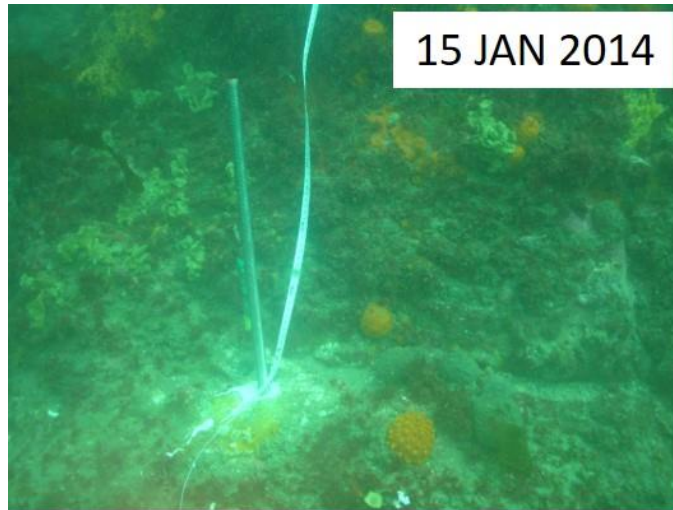
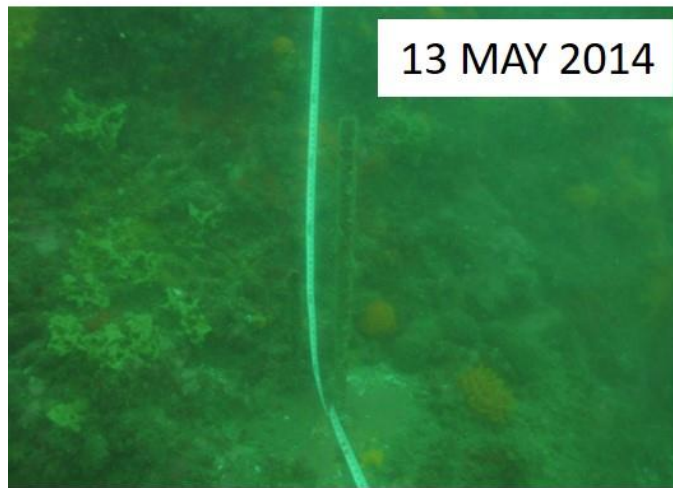
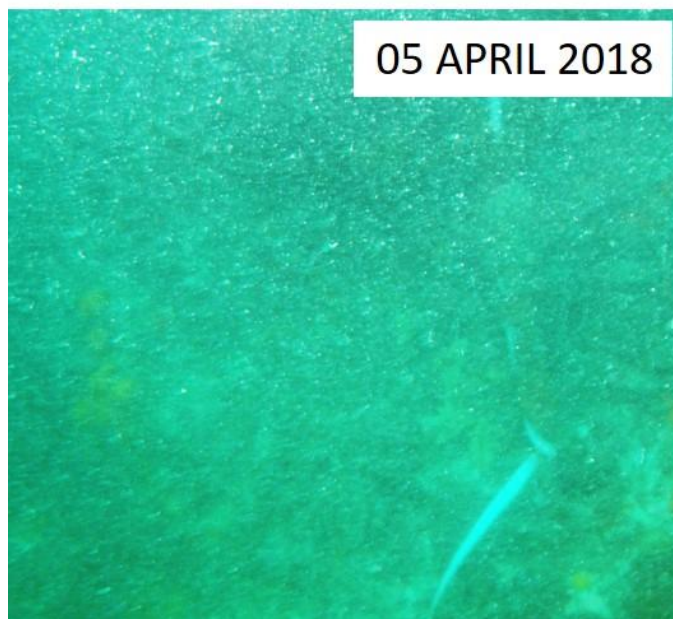
Figure 5. Images of the bottom pin at site 2 in January and May 2014 and April 2018. Visibility during the 2018 survey was very limited and only close up photos were able to be taken.

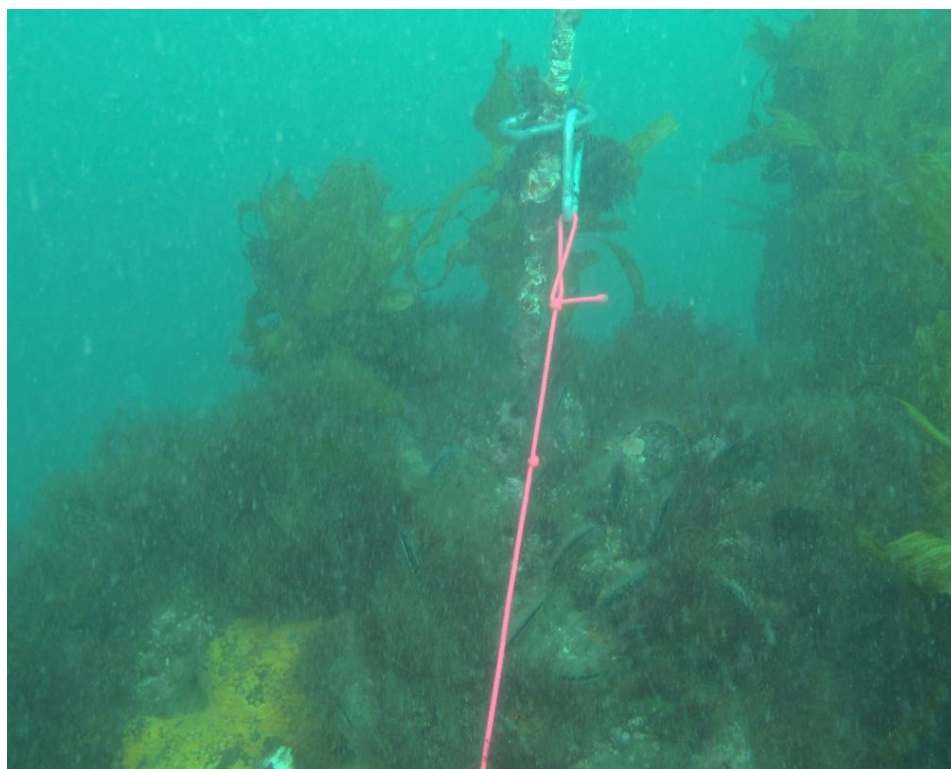
Figure 6. Mussels (*Perna canaliculus*) were recorded in high numbers at site 3 in 2018 and are shown here attached to the reef around the base of the uppermost marker pin.

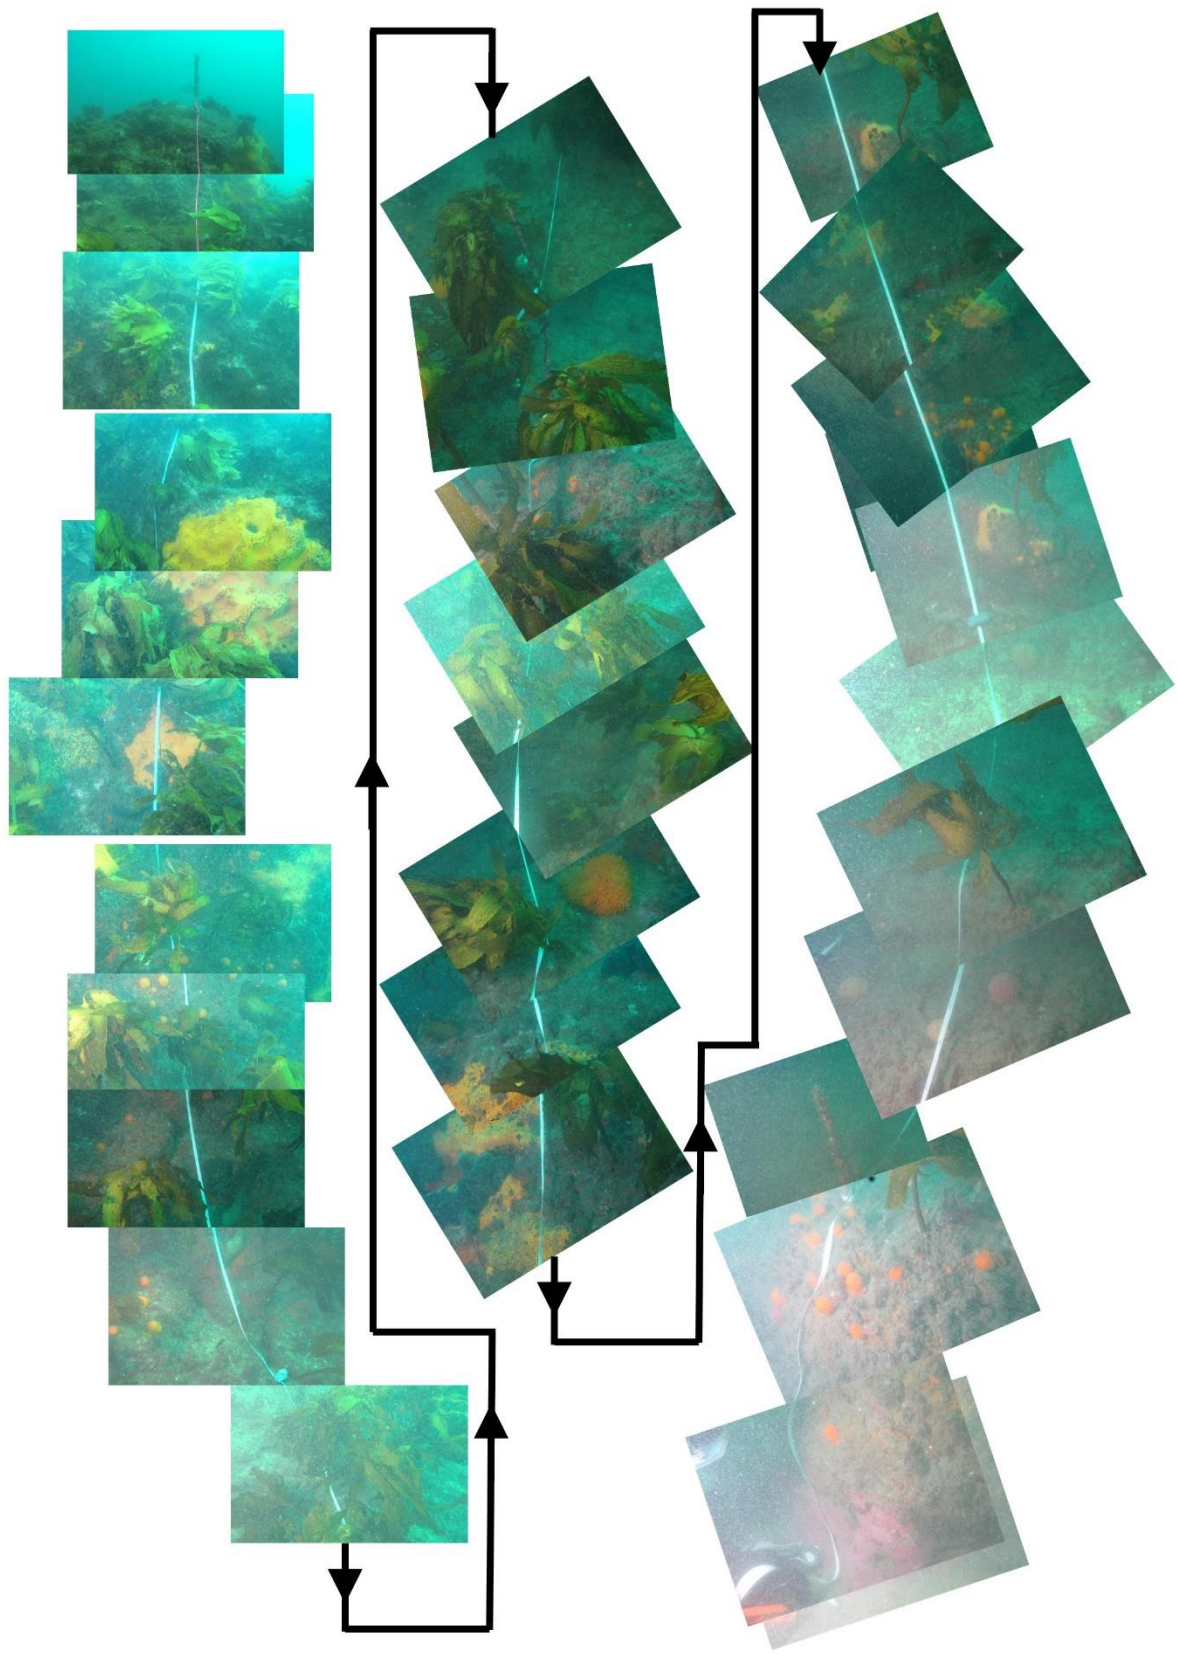
Figure 7. Photo mosaic of the permanent transect at site 1 in April 2018.

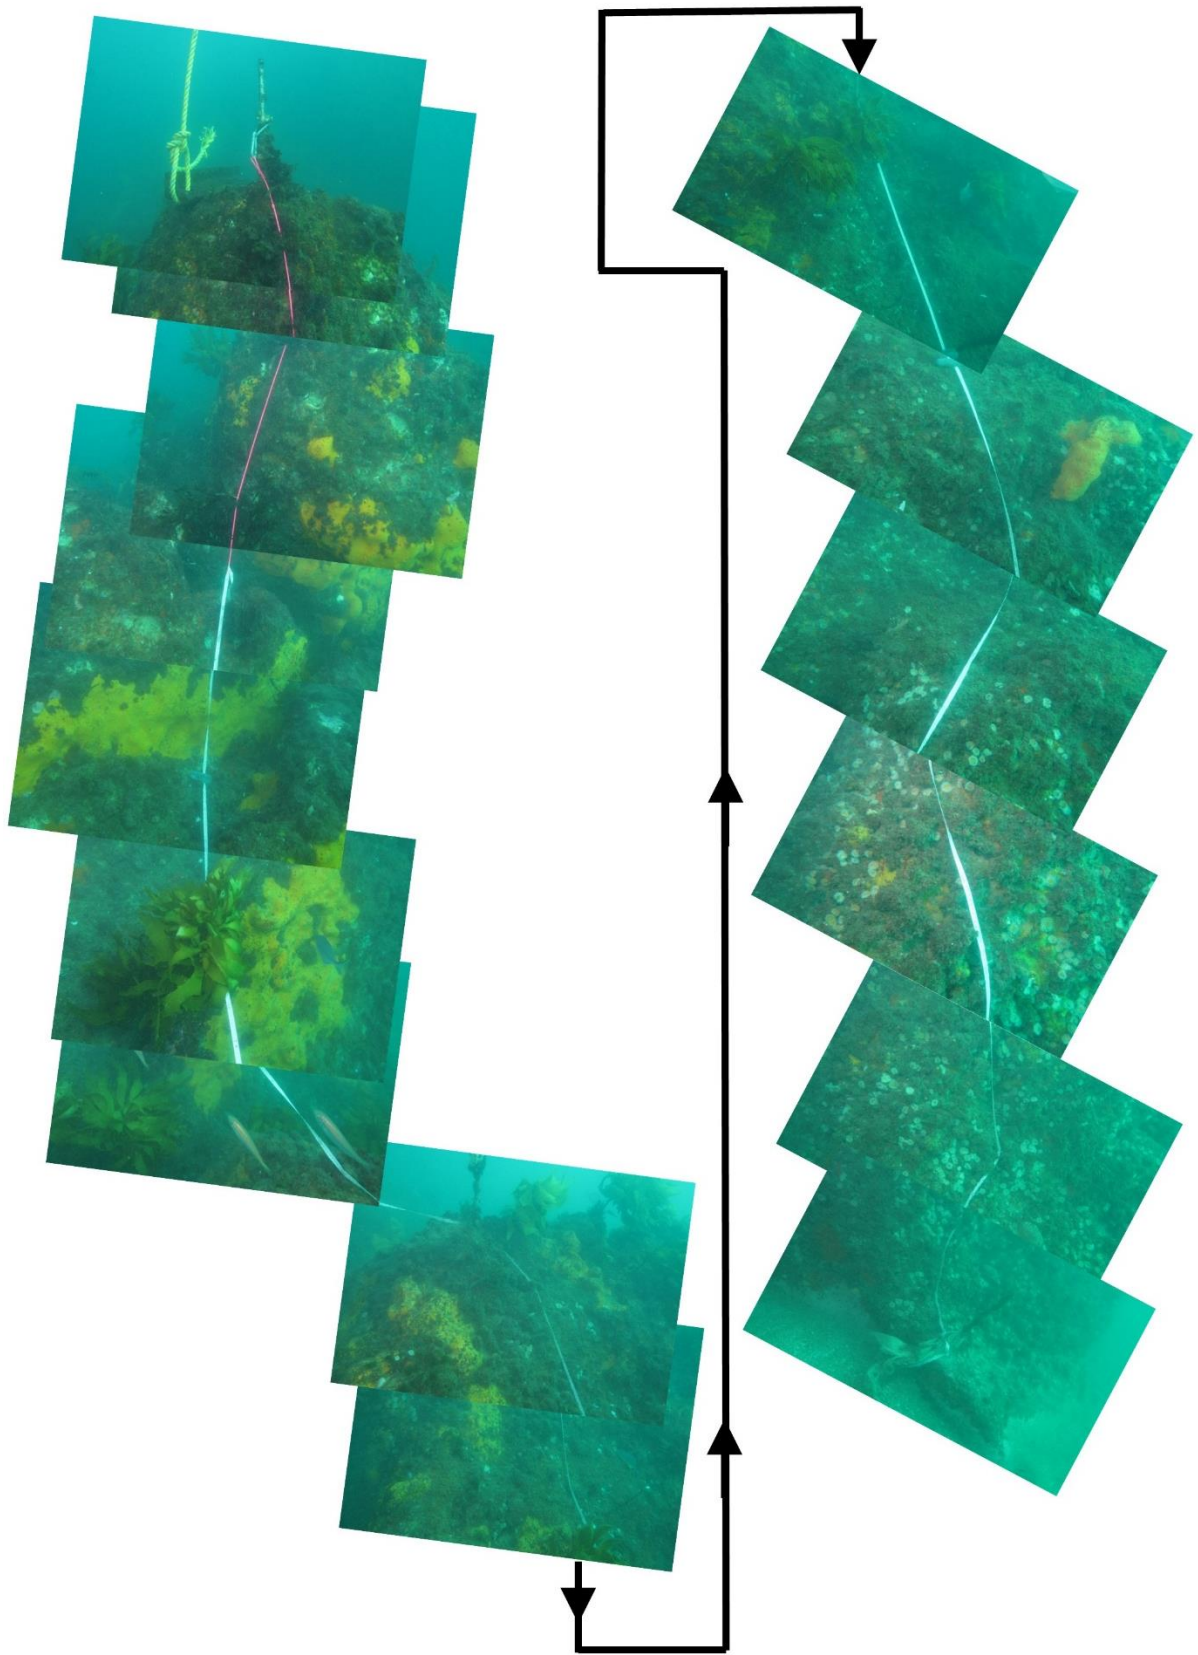
Figure 8. Photo mosaic of the permanent transect at site 2 in April 2018.

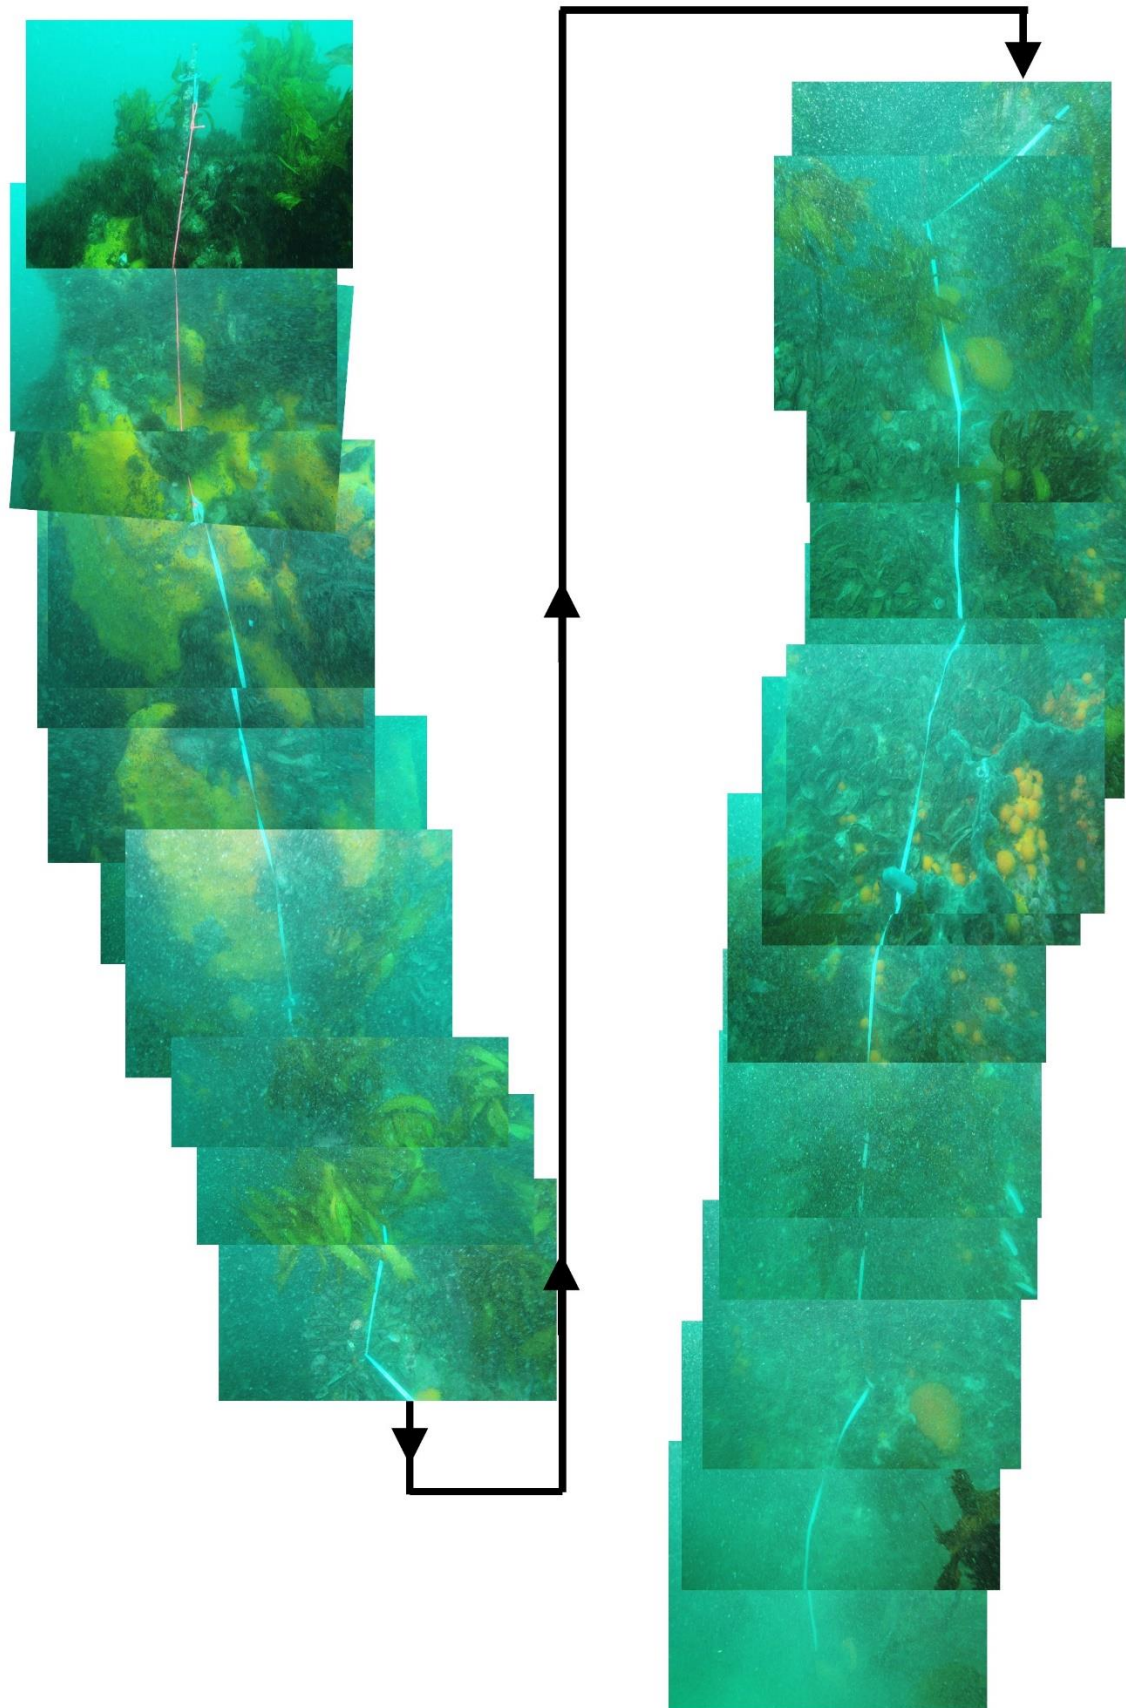
Figure 9. Photo mosaic of the permanent transect at site 3 in April 2018.
