11th Nordic Symposium on Building Physics, NSB2017, 11-14 June 2017, Trondheim, Norway

Deterioration and Preservation of City Wall in Nanjing

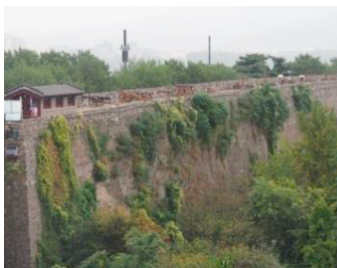
Fig. 4 Plant growing on south side of wall

On the side face of the wall, as shown in Fig. 4, a number of plants are growing, and an exfoliation or extrusion of bricks from the forces caused by tree roots or trunks can be seen. In contrast, the side faces of the wall in front of tall trees, as shown in Fig. 5, are in relatively good condition despite being covered by algae or moss. This is probably because of the protection from solar radiation and precipitation by the trees, and because of the evapotranspiration by the plants and microorganisms. The plants around the wall and on its side faces are thus closely related to the deterioration of the wall. In addition, solar radiation has a significant influence on the plant growth around the city wall. Therefore, the plants, microorganisms, and orientation of the wall have a drastic influence on its deterioration.

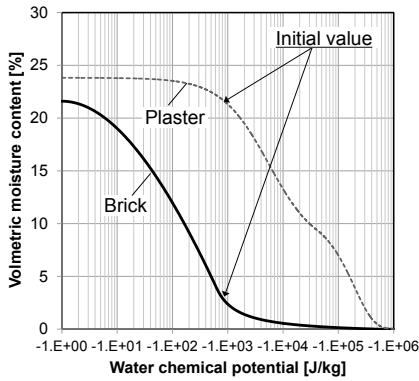
The physical properties of the wall are listed in Table 1, and the equilibrium moisture content of each material used is shown in Fig. 9 [11, 12]. Because the bricks and plaster comprising the present City Wall are considered more brittle and rougher than standard, the moisture transfer coefficients of the bricks and plaster were set to 10-times and a million-times greater than the standard values (Fig. 10), respectively [11, 12].

Fig. 9 Equilibrium moisture content of brick and plaster [11,12]

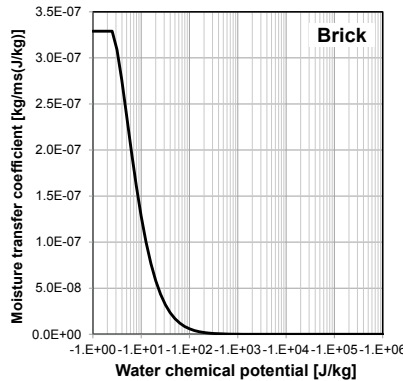
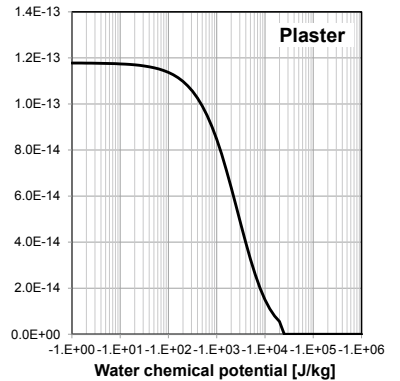
Fig. 10 Moisture transfer coefficients of brick (left) and plaster (right) under standard conditions [11, 12]

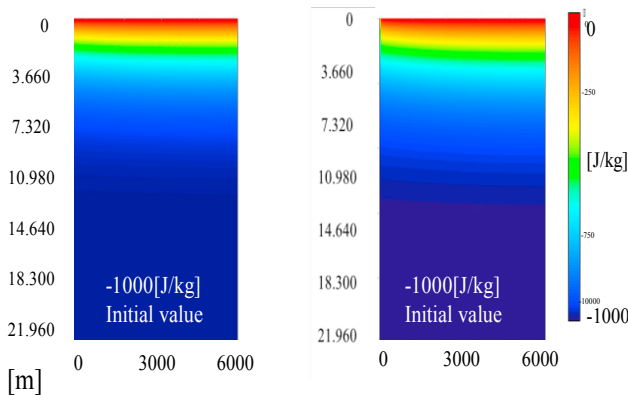
Heat and moisture transfer inside the wall when the upper surface is saturated with rainwater was calculated for a full year. Figures 11 and 12 show the water chemical potential and temperature after half a year and one year, respectively. Because the wall is symmetric to the centerline, only the results of the left half are shown.

The water chemical potential increases particularly at the upper part of the wall owing to the penetration of rainwater. Because the increased region of the potential extends wider after one year than after half a year, it can be stated that the moisture content inside the wall increases over time. From the detailed results of the moisture transfer within the region 1.65 m from the upper surface (corresponding to 14 layers of bricks) after one year, it can be understood that the moisture moved mainly through the plaster layers (figure omitted here), which resulted from setting the value of the moisture transfer coefficients of the plaster to larger than that of the brick.

Fig. 11 Water chemical potential after half a year (left) and one year (right)
