Evolution of Alluvial Meandering Channels: Comparison between Laboratory Experiments and Natural Channels

Saroj KARKI ⁽¹⁾, Hajime NAKAGWA and Kenji KAWAIKE

(1) Department of Civil and Earth Resources Engineering, Kyoto University

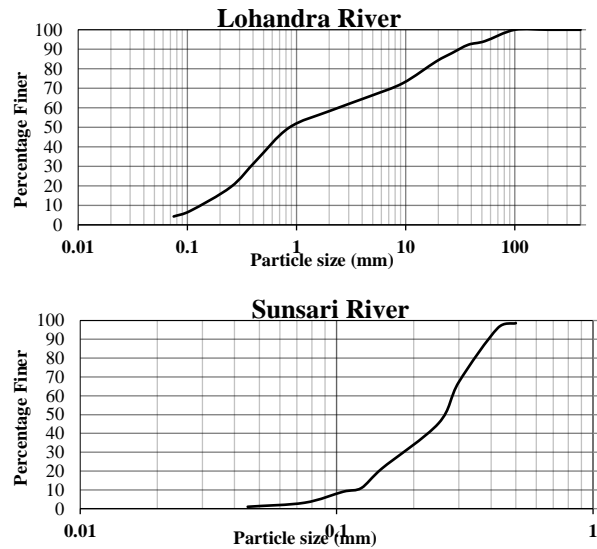
Fig.3: PSD curve for the study reach of two rivers

Sediment is one of the governing factors which determine channel stability, channel shape and sinuosity, Schumm (1963). Channel morphology of an alluvial river is the result of sediment transport and sedimentation, Church (2006). Sediment properties are therefore necessary to be assessed for further understanding of the channel morphological evolution. Accordingly, the sediment samples were collected for the selected river reaches and particle size distribution (PSD) analysis was performed. Fig.3 shows the PSD curve for each of the river.

Lohandra river sediment consisted of a mixture of gravel and sand and silt, JICA (1999) whereas the Sunsari River consisted of fine sand and clay mixture. The uniformity index (UI) defined by the ratio of D_{84} to D_{16} for Lohandra River was found to be high which signified the non-uniformity in the sediment particles as compared to Sunsari River.

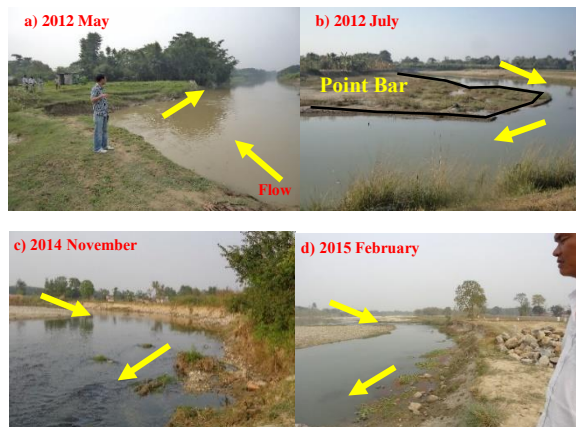
Photo 2: River Channel in the study reach; (a and b) Sunsari River, (c and d) Lohandra River

River channel characteristics can be briefly explained based on the channel shape, width, depth, slope, in-channel morphology, etc. Sunsari River is a perennial river originating in the Siwalik Hills, JICA (2003). In the study reach about 4.5 kilometers downstream of East-West Highway, it consists of a single thread sinuous channel with narrow and deep cross-section i.e. having a low width-depth ratio. The width and depth of the study reach vary between 30-40m and 3-5m respectively. The distinct meandering pattern is evident throughout the river reach. Formation of the curvature related point bar can be seen in the inner bank of the channel. These point bars are gradually armoured by the growth of vegetation which eventually develops into a mainland floodplain as seen in Photo 2. This formation has a significant implication on the channel planform evolution. Also, ox-bow Lake has been formed due to the meander cut-off at different meander bends. Most of these cut-offs are man-made for river channelization while few are naturally formed. Various kinds of cultivation can be seen on the adjacent floodplain. During monsoon, the

Lohandra River also originates in the Siwalik Hills. The study reach is located approximately 12 kilometres downstream from the foothills and 3.5 kilometres downstream of the Bridge at East-West Highway. The river channel is wide and braided in the upper reaches and gradually becomes narrow towards the lower reaches. Unlike Sunsari River, it has a relatively low bank with height 2-2.5m in the study reach. The main channel frequently wanders within the bankline. The average width of the main channel varied between 10-23m during the period of last 7 years from 2010-2017. However, the bank to bank width varies between 100-140m. The average channel slope of the channel for the study reach is about 1 in 250. Riverbed is composed of gravel, sand and silt while the bank materials basically constitute of sand, clay and silt mixture. Meander development, bank

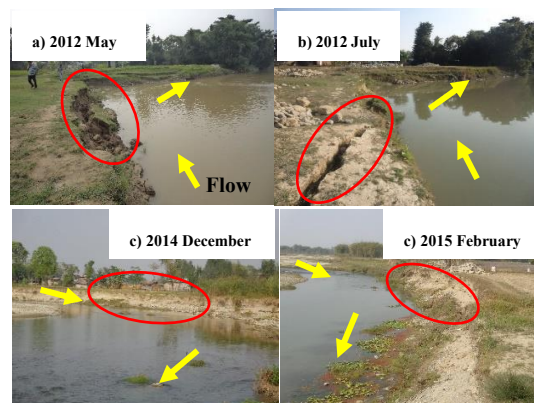
Photo 4: Bank erosion in the study reach; (a & b) Sunsari River and (c & d) Lohandra River

Photo 4 (a-d) shows the bank failure along the study channels. It was seen that in case of Sunsari River, the mass failure mode was dominant while fluvial erosion was principal mode of bank erosion in Lohandra River channel. High and steep banks with deep channels in Sunsari River resulted in the instability of the bank. Consequently, failure of the bank as a mass of soil was observed (see Photo 4a). Similarly, due to the undermining of the lower bank layer, cantilever or overhang bank was formed. As a result, tension crack was observed in the upper bank layer as can be seen in Photo 4b which ultimately resulted in the mass failure. The arrow in the photo represents the flow direction. Unlike in Sunsari River, in case of the Lohandra River, as it can be seen in Photo 4(c,d), mass failure is not the active mode of bank failure although some failed materials can be seen near the bank. It suggests that the erosion of bank toe caused some of the bank materials to fail. As a response, the bank readjusted to the stable slope by the failure of some materials. During the low flow, the failed bank materials tend to get armoured by the growth of vegetation which during the next flood period resist the bank erosion to some extent. In order to control the bank erosion process, different counter-measures were implemented along the study reaches of both the Rivers. The next sub-section discusses the performance of such counter-measures against bank

Before the implementation of groynes, as discussed in subsection 5.1 and shown in Photo 4 (a & b), the mass failure of bank materials along the outer bank was very active due to the concentration of flow along the outer bank. However, the implementation of counter-measures resulted in a massive evolution of channel alignment as well as morphology. As it can be clearly seen from Photo 6 (c, d) that a considerable amount of land has been reclaimed as a result of the deposition induced by the implementation of the counter-measures. This deposited land has eventually turned into a mainland floodplain. However, the risk of erosion is now shifted to downstream and hence bank protection is required in that portion. This had a positive impact on the outer bank but the opposite bank has been eroded significantly due to the shifting of the channel towards it. As a result, almost the same amount of area deposited on the outer bank has been

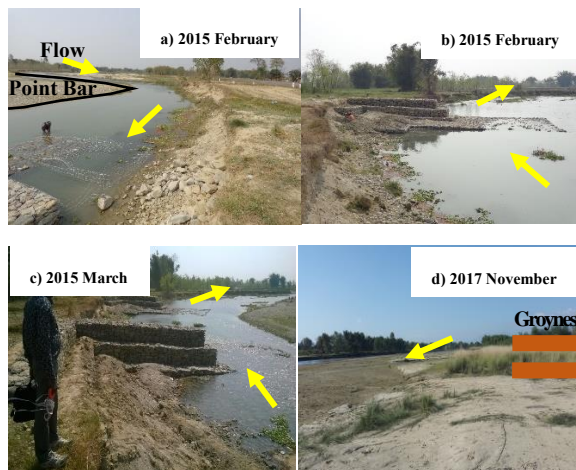
Photo 5: Implementation of groynes in Lohandra River.

A conceptual orientation of groynes in a channel bend is shown in Fig.7. In general, groynes are placed at the outer bank where the erosion is severe. In this regard, impermeable groynes made up of galvanized iron (GI) gabion wire and boulders were constructed in the study reach as shown in Photo 5.

Before the implementation of groynes, it can be clearly seen from Photo 5(a-c) that the flow is concentrated on the outer bank. Also, the point bar located on the opposite bank tend to push the flow further towards the outer bank. However, after the implementation of groynes, it had a significant influence on the flow and the bed morphology as seen in Photo 5d. Due to the effect of groynes, the point bar on the opposite side has been reduced and the main flow is now shifted towards the opposite banks. A significant amount of deposition has occurred in the space between the groynes as well as at the immediate downstream. In fact, the deposition is nearly upto the crest of groynes. Also, the growth of vegetation further strengthened the deposited sediments. Although it seemed that the purpose of implementing groynes was achieved, there are certain factors that need to be taken care of. As the flow is now shifted towards the opposite bank, there are high chances of erosion along that bank. Similarly, along the groynes implemented bank, the erosion shifted downstream. So it needs to be protected as well. This suggests that the phenomena of erosion and channel adjustment are complicated in a meandering channels. Therefore in case of meandering channel, the analysis of the problem needs

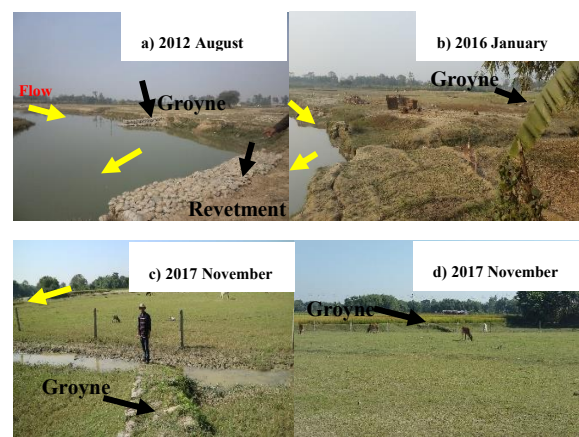
Photo 6: Implementation of Groynes for bank protection and its effect in Sunsari River.

In case of Sunsari River, as seen in Photo 6a, one straight type impermeable groynes, as well as a revetment, were implemented in the year August 2012 on the outer bank to check the bank erosion. The length of the groyne was 9m the top-level of which coincide with the level of the bank and slightly sloping towards the channel. The other configuration was similar to the groynes of Lohandra River with launching apron at the nose and at upstream and downstream of the main body. About 30m downstream of the groyne, a revetment wall of length 9m and height 1.5m was also installed.

a consistent erosion and shifting of the channel towards the right bank occurred. The implemented groyne as seen in Photo 6 (b-d) has been completely filled with the sediment and is about 100m away from new bankline. The deposited portion of land on the left bank has been reclaimed but the almost same amount of land has been lost to erosion on the opposite bank. The major factor that can be attributed to this evolution of channel pattern is the location of the apex-2. At first, the implementation of groyne pushed the flow towards the channel center. As it can be seen that the apex-2 has a very sharp bend almost 90°. Also, the bank just downstream of apex-2 is protected by the revetment as well as there is plenty of vegetation which further strengthened the bank against erosion. Due to this reason, the outer bank couldn't be eroded. This factor along with the groyne implementation behaved as an external forcing to the channel. Consequently, the channel tends to adjust to this external factor by eroding the bank that is weak and easy to erode. The consistent shifting of the channel centerline between the apices from left bank to the right bank clearly justifies the above discussion.
