Historic roof structures: life-cycle assessment and selective maintenance strategies

ABSTRACT: Many industrial and military constructions built between the end of the XIX century and the first years of the XX century show long span roof structures constructed using slender steel truss members. This characteristic makes the structures almost invisible and the interior space appears larger than it is. After 100 years or more, structures like these are still in good conditions although they may have fallen into disuse and neglect. Usually these buildings are protected by Cultural Heritage regulations. Therefore, it would be interesting to define suitable intervention strategies to maintain, conserve and possibly reuse them. This paper compares three different steel roof trusses, covering some buildings of a military installation in Pavia (Northern Italy), built from the end of the XIX century. The residual capacity has been probabilistically evaluated in order to check the efficiency of the most vulnerable members of the structures and investigate systems' robustness in case of sudden failure of the critical components. The method proposed can be considered as a reliable approach to

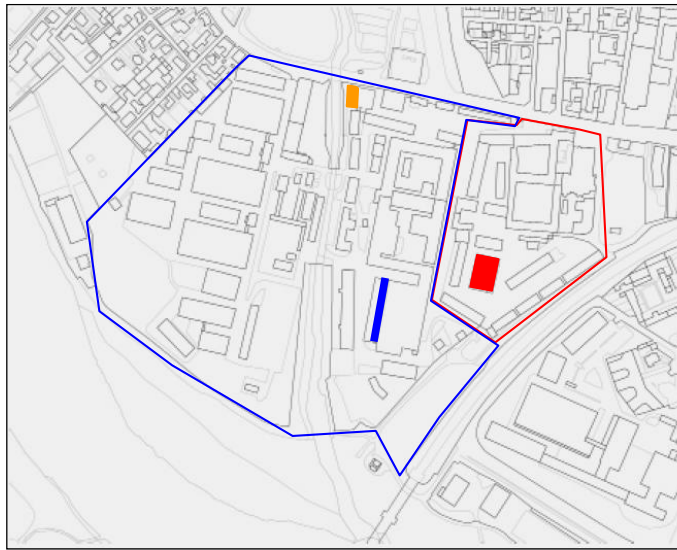
Fig. 1 Arsenal (blue perimeter) and Rossani barrack complex (red perimeter) planimetry in Pavia. Case study 1, Rossani's Pavilion in red; Case study 2, Arsenal Building 65 in yellow; Case study 3, Arsenal Building 15 in blue.

The three case studies analysed here refer to the roof structures of two pavilions of the Arsenal complex and one pavilion of Rossani barracks (Fig. 1).

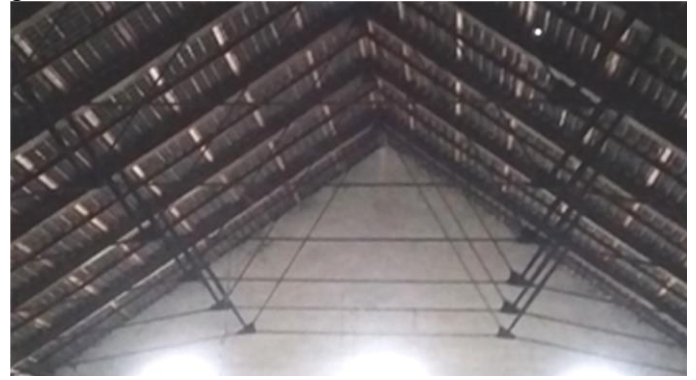
Figure 2 Pavilion in Rossani barracks.

The case study structure is a Polonceau truss made by small tension and compression iron and timber bars (Fig. 2; Tab. 1).

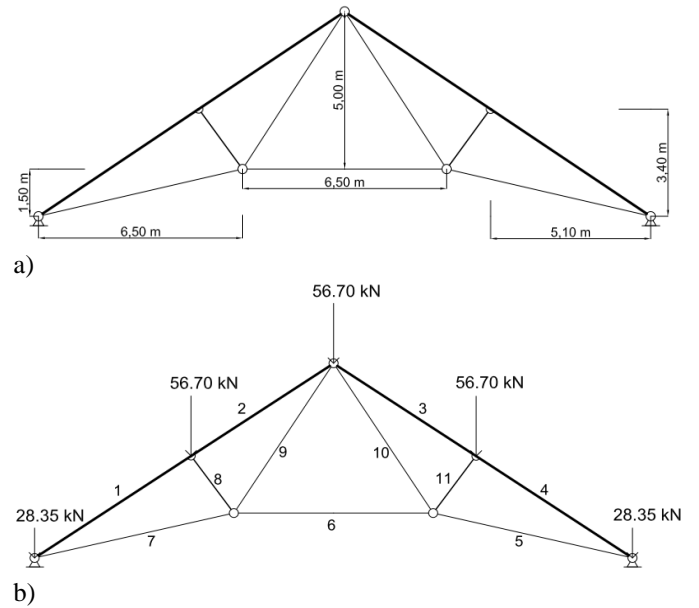
The original load on the structure has been estimated as approximately 9.7 kN/m² on a 60-sm influence area. Figure 3 shows the truss geometry and the forces applied to each node. Monte Carlo simulation refers to the static model in Figure 3(b). Members 1-

4 in timber and members 5-11 in iron have different geometries.

Fig. 3 (a) Truss geometry (in metres); (b) Truss static model

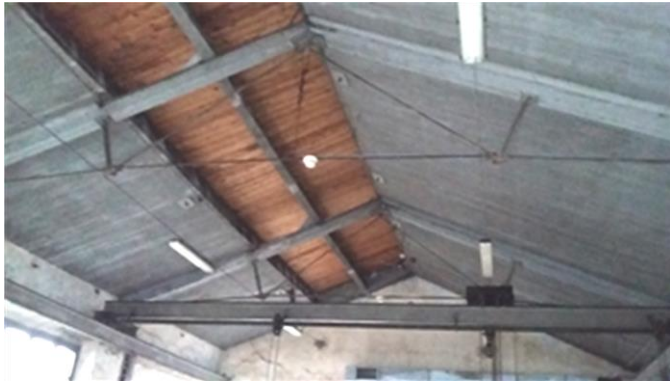
Figure 4 Arsenal Building 65

The structure is a Polonceau truss made by small tension and compression iron and timber bars (Fig. 4; Tab. 2).

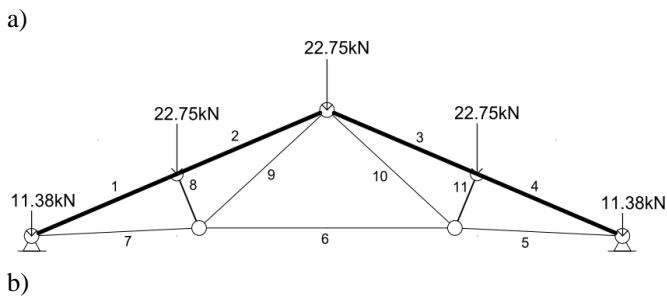
The original load on the structure has estimated to be approximately 2.0 kN/m² on a 42-sm influence area. Figure 5 shows the truss geometry and the forces applied to each node. Monte Carlo simulation refers to the static model in Figure 5(b). Members 1-4 in

timber, and members 5-11 in iron present different geometries.

Figure 5 (a) Truss geometry (in metres); (b) Truss static model

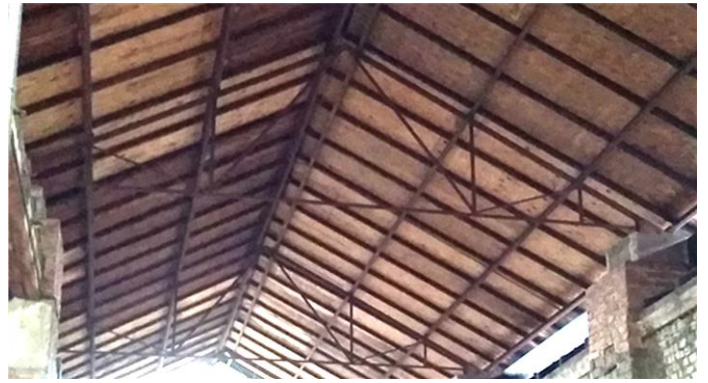
Figure 6 Arsenal Building 15

The structure is composed by a classic truss with small tension and compression iron bars (Fig. 6; Tab. 3).

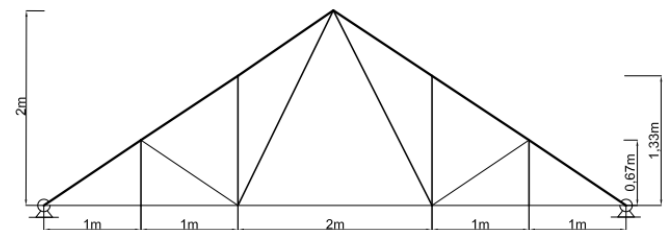
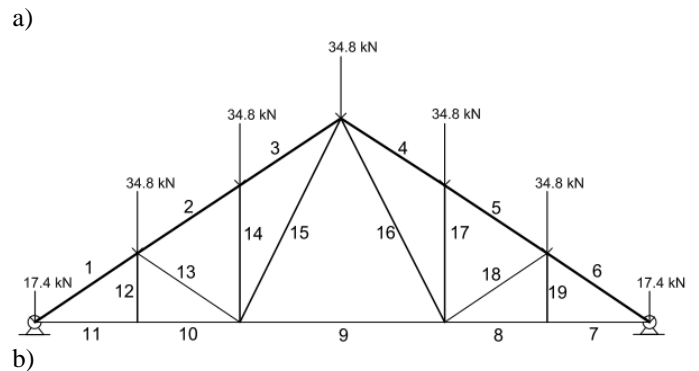
The original load on the structure was about 2.0 kN/m² on an influence area of 35 m². Figure 7 shows the truss geometry and the forces applied to each node. Monte Carlo simulation refers to the static model in Figure 7(b).

Figure 7 (a) Truss geometry (in metres); (b) Truss static model

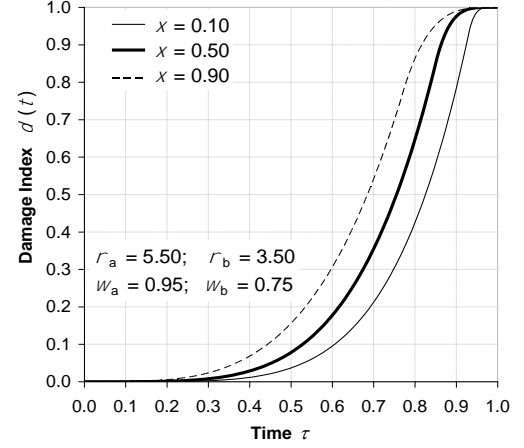
where $\tau = t/T_f$, T_f is the n -instant of time at which the failure threshold $\delta=1$ is reached, ρ and ω are parameters defining the damage curves (Fig. 8).

Figure 8 describes the decay law affecting the structure. Deterioration is assumed uniform on the whole element surface. Environmental aggressions

Figure 8 Damage index δ versus normalized time $\tau = t/T_f$ related to different performance loss percentage ξ .

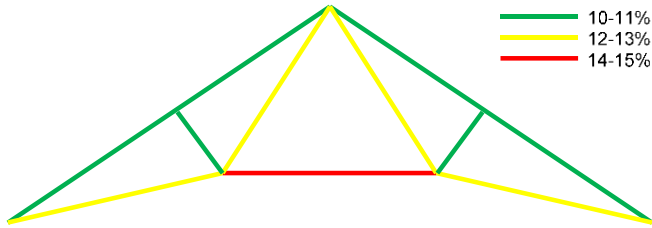
Monte Carlo simulation shows a 10% to 15% damage spread over the entire structure. Although the overall deterioration level doesn't seem to compromise the structural stability yet, member 6 critical conditions shouldn't be underestimated (Fig. 9)

Fig. 9 Damage percentage member by member

The comparison of the case studies reveals that the trusses are subjected to a different deterioration process depending on the elements' dimension and structural geometry, though the decay law applied is the same. For instance, Case 1 shows the horizontal member as the critical one, while mid-diagonal members (i.e. elements 9 and 10) are the weakest in Case 2.

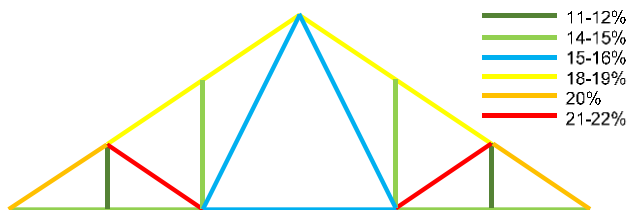
Once again, there is an overall deterioration. However, comparing Case Study 3 with the previous ones, because of the smaller dimension of its elements, the damage appears to be more consistent and it has been estimated in the range from 11% to 22% (Fig. 11).

Fig. 11 Damage percentage member by member

Monte Carlo simulation proves the structure to be still strong enough to withstand current loading and environmental aggressions, though the slenderest

members (i.e. elements 13th and 18th) have lost a significant portion of their original cross sectional area.

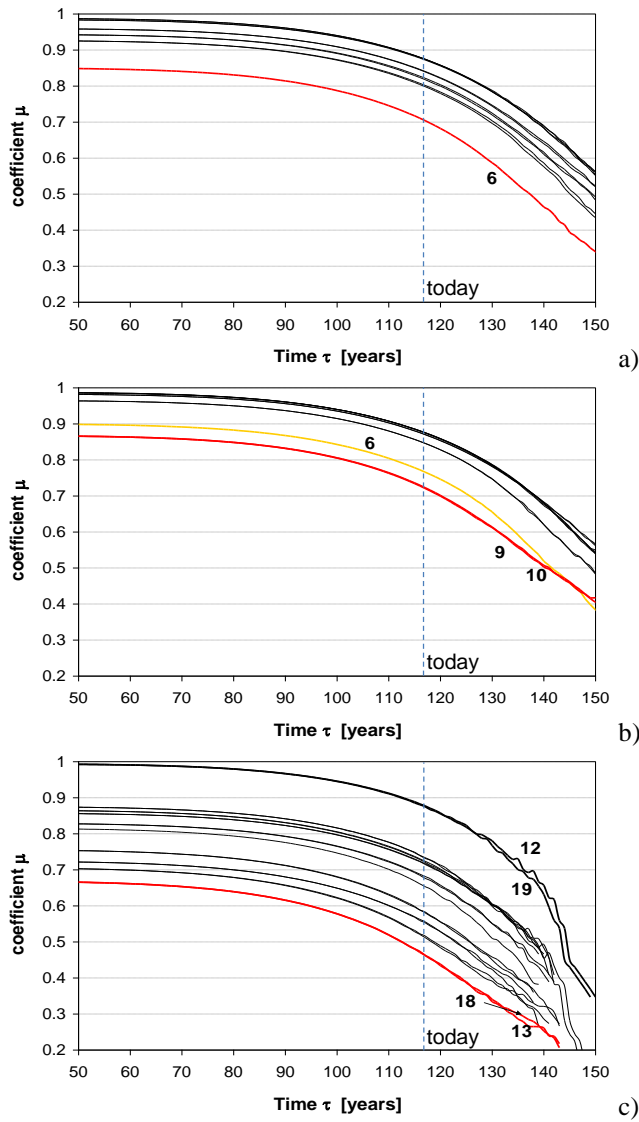
where $\delta(t)$ is the damage obtained by Eq. 2, $\sigma(t)$ is the level of stress at time t and $\bar{\sigma}$ is the ultimate stress (i.e. allowable/permisible stress). Figure 12 compares the time evolution of index μ for the three case studies.

Fig. 12 Comparison between index μ evolution over time for all the members of each roof truss: a) Case 1; b) Case 2; c) Case 3. The most vulnerable components have been highlighted in red and yellow.

Figure 12 shows which component is most likely to fail. Furthermore, it appears clear that Case 3 truss system (Fig. 12c) is characterised by a lower reliability level than the other structures (Fig. 12a and b).

A selective maintenance would require an urgent intervention to restore the volume loss or replace the critical elements and the members with an index μ close to 0.4. Otherwise, when it comes to components characterised by a higher index μ , maintenance actions may be postponed.

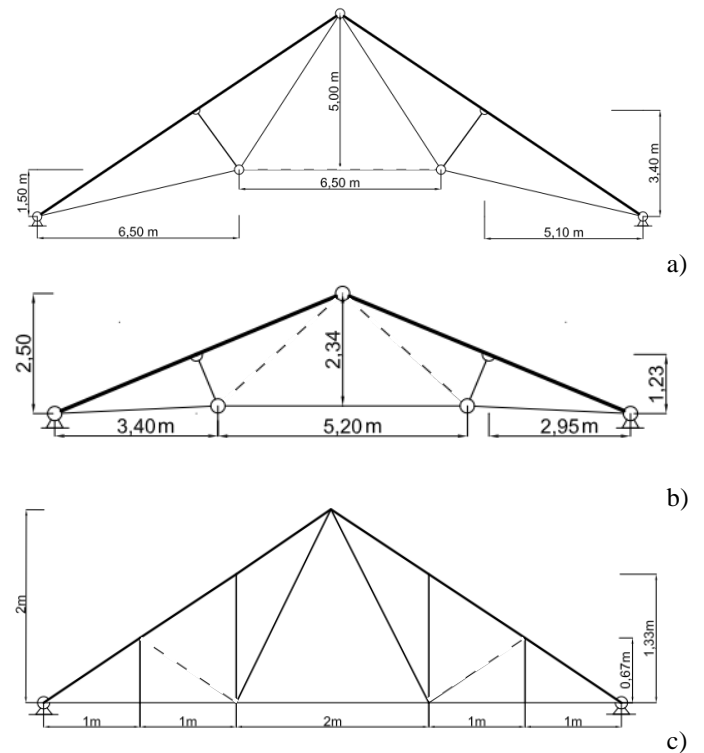
Assuming the most vulnerable elements of the three case studies suddenly fail at the current time (i.e. instant time t equal to 117 years), it is important to understand whether their robustness would be enough to resist or they would miserably collapse, and if the constraint redundancy (i.e. Case 3) has any role in affecting the structural strength. In order to investigate this specific condition, the case studies have been evaluated considering 117 years as actual instant time, and without the critical members' support (Fig. 13).

Fig. 13 Case studies analysed without considering the members affected by possible failure (dashed lines): a) Case 1; b) Case 2; c) Case 3.

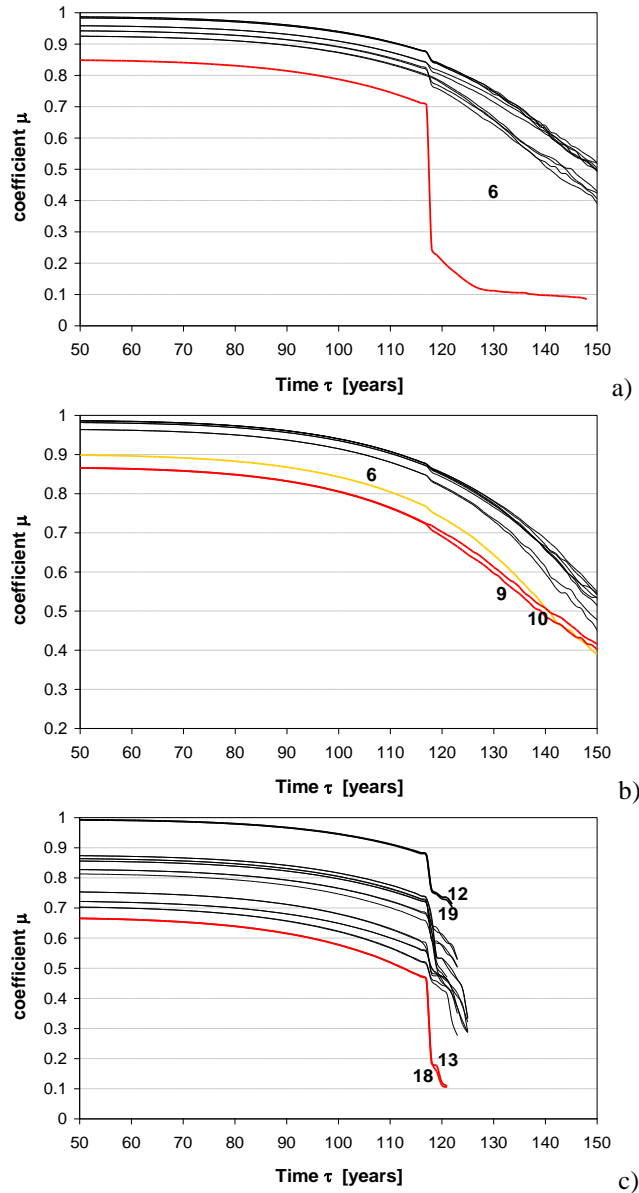
Figure 14 shows the results of the second analysis. In Case 3, index μ evaluation reveals that the system redundancy has not a significant impact on the stress distribution in the undamaged members, while a diffuse deterioration affects the whole structure with a failure time estimation of approximately 125 years (Fig. 13c; Tab. 5). Therefore, extensive maintenance actions over the whole roof structure would be necessary to protect the truss system and prevent it from failures.

Fig. 14 Comparison between index μ evolution over time for all the members of each roof truss: a) Case 1; b) Case 2; c) Case 3. The most vulnerable components have been highlighted in red and yellow

In Case 1, member 6 failure has a low impact on the overall deterioration. Index μ evolution suggests that element 6 should undergo urgent maintenance, while the rest of the structure could be maintained in the long term (Fig. 14a; Tab. 5).

In Case 2, members 9 and 10 failure doesn't affect the overall structural response very much. The time evolution of index μ in Figure 14b is close to the one in Figure 12b. The failure time results in Table 5 again confirm the previous assertions. Case 2 truss system appears to be characterised by appreciable robustness values, which indicates no urgent maintenance is needed.

Furthermore, this methodology can be very helpful in defining the robustness level of a structure. In particular, in Case 3 (i.e. 33 constraints), Table 5 and Figure 14 show that constraint redundancy has no positive effects on robustness. On the other hand, proper cross section and thickness design of roof truss components ensure a better structural response to sudden collapse of the most vulnerable members.
