## Micro-computed tomographic evaluation of dentinal defects after root canal preparation with hyflex edm and vortex blue rotary systems

Mandava J, Yelisela RK, Arikatla SK, Ravi RC. Micro-computed tomographic evaluation of dentinal defects after root canal preparation with hyflex edm and vortex blue rotary systems. J Clin Exp Dent. 2018;10(9):e844-51.

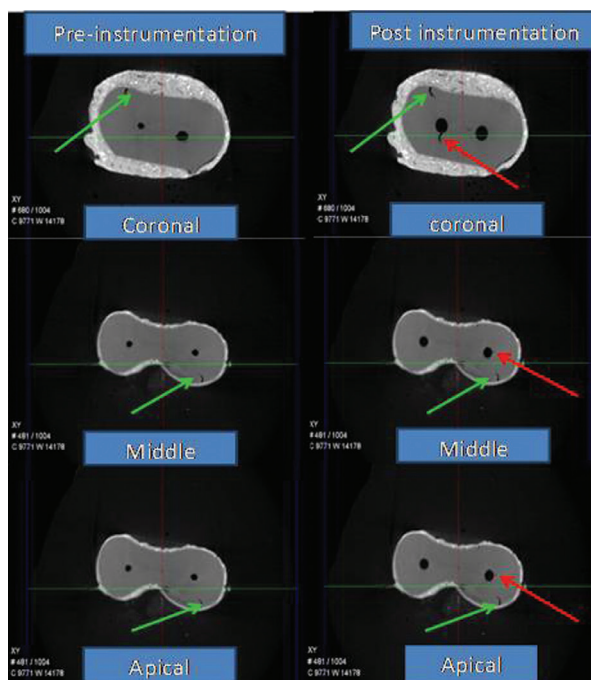
**Fig. 1:** Micro-CT images Ni-Ti Flex file group (Green arrow showing pre-instrumentation defects and red arrow post instrumentation defects).

After chemo-mechanical preparation of the root canals, all root specimens were imaged again through micro-CT scanner. The reconstructed 3-dimensional images of the samples before and after preparation were compared twice by 2 blinded observers to identify the presence of dentinal defects (Figs. 1-3).

Hand Ni-Ti instrumentation caused minimal increase (1.66%) in dentinal defects formation at coronal level. Use of gates glidden drills for coronal root canal flaring might have resulted in the formation of these defects. Similar findings were observed in the previous studies (20,21) where the samples prepared with gates glidden drills exhibited microcracks. To complete a preparation with rotary Ni-Ti files significantly more rotations are required as compared to hand files contributing to the formation of more dentinal defects. In accordance with the observations of the previous studies (11,14) both the rotary systems demonstrated significant increase in the percentage of dentinal defects after canal instrumentation. Contrary to this finding Bayram *et al.* (5) claimed that the instrumentation with Vortex Blue and HyFlex EDM rotary files developed no new microcracks and they attributed this finding to the heat treated structure of these instruments, which gives extra flexibility to the files. Straight root canals were used in their study, whereas moderately curved mesial roots (50 to 200) used in the present study might explain the possible reason for increase in dentinal microcracks formation. These findings differ from the observations by De-Dues *et al.* studies (15,17,18), where they found lack of correlation between dentinal microcracks formation and root canal preparations with rotary systems.

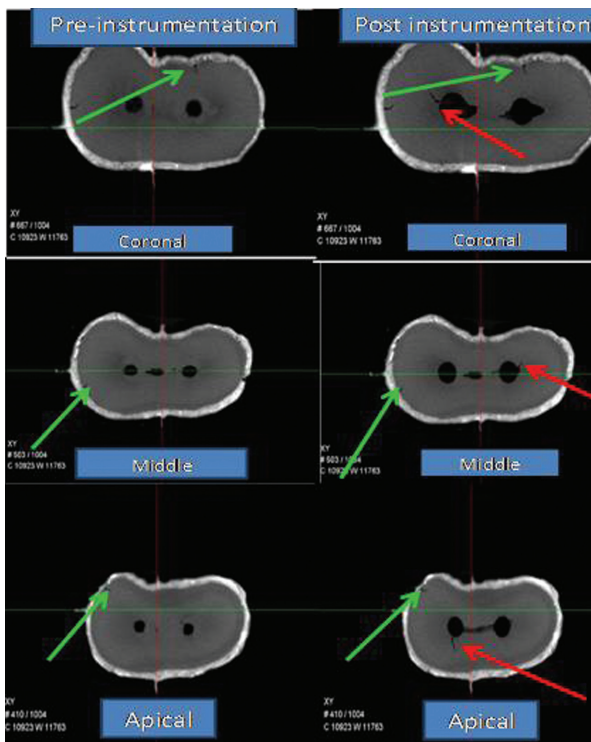
**Fig. 2:** Micro-CT images of dentinal defects in HyFlex EDM rotary system group.

Among the two rotary systems, HyFlex EDM has shown greater increase in post- instrumentation dentinal defects. Formation of defects might be associated with the tip design, cross-sectional geometry, taper type (constant or progressive), flute form and pitch (constant or variable) of the rotary file (22).

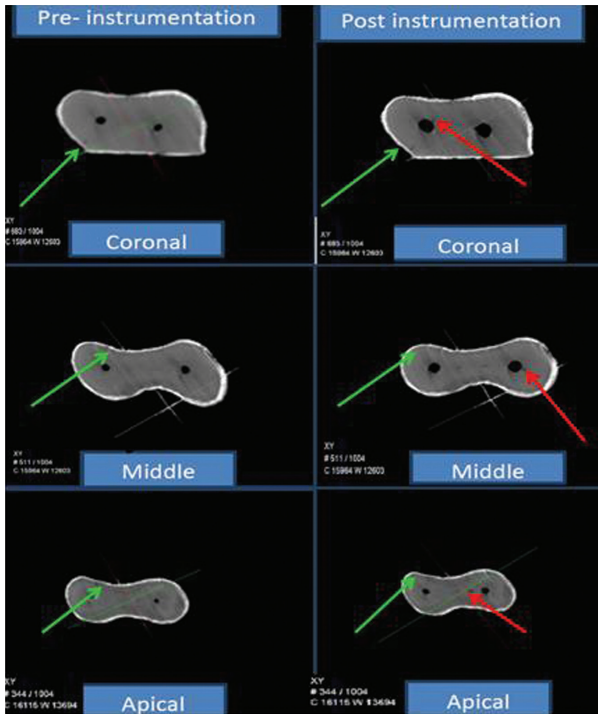
Fig. 3: Micro-cracks formation with Vortex Blue rotary files.
