CLEARING ALASKAN WATER  
SUPPLY IMPOUNDMENTS –  
MANAGEMENT, LABORATORY STUDY,  
AND LITERATURE REVIEW

Daniel W. Smith, Stanley R. Justice

Report No. IWR-67

April, 1976

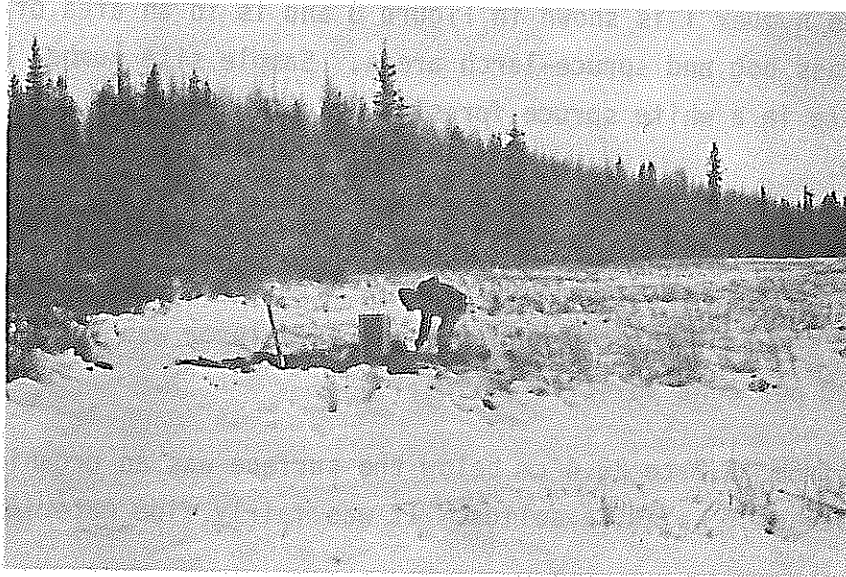
*FIGURE 8 : Sample Site Number 1, Moose Creek.*

Sample site number 1 is shown in Figure 8 and is in an area of transition between grass bog and spruce-larch areas. Sample site number 2 is from a dryer site in a white spruce forest. No photograph was taken of the second site.

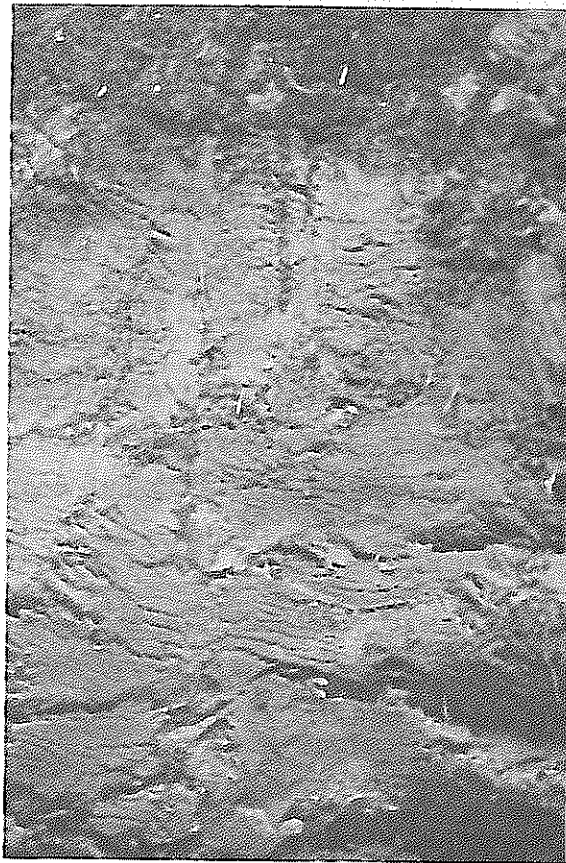
*FIGURE 9 : Soil profile at Sample Site Number 1, Moose Creek.*

The material 15.2 to 25.4 cm below the surface was rusty and grey silt with only 1.6 per cent organic matter. Sand amounted to 24 per cent of the soil and 42 per cent was fines. The water overlaying this soil was of good quality. Tannin/lignin and  $\text{NO}_3$  rose initially but decreased by the end of the run.

From 30.5 to 40.6 below the surface, gravel and sand were encountered which contained very little organic matter. Sand constituted 26.1 per cent of the soil and only 8.3 per cent was fines. Excellent water quality resulted from inundating this soil.

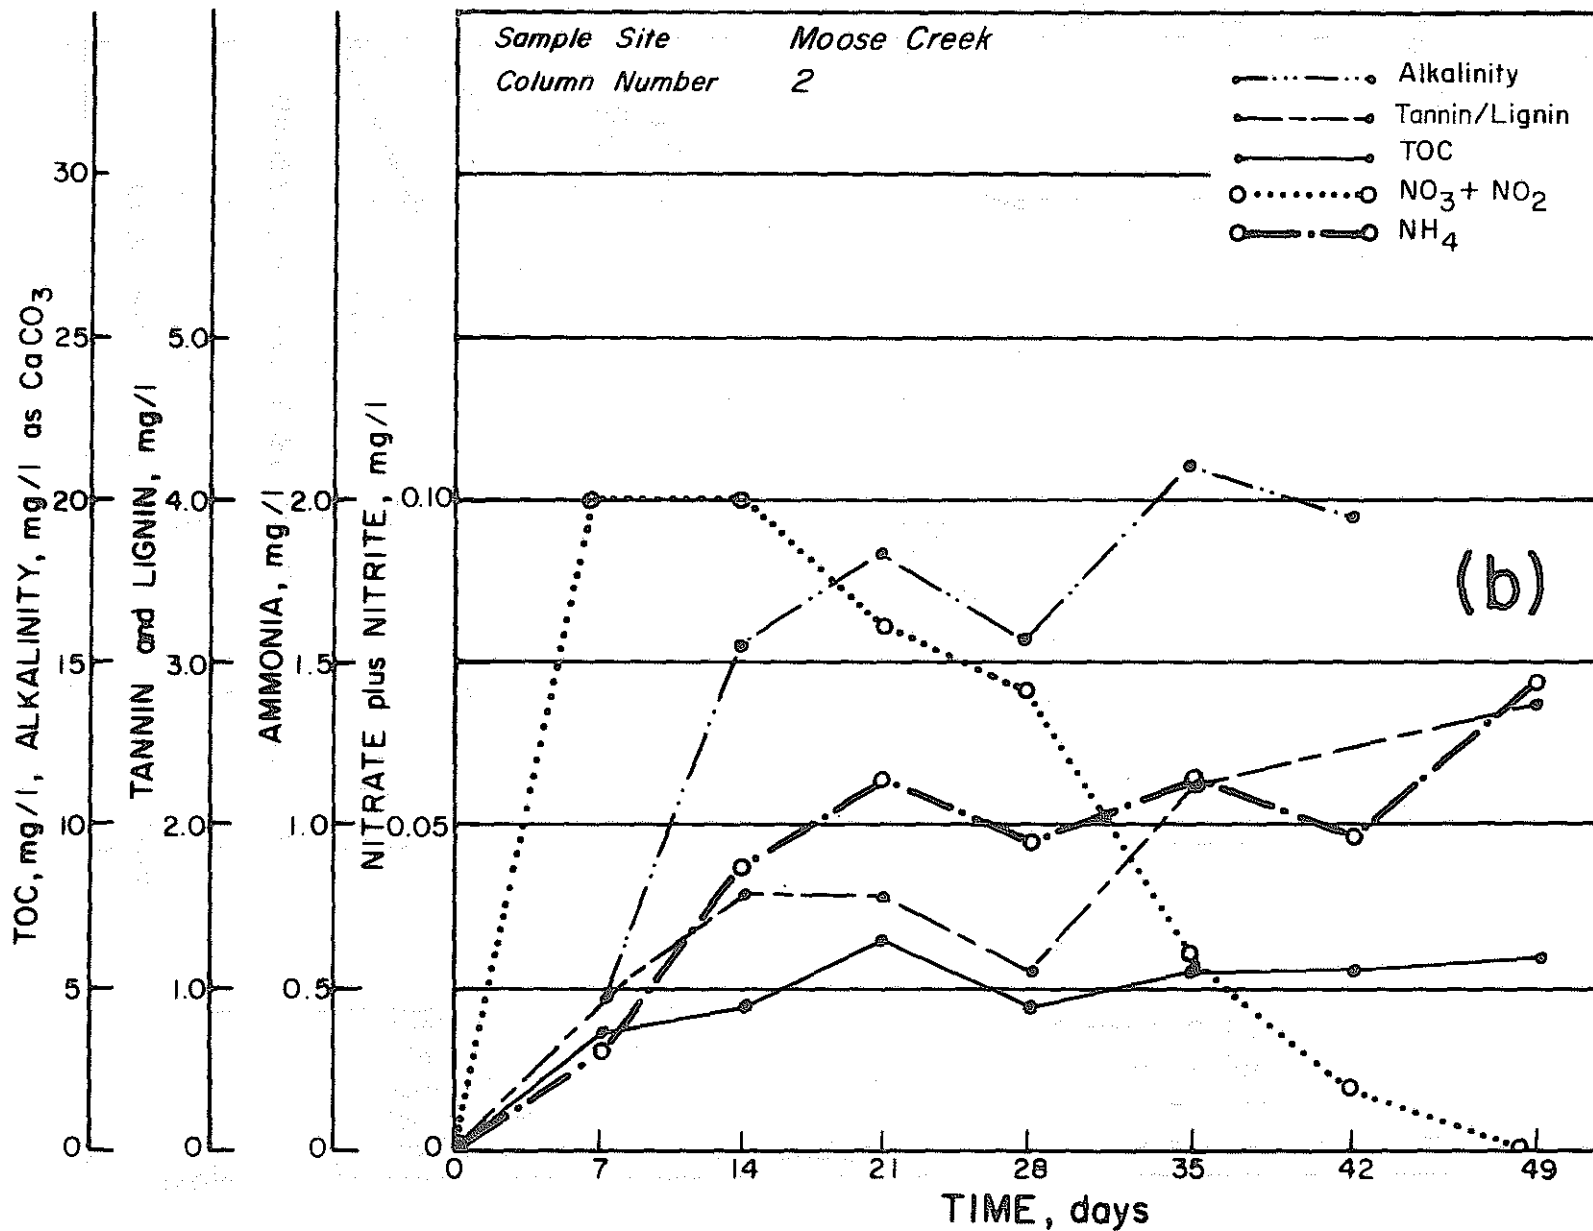
Conclusions and Recommendations: Figures 10 through 16 show the results of leaching different layers of soil from the two Moose Creek sampling sites. The upper two layers from the first sample site, Figures 10 and 11, developed severe water quality degradation. The top layer in particular released large quantities of undesirable constituents into the water which rapidly became anaerobic. The potential for pollution from this layer makes it imperative that it be removed prior to inundation. The second layer also degraded the water but not to the extent that the first layer did. Oxygen did not go to zero but iron and color rose to unacceptable levels. Removal of this layer is also recommended. The deeper layers did not degrade the water significantly and no improvement of water quality would be gained by their removal.

forms of nitrogen, or rose steadily as nitrate and nitrite were reduced. Figure 10 (column 2, Port A) is a typical example of nitrogen being reduced to  $\text{NH}_4^+$  and Figure 13 (column 5, Port A) shows the behavior when microorganisms consume the nitrogen forms. Similar reactions were reported by Mortimer (1941, 1942) and Hutchinson (1957). See the section on nitrogen in the Literature Review for more detailed information.

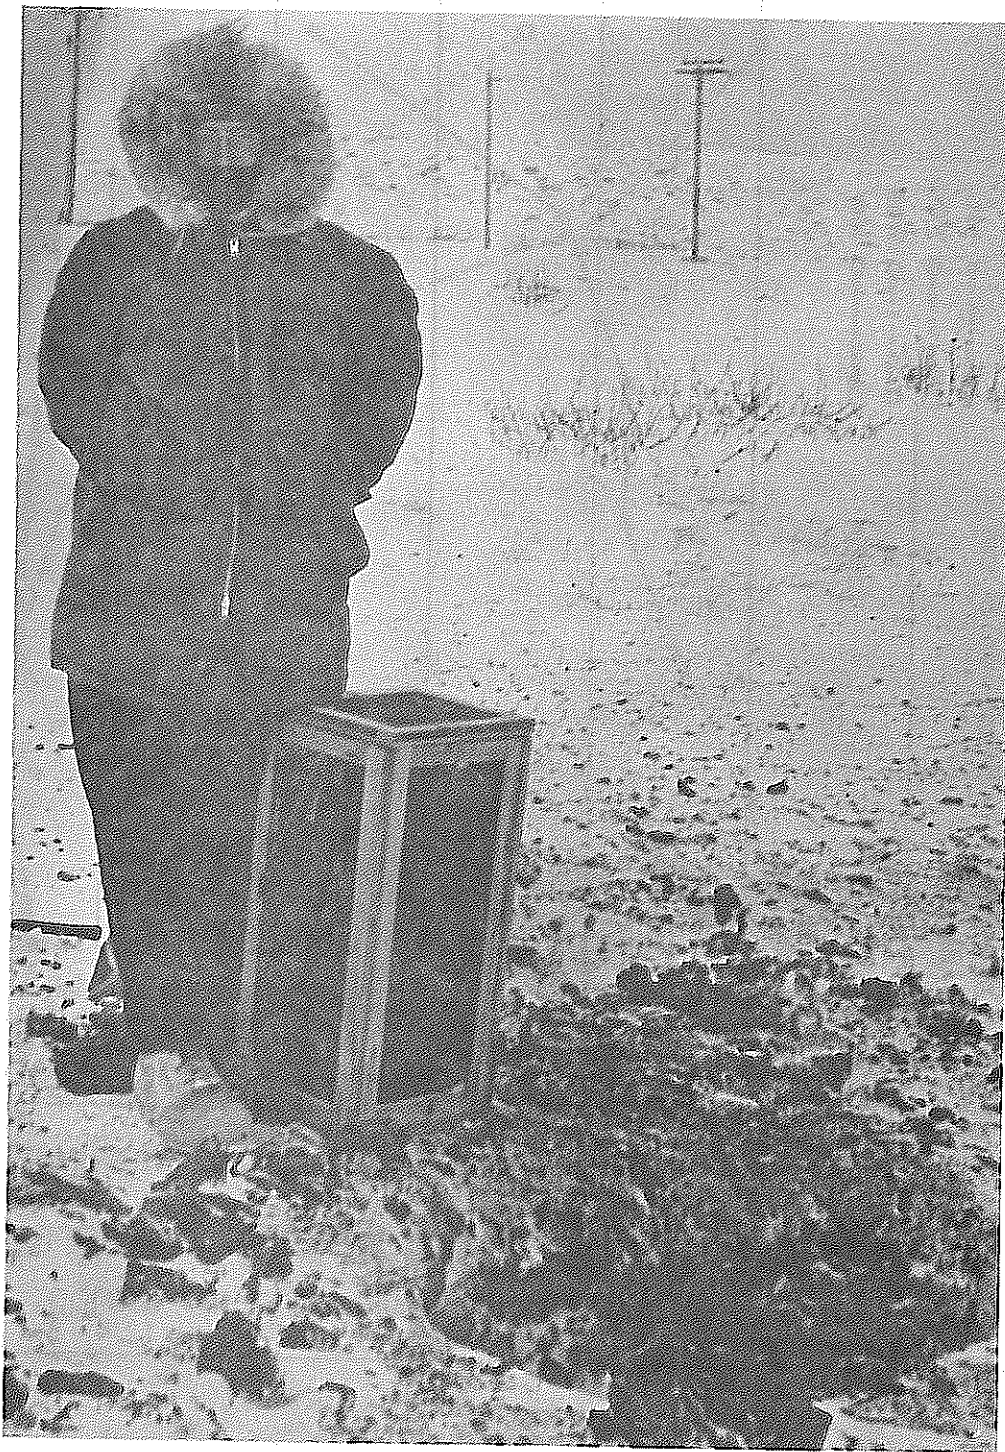
*FIGURE 17: Sample Site Number 3, below dam at Kotzebue.*

The land around Kotzebue is rather consistent, rolling tundra with some flatter bog areas. Sample site number 3 was located below the dam in what appeared to be typical tundra. Figure 17 shows the sample site. Some evidence developed during soil classification that indicated the sample may have been from a disturbed site, but the possibility is remote in that mature, slow growing tundra plants existed on the surface.

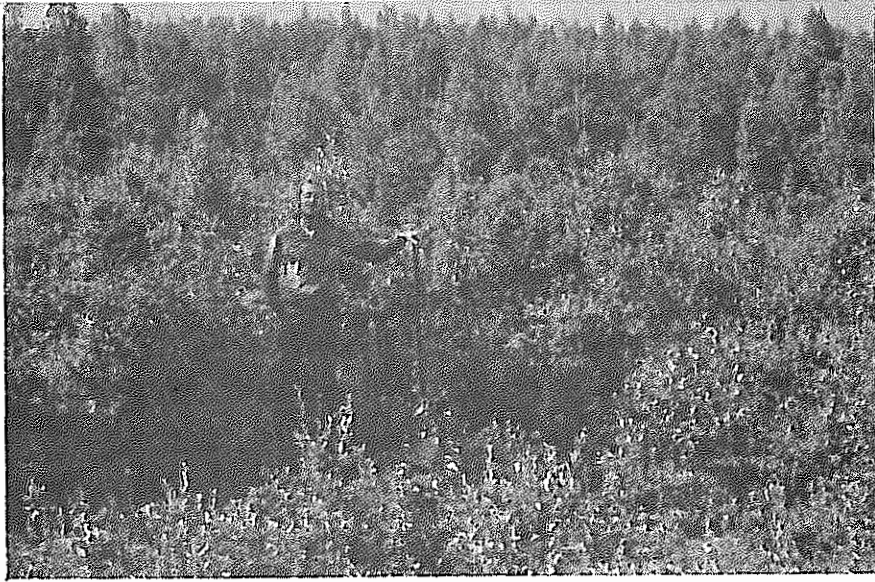
FIGURE 21: Sample Site Number 4, Ship Creek.

Figure 21 shows the dense birch, cottonwood, willow, fireweed, and small plants which characterize this area.

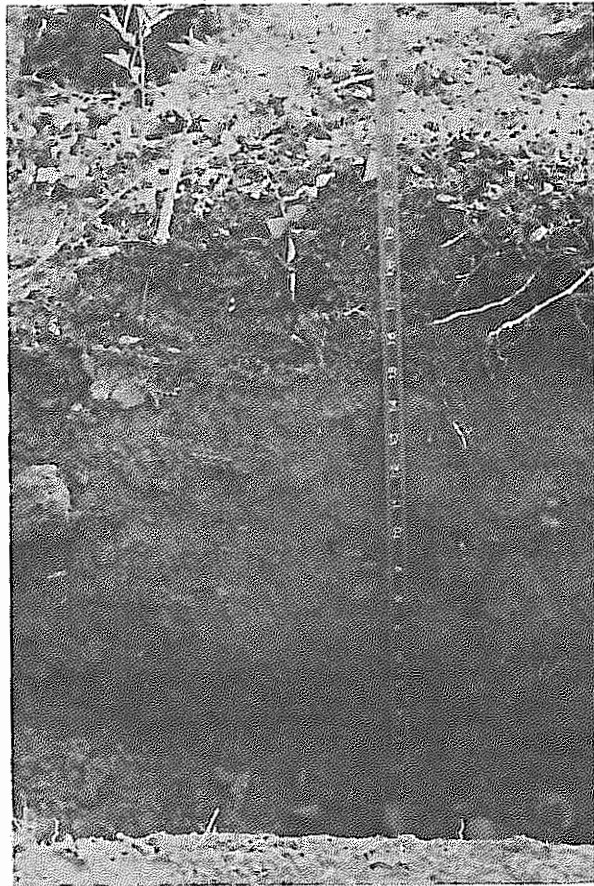
FIGURE 22 : Soil Sample at Ship Creek Sample Site.

From 20.3 to 30.5 cm below the surface, a brown soil was encountered with 39.9 per cent organics. Sand comprised 26 per cent of the soil and the remainder was fines.

At the 30.5 to 40.6 cm level a dark brown sand was encountered with 24.8 per cent organic matter. Only 10 per cent was fines, the rest being sand sized.

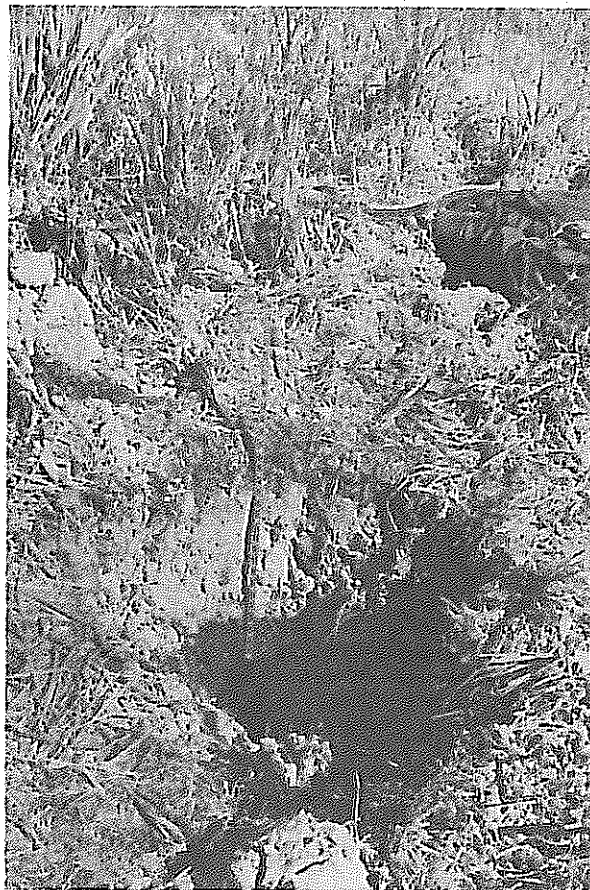
*FIGURE 30 : Soil Profile, Monashka Creek  
Sample Site Number 2.*

The surface layer at this site was a dark brown organic root mat with organic matter comprising 40.7 per cent.

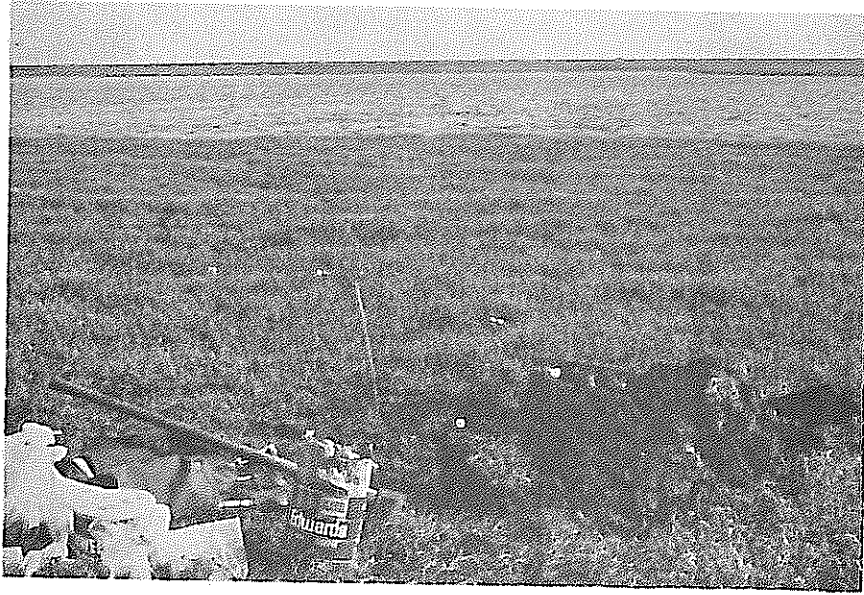
FIGURE 31 : Sample Site Number 7, Barrow -  
Isatkoak Lagoon in background.

The vegetation is typical north slope tundra consisting of grass, arctic poppies, and various alpine plants. Sample site 7 is located near the proposed raw water intake on the shore of Isatkoak Lagoon (See Figure 31).
