EVALUATION OF CRACK SEALING TECHNIQUES IN ALASKA'S ASPHALT
CONCRETE PAVEMENTS

A Dissertation Submitted in Partial Fulfillment of the Requirements

Civil Engineering

University of Alaska Fairbanks

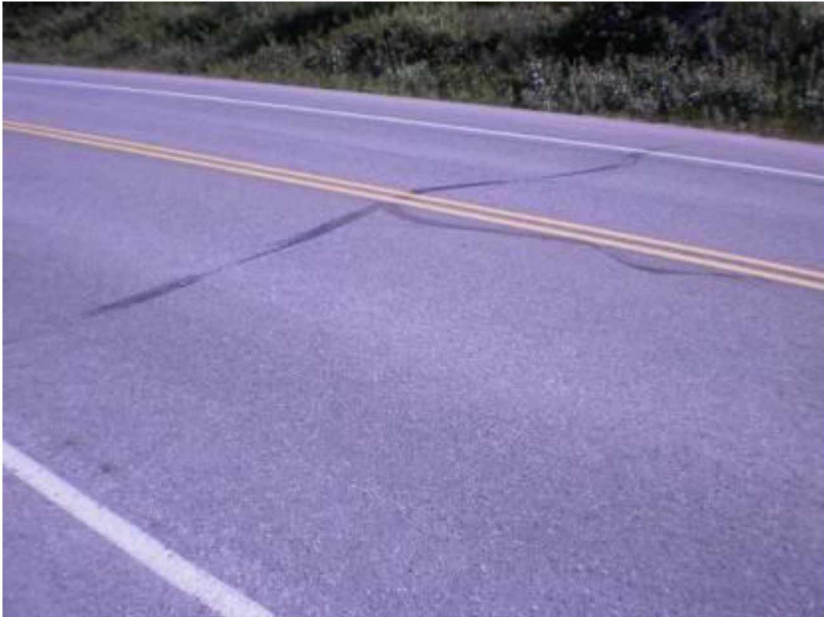
Figure 3.1: Abbott Road, Anchorage, crack seal, thermal crack and frost damage, 2011.

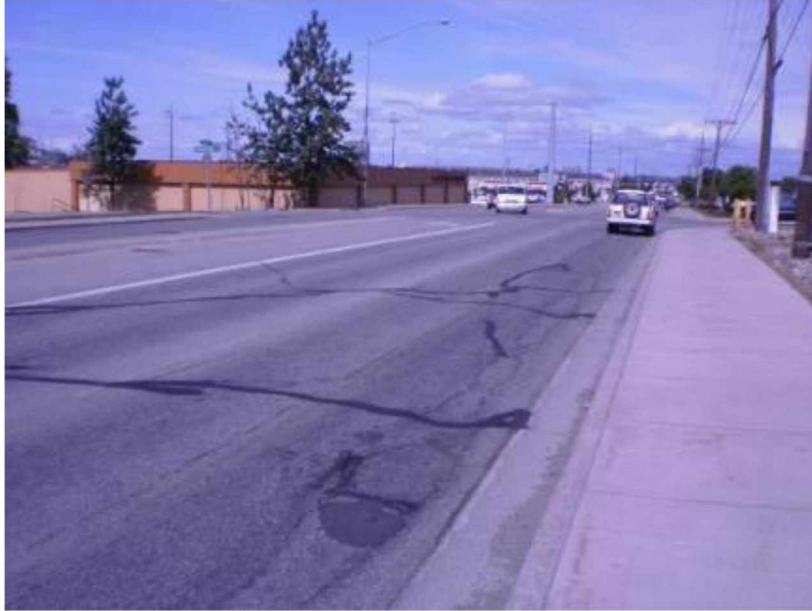
Figure 3.2: Old Seward Highway, Anchorage, crack seal, thermal and frost damage, 2011.

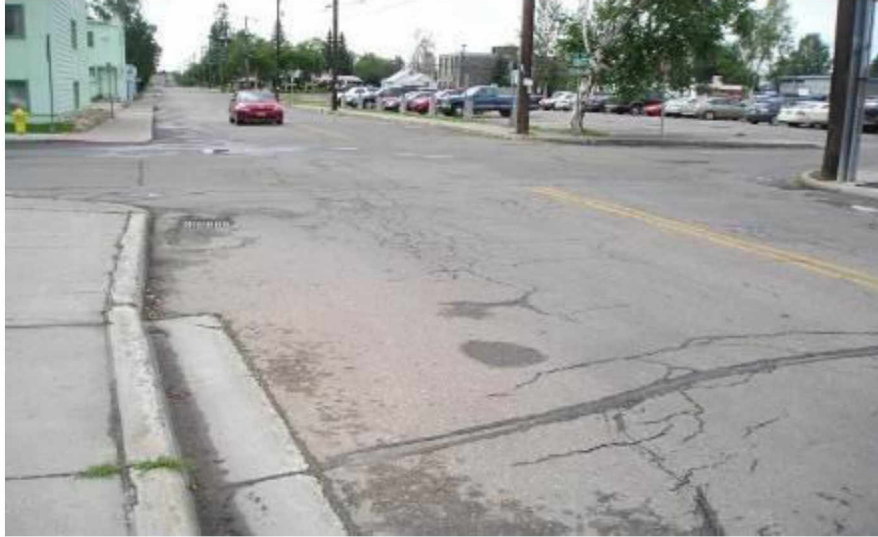
Figure 3.6: Lacey Street, Fairbanks, crack seal, thermal cracking, and alligator cracking, 2011.

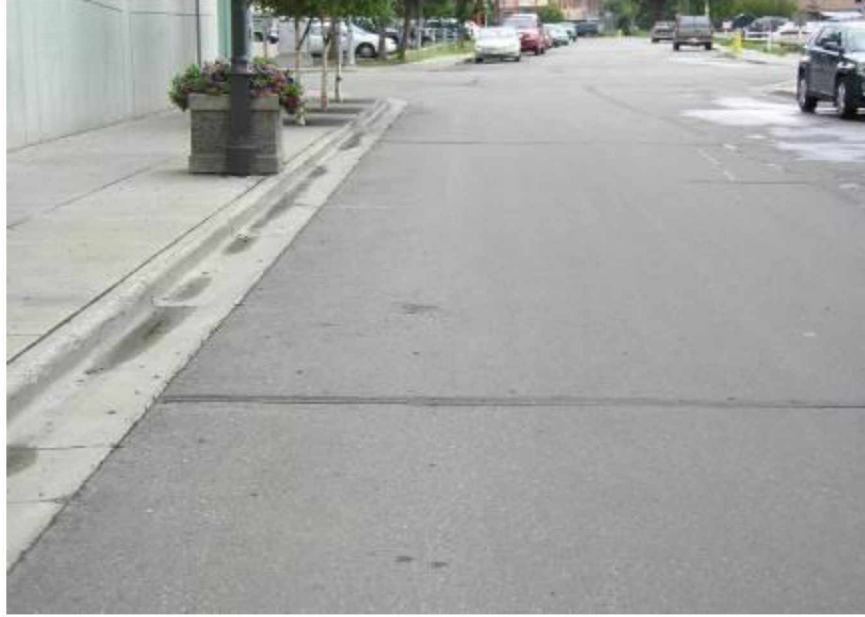
Figure 3.8: 3rd Avenue, Fairbanks, crack seal, thermal cracking, 2011.

8	Fairbanks	2011	3rd	Cushman	Lacey	Low transverse and longitudinal cracking, and a few potholes. Figure 3.8.
---	-----------	------	-----	---------	-------	---

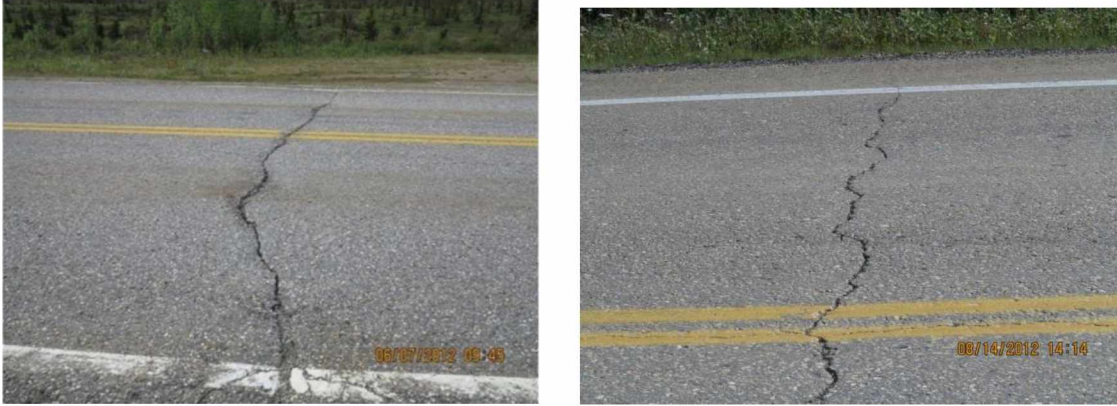
In general, recording data for the STCE method requires recognizing thermal cracks of two types: major thermal cracks and lesser thermal cracks. Major transverse thermal cracks are oriented perpendicular or nearly perpendicular to the road's centerline. They vary in appearance from hairline, extending nearly straight across the road (almost invisible to casual observation), to spalled, ragged zones, several inches wide that may extend crookedly across the road. Many of these cracks bifurcate between the two pavement edges and form two or more branches. The cracks are usually identified easily, even from vehicles at a speed of 60 mph. A zone of pavement along the crack is nearly always at least slightly depressed, and this produces the somewhat rhythmic bump felt by all vehicle occupants on all roads in colder areas of Alaska. These depressed zones can become quite deep and extremely annoying to those inside the vehicles, even possibly influencing user costs through accumulated vehicle damage. It is common knowledge among ADOT&PF engineers that these cracks extend below the bottom of the pavement to variable depths. Examples of major thermal cracks are shown on Figure 3.13.

Figure 3.13: Examples of major thermal cracks.

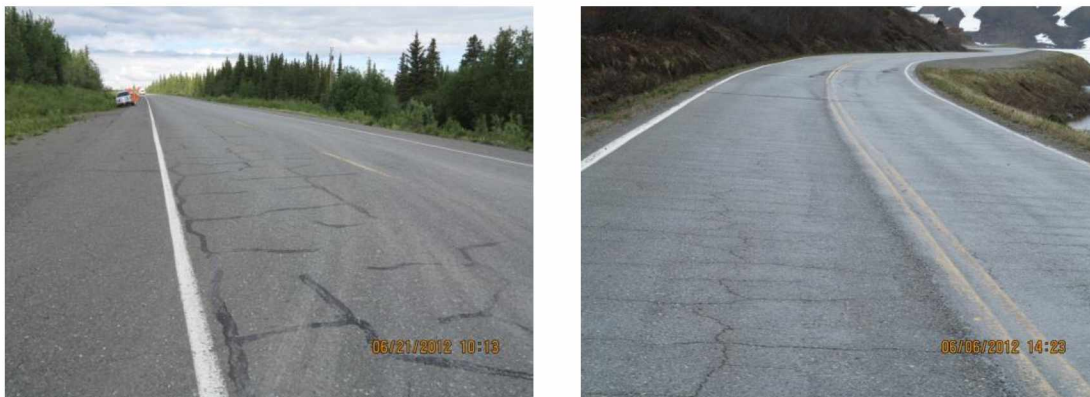
Lesser thermal cracks constitute all other thermally induced cracks that are not major transverse cracks. Their appearance ranges from short segments of hairline cracking to a very distinctive grid-like pattern. In newer pavements, short segments of this crack type are usually more or less perpendicular to the centerline and can be more or less parallel to the centerline. In older pavements, the maturing pattern often becomes grid-like, as the individual segments lengthen and intersect. These cracks are referred to as lesser thermal cracks because their width is nearly always less than 1/4 inch (they are also known as block cracking or grid cracking). It is believed that these cracks do not extend below the bottom of the pavement. Additional research is needed to confirm this belief. Examples of lesser thermal cracks are shown in Figure 3.14.

Figure 3.14: Examples of lesser thermal cracks.

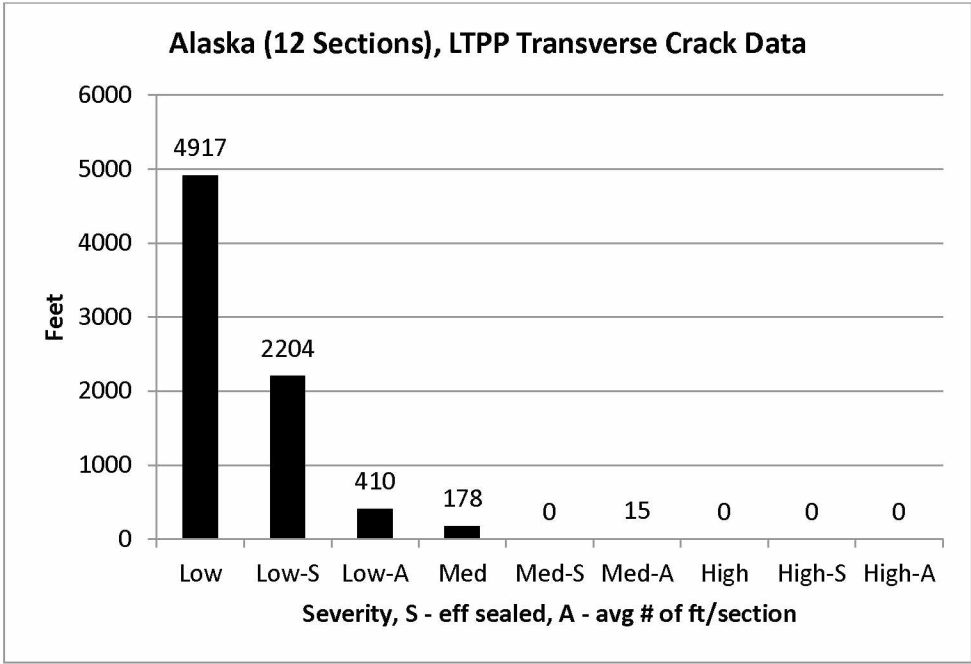
Figure 4.1: Length of transverse cracks at the different severity levels per LTPP method for: (a) The Richardson Highway, (b) The Alaska Highway, (c) The Tok Cutoff Highway, (d) The Glenn Highway, (e) The Steese Highway, (f) The Elliott Highway, (g) The Parks NR Highway, (h) The Parks CR Highway, (i) The Sterling Highway

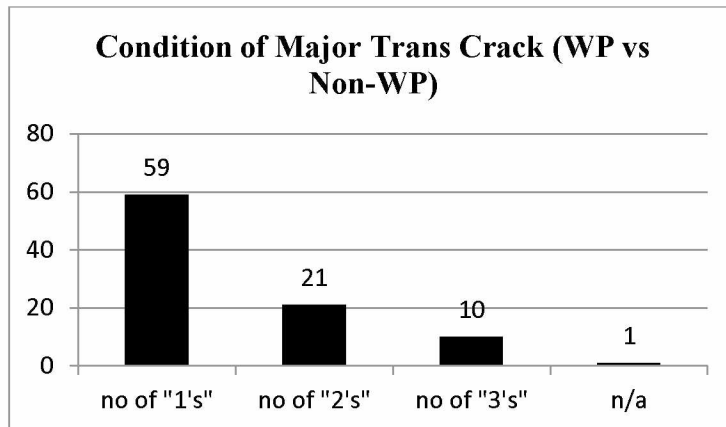
Figure 4.3 shows whether portions of major transverse cracks within wheel paths are performing worse than portions outside the wheel paths. Consistent, large differences in performance between the two locations would indicate that traffic loading plays an important part in degrading pavement near the cracks themselves. Theory indicates that the difference between wheel path and non-wheel path damage should be rather substantial. Such a difference should occur if the combination of wheel loads plus the softening influence of water intruding beneath the AC pavement combines to amplify damage in the wheel paths. Assuming that the wheel loading/water theory is correct, one could assume that fairly large areas of the pavement are affected within the wheel path and not just the pavement immediately adjacent to the edge of the crack. What Figure 4.3 reveals is that differences were observed only 35% of the time (no of “2’s”), and large differences, only 11% of the time (no of “3’s”). This finding suggests that there is often no marked softening of the pavement structure in the wheel path concerning major thermal cracks.

Figure 4.3: Condition of major transverse cracks (wheel path vs. non-wheel path). 1 = no difference, 2 = slight difference, 3 = much difference

Figure 4.5 supports Figure 4.3 for transverse cracks by showing not only is there usually little damage difference between wheel path and non-wheel path locations (Figure 4.1), but also usually no marked softening much beyond the edges of the cracks themselves. The crack zone width indicated in Figure 4.5 includes the combined total width including both sides of the crack.

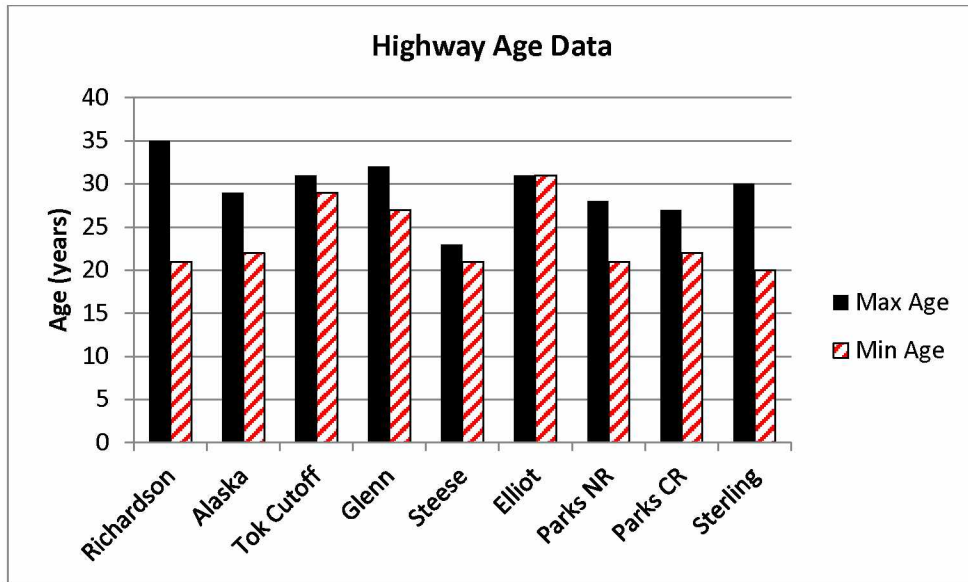
Are temperature regime and pavement age significant in this age of new paving materials, for example, polymer-rich asphalt cements? The ADOT&PF now uses performance graded (PG) asphalt cements for all AC paving in Alaska. This new material is supposed to modify the long-term temperature susceptibility of AC pavements and may someday prove to minimize or even eliminate thermal cracking. Such benefits have not been field-verified in Alaska. Until then, this study of old pavements provides insight into thermal cracking versus other pavement performance issues in Alaska. Figure 4.11 shows the minimum and maximum age for the road sections evaluated on each of the indicated highways.

Figure 4.11: Maximum and minimum age for the different highways evaluated.

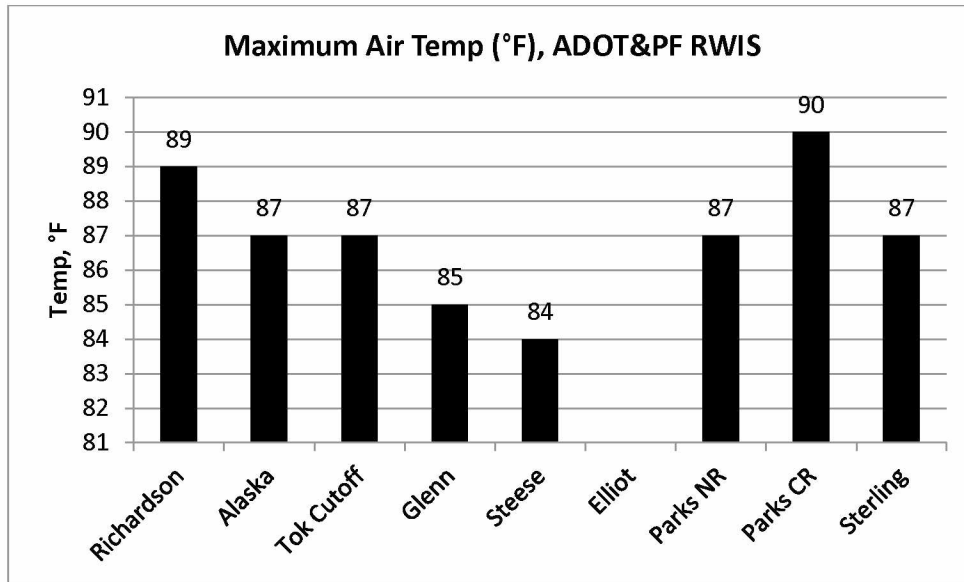
Figure 4.12 shows the extreme temperatures for minimum and maximum air temperatures as per ADOT&PF'S Road Weather Information System (RWIS) website data. Data were extracted from the temperature data probe information that can be found at <http://www.dot.state.ak.us/iways/roadweather/forms/AreaSelectForm.html>. At this URL, temperature probe data are obtained via the "RWIS – Camera – TDP Area & Corridor Maps" tab.

Figure 4.12: Minimum and maximum air temperature for RWIS sites on the various roads in proximity to the sites evaluated (approximately past 5–6 years).

Note the largest extreme minimum/maximum air temperature range of 125 °F for the Northern Region end of the Parks Highway. The smallest extreme minimum/maximum air temperature range shown is 114 °F for the Steese Highway. The minimum air temperature recorded was -40 °F for five different sites: one on the Richardson, one on the Alaska, one on the Tok Cutoff, one on the Glenn, and one on the Parks Northern Region (NR). The lowest pavement surface temperature was -39 °F, which occurred on the Alaska Highway. The maximum air temperature was 90 °F, which occurred on the Parks Central Region (CR), and the maximum pavement surface temperature was 129 °F, which occurred on the Richardson Highway. Figure 4.13 shows the extreme temperatures for minimum and maximum pavement surface temperatures according to RWIS data. The largest minimum/maximum pavement surface-temperature range is 161 °F for the Richardson Highway. The smallest maximum/minimum pavement surface-temperature range is 146 °F indicated on both the Steese and Sterling Highways.

A couple of interesting details are clearly shown on Figures 4.12 and 4.13:

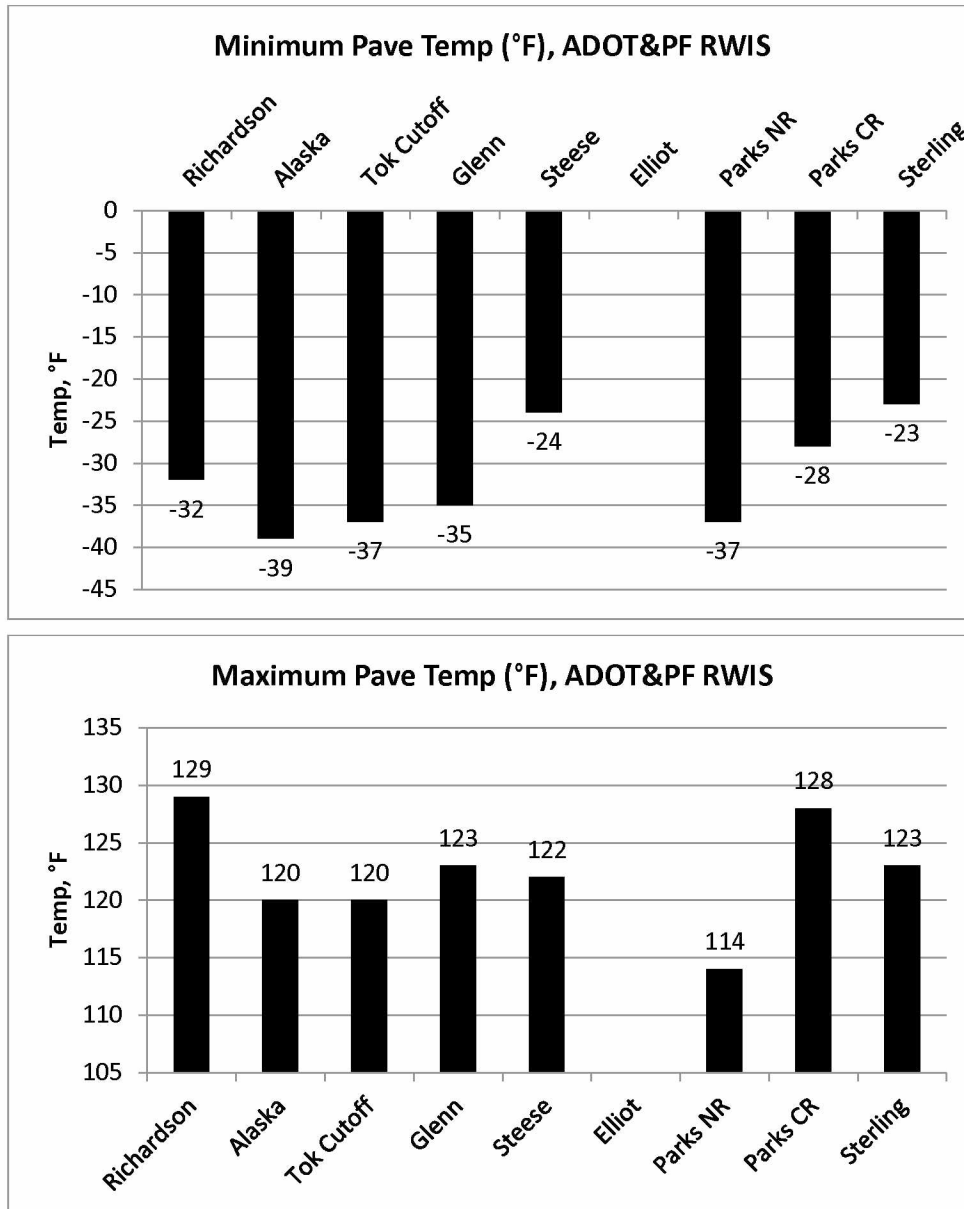
Figure 4.13: Minimum and maximum pavement surface temperature for RWIS sites on the various roads in proximity to the sites evaluated (approximately past 5–6 years).

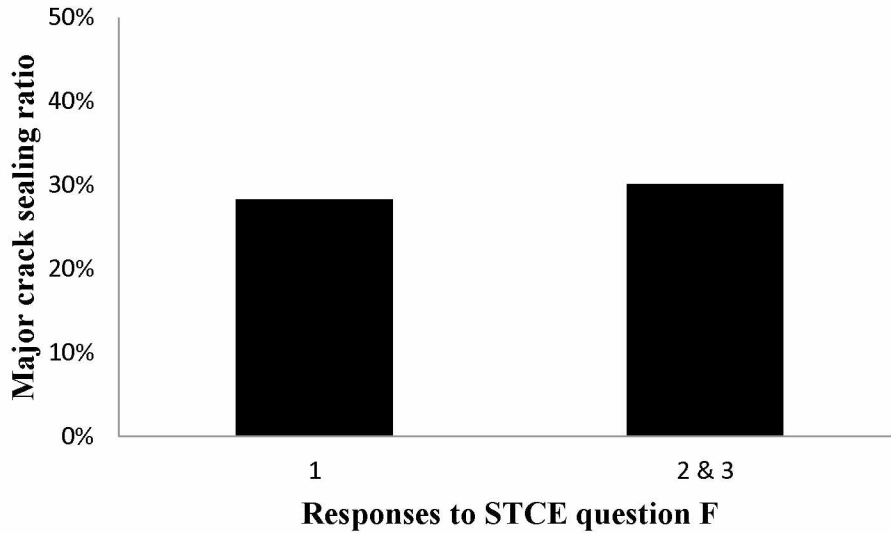
Figure 4.15: Major crack sealing ratio conditioned on STCE question F.

Here the sealed ratio is the same despite the STCE question F rating. For STCE question F conditioned on sections and lengths the percentages conditioned to a “1” are calculated as $[84/(84+5)] = 94\%$ for sections and $[44125/(44125+664)] = 99\%$ for lengths. This supports that regardless of whether the minor cracks are sealed or not they did not contribute to the deterioration of surrounding pavement. This agrees with recommendations given by McHattie et al. (2013).

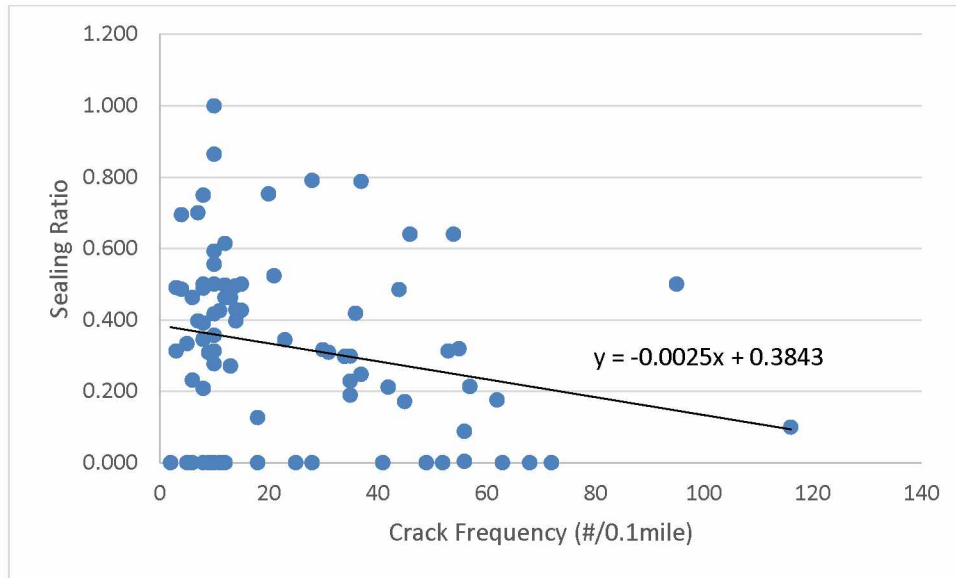
Figure 4.19: Plot of sealed ratio versus crack frequency.

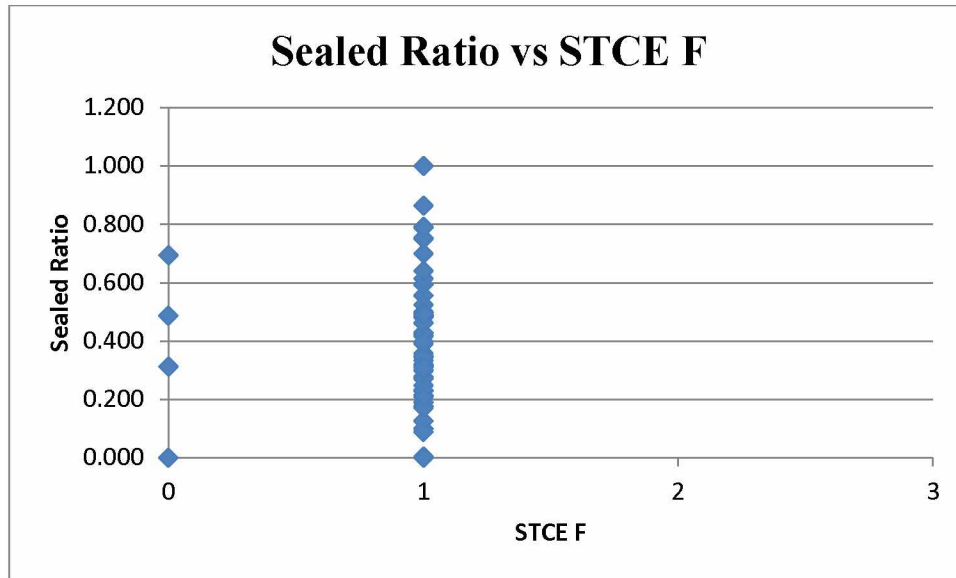
Another question to ask is whether other data is useful even if it does not display variation either directly proportional or indirectly proportional to each other. STCE F asks whether minor thermal cracks contribute to the surrounding pavement deterioration with responses of 1, 2, or 3 meaning not at all, slightly, or contributing. When looking at this plot on Figure 4.21, it can be seen that almost all responses are a “1” or not contributing. So no matter what the sealed ratio is, all of the sections show that minor cracks do not contribute to pavement deterioration. This supports the recommendation of not sealing minor thermal cracks as recommended by McHattie, et al. (2013).

Figure 4.21: Plot of Sealed Ratio versus STCE question F.
