SPATIOTEMPORAL PATTERNS OF BLUFF EROSION AT GOODNEWS BAY, ALASKA

Richard Michael Buzard, B.S.

A Thesis Submitted in Partial Fulfillment of the Requirements

University of Alaska Fairbanks

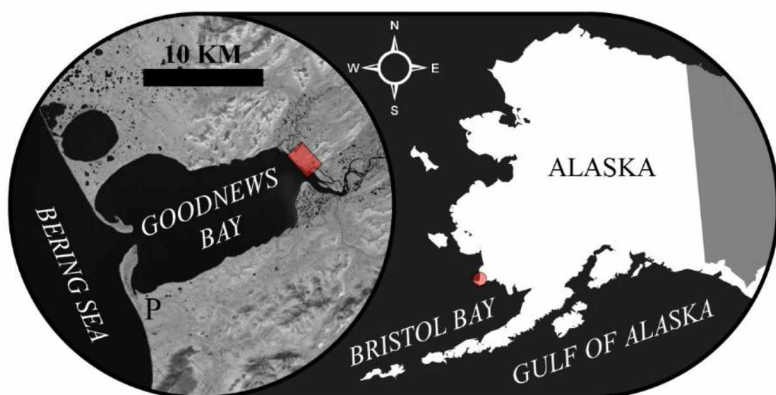
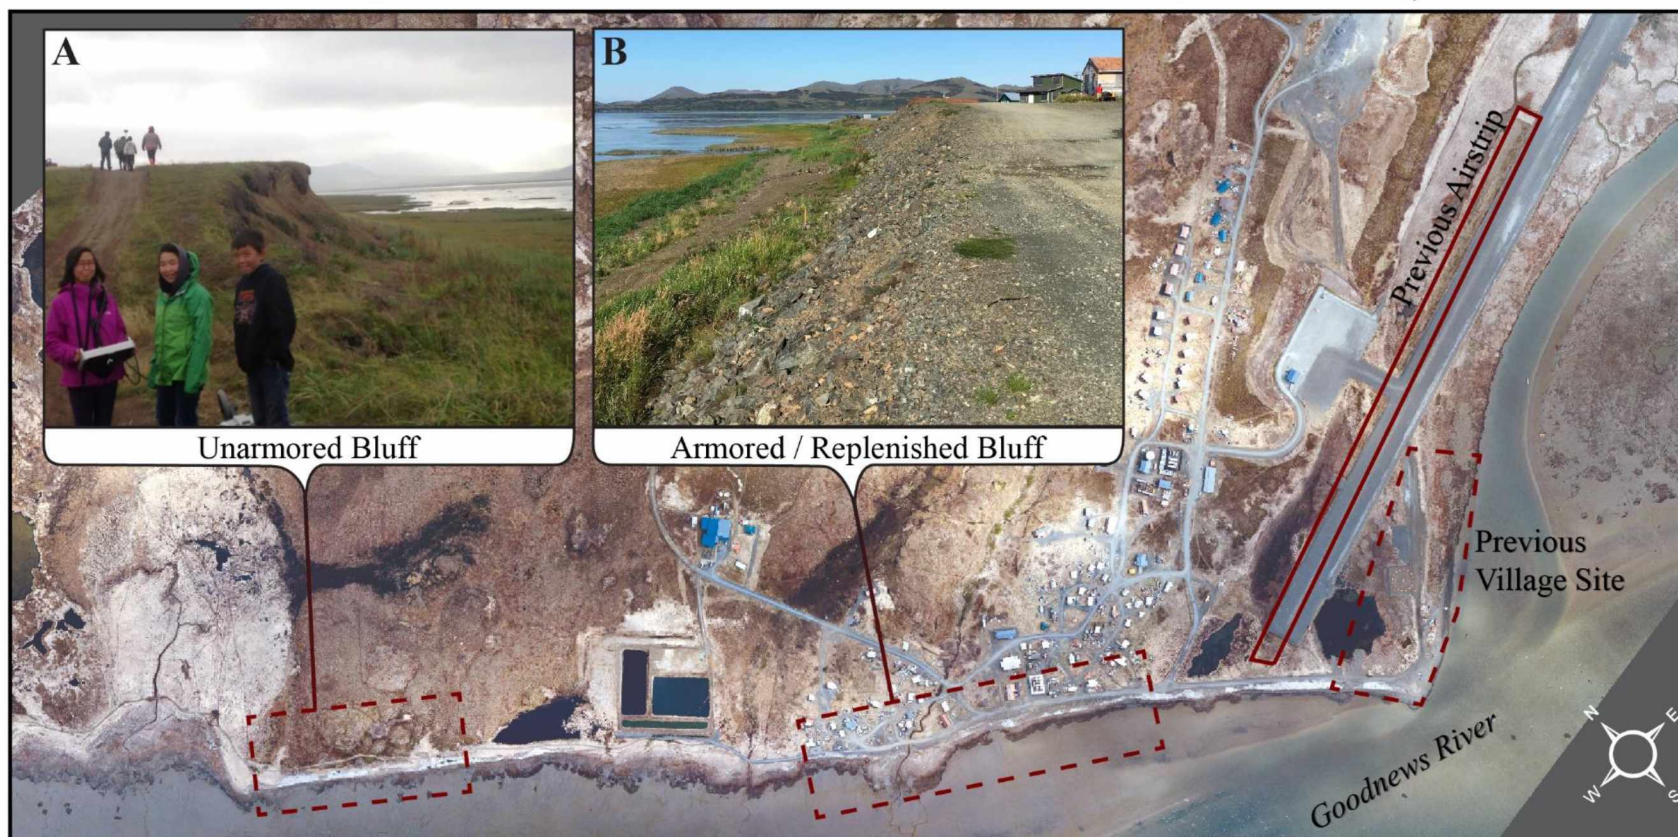
Figure 1. The village of Goodnews Bay. The bluff fronting the village (B) has been covered with armor rock to protect against erosion. The bluff northwest of the sewage lagoon (A) is not covered. The new airstrip is higher in elevation than the previous, but still experienced partial flooding in the 2011 storm. Inhabitants moved northwest from the previous village site between the 1920s and 1950s due to flooding. New homes are built uphill to the northeast.

The two bluffs in the Goodnews area identified in Figure 1 are composed of unconsolidated, primarily fine-grained sediments. The unarmored bluff northwest of the village is examined as a control variable. There is no evidence of attempted erosion mitigation or replenishment for the unarmored bluff. The bluff fronting the village is designated as the “armored bluff” because residents have placed large (10 - 50 cm) angular serpentinite and basalt rocks sourced from the local quarries. The date when armoring began is not known, but evidence from aerial imagery suggests that the first two large quarries were excavated between 1957 and 1983 (Figure 3). This corresponds with the construction of the previous airstrip, which is a probable cause for quarrying (as well as for roads and infrastructure foundation). The area of the current armored bluff appears to be vegetated in aerial imagery from 1983, suggesting either it has not been armored or it was overgrown. The third large quarry was excavated between 1983 and 2005, before the current runway was built. The 2005 image shows that the bluff is armored with exposed rock. The frequency of armoring is also unknown; whether armoring is a direct response to large events, is gradually replenished, or a combination, is still being investigated. The discussion of armoring history and impact is continued in Section 4.1.

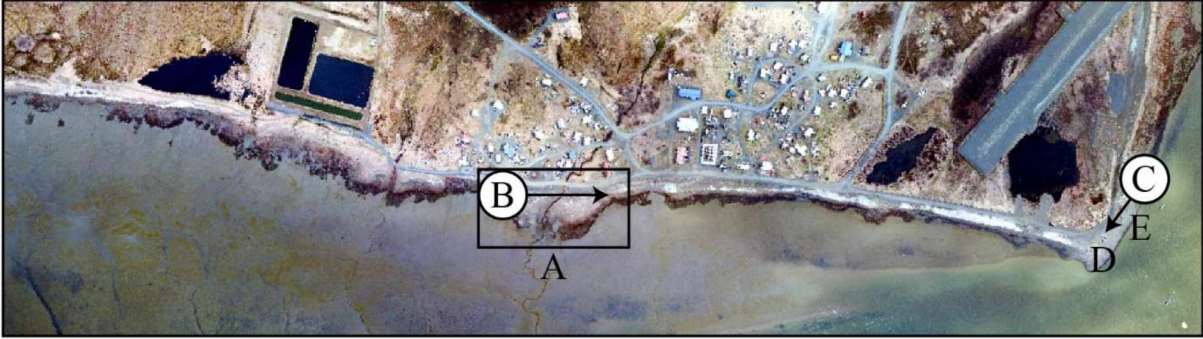
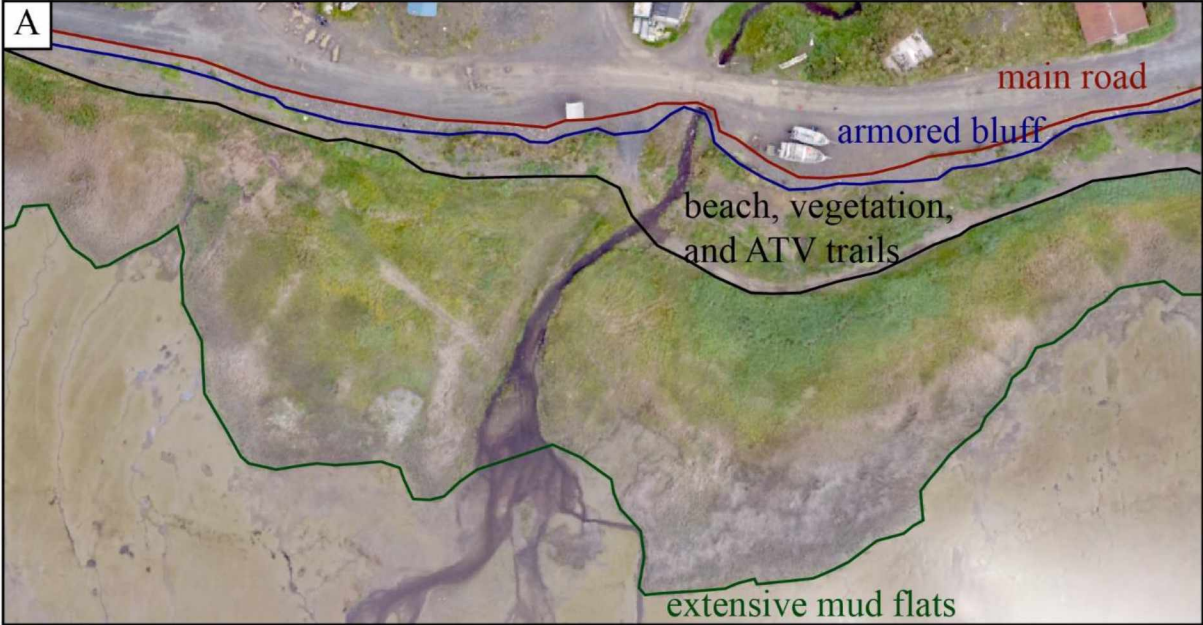
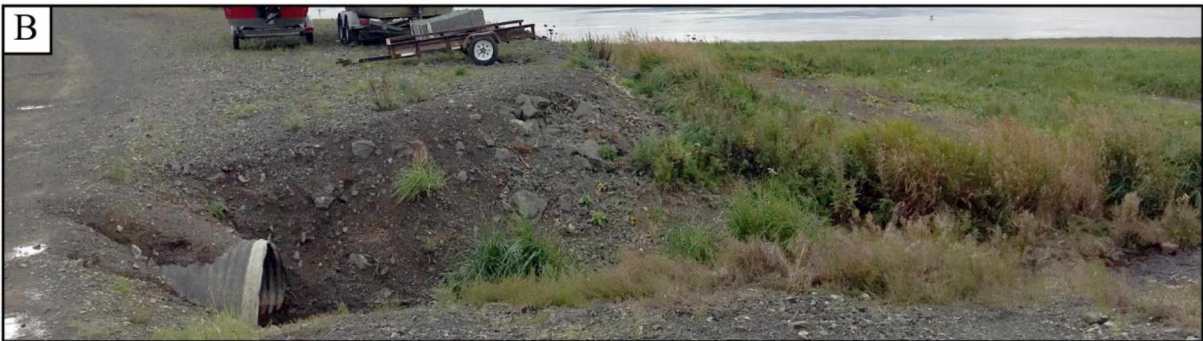
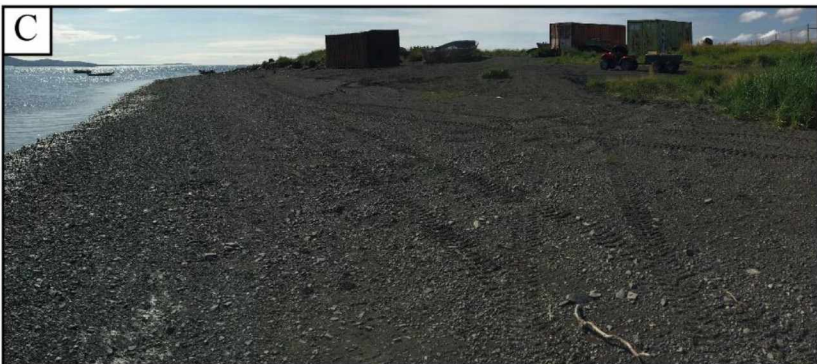
Figure 2. General gradation of beach surface features. White circles with arrows denote the direction a picture was taken. A) The main road runs adjacent to the armored bluff, and beach, ATV tracks separate vegetation, and vegetation gradually gives way to extensive mud flats. Image acquired August, 2016. B) Creek culvert allowing water through the armored bluff. C) Gravel beach at The Point (boat launch). D) Coarse gravel (3-10 cm) at The Point. E) Finer gravel (1-3 cm) east of The Point.

Surface features change gradually from the mountains to the bay. The village infrastructure is built on the surrounding low-shrub tundra, which is mixed with tussock-sedge, dwarf-shrub, and moss (CAVM Team, 2003). The road gravel is sourced from three local serpentinite quarries (see Section 1.2.2), and is typically broken down to 0.5 – 3 cm angular grains. Grain size increases to as much as 10 cm at The Point, the southernmost section of beach where boats are stored and launched. Grain size gradually decreases seaward, also becoming more rounded, before terminating at the mud (clay) line. From this observation, it seems likely that the angular gravel and rock is brought from the quarry in order to allow vehicle access to The Point, although no record of beach replenishment has been found. Beach sediments also vary alongshore, gradually shifting from the large angular gravel on The Point in the south into sand, and ultimately mud northwest of Quirkik Hill. Vegetation cover increases from southeast to northwest, opening up into extensive low-lying reed grass beyond the unarmored bluff. In general, the beach transitions from gravel-topped road to gravel- and rock-topped bluff, into the mixed beach with varying degrees of vegetation, before gradually decreasing slope into extensive mud flats out to the Goodnews River and Bay (Figure 2).

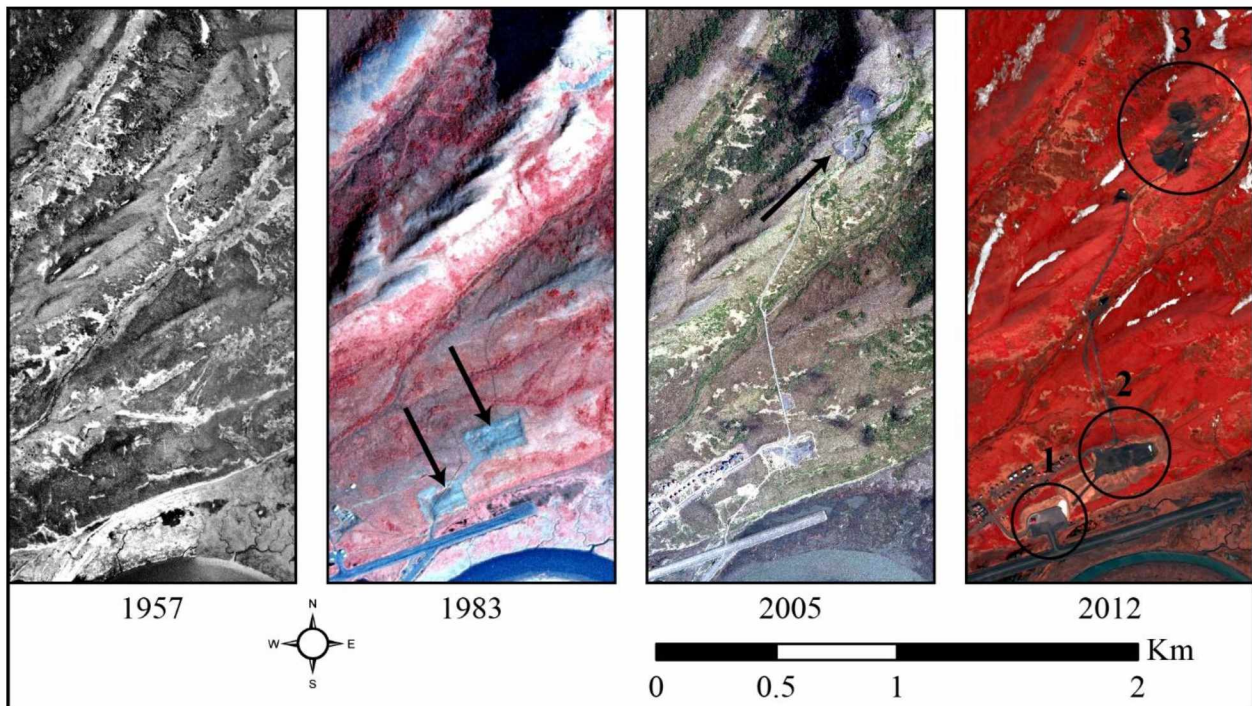
Figure 3. Aerial and satellite images of large rock quarries opened in Goodnews. Two quarries opened between 1957 and 1983, and a third was opened by 2005.

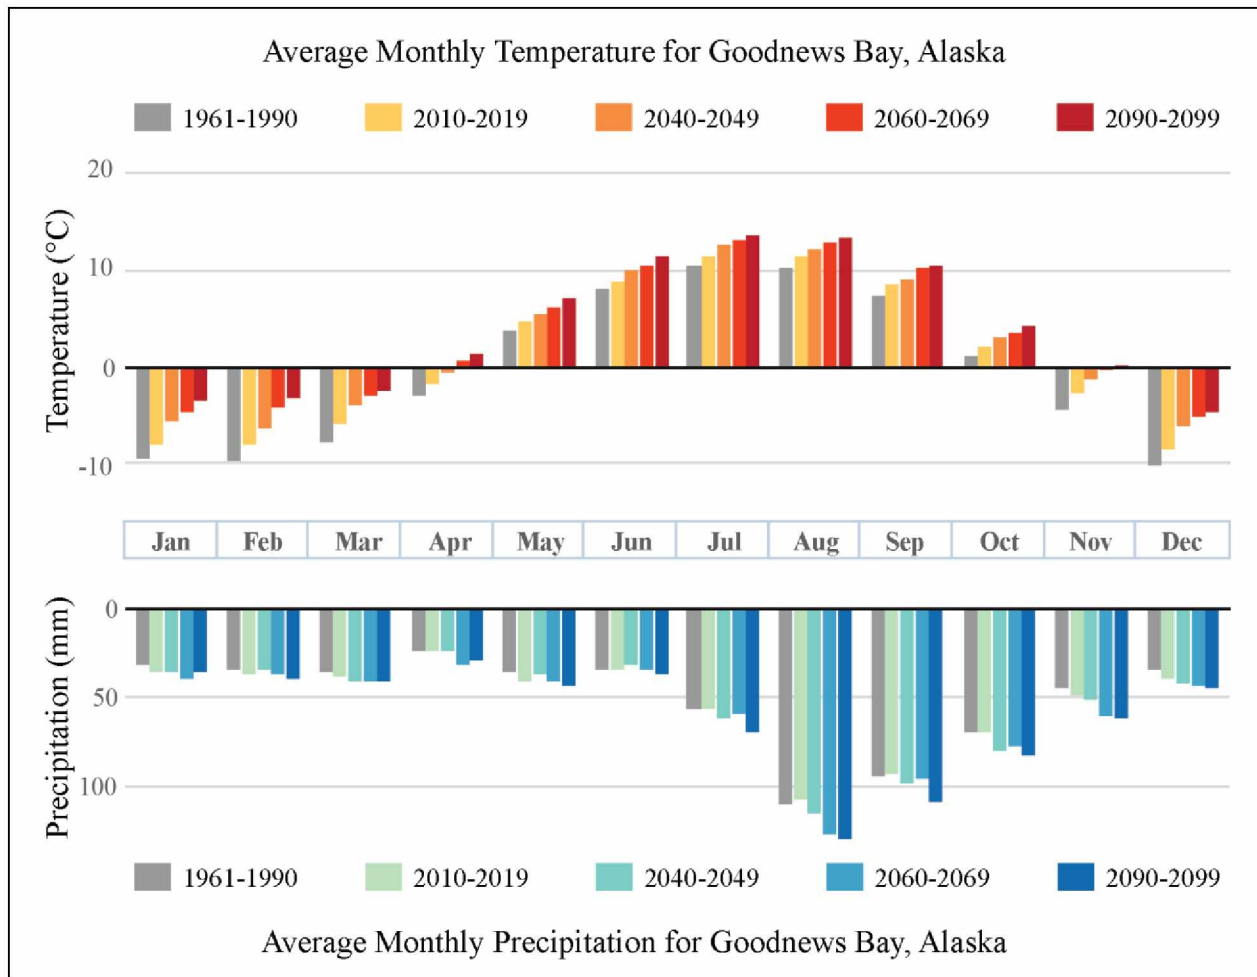
Figure 4. Historical and projected future temperature and precipitation for Goodnews Bay. Data provided by Scenarios Network for Alaska + Arctic Planning (SNAP). The 5-model projected average values are determined on a 2 km resolution grid, based on mid-range emissions (RCP 6.0) from the International Panel on Climate Change’s fifth Assessment Report published in 2014. Error in these projections, especially precipitation, is significantly high (SNAP, 2017).

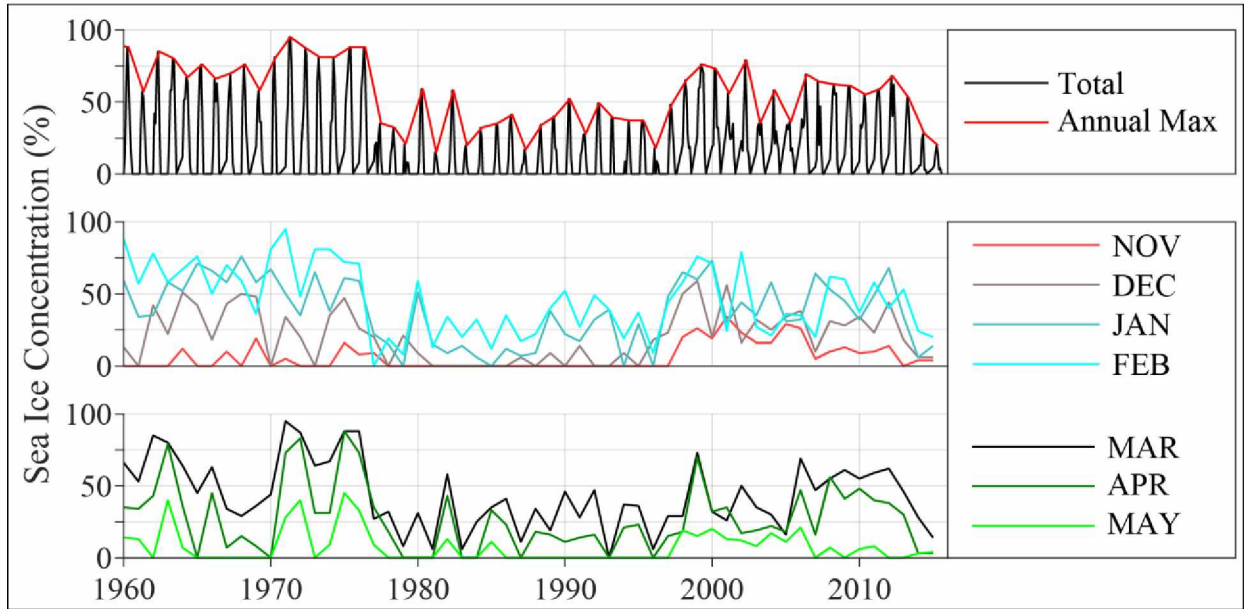
Figure 5. Annual sea ice concentration 50 km west of Goodnews Bay. Offshore sea ice began steeply declining in 2012, such that total concentrations dropped below 25% in 2015. Calculated from data produced by the Historical Sea Ice Atlas (2017).

The Goodnews River and Bay tend to freeze over from late fall until spring. Residents travel on the ice for subsistence hunting and to connect with Platinum, the nearest city (Wildlife Service, 1986). Residents reported that the bay ice was repeatedly broken up by strong winds in recent years, and they could not travel on it. No assessment of sea ice concentration in the bay has been quantified, but these anecdotal accounts are consistent with the qualitative observations of the bay using Landsat imagery (Appendix III). Sea ice concentration data from approximately 50 km west of the bay suggests annual maximum sea ice concentration decreasing in recent years, with formation occurring later and breakup occurring earlier (Figure 5). Some climate

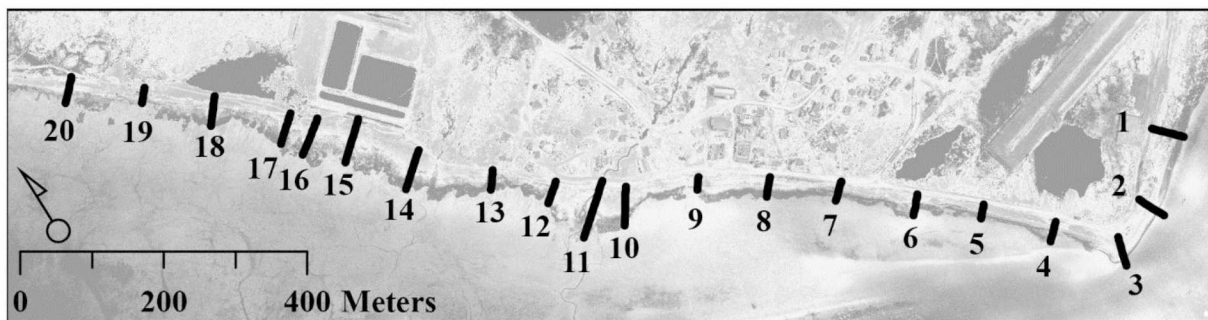
Figure 6. Cross-shore beach profiles sampled at 100 meters. Sub-sampled profiles occur in areas of higher variability.

A cross-shore beach profile survey was conducted from August 25 to 27, 2016, in order to create a baseline dataset for the village. Beach profiles were placed every 100 m running parallel to the shore from southeast of the airport runway to the northwest end of Quirkik Hill (Figure 6). Recorded features included the current water line, vegetation line, high water line (wet/dry or rack line), beach berms, bluff toe and top, and infrastructure features such as road edges, fences, and buildings. See Appendix V for data table.

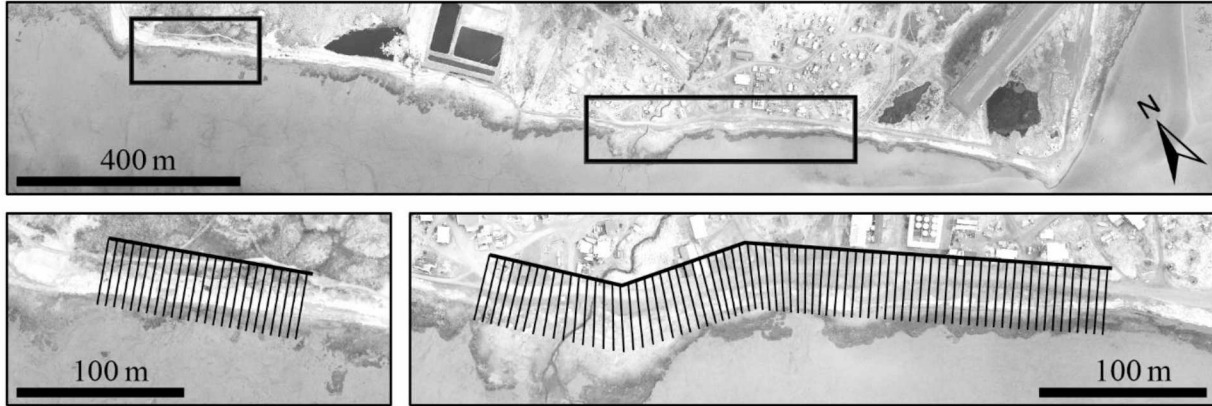
Figure 8. DSAS transects cast for change analysis of the unarmored bluff (left) and armored bluff (right).

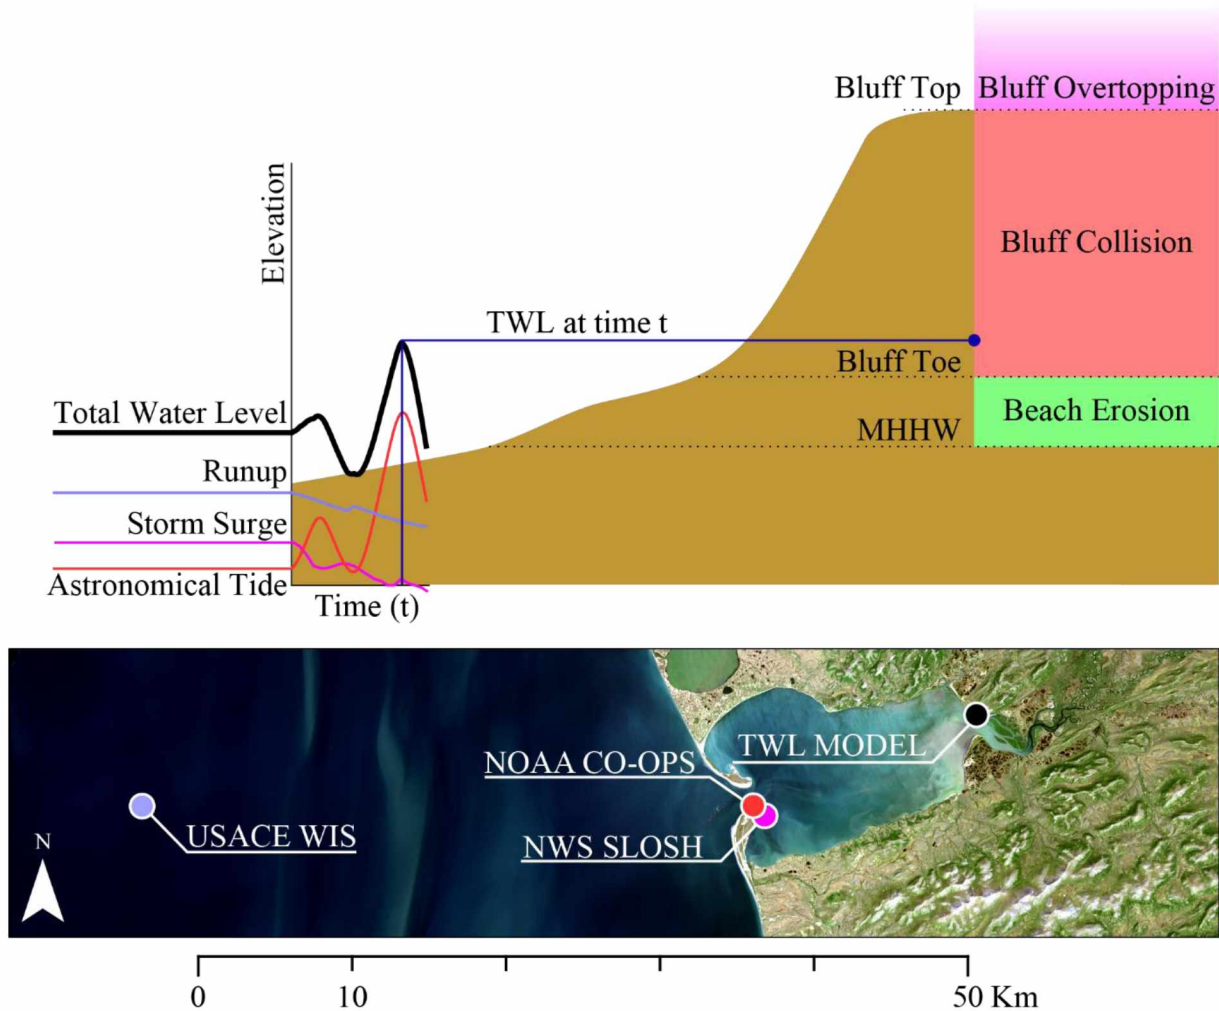
Figure 9. Datasets used for total water level and wave impact hour analyses. Total water level at Goodnews is computed as the summation of NOAA tide estimates (red), NWS storm surge estimates (purple), and USACE offshore data with the Stockdon et al. (2006) runup equation (periwinkle). In a given time period, the number of hours that total water level exceeds MHHW, the bluff toe, and the bluff top is calculated and categorized into beach erosion, bluff collision, and bluff overtopping. In this schematic, the total water level at selected time  $t$  exceeds the bluff toe, but not the bluff top, resulting in bluff collision.

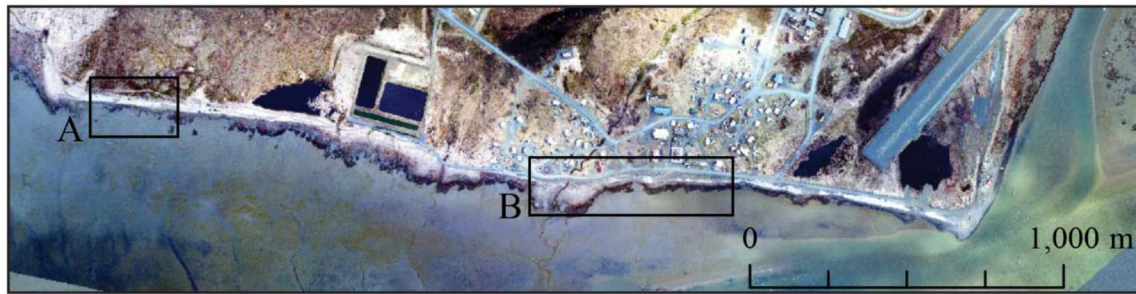
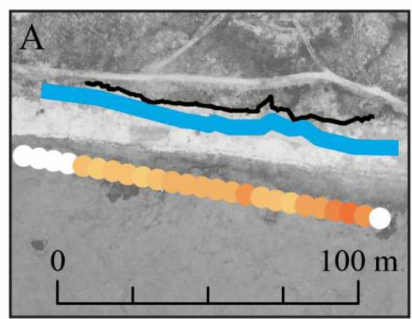
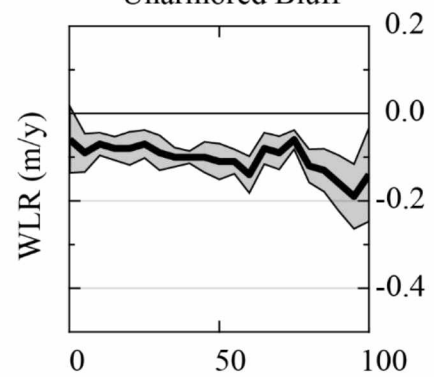
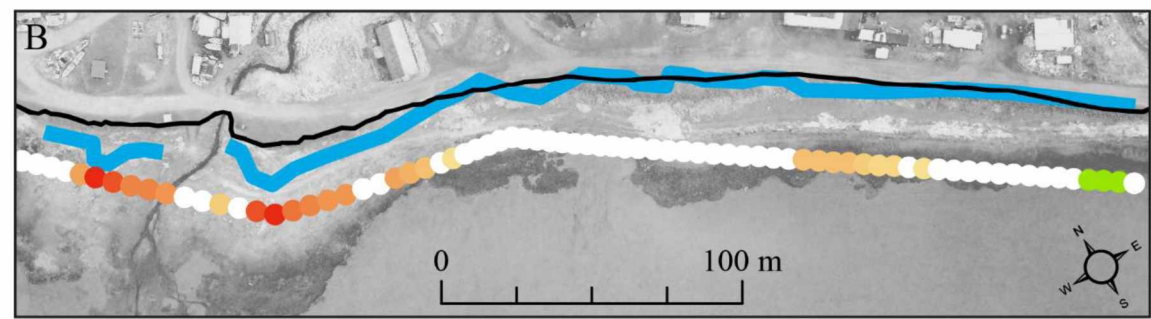
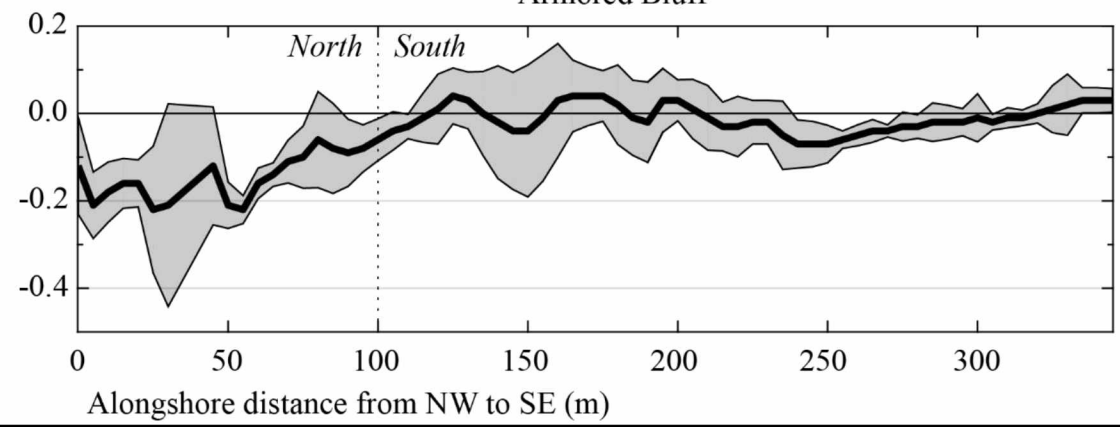
Bluff Position Change 1957 - 2016  
Goodnews Bay, AK

Figure 10. Net movement and weighted linear change of bluff top edges between 1957 (blue) and 2016 (black). The footprint of each line represents total uncertainty. Net movement is shown by the color of the circles following each bluff: red circles are high landward movement and green circles are seaward movement. White circles are plotted where the bluff is considered stable, based on when the WLR is less than the 90% CI. The unarmored bluff (A) exhibits fairly consistent erosion, whereas the spatially variable armored bluff (B) has the highest net movement in both directions, as well as the greatest area of stable shoreline. For averaging change of the armored bluff, the region is divided by the dotted line into *North* and *South* to account for this transition.

The weighted linear rate of change statistic (WLR) incorporates all available shorelines and their uncertainties to calculate the rate of movement per year. Based on these calculations, the unarmored bluff eroded at an average rate of  $0.10 \pm 0.07$  m/y (95% CI;  $R^2 = 0.92$ ; Table 7). The armored bluff exhibited spatially variable erosion rates, and was thus sub-divided into northern and southern regions (Figure 10). The northern 100-meter section of the armored bluff eroded  $0.14 \pm 0.11$  m/y on average (95% confidence;  $R^2 = 0.82$ ). Meanwhile, mean change of the 245-meter southern armored bluff remained insignificant from 0 m/y (Table 7). Thus, the northern armored bluff and the unarmored bluff are shown to erode at similar rates, while the southern armored bluff appeared fairly stable overall.

Mean erosion rates derived from the shoreline change analysis are found to be statistically significant over the entire study period, and areas of substantial change are visualized in Figure 10, Figure 12, and Figure 22. The unarmored bluff eroded at a relatively consistent rate of  $0.10 \pm 0.07$  m/y, whereas the highly variable armored bluff exhibited mean erosion of  $0.05 \pm 0.15$  m/y (Table 7). Even though portions of the southern section experienced significant erosion during the 1957-1983 period, the bluff averaged near-zero net change due to mitigation (Figure 10; Figure 14). In contrast, the northern section eroded  $0.14 \pm 0.11$  m/y on average, exhibiting the largest and fastest movement recorded. The majority of erosion at both sites occurred after the 1983 image acquisition (Figure 14).

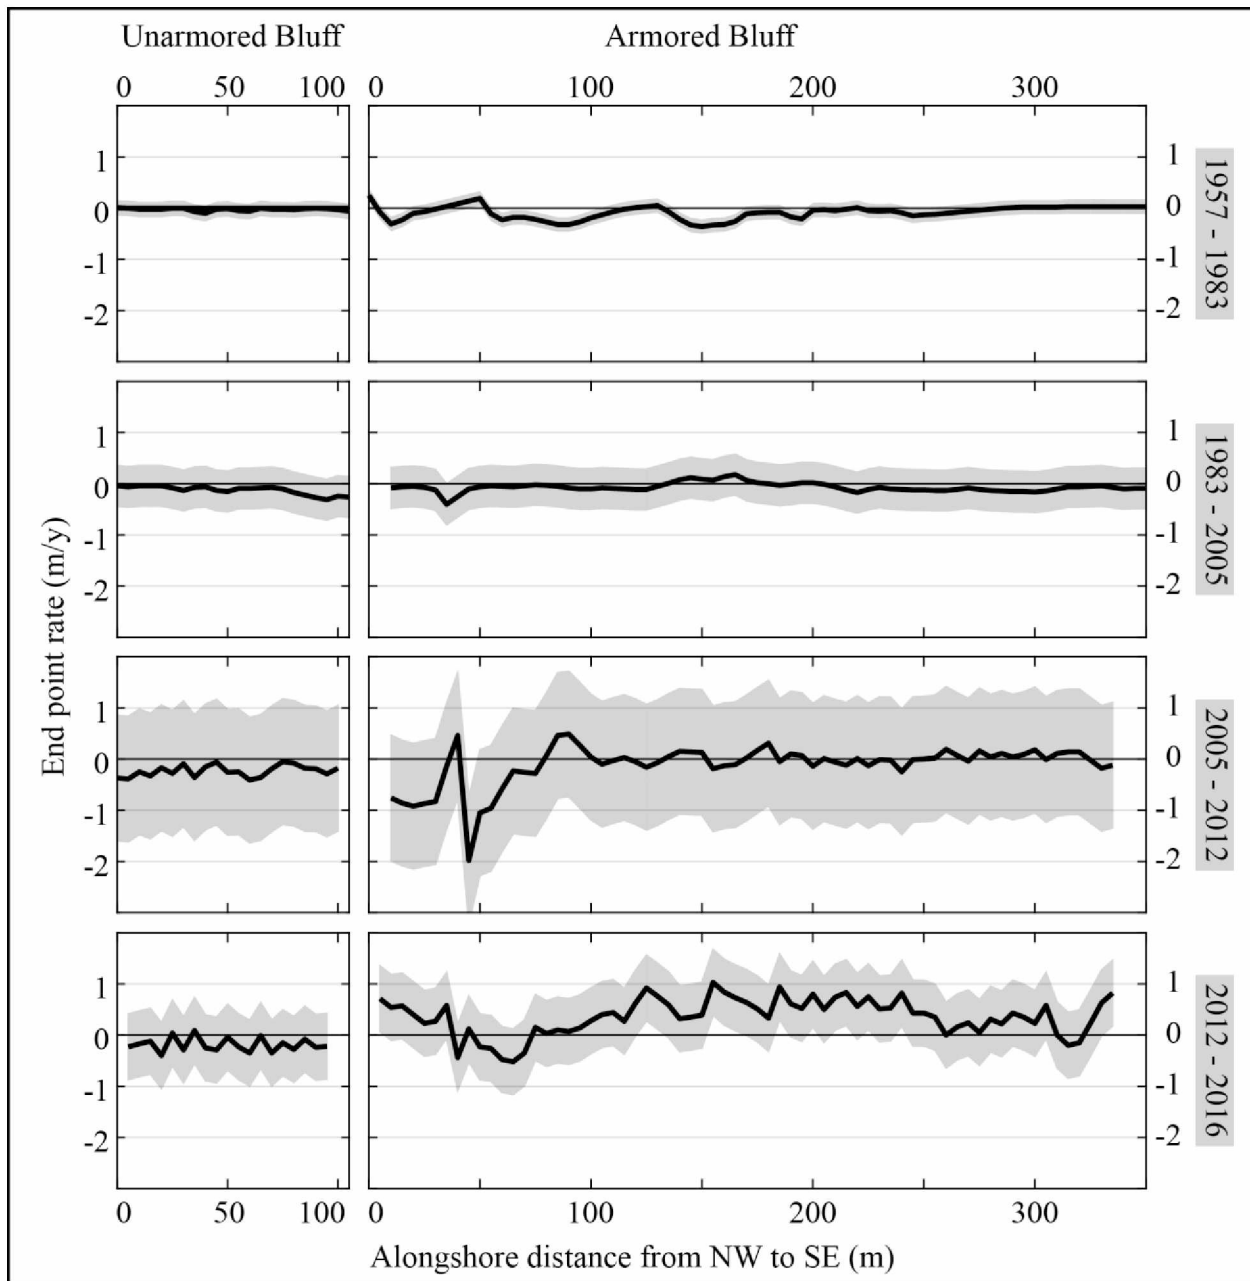
Figure 11. Bluff edge change rate (black line) for each time period. The gray region represents the 95% confidence interval. When the gray region is not crossing 0, a significant change was detected. Change in the unarmored bluff (left) is not detected for any period, and for most periods the armored bluff (right) exhibits no detectable change.

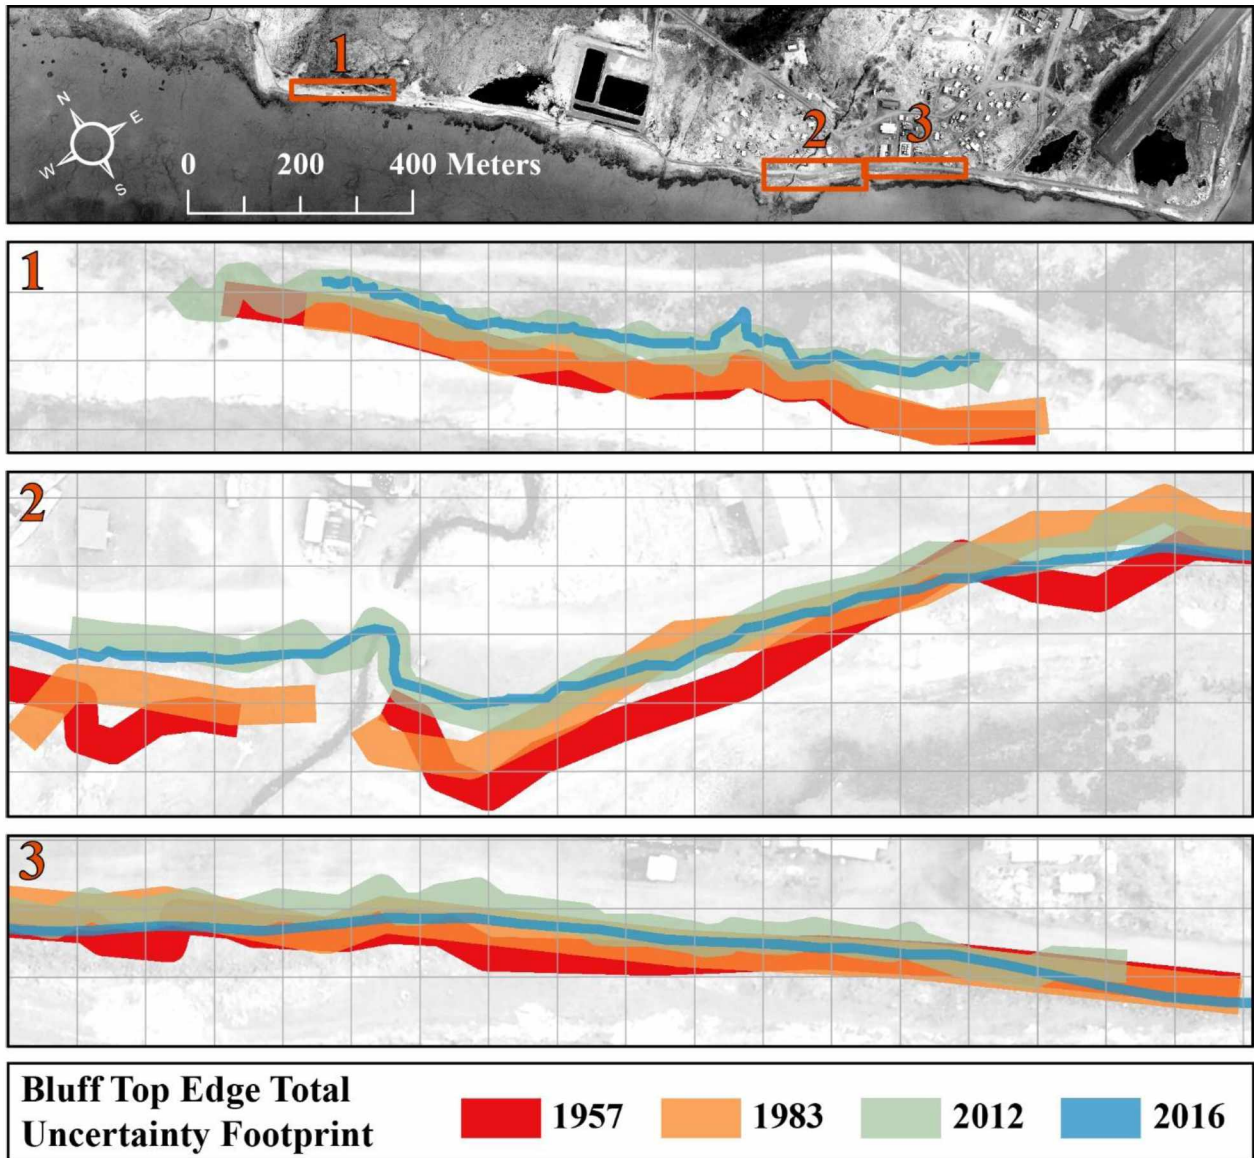
Figure 12. Total uncertainty footprint of each bluff edge overlaid on a 20x20 meter cell grid. Overlapping footprints indicate insignificant change measured in that location. The majority of the unarmored bluff (zone 1) is indistinguishable on an image-to-image basis, but exhibits detectable change over longer periods. The armored bluff displays distinct movement between the 1983 and 2012 in zone 2, but essentially no change between any periods in zone 3. The 2005 footprint intersects all other bluff edges (due to very high uncertainty), and thus was left out of this graphic for simplicity.

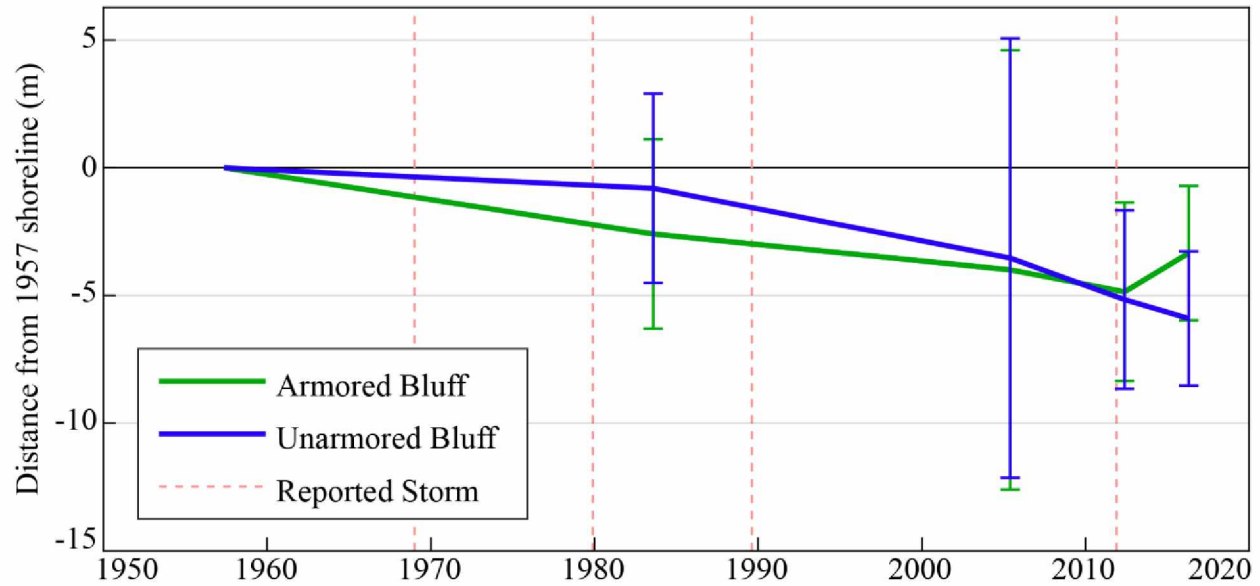
Figure 13. Mean distance from the 1957 bluff top edge. Error bars reflect the RSS of the uncertainties of 1957 and the respective year. Dashed red lines represent strong storms that reportedly flooded the airstrip. Only since 2012 do mean distances become statistically significant from 1957 positions.

1957 to 1983, two major storms occurred which reportedly flooded the airstrip (Figure 13; Table 1). During this period, the armored bluff eroded up to 9 m at certain points around the creek area (Figure 14). In contrast, the unarmored bluff did not exhibit any change that could be detected. From 1983 to 2016, two major storms occurred which reportedly caused flooding and erosion of the airstrip (Figure 13; Table 1). The unarmored bluff eroded uniformly along its extent, with an average along-shore retreat of 4.4 m. The armored bluff eroded up to 9 m near the creek, but seaward change was also detected in the southern region, which had eroded significantly before 1983. This apparent progradation of the bluff face is likely from re-armoring the bluff (see Section 4.1). It is important to note that the net movement in parts of the southern region is identified as stable in Figure 10, but this evidence suggests that that the bluff has undergone intense modification.

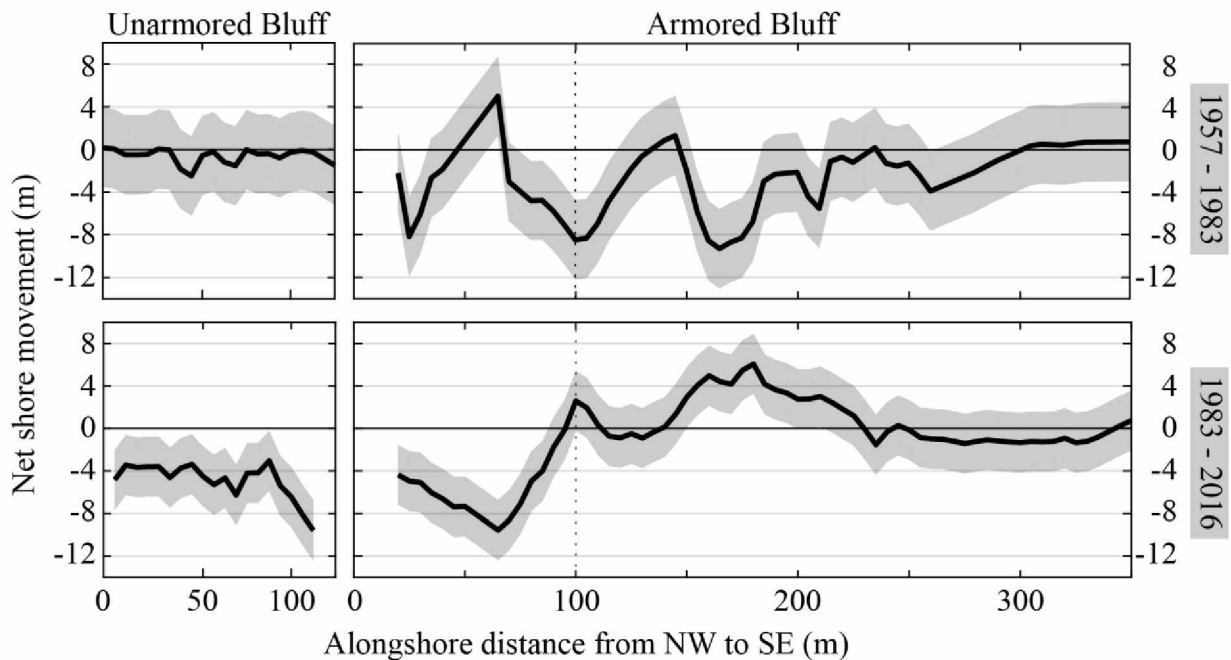
Figure 14. Net horizontal movement of the bluff edge from 1957 to 1983, and from 1983 to 2016. The gray area represents the RSS of the respective uncertainties. The unarmored bluff eroded consistently across its face in the recent period. The armored bluff experienced significant erosion near the creek in both periods, but erosion and replenishment in the southern section.

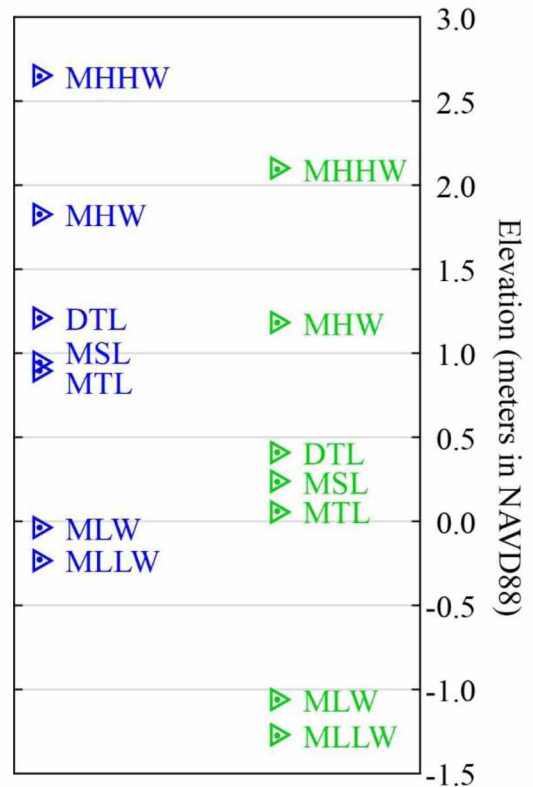
Figure 16. Plotted tidal datums for Platinum (blue) and Goodnews Bay (green).

Local Tidal Datum	Platinum, AK	Goodnews Bay, AK
MHHW	2.648	2.095
MHW	1.827	1.182
MTL	0.895	0.060
MSL	0.945	0.235
DTL	1.210	0.410
MLW	-0.037	-1.061
MLLW	-0.228	-1.275
GT	2.876	3.370
MN	1.864	2.243
DHQ	0.821	0.920
DLQ	0.191	0.197

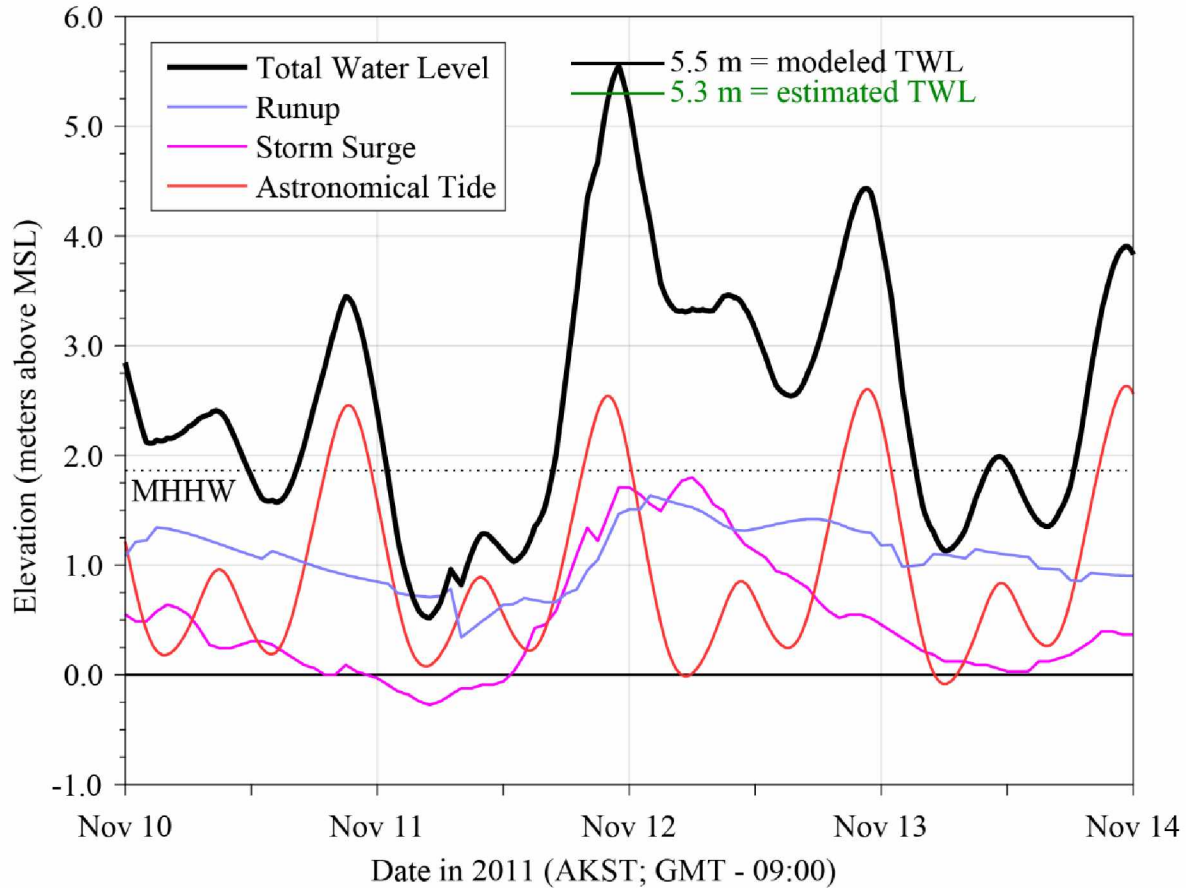
Figure 17. Estimated total water level of 11/11/2011 storm in Goodnews Bay. NOAA CO-OPS-predicted astronomical tide for the bay entrance (red), historical extra-tropical storm surge (ETSS) predictions by the NWS Meteorological Development Laboratory (purple), and empirically adjusted runup values from the Stockdon et al. (2006) equation (periwinkle) are combined to model total water level (black). The maximum modeled height during the storm is within 0.2 m of the maximum estimated height (based on imagery and RTK-GNSS survey data).

Total water level (TWL) estimates are made for specific storms from the data sources described in Section 2.7 (Table 9). These estimates suggest that the 2011 storm surge reached the highest elevation of any recorded flood event, 5.3 m MSL. The 1979 storm surge reached up to 4.6 m MSL, enough to flood the previous runway, but not high enough to impact any currently occupied homes. This elevation is the lowest recommended for new construction by flood plain

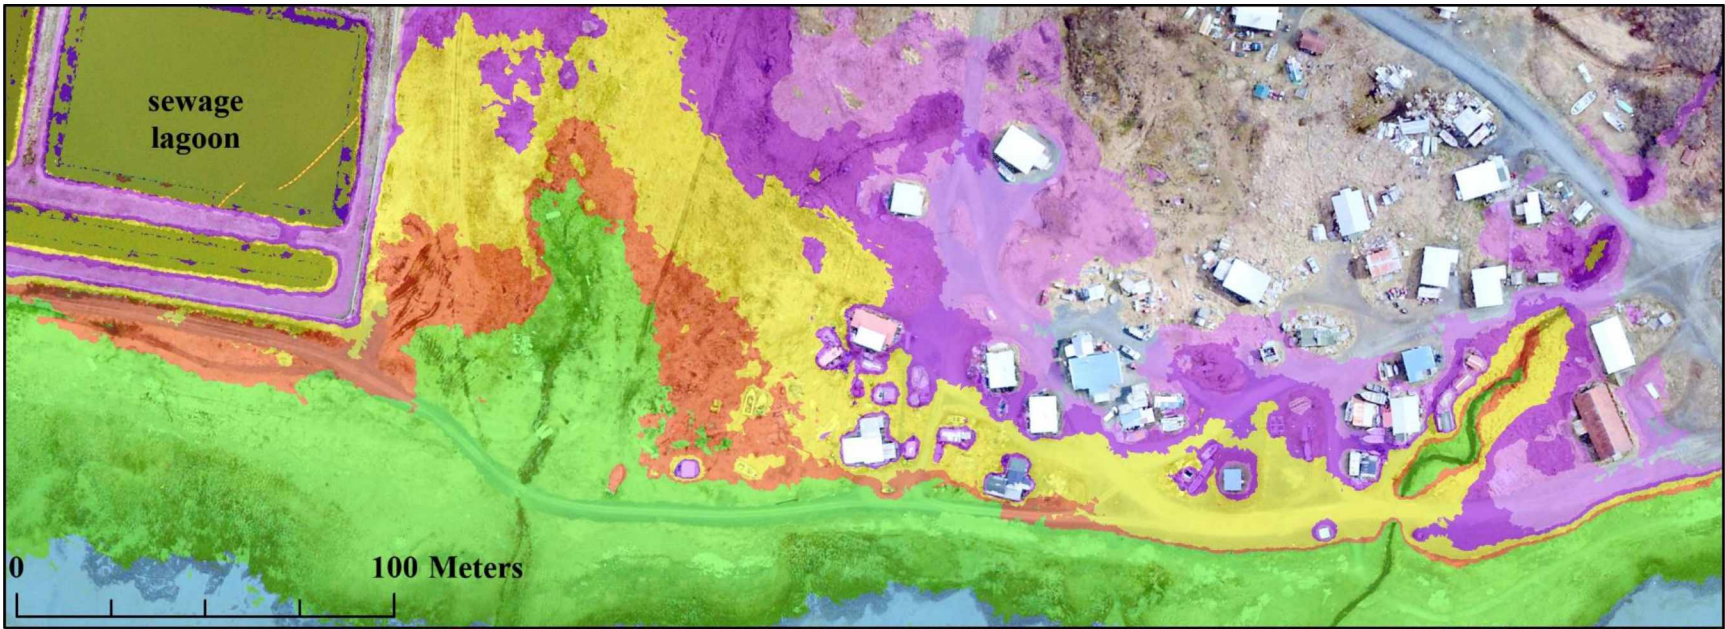
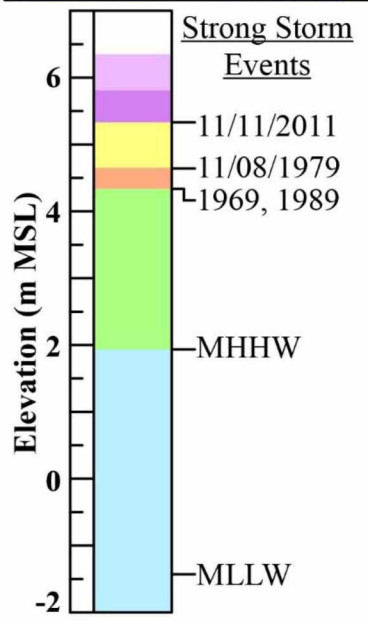
Figure 18. Map of horizontal extent of estimated total water level of strong storms. All structures in the yellow zone were flooded during the 2011 storm. All but one were abandoned homes, the last being abandoned after the storm. The 1969, 1979, and 1989 storms were not projected to cover the current runway. Purple zones do not represent any known flooding events, but are displayed to visualize extent of a hypothetical storm reaching up to 1 meter above the 2011 storm.

Approximate historical flooding levels for 1969, 1979, 1989, and 2011 are projected onto the 2016 DSM using a simple single-value (bathtub model) visualization (Figure 18). In this model, every storm estimate reaches the lowest-lying residential building in the village, and the 2011 storm is shown to reach up to five residential buildings. Most residences and some public and private infrastructure such as the diesel station and school are located at least 4 m (13 ft) above historic flooding levels. This simplistic graphical representation of peak TWLs confirms observed reports that the sewage lagoon was effectively surrounded by the 2011 storm water, but was not breached and did not sustain significant damage. The previous airport runways were

lower in elevation than the current runway, thus, while all storms flooded their respective runway, none but the 2011 storm would have flooded the current runway. Regardless, all of these storms would cut off access to the runway during their peak.

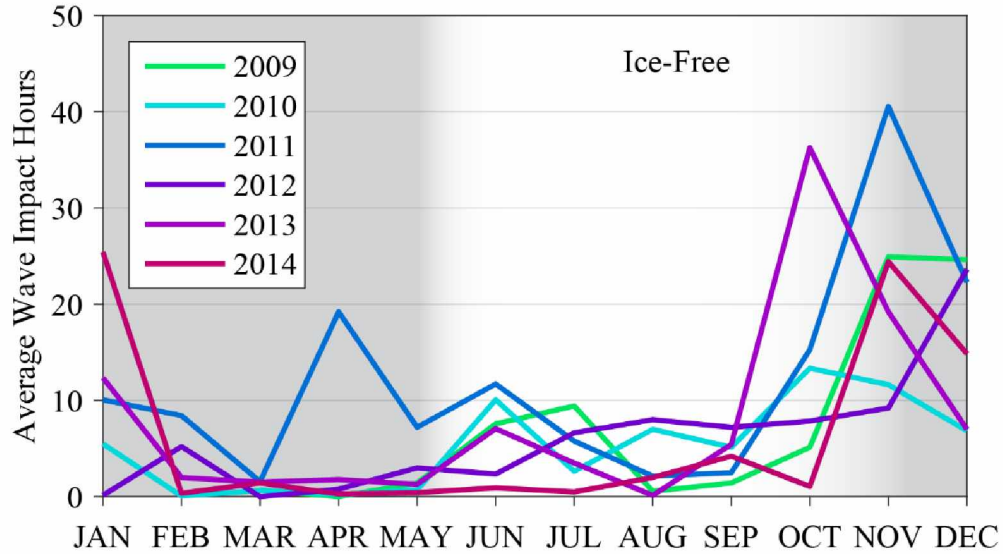
Figure 19. Average monthly wave impact hours contacting and overtopping bluffs from 2009 through 2014. Offshore and bay ice concentration, not accounted for in this model, is typically highest between January and May, denoted by the gray area. The total WIH are calculated during the ice-free season.

Wave impact hours (WIH) were calculated by determining the amount of time specific coastal features were exceeded by the modeled TWL. The average monthly WIH show that bluffs tended to be impacted most by waves from October through December, which is consistent with the fall storm season (Figure 19) (Terenzi, Jorgenson, and Ely, 2014). The 2011 ice-free season exhibited 110 WIH on the bluffs, only to be exceeded in the year of 2013 when mean monthly sea and bay ice concentrations never reached above 50% (Figure 20). This finding suggests that the later formation of sea ice or significant degradation of sea ice cover can result in annual WIH that rival significant storm years.
