SPATIOTEMPORAL PATTERNS OF BLUFF EROSION AT GOODNEWS BAY, ALASKA

Richard Michael Buzard, B.S.

A Thesis Submitted in Partial Fulfillment of the Requirements

University of Alaska Fairbanks

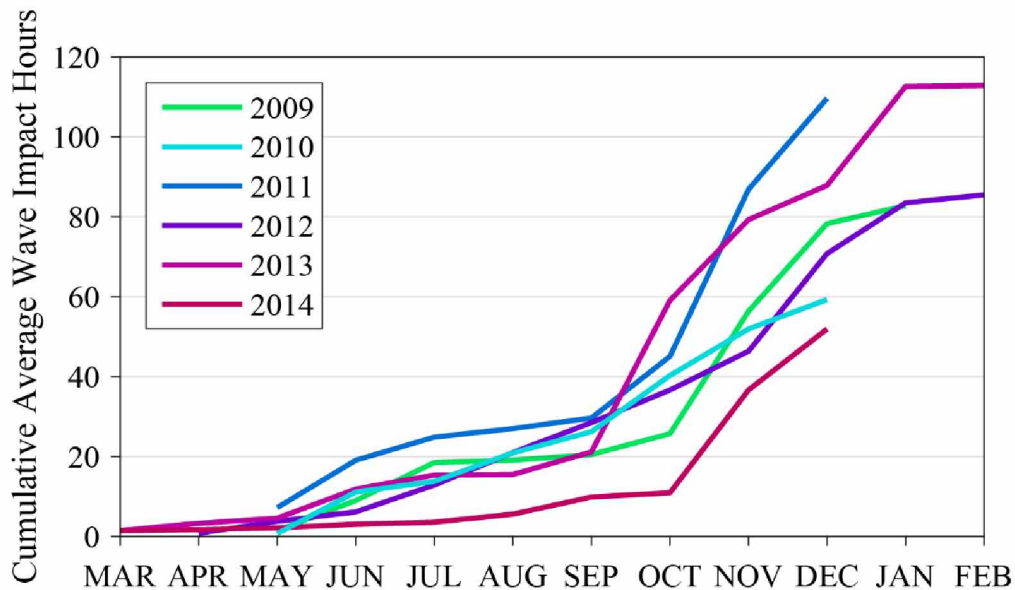
Figure 20. Cumulative average monthly wave impact hours contacting and overtopping bluffs from 2009 through 2014. Data are modeled from March to February to show one year of related open water and ice cover. Data are constrained by ice timing: open-water is determined as when sea or bay ice concentration is less than 50%. This demonstrates how significant ice cover can dampen annual wave energy.

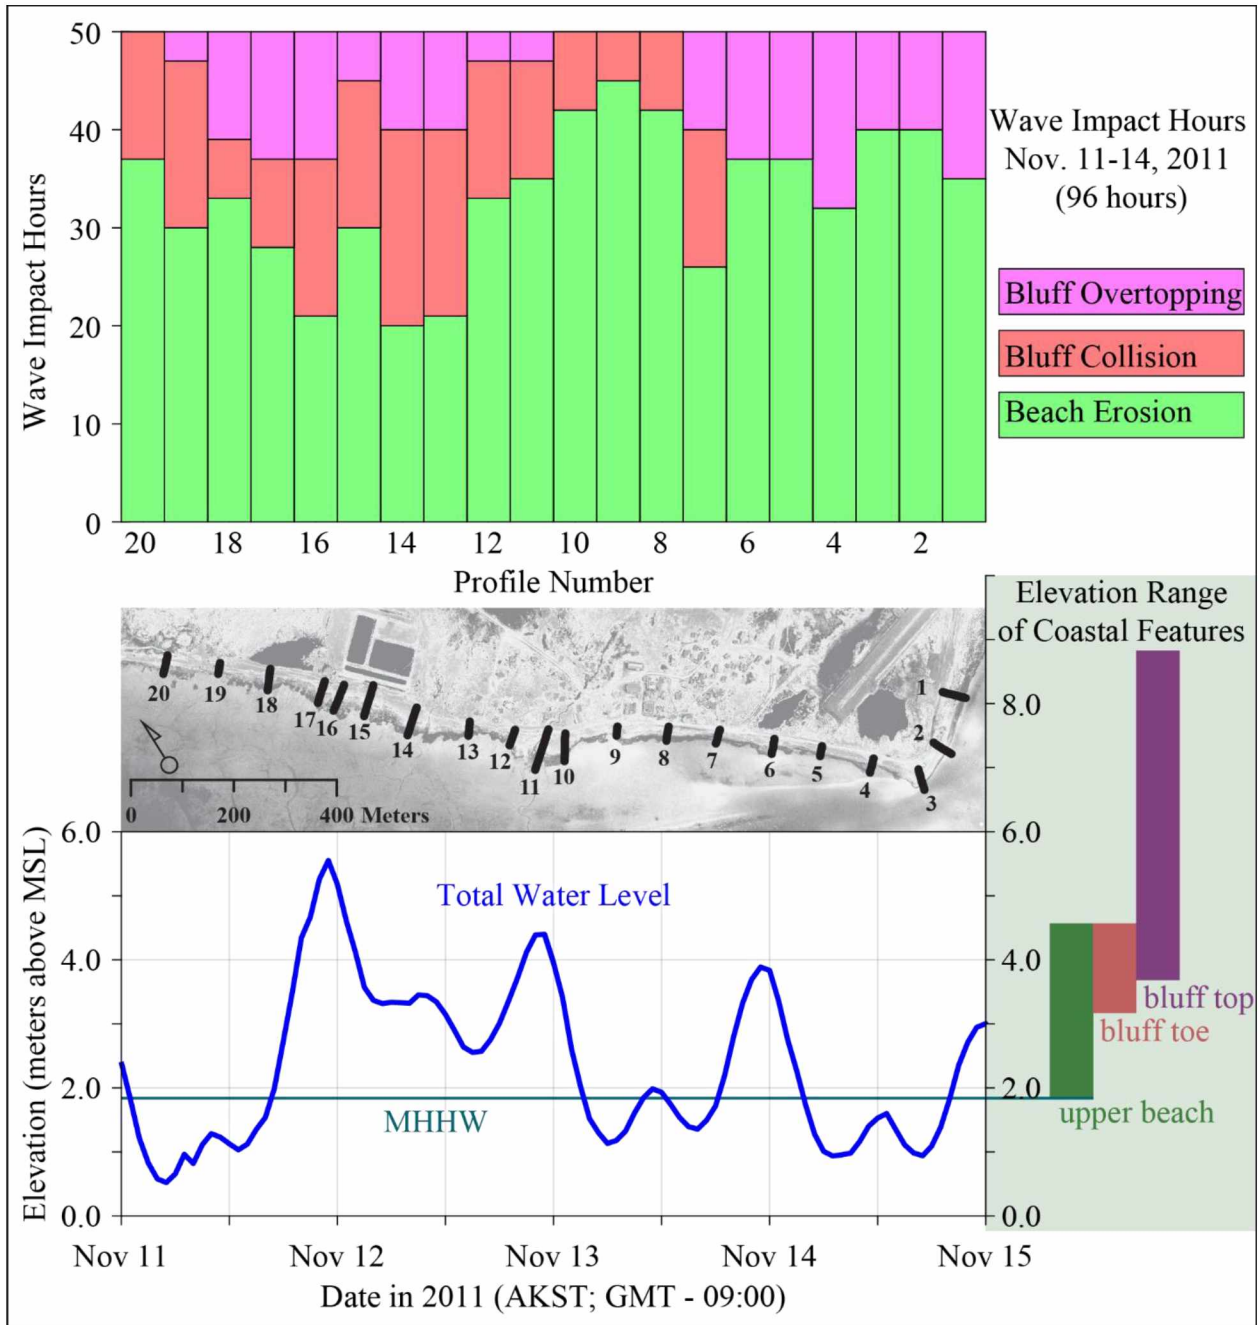
Figure 21. Spatial distribution of wave impact hours for the 11/11/2011 storm. Where bluffs are not present (profiles 1 - 6), overtopping was measured where water reached the road. Because MHHW is the same elevation for all profiles, each experienced the same total number of wave impact hours (i.e. the modeled surge spent 50 hours above MHHW).

The spatial variability of WIH was also examined during the Nov 2011 storm (Figure 21). Throughout the storm, profiles to the northwest experienced the greatest wave impact on the bluff, whereas the tallest part of the armored bluff (profiles 8 and 9) received the least. When the storm peaked, every bluff was impacted and the majority of profiles were overtopped. TWL was modeled to exceed the roadway at The Point (profiles 1-6) for at least 10 hours.

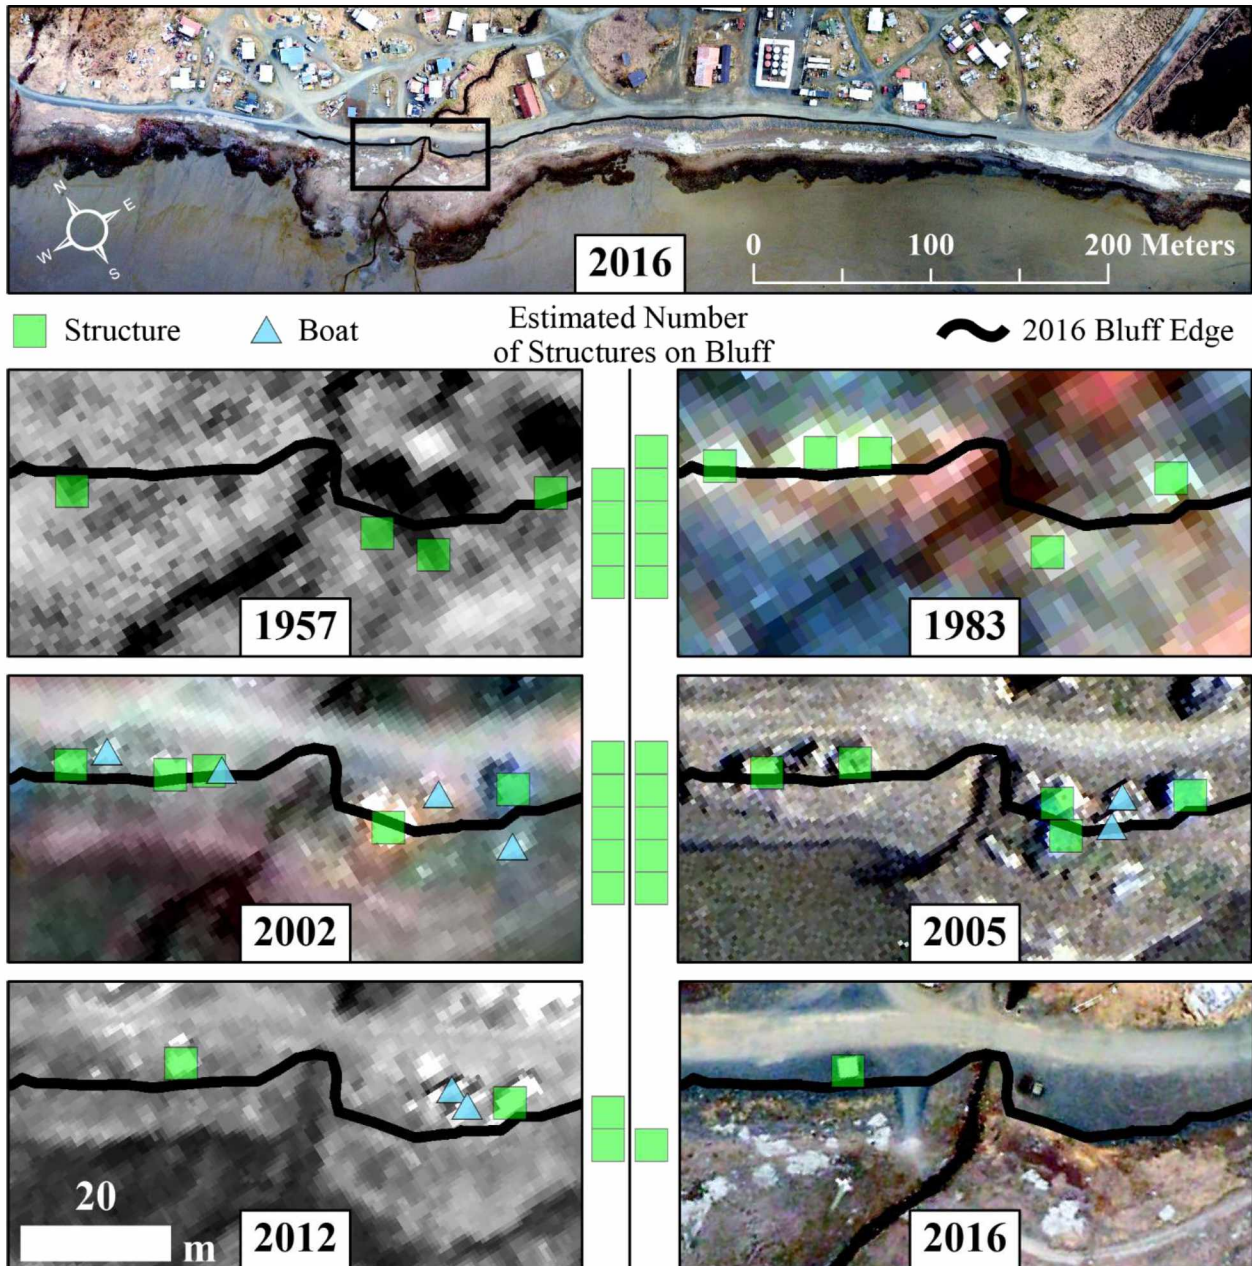
Figure 23. Estimated number of structures on the armored bluff where the highest erosion rates are observed. These structures, reported to be smokehouses in Denning-Barnes (2011), are all absent in the 11/12/2011 photographs, but one smokehouse was rebuilt. This type of qualitative verification supports the results of the shoreline change study, especially in conjunction with Figure 11, which depicts a significant erosion pulse in this region from the 2011 storm. Given the relative stability of the structures from 1983-2005, this also suggests that storms in this period were not as severe at this location.

that detail the bridge washing out, and with images taken after the 2011 storm (Table 1; Figure 22; Appendix I). In addition, there are fewer structures on the bluff after the 2011 storm (Figure 23). These observations help to validate that the event caused a significant amount of damage in the creek area.

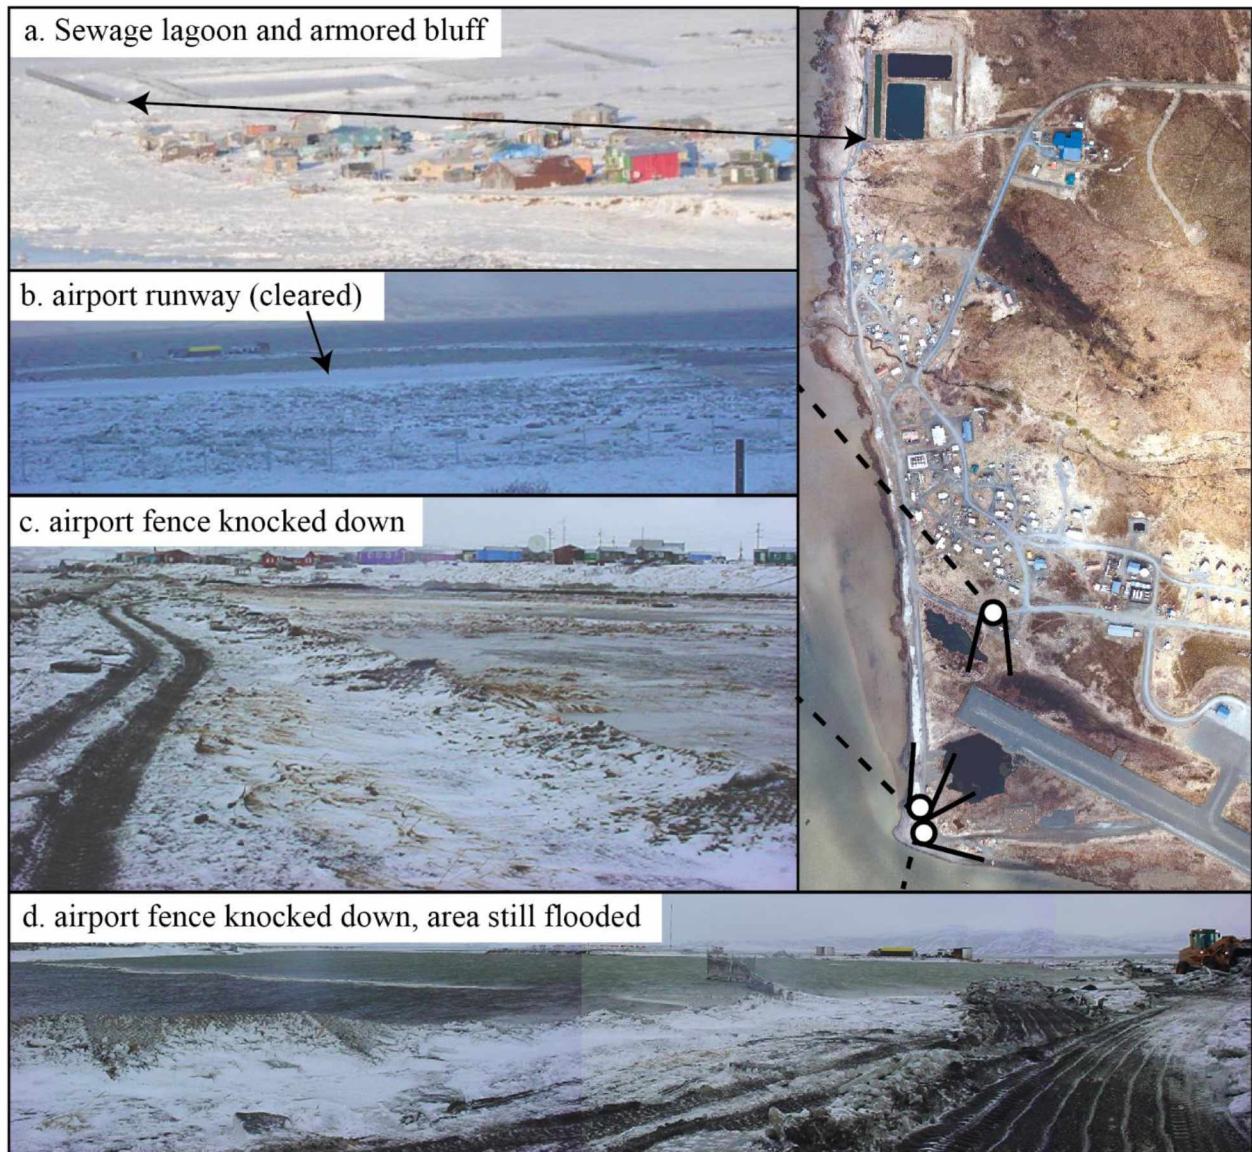
Figure 24. Pictures of damage from the 11/11/2011 storm. Each photo is connected by a dashed line to map symbols that represent the estimated camera position and field of view. (a) The sewage lagoon and lowest-lying region of the village, taken from a plane ten days after the storm. (b) The airport runway's northwestern terminus seen the day following the storm. The runway has been bulldozed, and the cleared debris is piled up around the edges. (c) The airport fence was completely knocked down on the road to The Point. (d) Photomosaic of the knocked down fence and floodwater remaining between the fence and the runway. Photo credit: Alice Julius.

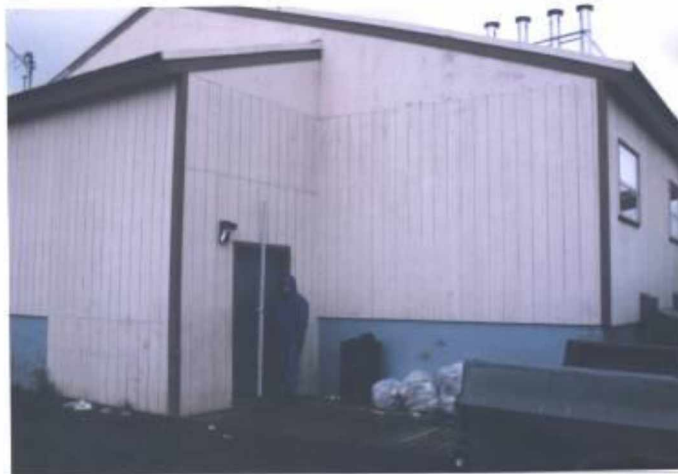
Temporary bench mark is the front door sill at the city hall.

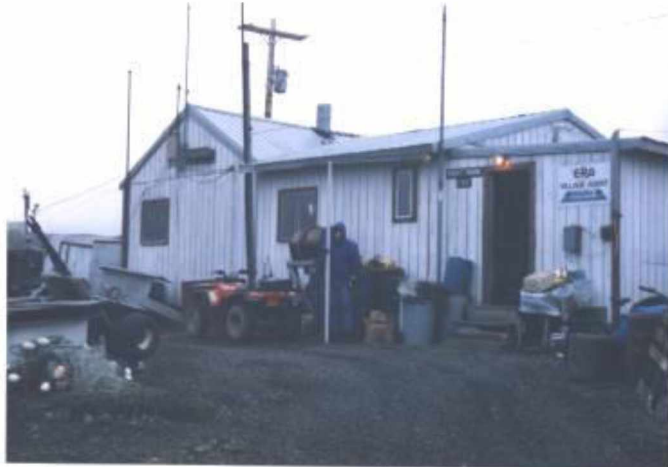
Measured ground elevation at James Bright's house.
