Accelerated aging test of solar reflectors according to the new AENOR standard – results of a round Robin test

Citation: [AIP Conference Proceedings](#) **2033**, 230003 (2018); doi: 10.1063/1.5067231

Abstract. Durability tests of reflector materials for concentrating solar applications are crucial to guarantee the profitability of the plants and to ensure a proper efficiency during their lifetime. A standard including a set of five accelerated aging tests is close to be published by the Spanish standardization entity AENOR, within the sub-committee AEN/CTN 206/SC117. Under the framework of the STAGE-STE project, a Round Robin Test was organized by six partners to evaluate the comparability of results obtained in their respective laboratories after performing these durability tests. According to the results, in general a good agreement among the partners was found, with negligible to slight reflectance losses. In addition, it was noticed that the reference standard used in the reflectance measurements is of high importance. The conclusions of this work will help to improve the standard in future versions.

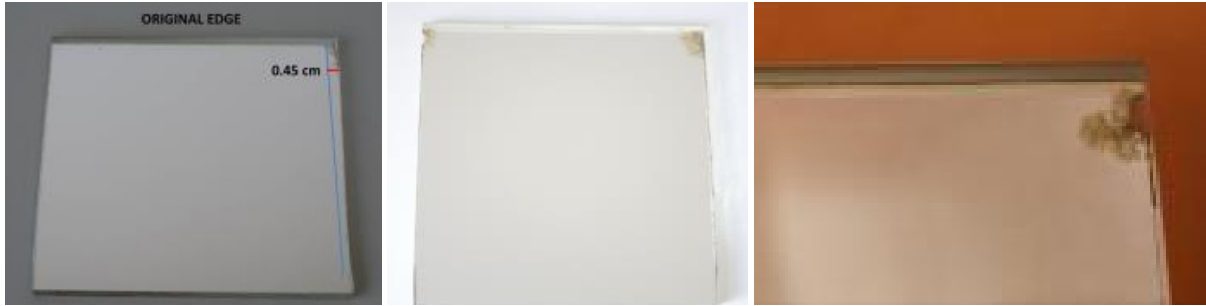
FIGURE 3. Degradation at the non-protected edges of samples tested by #2 (left), #3 (center) and #5 (right) after the NSS test.

Table 3 and Fig. 2 show a summary of the reflectance differences after the NSS test for all the evaluators. As can be seen, similar results were presented by all of them. No significant spectral hemispherical reflectance loss was detected. The slight reflectance loss and increase can be considered negligible because they are in the range of the equipment uncertainty. Regarding the monochromatic specular reflectance, slight and medium reflectance losses were detected in the samples tested by the different partners, with an average of $\Delta\rho_{\lambda,\varphi}(660nm, 15^\circ, 12.5mrad) = -0.002 \pm 0.001$ by #1, $\Delta\rho_{\lambda,\varphi}(660nm, 15^\circ, 12.5mrad) = -0.006 \pm 0.001$ by #2 and $\Delta\rho_{\lambda,\varphi}(660nm, 8^\circ, \varphi) = -0.004 \pm 0.002$ by #5. There is no clear explanation about the decrease detected by #2. However, no monochromatic specular reflectance loss was detected by #4. Regarding the visual inspection, as can be observed in Fig. 3, degradation at the non-protected edges of the samples was noticed by most of the evaluators. In the protected edges, none of the evaluators detected degradation. In addition, bubbles in the back paint layer of the samples were observed by #4 and corrosion spots in the silver layer were detected by #5 (see Table 3).
