J. Engineering Failure Analysis

An experimental investigation of the effect of defect shape and orientation on the burst pressure of pressurised pipes

Sultan Al-Owaisi¹, Adib A. Becker^{*1}, Wei Sun¹, Abdullah Al-Shabibi², Majid Al-Moharbi², Tasneem Pervez², Hussain Al-Salmi³

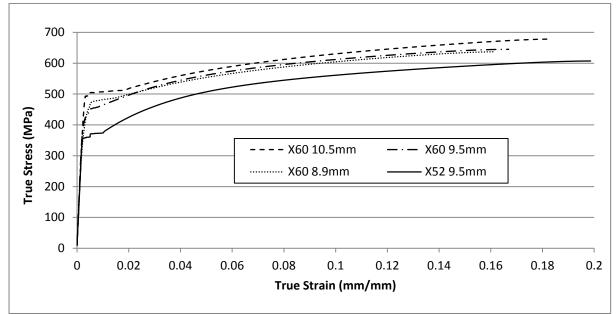
Figure 1: True Stress Strain Data for all tested samples

Tables 1 and 2 list the extracted mechanical properties from the true stress-true strain curves of X52 and X60 materials. It should be noted that the value of the 'true' ultimate tensile strength (UTS) is obtained by converting the 'engineering' UTS into the true stress value.

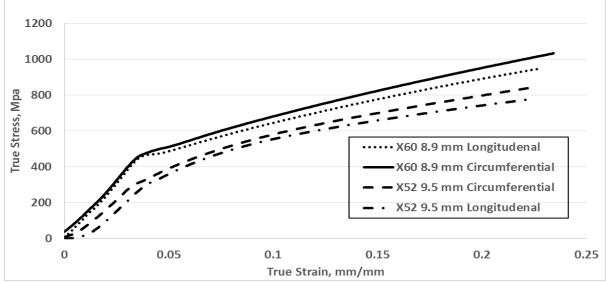
Figure 2: Compressive true stress-strain curves of X52 9.5 mm and X60 8.9 mm tested materials

Compression tests have also been carried out on both materials (X52 with 9.5 mm thickness and X60 with 8.9 mm thickness) along two principal directions of the pipes: circumferential and longitudinal. Stress in the radial direction is of no importance in the tests as it plays a minimal role (radial stress through the wall thickness being very small due to the very small thickness/diameter ratio). The compression samples were $4 \times 4 \times 8$ mm. All tests were performed without the use of an extensometer. These tests have been carried out using a strain rate of 2.5×10^{-4} s⁻¹ and up to a compressive strain of 0.25 mm/mm. Figure 2 shows the true stress-strain curves, where it is clearly seen that the mechanical behaviours of both pipe materials along the longitudinal and circumferential directions are quite similar, indicating that these ductile steel materials have an isotropic behaviour. Similar findings were also reported in the literature, see for example [34].

It can be concluded from the compressive stress-strain curves that the longitudinal direction specimen data can be used for the circumferential direction too as isotropy prevails in this case. It is also clear that the circumferential compressive yield strength of X52 is higher than that of the longitudinal one which could be attributed to the presence of some residual stresses existing in the pipe as a result of the pipe manufacturing processes [35].

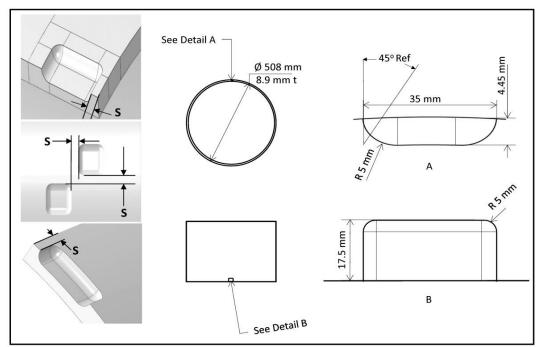
Figure 3: Schematic drawing of the boxed defects

For practical reasons, the metal loss defects were machined on the external surface at the centre of the pipe and 180° degree away from the pipe seam weld in order to avoid the weld and heat affected zone areas. The circular and the boxed defect geometries have been chosen in order to make it practical to machine these defects on actual steel pipes to facilitate experimental burst pressure tests. For the sake of practicality and to represent real-life defects, the dimensions were chosen to be in line with the pipeline operator forum (POF) [36] for general corrosion, and as such these types of defects can be detected and sized, and interaction rules can easily be applied by the existing inline pipe inspection tools [37]. Additionally, such general corrosion defects are widely observed in service in the oil and gas pipes industry and both circular defects and boxed defects have been used in the literature in the past for studying the effect of failure pressure on metal loss defects [7, 25].

It is important to note that metal loss in pipes can take place either internally or externally depending on the corrosion process taking place at the defect site. The boxed defects machined on the pipe's external surface have a length of 35 mm and width of 35 mm, while the circular defects have a diameter of 35 mm. The corners of the defect were made with a curve radius, as shown in Figure 3 and Figure 4. The defects were machined using a computer numerical control (CNC) machine to create a smooth flat bottom defect on the external surface of the pipe. The curved boxed defect machined on the pipe has a length of 35 mm, width of 35 mm and depth of 50% of the wall thickness. The circular shaped defects were also machined with a diameter of 35mm and depth of 50% of the wall thickness. In all the burst cases, detailed measurements of the pipe wall thickness, defect depth, width and length were made. The pressure was monitored by pressure transducers mounted at both ends of the pipe through adaptors welded through the flanges. The defect depths were chosen to be half the wall thickness as it represents a significant pipe defect. The wall thicknesses were measured at various locations along the tested pipe using ultrasonic transducers and an average value was taken. As with all previous studies of defect assessments, microcracks were not considered as all defects were created using CNC machines with high precision. Fracture mechanics and corrosion growth were not considered as part of this study.

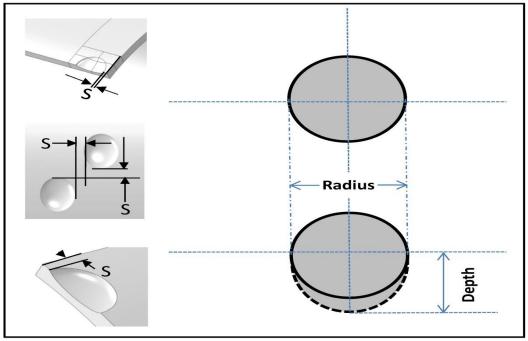
Figure 4: Schematic drawing of the circular defects

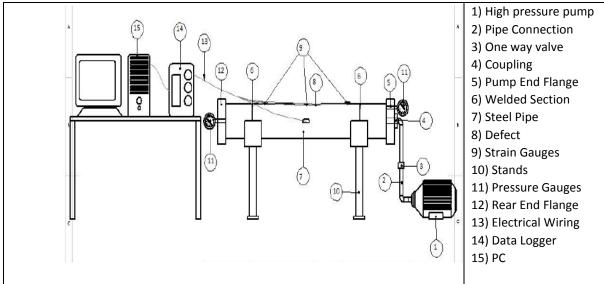
Figure 5: Burst pipe test setup

Figure 5 shows a schematic diagram of the test assembly. The test setup mainly consists of test specimen, high pressure pump, strain and pressure gauges, and a data logger. Each test specimen consists of 1.8 meter long pipe welded to 50 mm thick flanges made from carbon steel as shown in Figure 6.

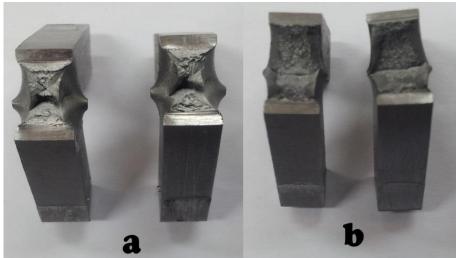
Figure 7: Fractured Charpy v notch samples of (a) X60-8.9 mm and (b) X52-9.5 mm materials.

In order to evaluate the impact of fracture toughness of ductile steel on defect interaction, a Charpy impact test according to ASTM-E23 was conducted. The results of the fracture toughness tests are listed in Table 3. The fractured samples are shown in Figure 7. It is clear from the measured energy absorption values listed in Table 3 that the X60 material has a higher fracture toughness.

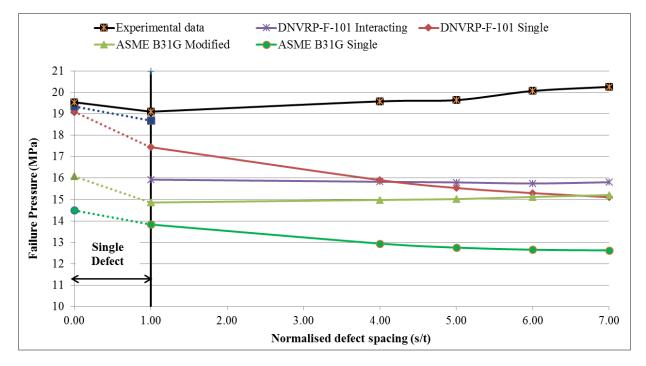
Figure 8: Comparison between experimental results and both analytical methods for X52 pipe with circular defects longitudinally spaced

The results in Table 4 are further analysed and shown in Figure 8 and Figure 9. Comparison of the experimental results with those obtained via analytical methods was done for the X52 pipe with 9.5 mm wall thickness containing circular defects. Due to the limited number of cases for the X60 pipe, the comparison was carried out only for the X52 material. Table 4 shows that Test 19 (s=1t) indicates an interaction, similarly with Test 21 (s=5t). However, Test 20 (s=4t) shows that no interaction is taking place, thus making it an invalid test due to reasons attributed to the pressure test setup. Results shown in Figure 8 reveal that the analytical predicted failure pressure values are very conservative compared to those obtained from the experimental tests for circular defects. The same conclusion is also valid for boxed defects as shown in Figure 9. A slight drop in the experimental failure pressure is observed at 7t, where t is the pipe wall thickness, in Figure 9, which could be attributed to either the fact that wall thickness is not exactly uniform along the pipe length or pre-existing manufacturing imperfections. The failure pressure using DVN RP-F101 was based on Part B whereby the failure pressure is based on the ASD (Allowable Stress Design) format. The total usage factor used was based on F1 as 0.9 and F2 as 1.0.

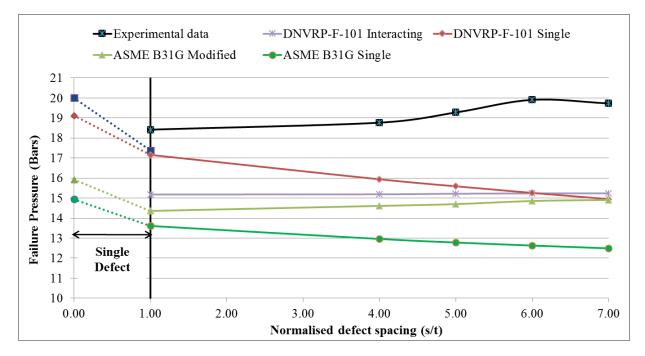
Figure 9: Comparison between experimental results and analytical methods for X52 pipe with boxed defects longitudinally spaced

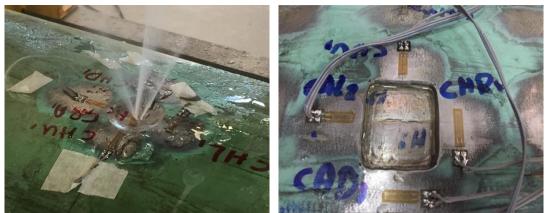
Figure 10: Typical failure of typical single circular and boxed defects in the X60 pipe

All single defects failed locally and no further tearing beyond the defect area was observed. Figure 10 shows the failure experienced for a typical single defect in the X60 pipe. In all cases of circular single defects, failure was observed to occur at the centre of the defects, while failure in the boxed defects occurred either at the centre or at the base of the curve. The location of the failure for the boxed shape could be possibly due to the presence of imperfections created during the defect machining process or as a result of the stress concentration at the base of the boxed area.

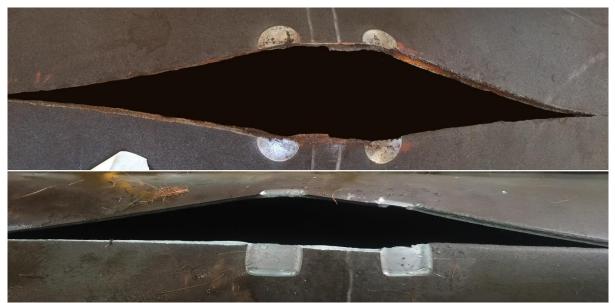
Figure 11: Typical failure of circular and curved boxed defects spaced by a distance of 6t in the X52 pipe

For the majority of the double longitudinal defects, the extent of rupture was observed to extend beyond the two defects area. The length of the crack appears to vary from one test to another depending on the material toughness of the tested pipes. Figure 11 shows the failure experienced in the X52 pipe when testing two adjacent defects, for circular and boxed defects, spaced by a distance of 6t.

The effects of defect shape on the burst pressure can be seen in Figure 11. For the circular defects, the failure seems to occur at the centre of the defect which then extends longitudinally through the ligament, joining the two defects together. The boxed defects seem to behave differently, where the failure appears to start at the defect corner and then progresses across the line joining the two defects. Additionally, pipes with boxed defects have slightly, but not significantly, lower burst pressure than circular defects, by up to 5% as seen in Test Cases 13 and 16. Interaction between the defects considered in this study, circular and boxed, occurs at the same spacing and fades away at the same distance as well.

The X52 pipes were tested with defect spacings of up to 7t as shown in Table 3, Test Cases 23 and 28. The crack continues to open wide and to connect the two defects (both circular and boxed), as shown in Figure 11 and Figure 12. This can be caused by the lower fracture toughness of X52 compared to X60. It can be also concluded that the burst pressure started to stabilize at a spacing of 6t in Test Cases 22 and 27 indicating that the defect interaction effect is negligible beyond this spacing.

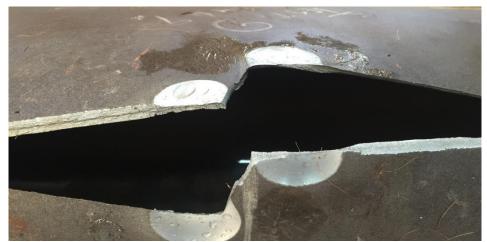
Figure 12: Failure behaviour of diagonal circular defects spaced by a distance of 0.5t in the X52 pipe

The effect of defect orientation is one of the parameters that were investigated in this work. Defects are either placed in longitudinal, circumferential or diagonal directions, as shown in Figure 3 and Figure 4. All defects were machined to a maximum depth of 50% of the wall thickness. Defects placed along the circumferential direction in the X52 pipe did not interact even when the spacing was as small as 0.5t for circular shaped defects. The hoop stress in internally pressurised thin pipes is more dominant than the longitudinal stress, and hence the crack will initiate in the longitudinal direction. For the diagonal defects, where circular defects are placed at an inclination of 45° to the longitudinal direction, defect interaction takes place only at a spacing of 0.5t in the X52 pipe. The crack has a wavy (zigzag) shape, as seen in Figure 12, which indicates higher stress levels at the ligament between the two defects.

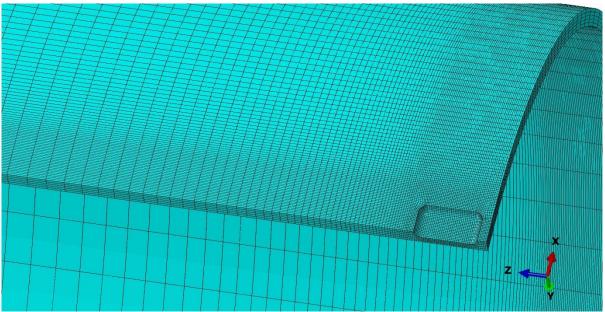
Figure 13: Typical FE mesh for boxed defects oriented in the longitudinal directions

Investigations of the effect of shape and orientation of closely spaced defects were carried out using the Abaqus 6.14 FE software [38]. Exact dimensions of the defects in the experimental tested pipes were used in the FE models. The uniaxial stress-strain data were used as input to Abaqus where isotropic hardening was assumed in the FE analysis. Two failure criteria are specified for single defects and interacting defects [39].

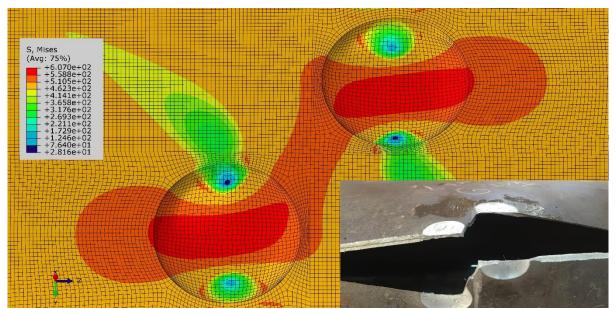
Figure 14: von Mises stress across contours (in MPa) for a circular defect for X52 pipe with a depth of 50% of wall thickness with a defect spacing of 0.5t. The inset figure shows the actual failure in the experimental test.

For a single defect, failure is assumed to occur when the von Mises equivalent stress value across the wall ligament falls between the engineering UTS and the true UTS values. This is used in preference to using the maximum von Mises stress value at a single node, which would be sensitive to mesh refinement at the defect area. A separate failure criterion is adopted for defect interaction. Defect interaction is deemed to occur when the von Mises equivalent stress value along the spacing line between the two defects reaches a value between the engineering UTS and the true UTS, at or before the wall thickness ligament [39].

The main findings of the FE simulations indicate that defect shapes have minimal, if not negligible, influence on the failure pressure of pipes containing interacting defects. Circumferentially spaced defects for both defect shapes and both pipe materials will not interact if spaced by a distance of 0.5t, even for deep defects of 80% of the wall thickness. In other words, the pipe would fail from a single defect before defect interaction occurs between circumferential defects. FE results also show that circular defects spaced diagonally tend to interact only when spaced by a distance of less than or equal to 0.5t, which is also observed experimentally. The preliminary FE results showed that defect interaction in the X52 pipes tends to occur for circular and boxed defects spaced by up to 6t, while it was up to 4t in the X60 pipes. A typical example of the FE mesh for the longitudinal defects is shown in Figure 13. Figure 14 shows the von Mises stress contours around the defect area compared to a photograph of the actual failure observed in the experimental work. Details of the FE simulations will be presented in a future publication.
