# Effect of non-structural masonry brick infill walls on the robustness of a RC framed building severely damaged due to a landslide

Mariana Barros<sup>a</sup>, Eduardo Cavaco<sup>b</sup>, Luís Neves<sup>c</sup>, Eduardo Júlio<sup>d</sup>

In this paper, the robustness of framed RC buildings is analysed by comparing the reliability of the damaged structure with that of the original structure and considering (or not) the contribution of the masonry infill walls. To validate the adopted methodology, this is tested on a residential RC building severely damaged due to a landslide, herein considered as case-study. A numerical model of the original, as well as, of the damaged structure is defined using force-based finite elements with distributed plasticity. Masonry infill walls are modelled as equivalent internal struts. Monte Carlo simulation and FORM coupled with artificial neural networks and response surface polynomials are used in parallel to perform the reliability analyses of both original and damaged structures. Obtained results show that the masonry infill walls are fundamental to contain damage progression after the failure of a couple of columns. In fact, without these non-st

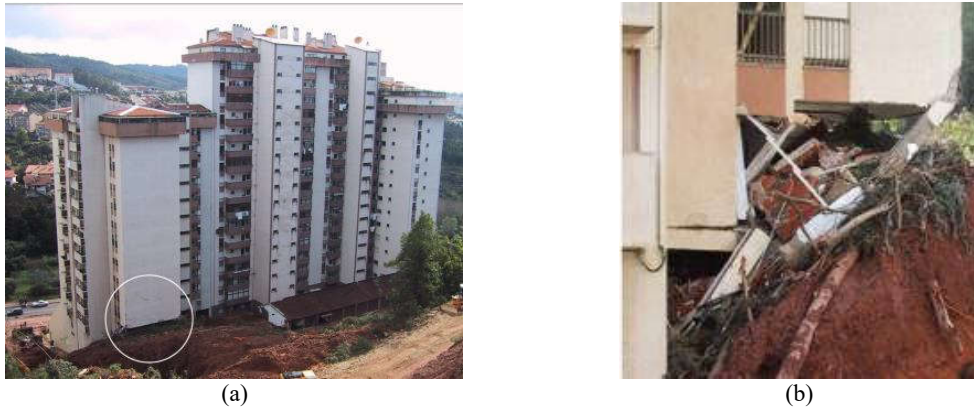
Figure 1 –Severely damaged RC residential building after a land slide: (a) rear façade; (b) collapse of the outer columns of the rear body of building.

135 In 2000, in Coimbra, Portugal, a landslide caused severe damage to the RC structure of a 16 stories  
136 residential building (Figure 1). The first two levels of three exterior columns were destroyed and the rear  
137 body of the building supported by these, with a dimension in plant of  $9.5 \times 6.7 \text{ m}^2$ , became a 7.0 m span  
138 cantilever with 12 stories above (Figure 1 (b)). Unlike what would be expected, no significant anomalies  
139 were identified, other than cracks on the masonry infill walls with a maximum width of 2 mm, located

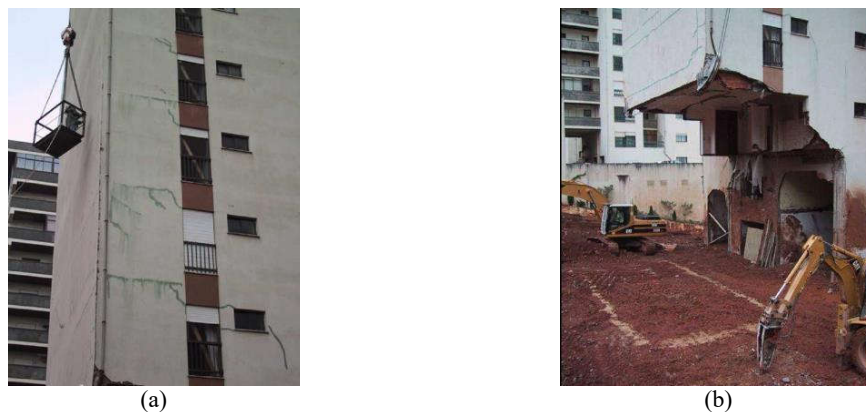
Figure 2 –Details of the accident: (a) cracks along the façade masonry infill walls; (b) removal of debris from the accident site.

140 predominantly at the openings' corners (Figure 2 (a)). After the inspection, the damaged part of the  
141 structure was consolidated using external prestress, the debris was removed, and the retrofitting works  
142 started (Figure 2 (b)).

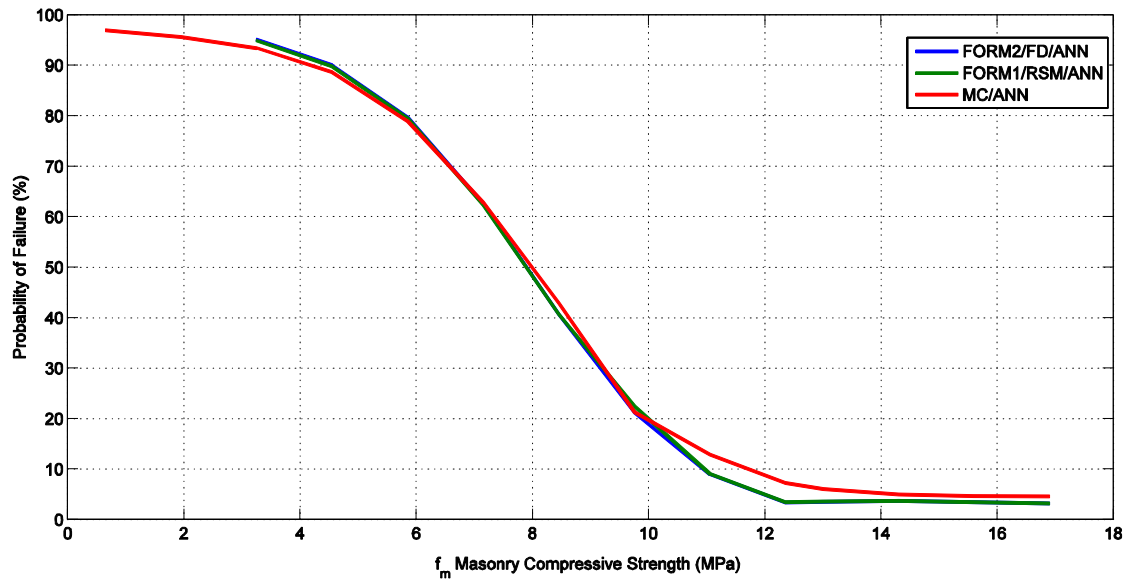
Figure 9 – Effects of the mean value of the masonry compressive strength to the damaged building probability of failure.

404 To highlight the role played by the masonry infill walls in the safety of the damaged structure, Figure 9  
405 and Figure 10 show the influence of the mean value of the masonry compressive strength, on the  
406 probability of failure and reliability index, respectively. Calculations were performed using both the  
407 simulation (MC/ANN) and the gradient-based approaches (FORM1/RSM/ANN and FORM2/FD+ANN).

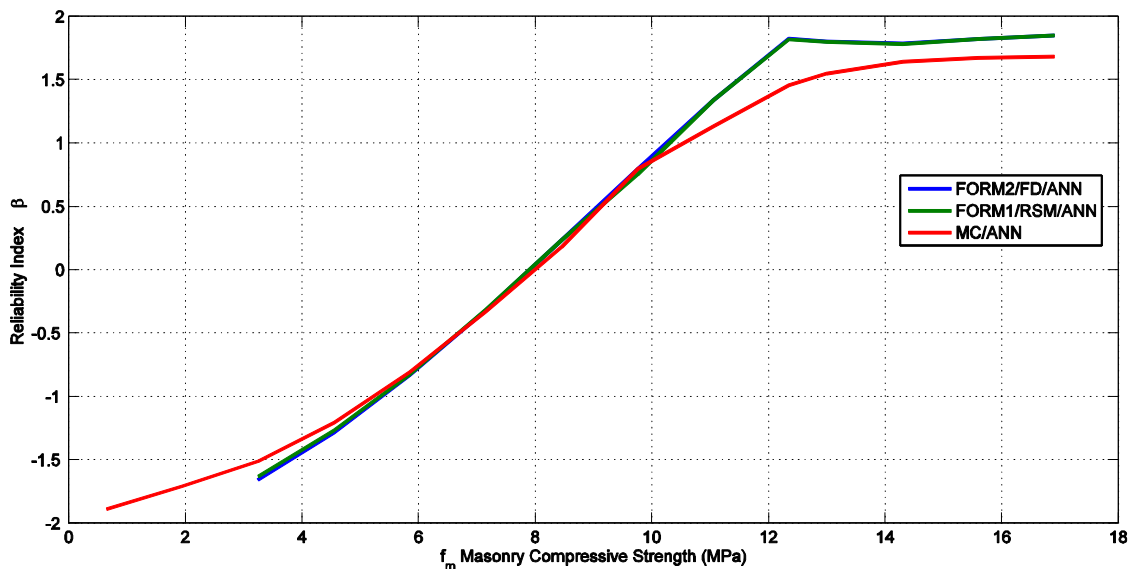
Figure 10 – Effects of the mean value of the masonry compressive strength to the damaged building reliability.

410 Results in Figure 10 show that the probability of failure decreases as the mean value of the compressive  
 411 strength of the masonry increases up to 14MPa. This is particularly evident for masonry compressive  
 412 strengths within the range of 5 MPa to 10-11 MPa. For lower values, the material is too weak and  
 413 therefore the masonry equivalent strut does not provide a significant alternative load path to the RC  
 414 structure. For higher values, and in particular above 14 MPa, results do not show significant increase of  
 415 the damaged building's safety with the increase of the masonry compressive strength. The structural  
 416 analysis showed that too strong masonry infill walls do not increase the load-bearing capacity of the  
 417 damaged RC frame, as structural collapse is mainly controlled by the RC frame failure. Results presented  
 418 in Figure 11 show the square of the direction cosines, which translate the relative importance of each

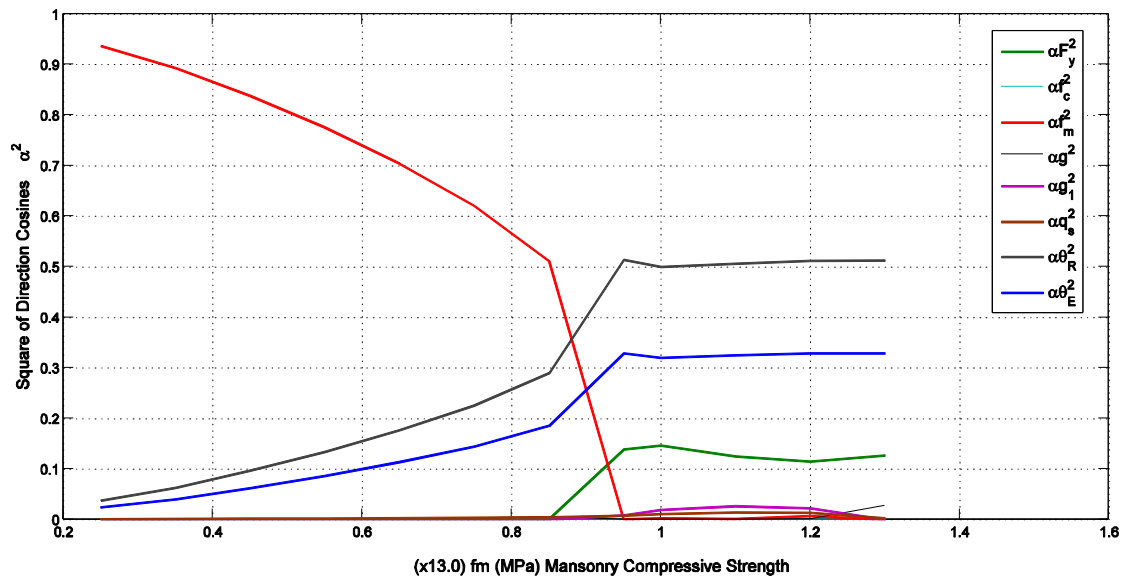
Figure 11 – Effects of the mean value of masonry compressive strength at the square of direction cosines.

419 random variable to the global safety. These results were obtained with FORM1/RSM+ANN method for  
 420 critical load case 2. As observed, for compressive strengths up to approximately 90% of the average value  
 421 (11-12 MPa), the uncertainty related to the masonry infill walls is critical for the safety of the damaged  
 422 structure. Above these values, the steel yield strength random square cosine shows a significant increase,  
 423 meaning that, for higher values of the compressive strength of the masonry, the structural collapse is  
 424 mainly controlled by the failure of the RC elements. Figure 11 also shows that uncertainties related to the  
 425 strength and load models are of paramount importance in the assessment of the damaged structure  
 426 reliability.
