**The Behavior of Drilled Shaft Retaining Walls in Expansive Clay Soils**

**Dissertation**

The University of Texas at Austin

**August 2013**

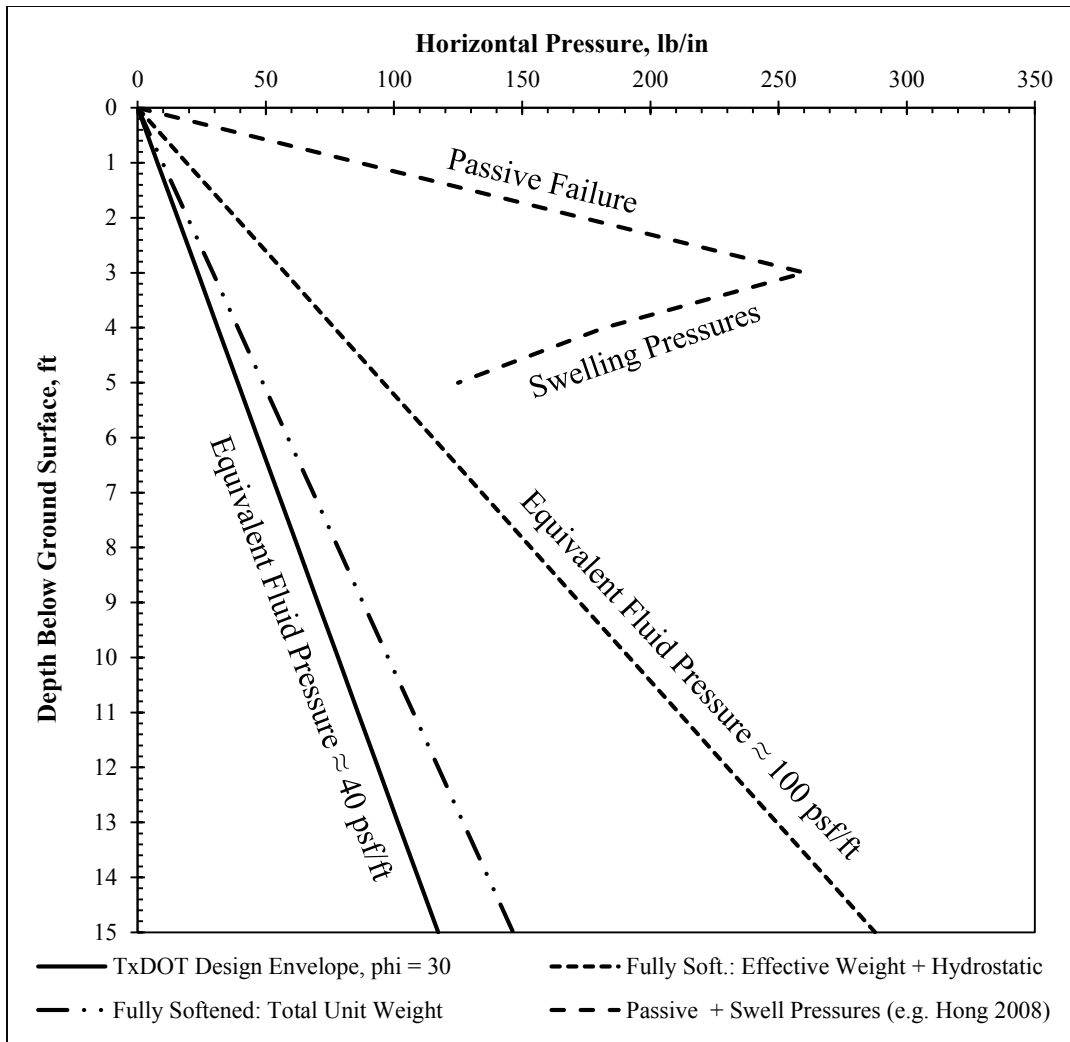
Figure 2.3: Examples of proposed long-term earth pressure envelopes for expansive clay (pressures are acting on a 2.5-foot shaft width).

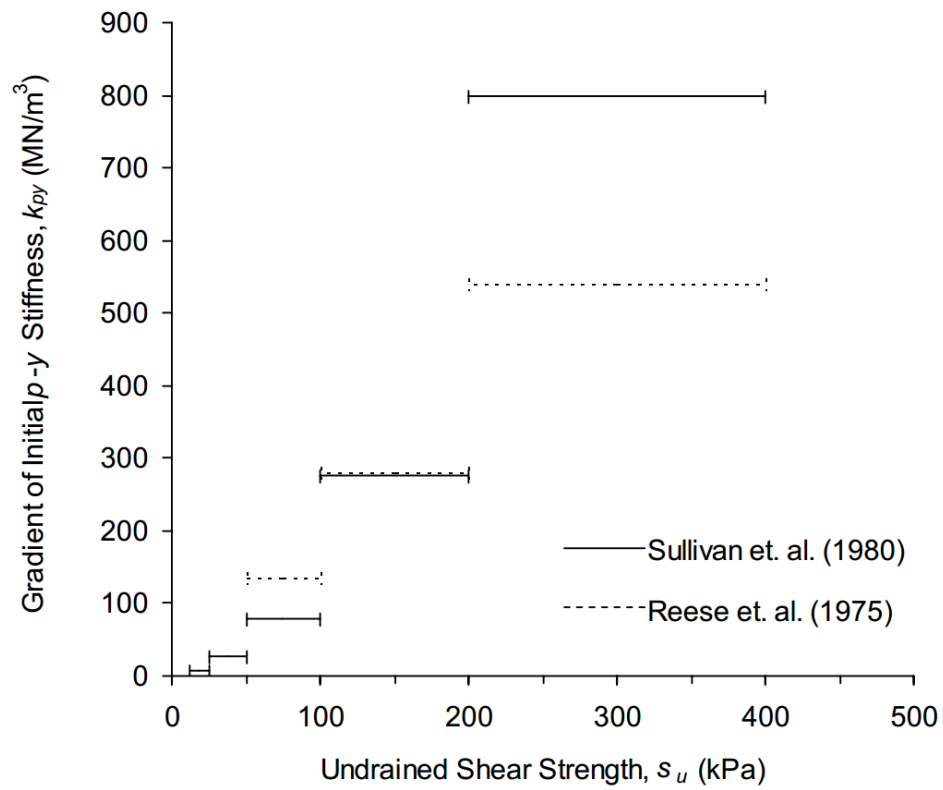
Figure 2.4: Typical  $k_{py}$  values for clays (after Dodds and Martin 2007).

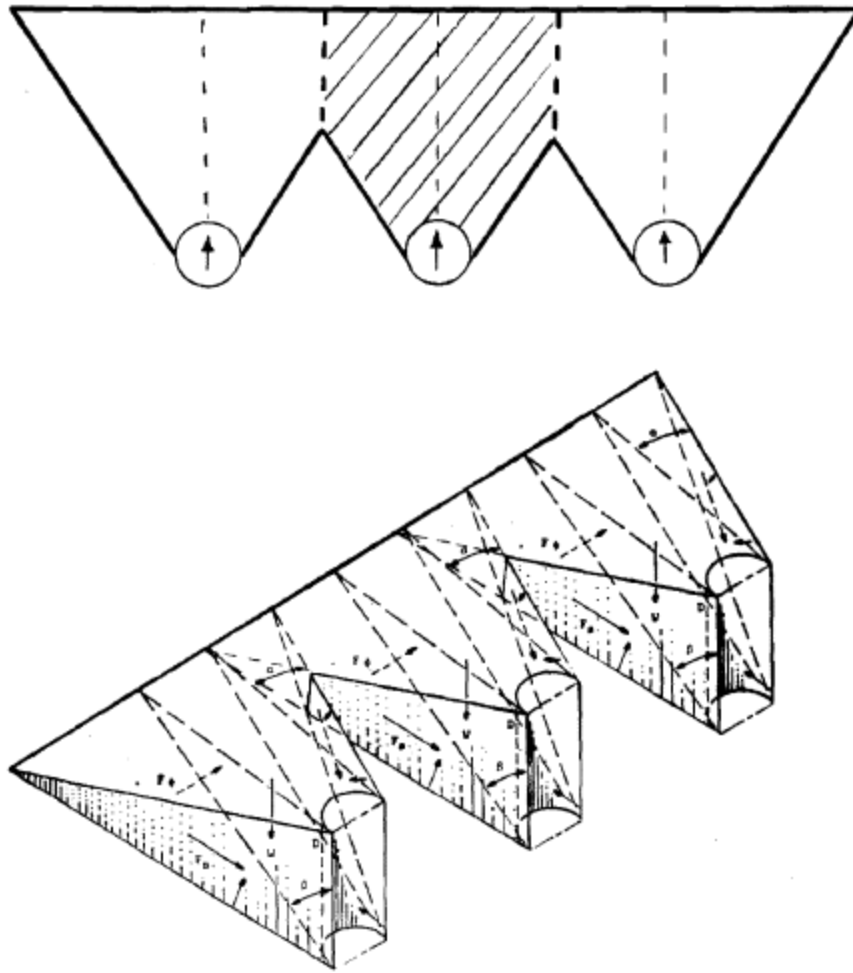
Figure 2.6: Illustration of strength reductions due to passive failure wedge interaction of closely spaced piles in sand (after Wang and Reese 1986).

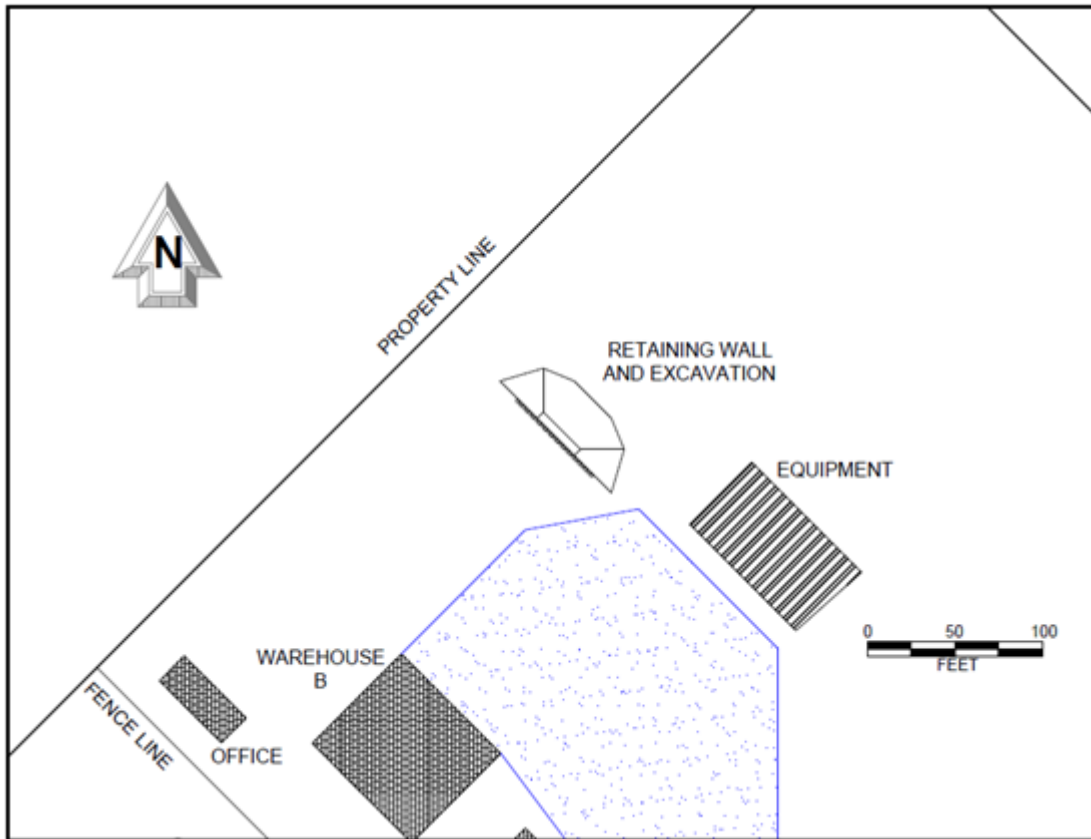
Figure 3.2: Detailed site plan with location of test wall.

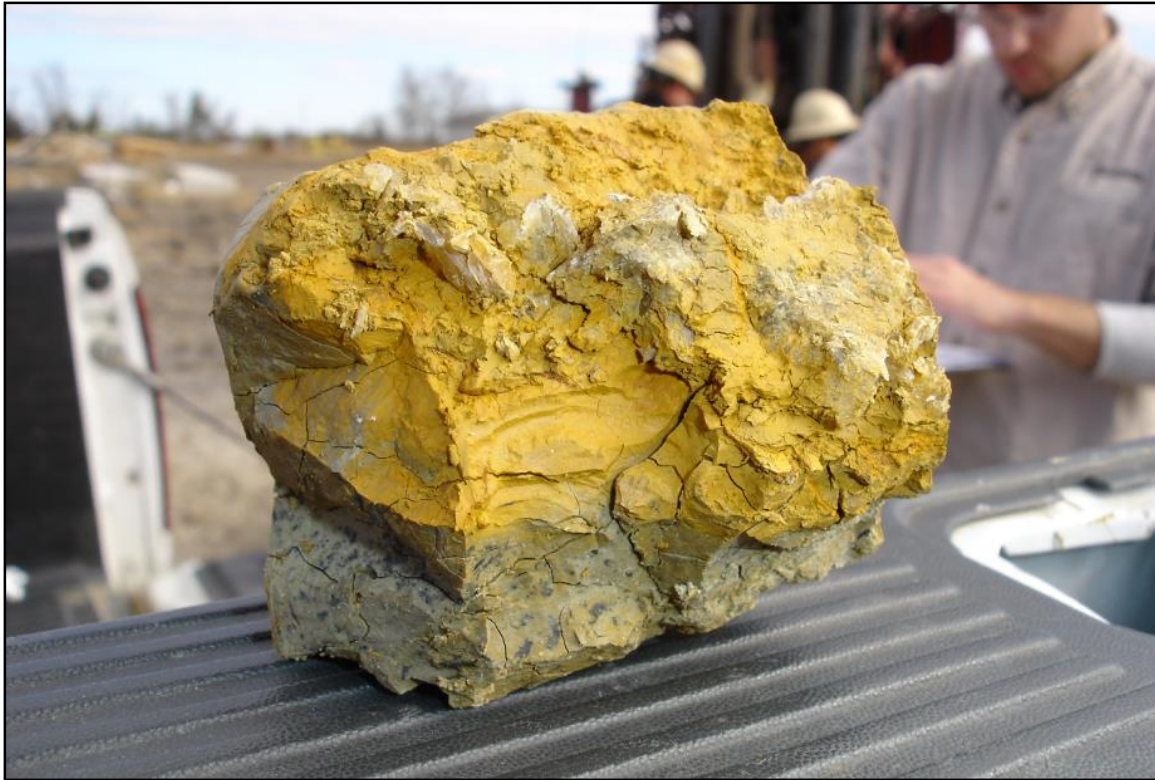
The test wall is underlain by approximately 50 feet of the Taylor Formation, a highly expansive and problematic clay. A sample of the Taylor Formation from the project site is pictured in Figure 3.3.

Figure 3.3: Taylor Clay from the project site in Manor, Texas.

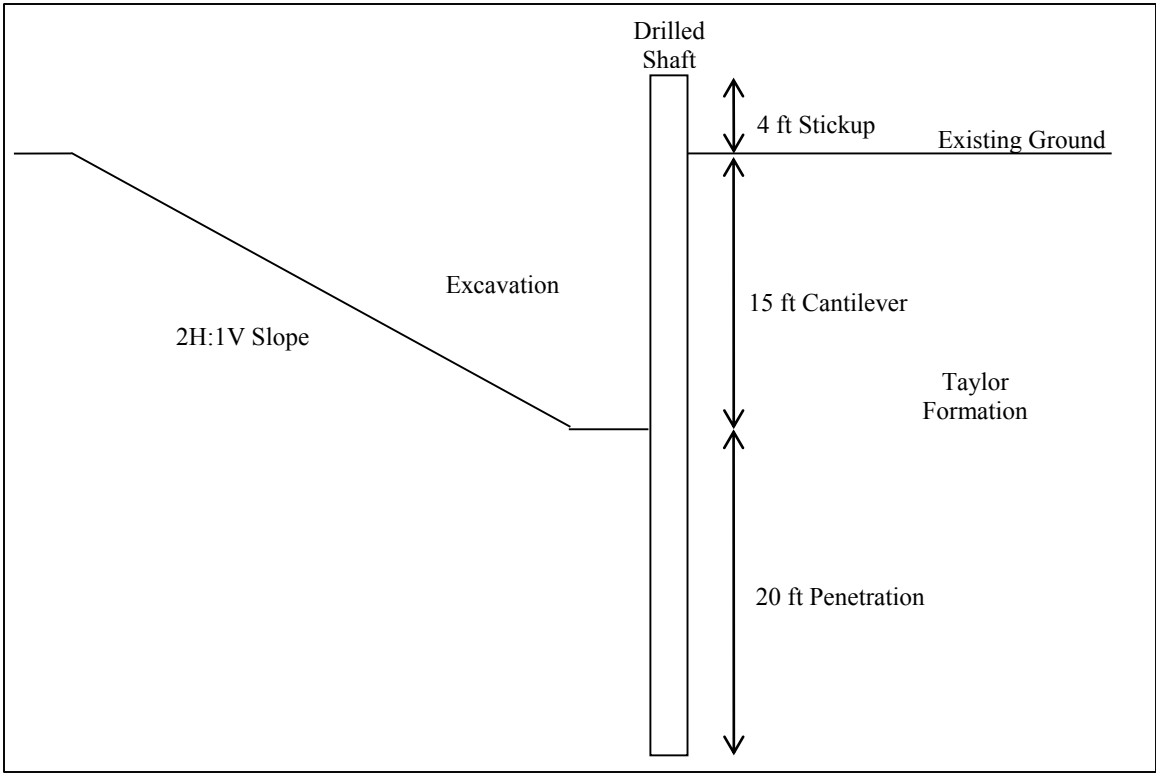
Figure 3.5: Cross-section of wall and excavation at center shaft, facing east (not to scale).

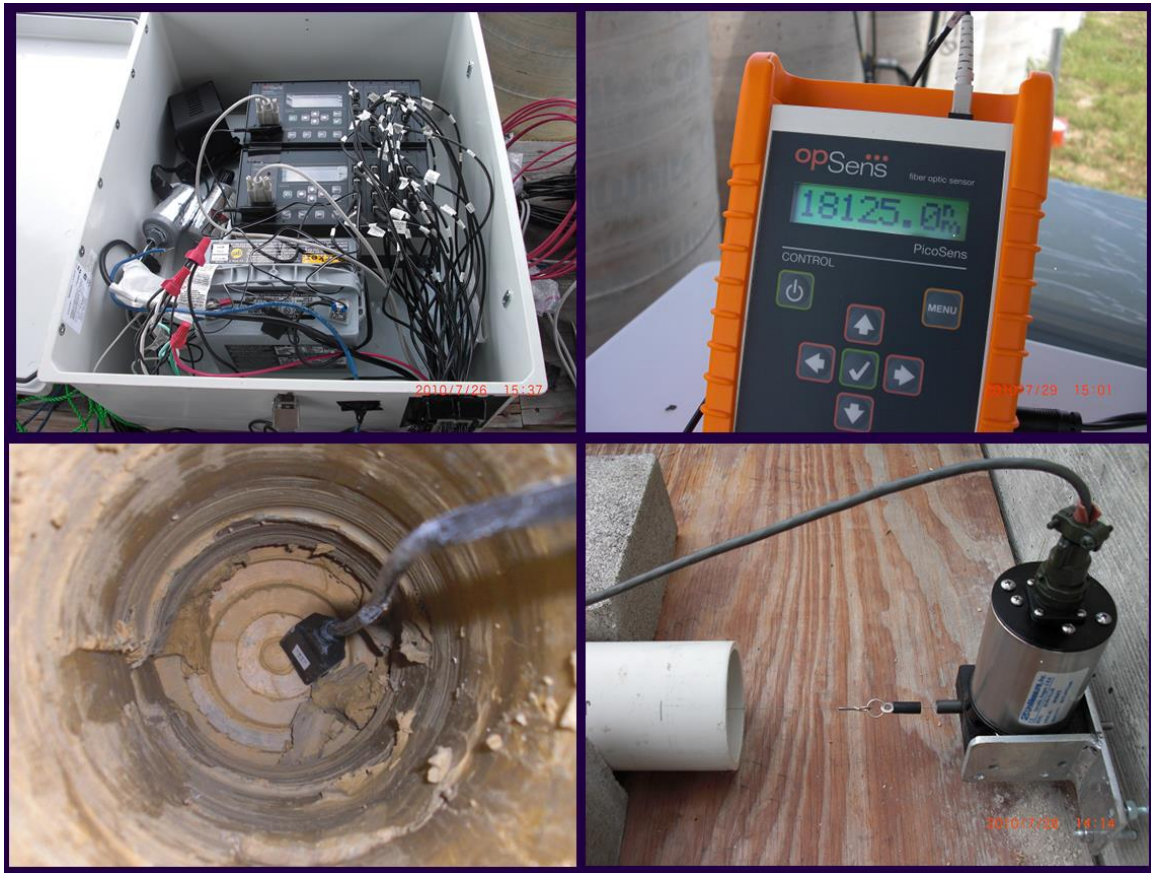
Figure 3.9: Instrumentation on the project site. Clockwise from top left: temperature resistant datalogger and enclosure for continuous strain readings; signal conditioner for individual strain readings; linear potentiometer; TDR probe installed through facing.

instrumented shaft (shaft #15). The linear potentiometer provides continuous data on top-of-wall deflection and redundancy with the inclinometer data. To provide information on the moisture conditions in the retained soil, a total of 20 Time Domain Reflectometry (TDR) moisture probes were installed in behind the wall. Because of the high spatial variability of rainfall across the region, an electronic tipping bucket rain gauge was installed at the test wall to augment measurements from nearby weather stations. The linear potentiometer, TDR moisture probes, and rain gauge are monitored continuously. Figure 3.9 shows some of the instrumentation installed on the project site.

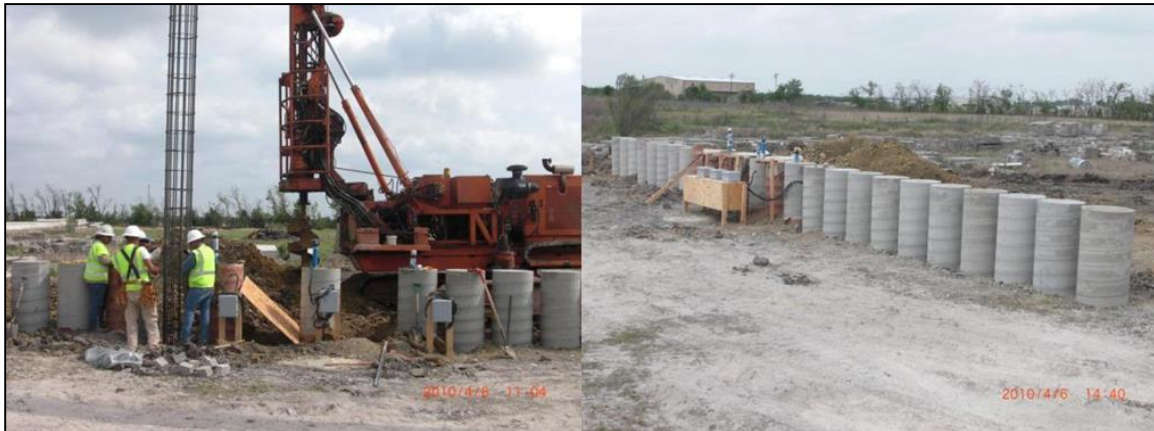
Figure 3.10: Construction of test wall, April 2010.

The drilled shafts and instrumentation were installed in early April, 2010 by McKinney Drilling Company (Figure 3.10). In order to prevent excessive bending of the rebar cage and damage to the instrumentation, the instrumented cages were lifted with two cranes (Figure 3.11). To prevent sensor damage during concrete placement, cables were protected within slotted PVC pipes and concrete was directed down the center of the rebar cage with shovels. Initial sensor survivability was excellent, with 88 of 90 strain gauges and all inclinometer casings functional after rebar cage placement and concrete installation. A summary of wall construction activities and concrete strength data is provided in Table 3.2.

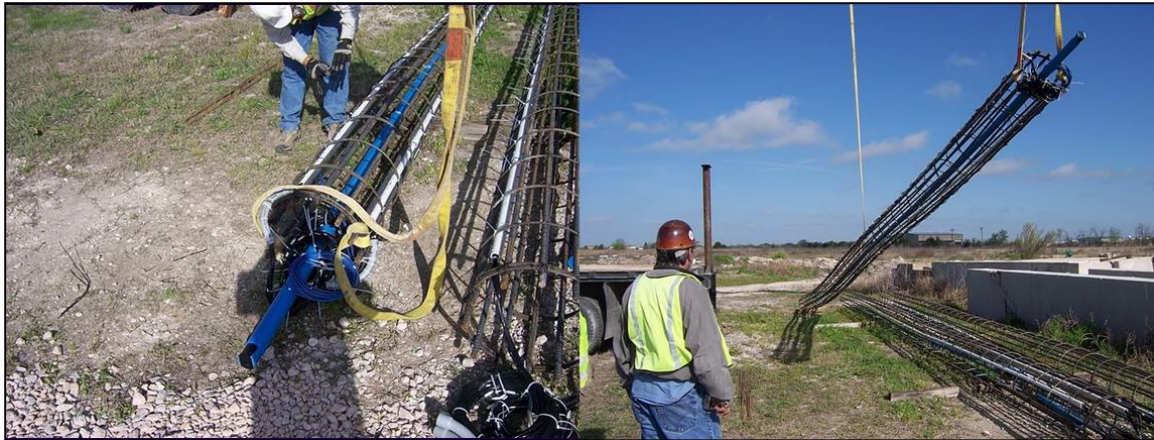
Figure 3.11: Lifting an instrumented cage with two cranes.

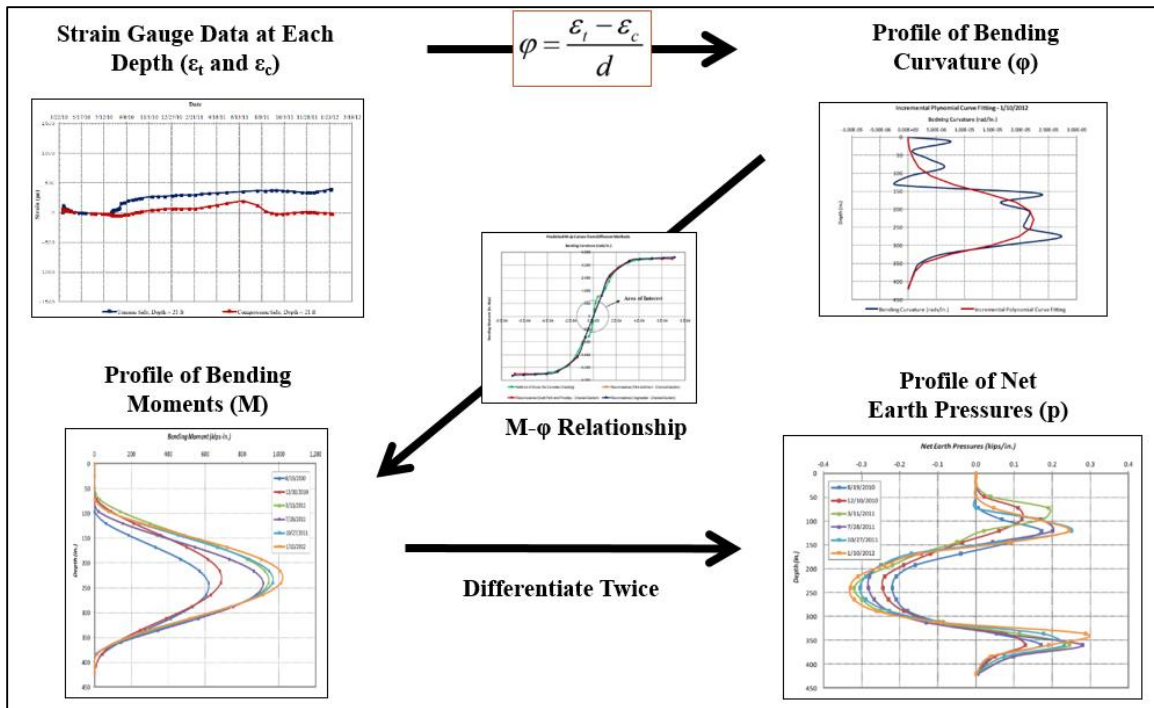
Figure 3.13: Strain gauge data reduction (after Koutrouvelis 2012).

explanation of strain gauge data reduction for the Lymon C. Reese research wall can be found in Koutrouvelis (2012).

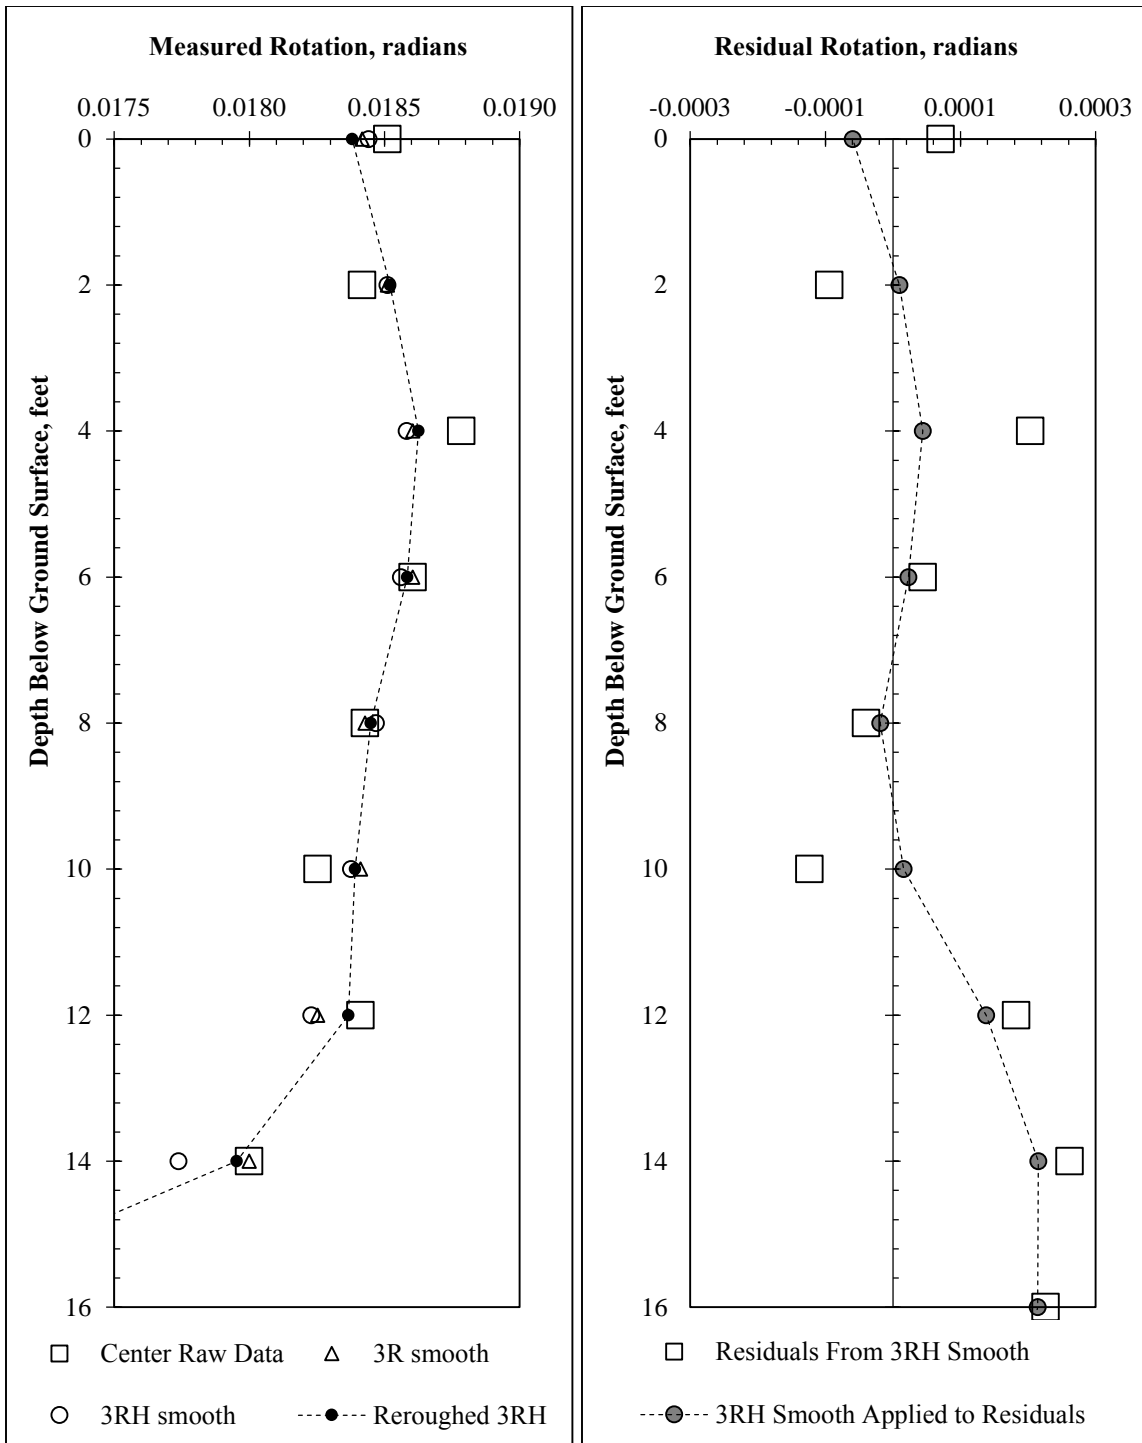
Figure 3.16: Illustration of the 3RH smooth with re-roughing applied to the center shaft rotation data between 0 and 14 feet.

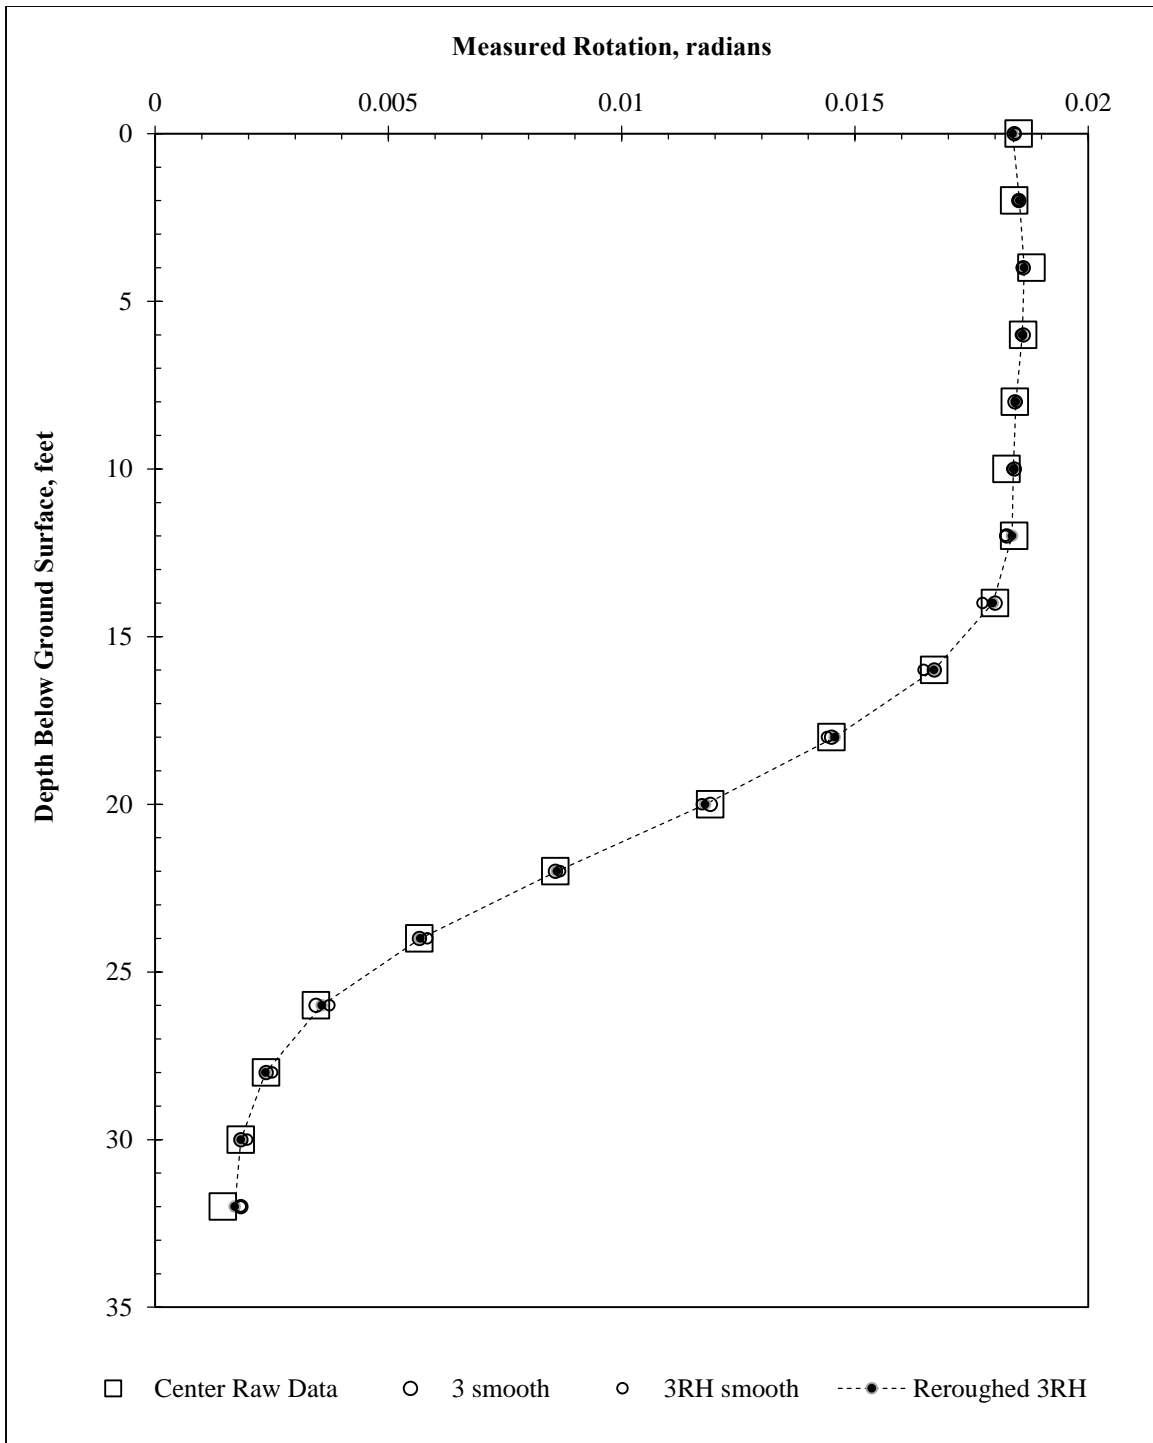
Figure 3.17: Comparison of original and smoothed rotation data from the center shaft on 5/28/2013.

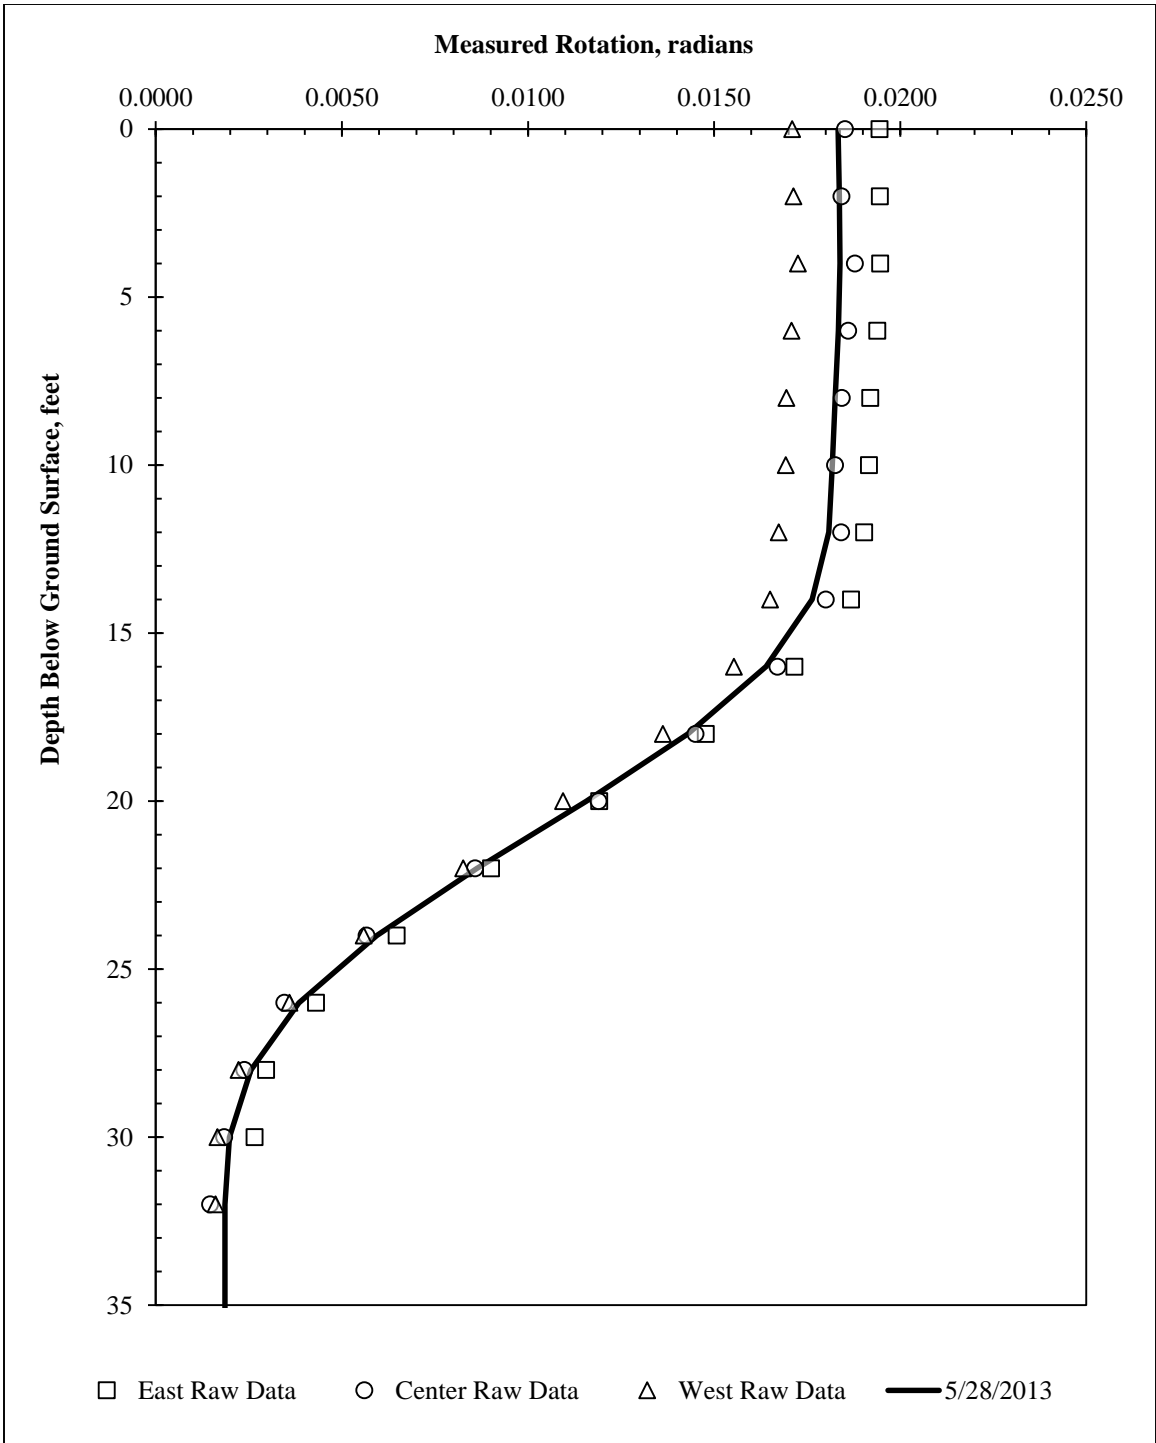
Figure 3.18: Comparison of raw rotation data from the three instrumented shafts with the final smoothed rotation profile for differentiation.

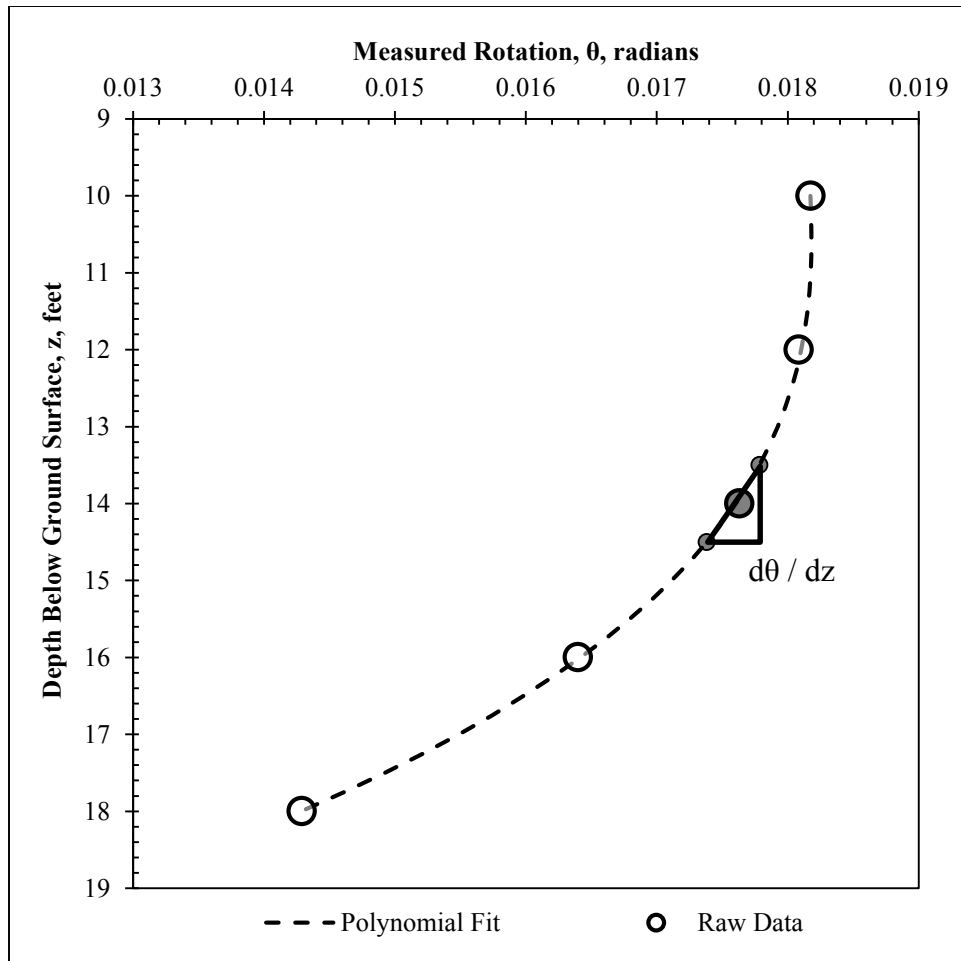
Figure 3.19: Illustration of piecewise third-order polynomial fitting to a moving window of five points at a depth of 14 feet. First derivative at 14 feet is estimated numerically using a central difference approximation between polynomial values at 13.5 and 14.5 feet.

Ooi and Ramsey (2003) detail a variety of methods for obtaining bending moments and curvatures from inclinometer data. Of the methods surveyed, the most favorable was found to be fitting a third-order polynomial to a moving window of five points along the deflection profile, then analytically taking the second derivative of this curve to obtain a profile of bending curvature. For inclinometer data recorded at the test wall, a third-order polynomial was fit to a moving window of five points along the smoothed rotation profile, and the first derivative was taken numerically at the center point (using a central difference approximation at depths  $\pm 0.5$  feet from the center point). This process is illustrated in Figure 3.19 at a depth of 14 feet.

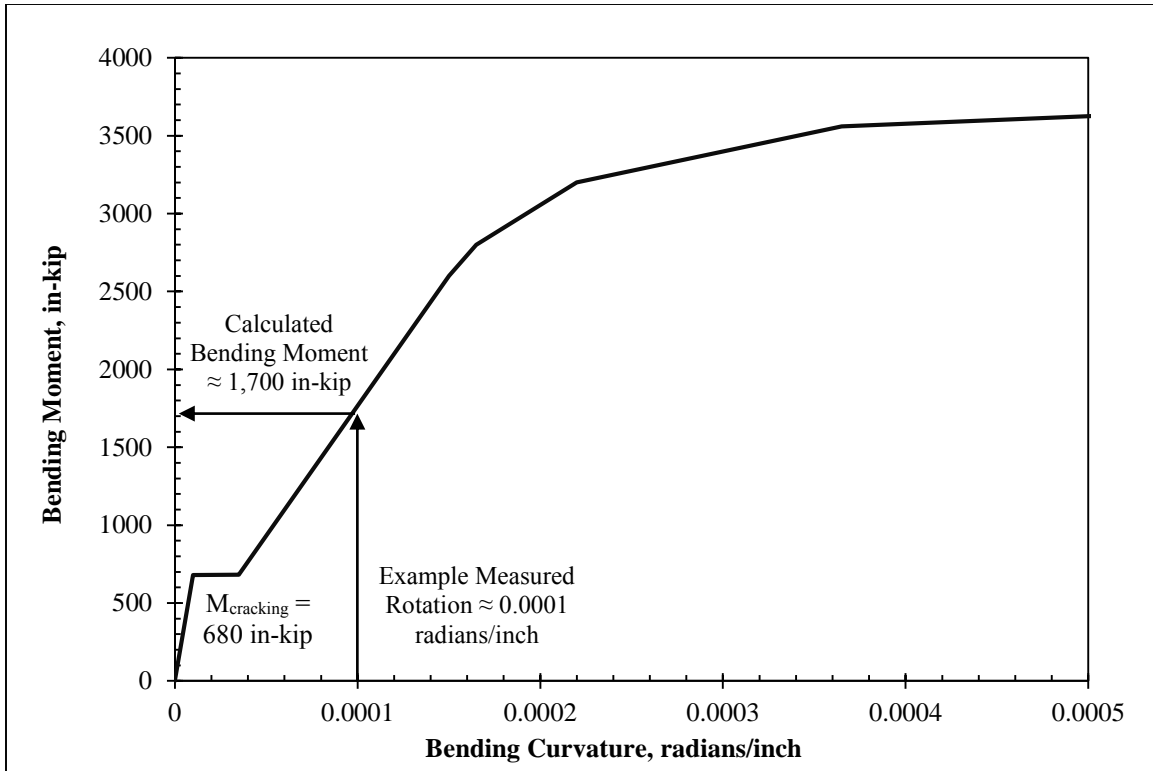
Figure 3.20: Relationship between bending curvature and bending moment ( $M-\Phi$  relationship) used for LPILE and field instrumentation data analysis.

of bending moment as shown in Figure 3.20, is shown in Figure 3.21. Using cracked section properties in the  $M-\Phi$  relationship generates a smoother profile of bending moment versus depth (there is no “hitch” near the cracking moment), but analysis of the test wall data for this project indicates that the earth pressures estimated at locations with small bending curvatures are unrealistically small when using cracked section properties. This may be a function of the heterogeneous nature of the concrete itself, which inherently produces variations in local stress-strain behavior at different locations within the shaft. If structural stresses are concentrated in the stiff (i.e. uncracked) sections of the shaft, and deformations are primarily located in the more flexible (i.e. cracked) sections, some difficulty in data interpretation can be encountered in the range of small strains. Despite this difficulty, because bending moments in the range of interest are larger than the cracking moment, the interpretation of maximum bending moment in the shaft is relatively unaffected by the choice of cracked or uncracked properties. The influence of concrete cracking on data interpretation is discussed in more detail in subsequent chapters.

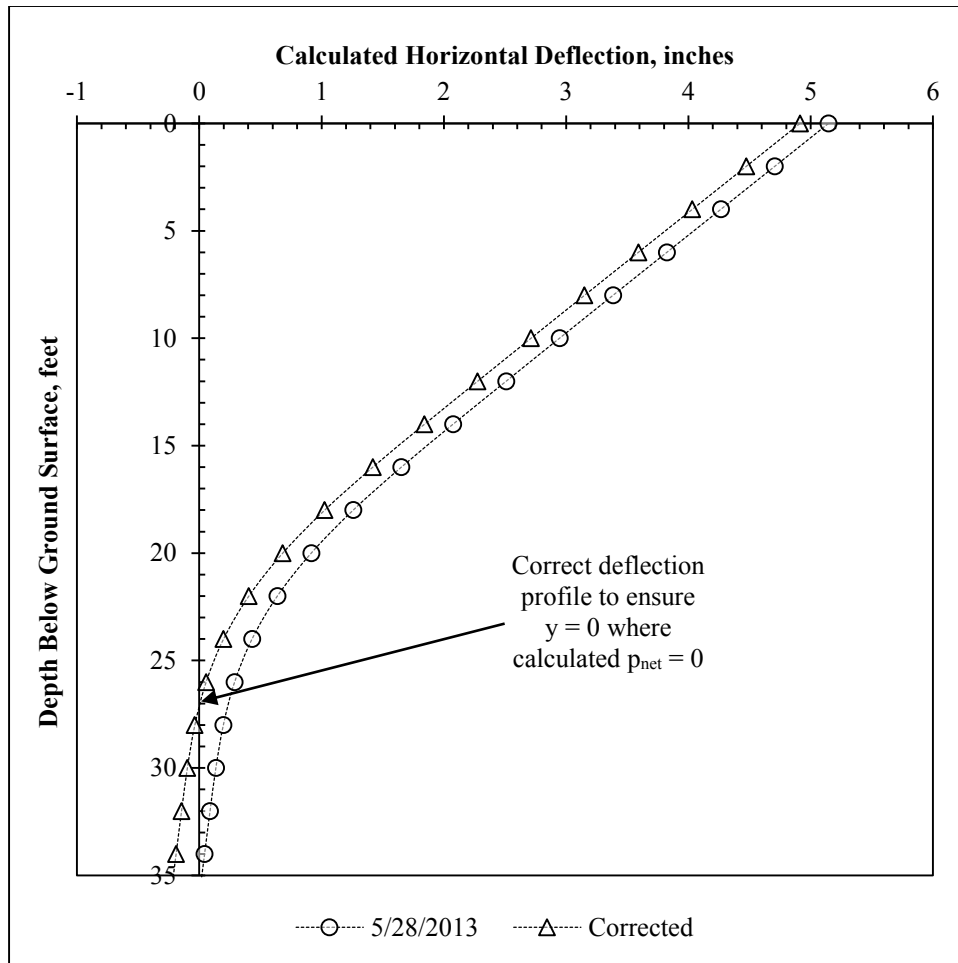
Figure 3.24: Correction of deflected shape about center of rotation for p-y curves

shape generated from inclinometer data, however, the shaft base is assumed to be fixed, and all deflections appear to be positive. This can provide misleading results for p-y curves; if the raw inclinometer deflections are used, at the center of rotation, the shaft appears to have moved without any corresponding increase in earth pressure. Similarly, without corrections to deflection data, at the shaft base, nonzero soil forces appear to be present without any shaft deflections. To prevent unrealistic results such as these in data interpretation, and to allow for pile conditions closer to force equilibrium, the inclinometer data is adjusted to allow the shaft to rotate about the center of rotation (defined for the purposes of this analysis as the depth at which the soil resistance below the excavation is equal to zero) as shown in Figure 3.24.

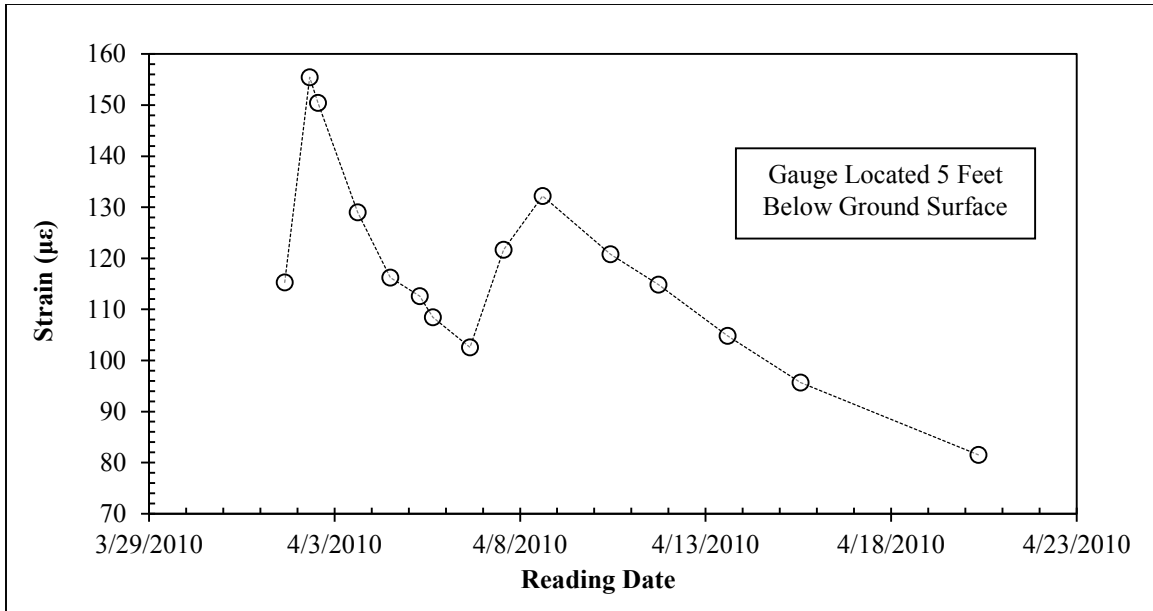
Figure 4.17: Three weeks of strain measurements during concrete curing. Concrete placed on April 1; concrete in adjacent shafts placed on April 6. Positive strain indicates tension.

After successful installation of the strain gauges and field enclosure, strain measurements were taken at least once per day for several weeks. Initial strain measurements behaved similarly as other published data from concrete curing (e.g., Fellenius et al 2009). As the concrete heated after placement, tensile strains tended to rise sharply and then decrease gradually as the concrete cooled (Figure 4.17). Heating from adjacent shafts also caused less pronounced spikes in tension (Figure 4.17). Because the gauges were zeroed in the lab to a value of zero force and no drift has been observed, nonzero initial strains are assumed to represent forces picked up during installation and concrete placement prior to the first reading.

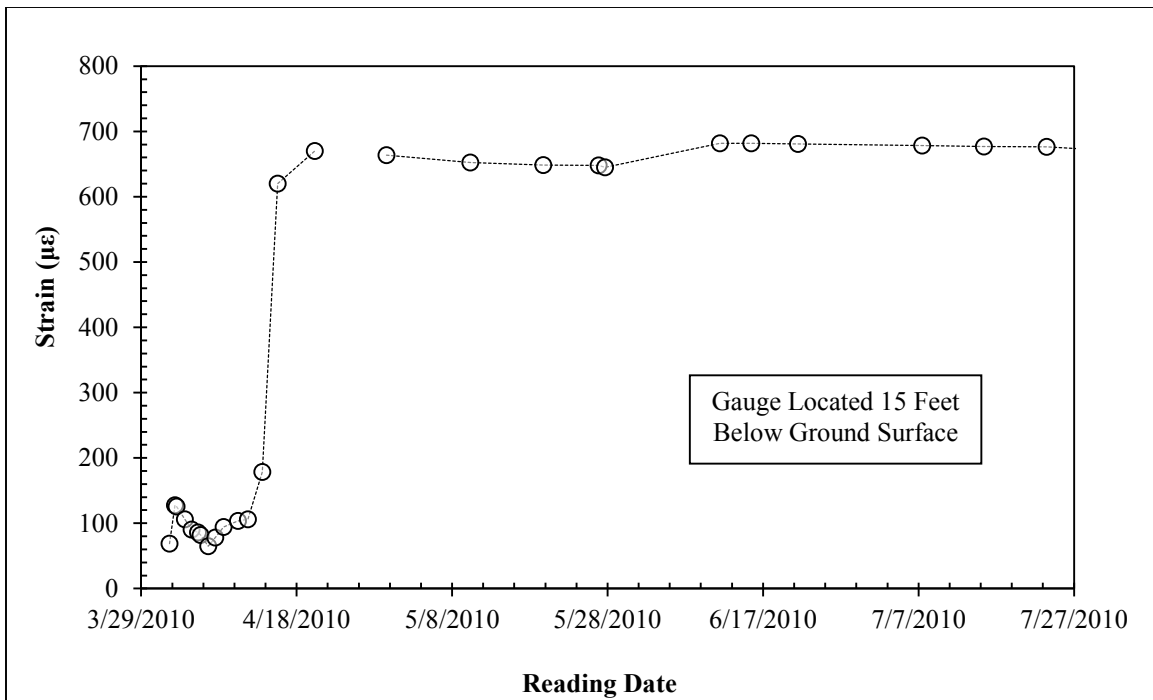
Figure 4.18: Illustration of tension crack formation in concrete near gauge.

the 12 #7 bars. A tensile force of 180 kips corresponds to a strain of about 900 microstrains in the bars, which is consistent with the magnitude of tensile strains associated with these jumps (Figure 4.18).

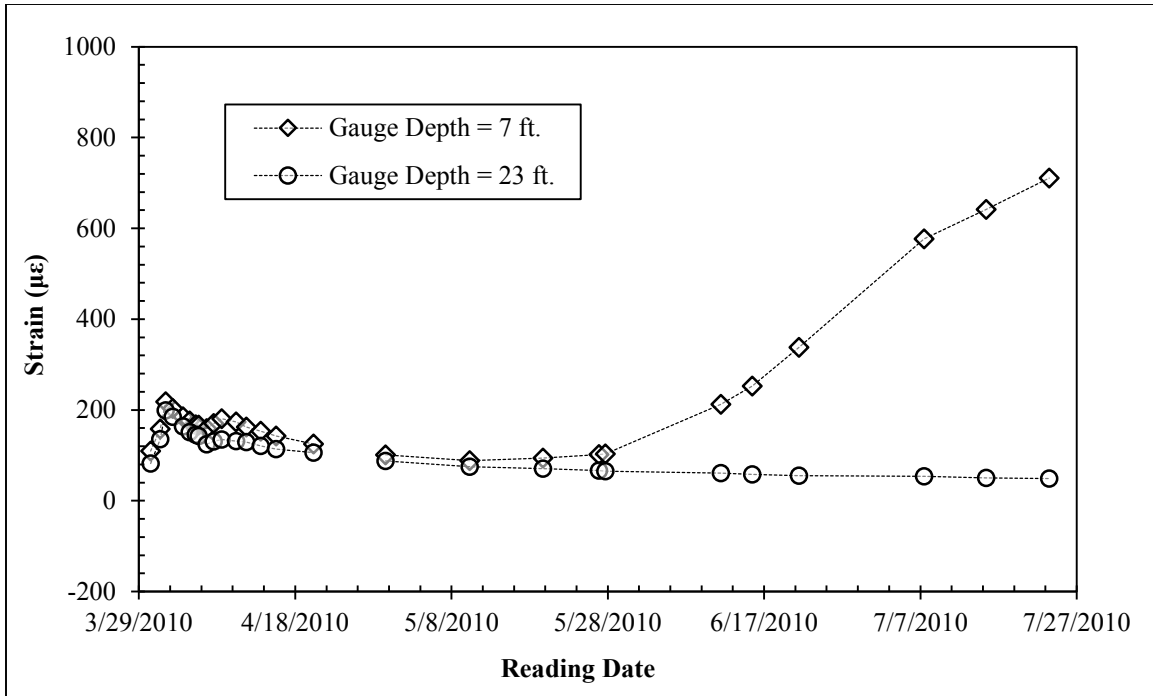
Figure 4.19: Strains occurring between concrete curing and excavation. The gauge at a depth of 7 feet may be experiencing changes in side shear due to moisture fluctuations in the active zone (e.g., Kim & O'Neill, 1998).

After the influence of concrete curing and tension cracks diminished, approximately 10 percent of gauges showed steady increases in tension over the remaining three months between concrete placement and excavation. The increases in tension occurred most commonly in gauges located between 0 and 10 feet below the ground surface. Figure 4.19 shows a gauge, located seven feet below ground surface, exhibiting this behavior. A gauge at 23 feet showed similar strain behavior early on, but did not exhibit the same increase in tension with time. Qualitatively, the increase in tension begins at a similar time as the transition from below average rainfall in April and May to above average rainfall in June and July. A pre-excavation strain value of approximately 700 microstrains also suggests that a tension crack may also be present near the gauge. The shaft may be experiencing changes in side shear stresses due to moisture content changes in high plasticity clay (e.g., Kim and O'Neill, 1998), along with the effects of tension cracking in the concrete. This behavior is most pronounced in gauges located between 5 and 9 feet below ground surface, above the water table where the natural moisture content fluctuates in response to weather patterns.

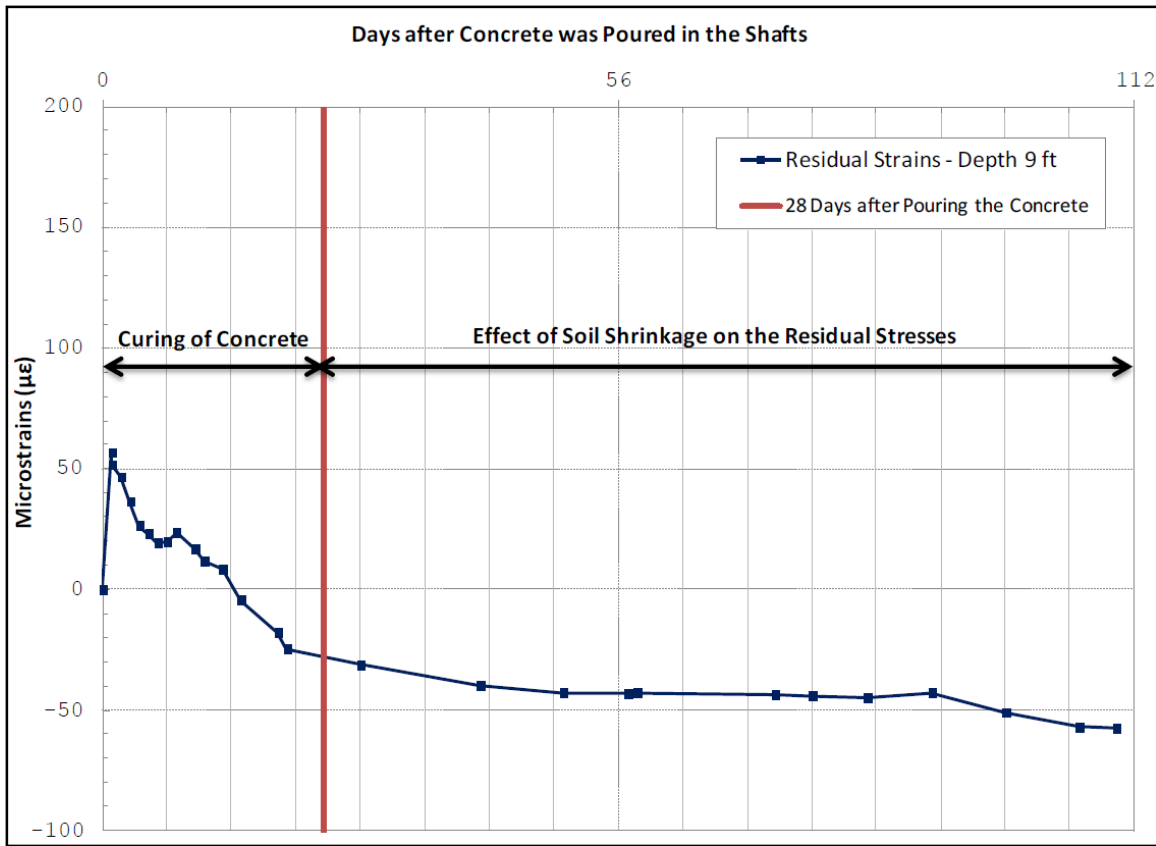
Figure 4.20: Development of residual strains at a depth of 9 feet between shaft construction and excavation (after Koutrouvelis, 2012).

Koutrovelis (2012) attempted to idealize the residual stresses that existed in the concrete of the Manor test wall prior to excavation by interpreting data from the optical strain gauges. The analysis suggested that, on average, our test wall experienced an initial increase in tension followed by a period of compression (Figure 4.20).

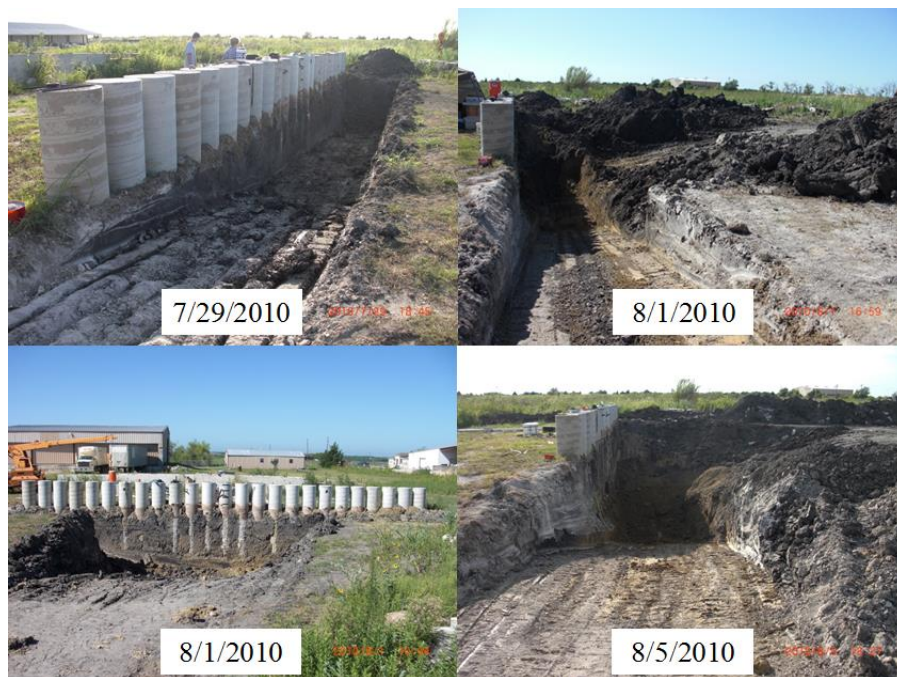
Figure 5.1: Photos of initial excavation progress (7/29/2010 – 8/5/2010).

Excavation of the test wall began on July 29, 2010 and took place over a period of approximately four weeks. The full cantilever height of 14 to 15 feet was reached on August 13, 2010, and the preliminary slopes were completed on August 19, 2010. The slopes were improved on September 30, 2010, and facing was installed on October 8, 2010. Photos of the excavation progress are provided in Figure 5.1 - Figure 5.2.
