**The Behavior of Drilled Shaft Retaining Walls in Expansive Clay Soils**

**Dissertation**

The University of Texas at Austin

**August 2013**

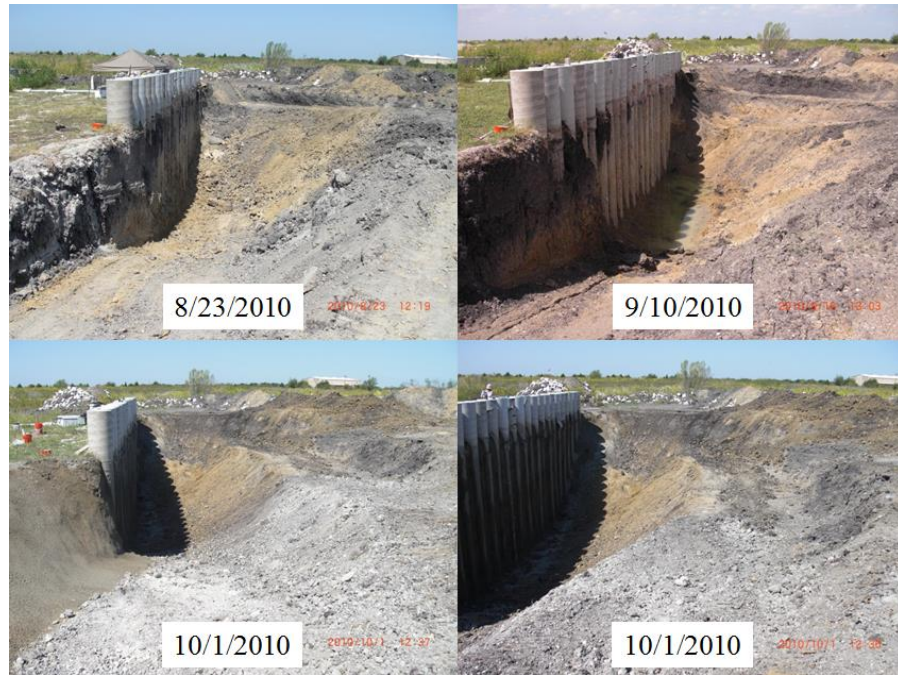
Figure 5.2: Photos of later excavation progress (8/23/2010 - 10/1/2010).

Excavation of the test wall began on July 29, 2010 and took place over a period of approximately four weeks. The full cantilever height of 14 to 15 feet was reached on August 13, 2010, and the preliminary slopes were completed on August 19, 2010. The slopes were improved on September 30, 2010, and facing was installed on October 8, 2010. Photos of the excavation progress are provided in Figure 5.1 - Figure 5.2.

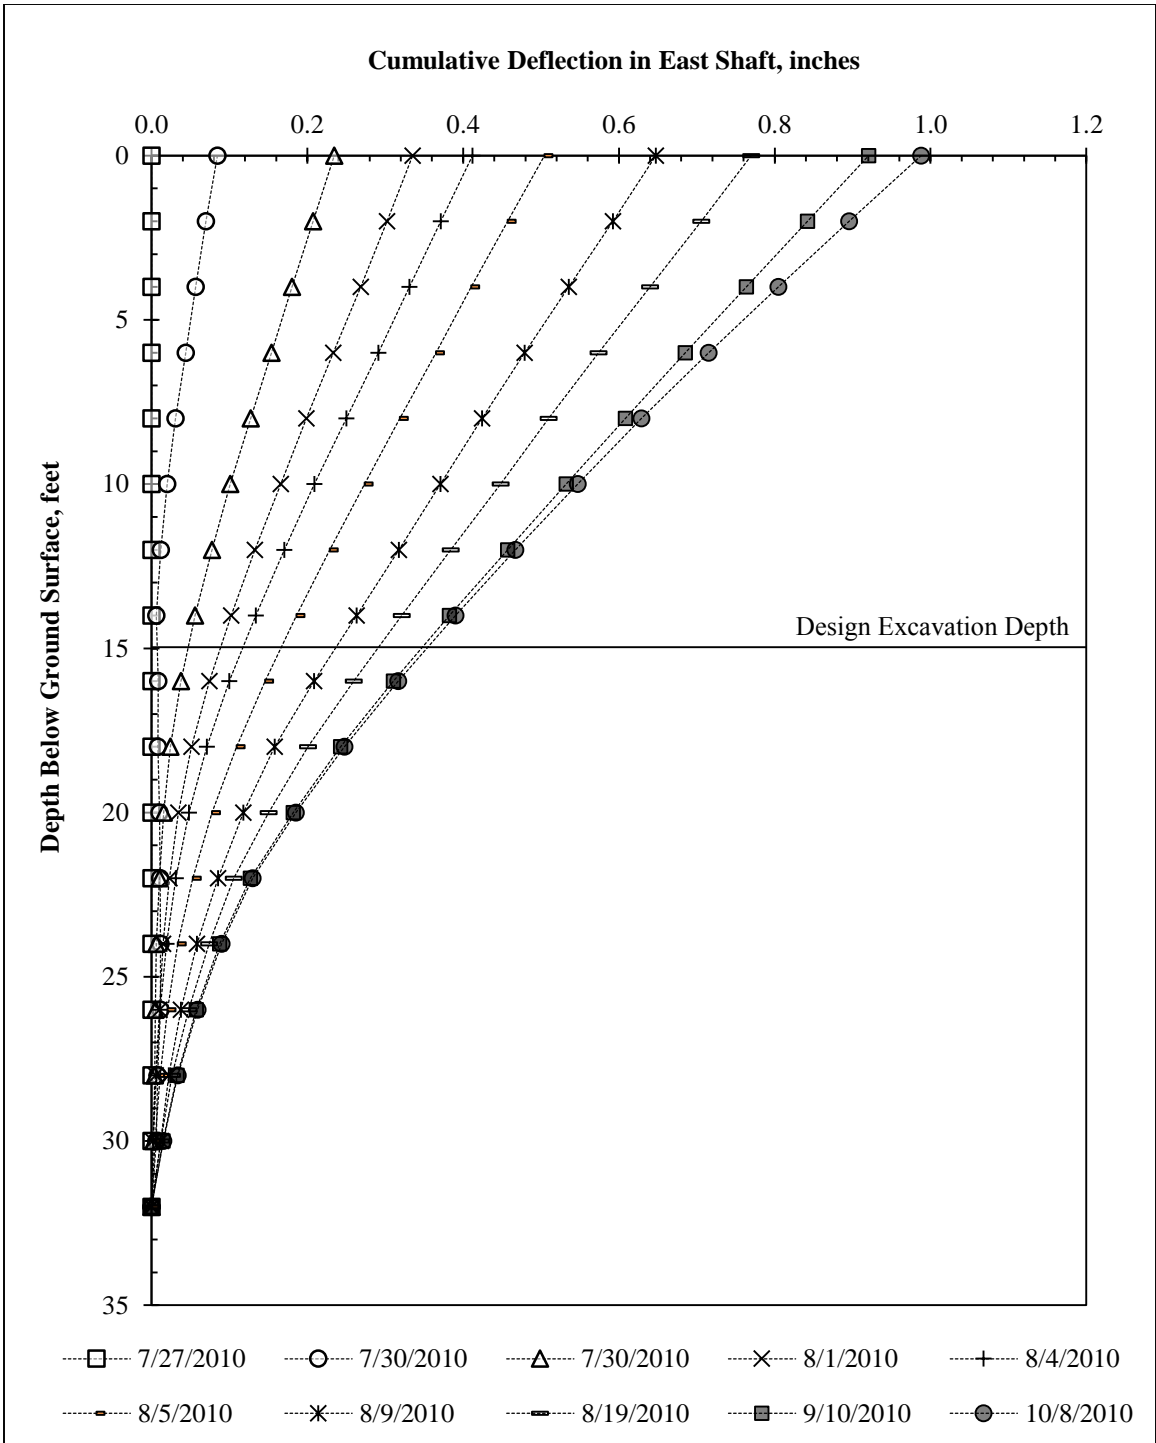
Figure 5.7: Deflected shape of east instrumented shaft at various dates during excavation.

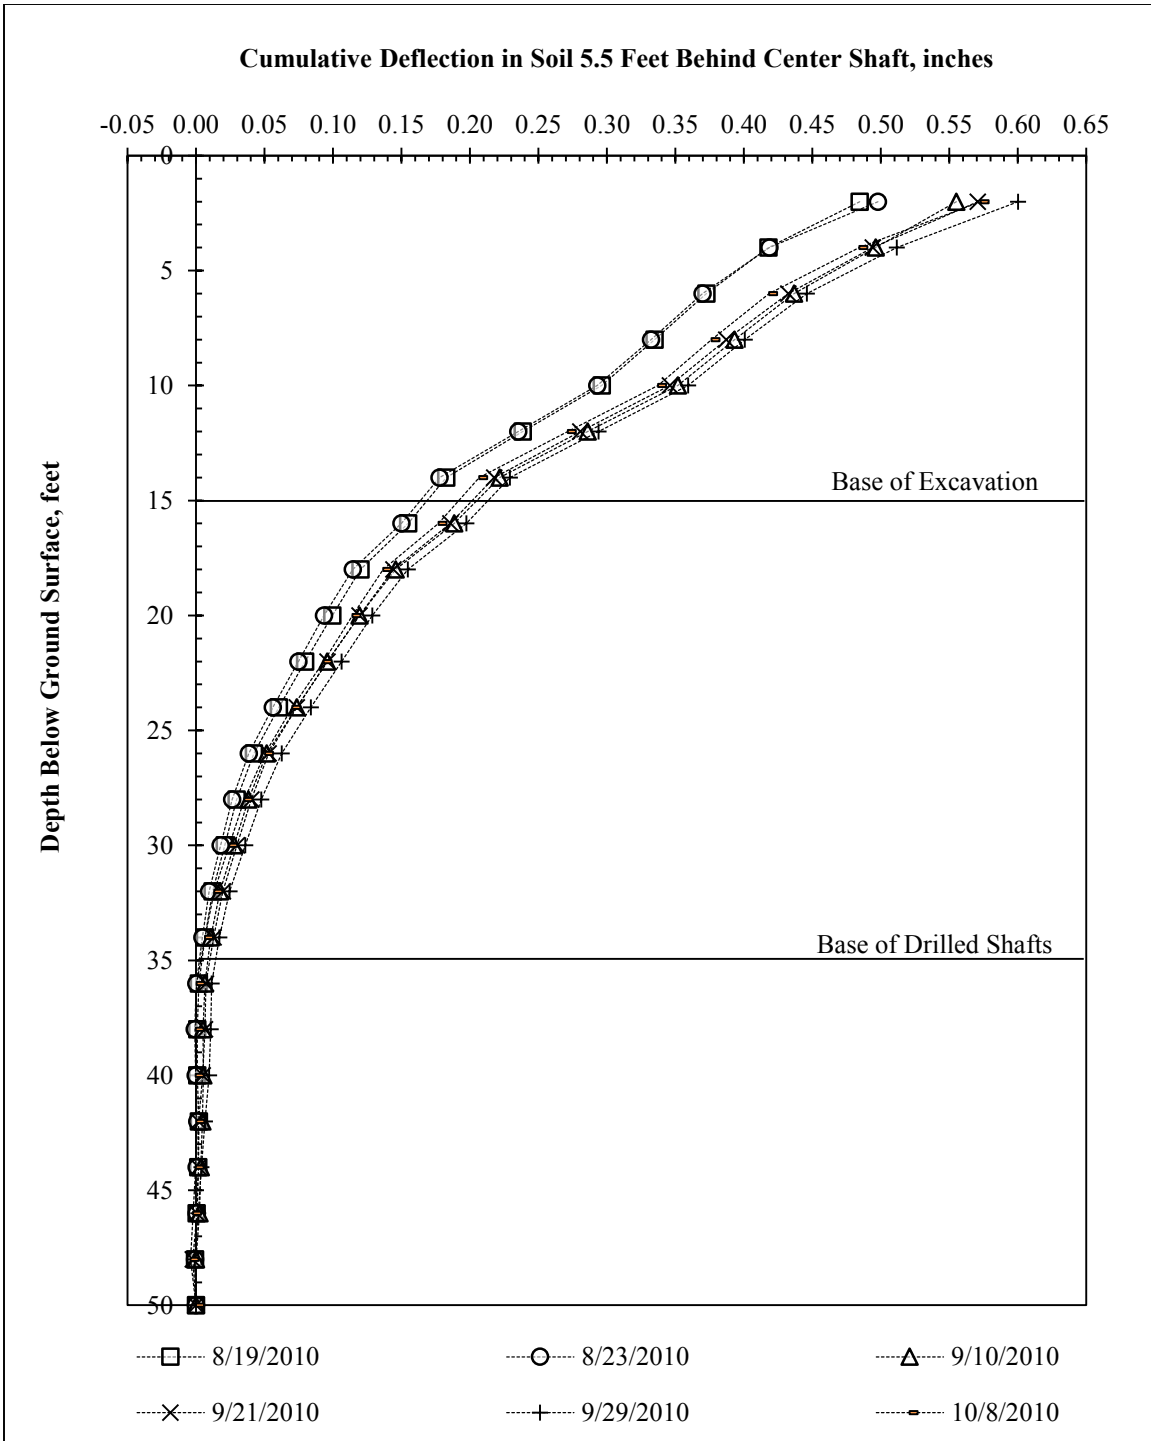
Figure 5.8: Cumulative deflections recorded in inclinometer installed through the soil 5.5 feet behind the center instrumented shaft.

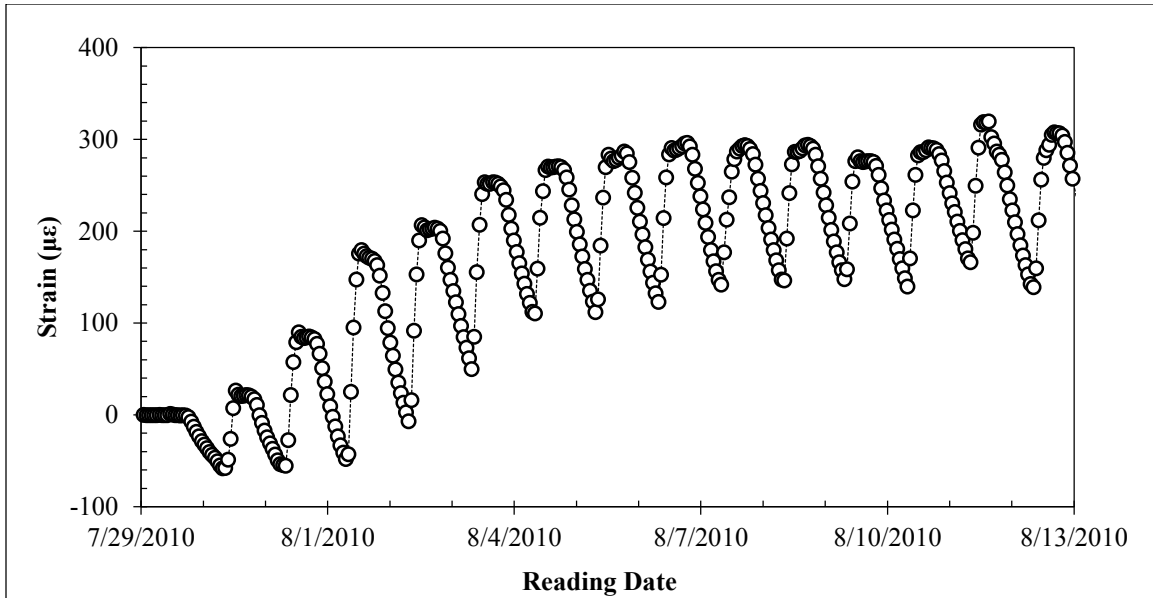
Figure 5.28: Strains related to temperature changes in exposed concrete. Gauge located 1 foot below ground surface on exposed side of wall. Soil at gauge location was excavated on July 29-31.

As concrete was exposed to temperature changes during excavation, gauges on the exposed side of the wall began to register strains consistent with daily temperature fluctuations (Figure 5.28). Additionally, the average daily strain value increased as the shafts were exposed to the high ambient temperatures encountered during excavation. At a depth of 1 foot below ground surface, predicted bending moments are relatively small; the majority of the measured strains at shallow depths appear to be related to temperature increases, rather than increases in bending curvature caused by earth pressure loading. When strain gauge data are compared with daily temperature data, the strain gauges on the exposed side of the test wall register approximately 7 to 8 microstrains per degree Fahrenheit. Thermal strains will be analyzed in more detail in subsequent chapters.

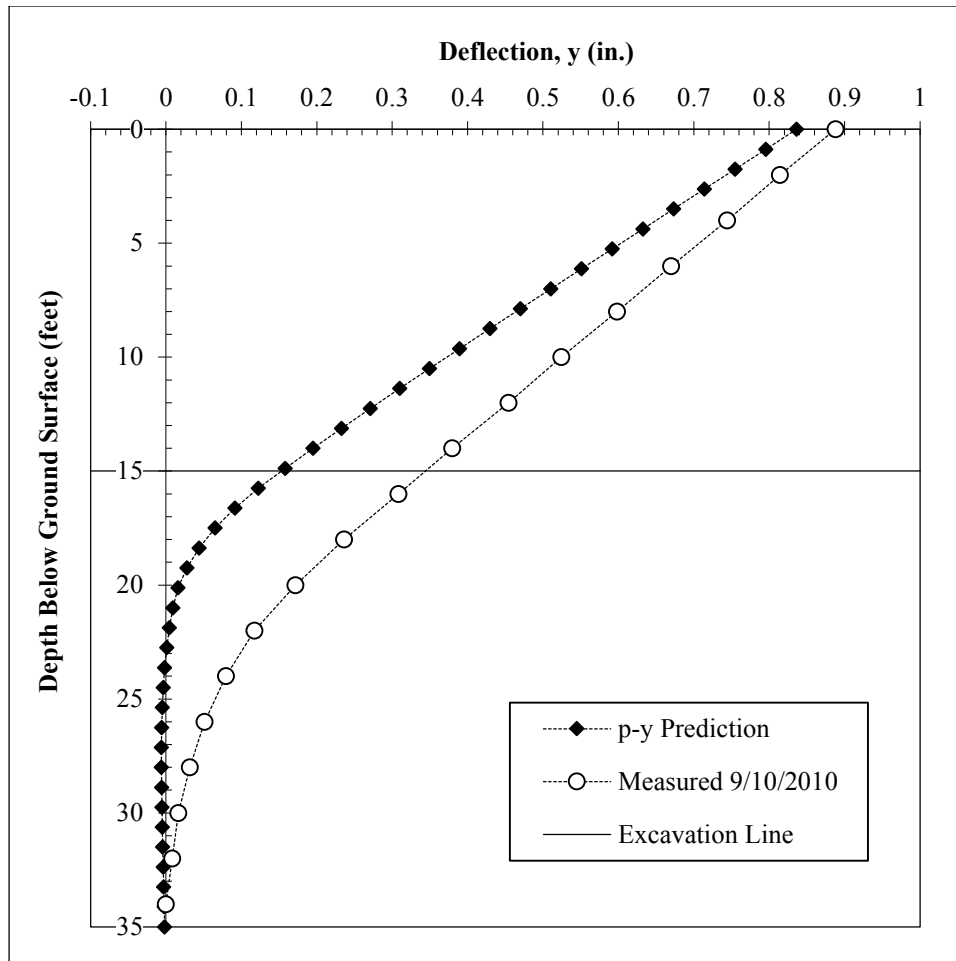
Figure 5.29: Comparison of p-y prediction with measured field data. P-y analysis used a triangular earth pressure distribution of 40 psf/ft.

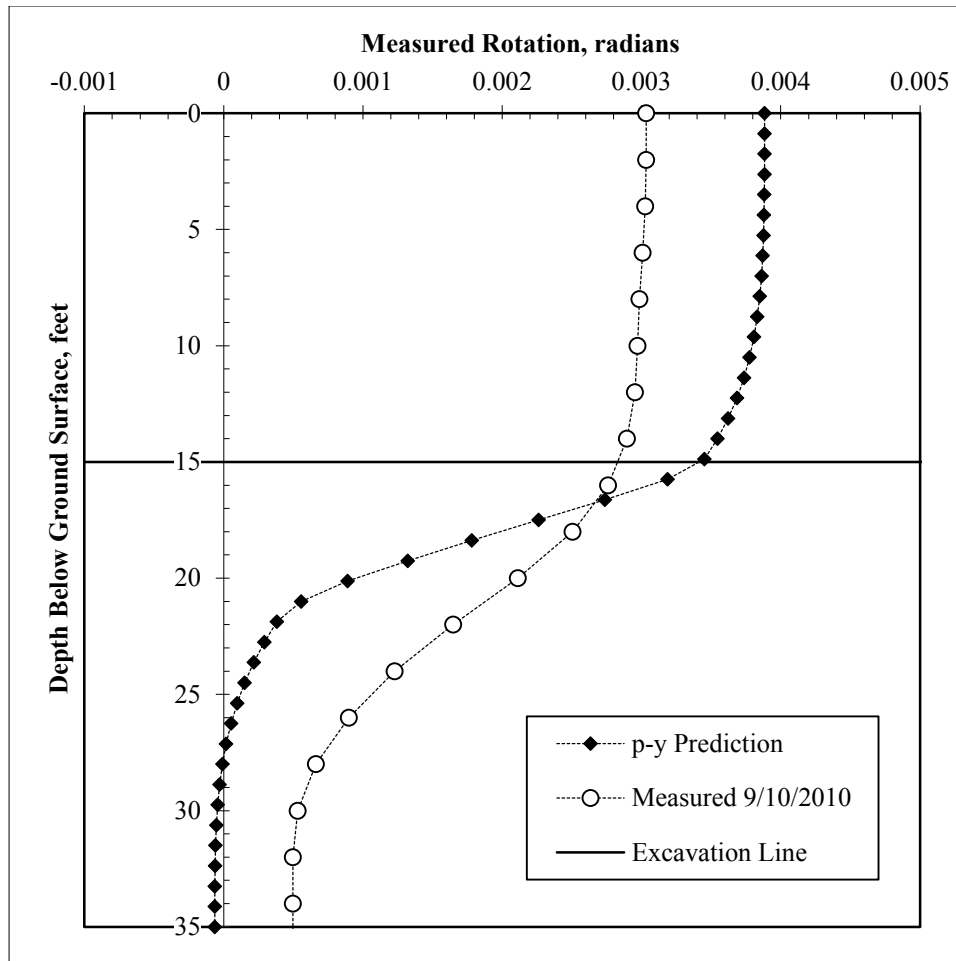
Figure 5.30: Comparison of predicted and measured shaft rotation profiles induced by removal of soil during excavation.

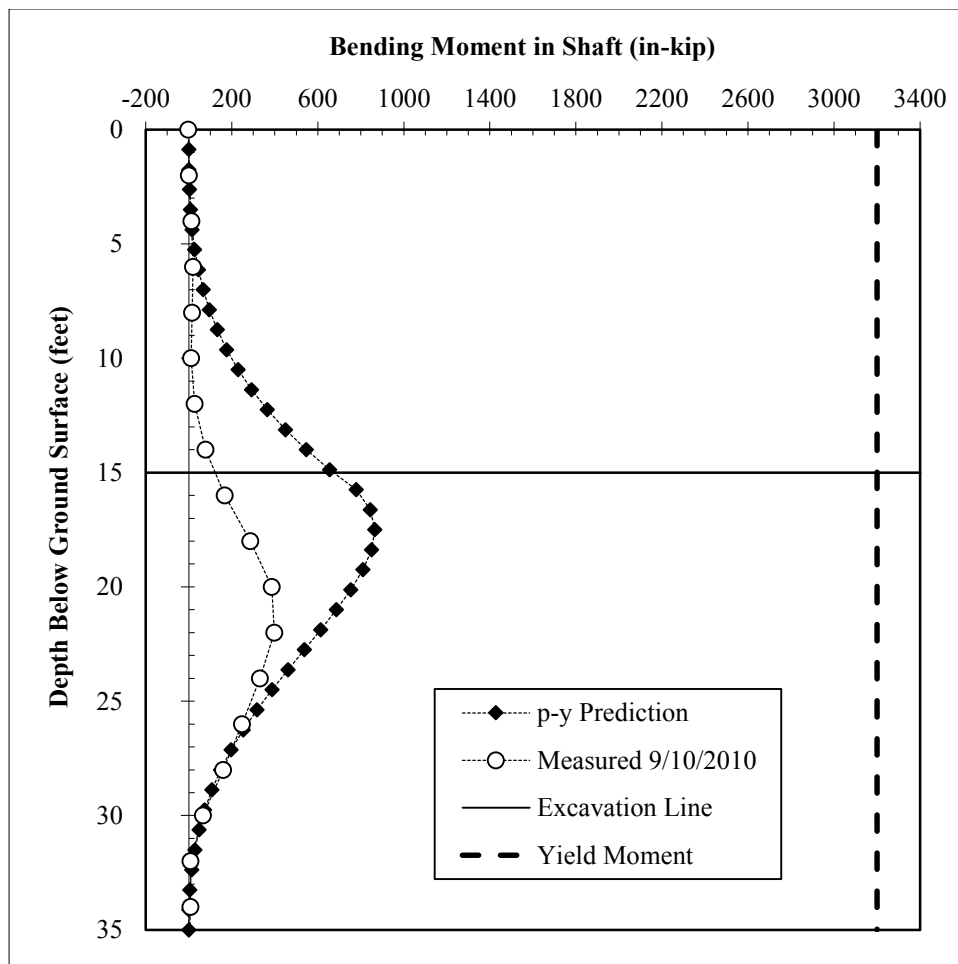
Figure 5.31: Comparison of predicted and measured bending moment profiles induced by removal of soil during excavation.

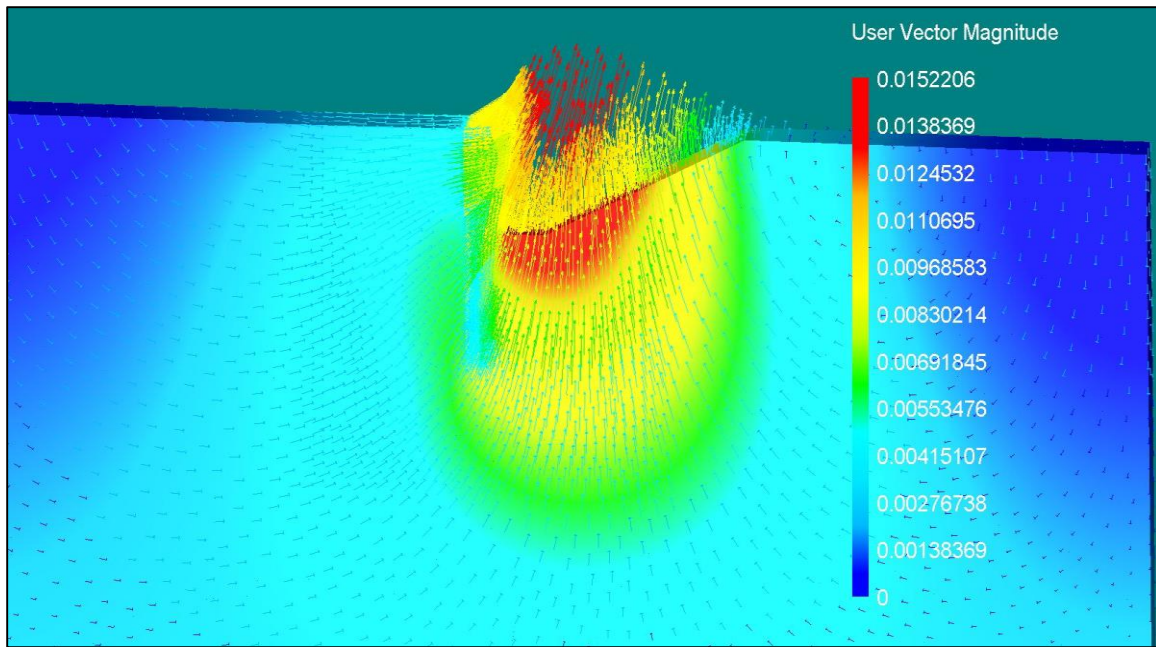
Figure 5.32: Global response to removal of soil in linear elastic FEM.

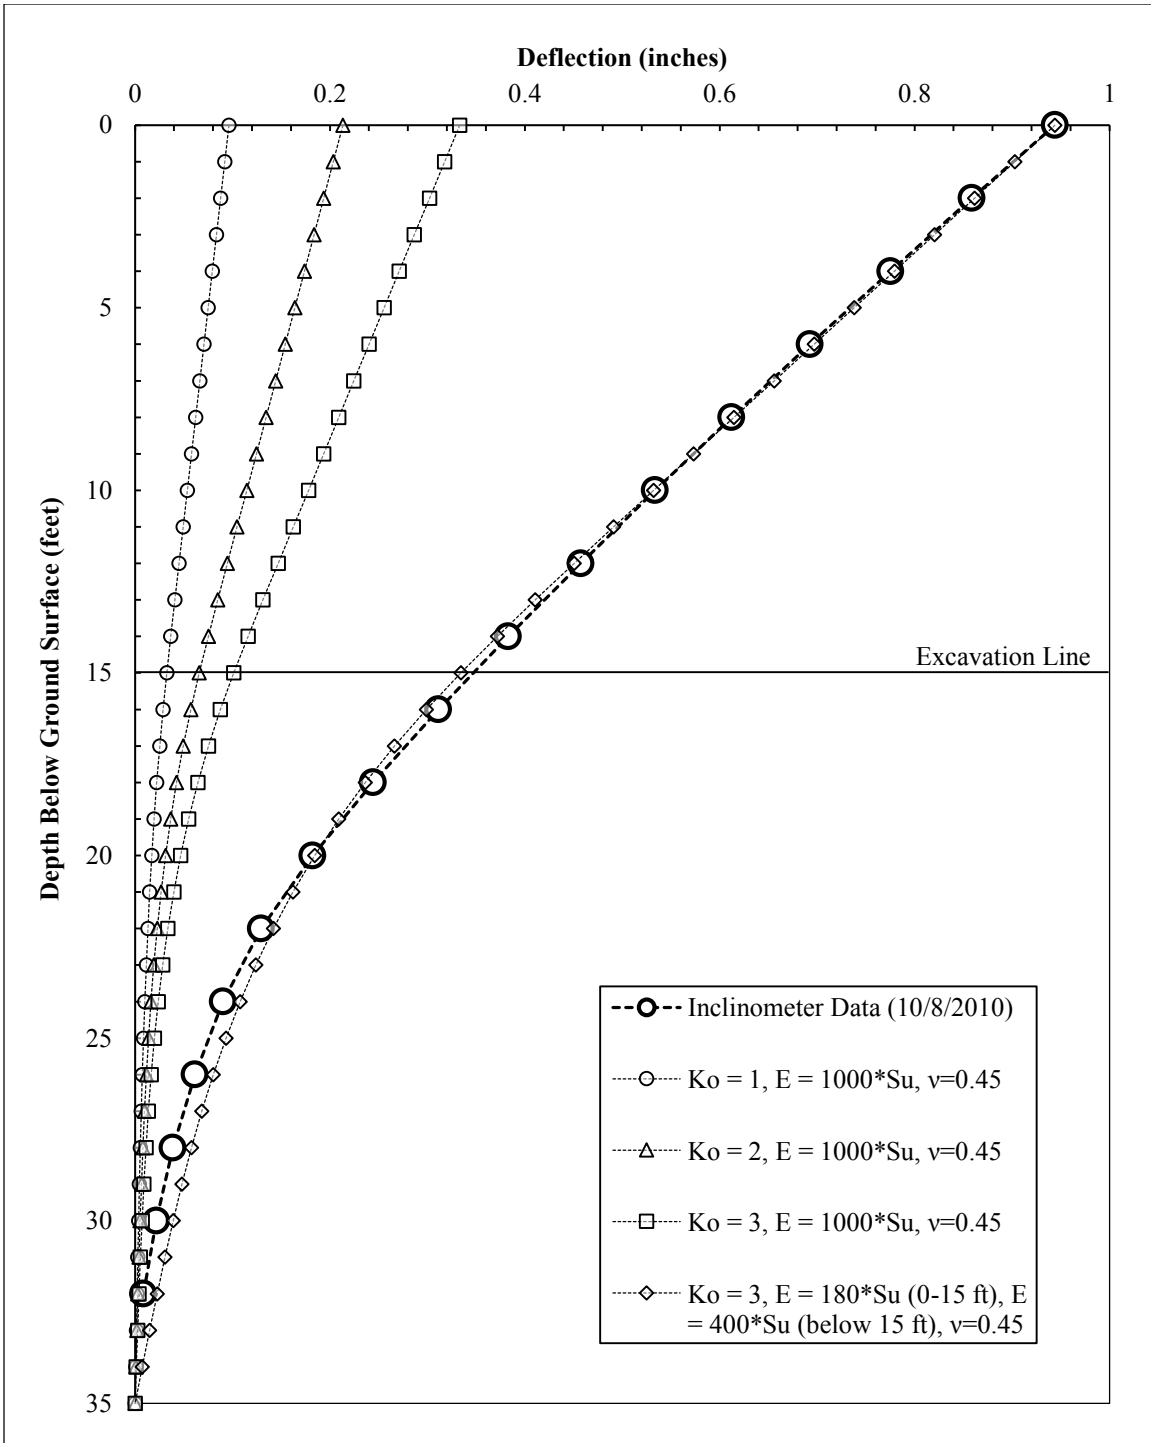
Figure 5.34: Comparison of linear elastic finite element model predictions with measured field data.

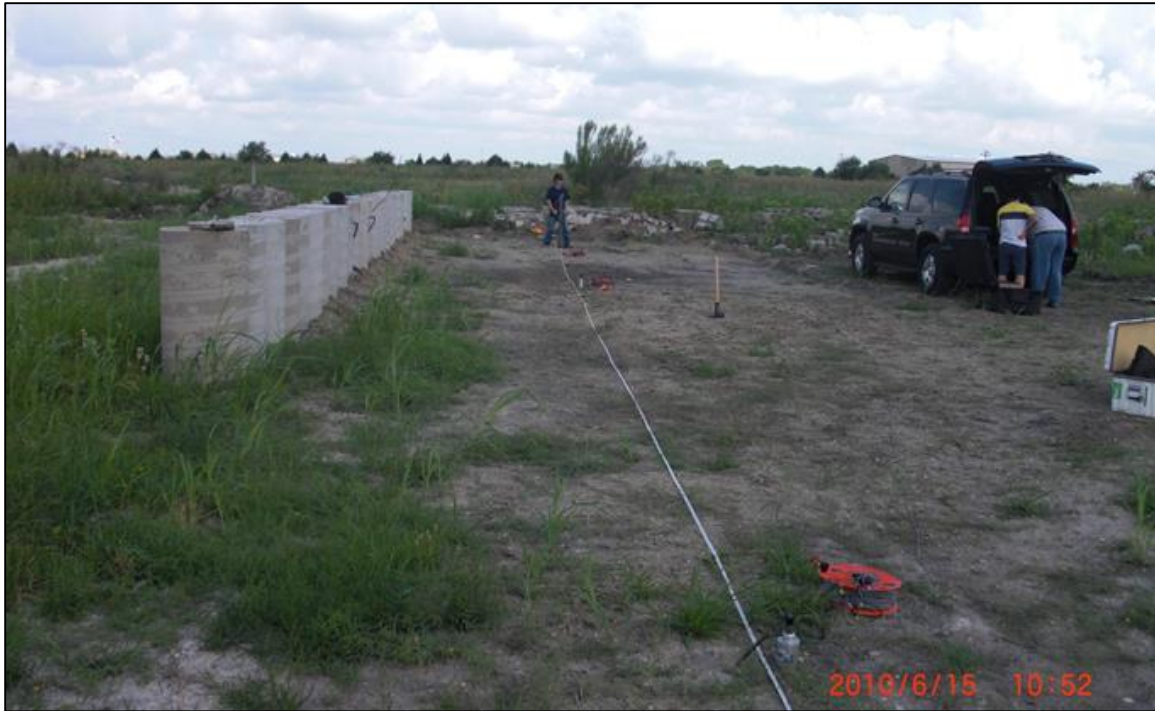
Figure 5.35: SASW testing at the test wall prior to excavation, June 2010.

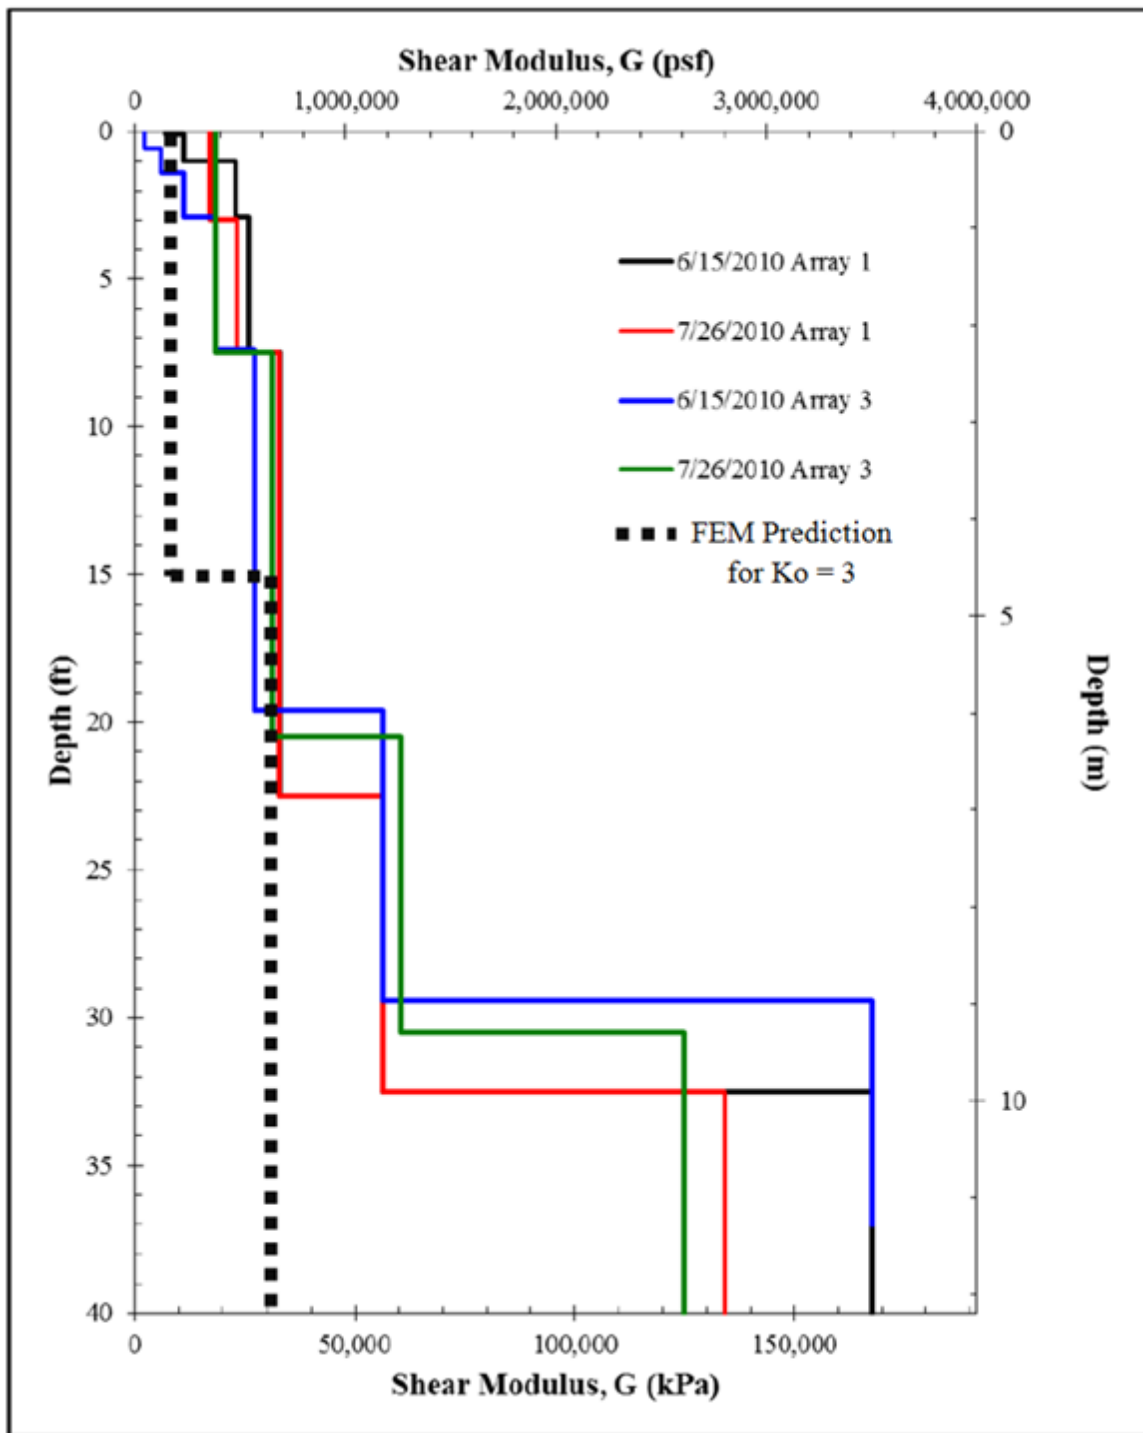
Figure 5.36: Comparison of measured shear modulus profiles from SASW testing with finite element model prediction (after Ellis, 2011).

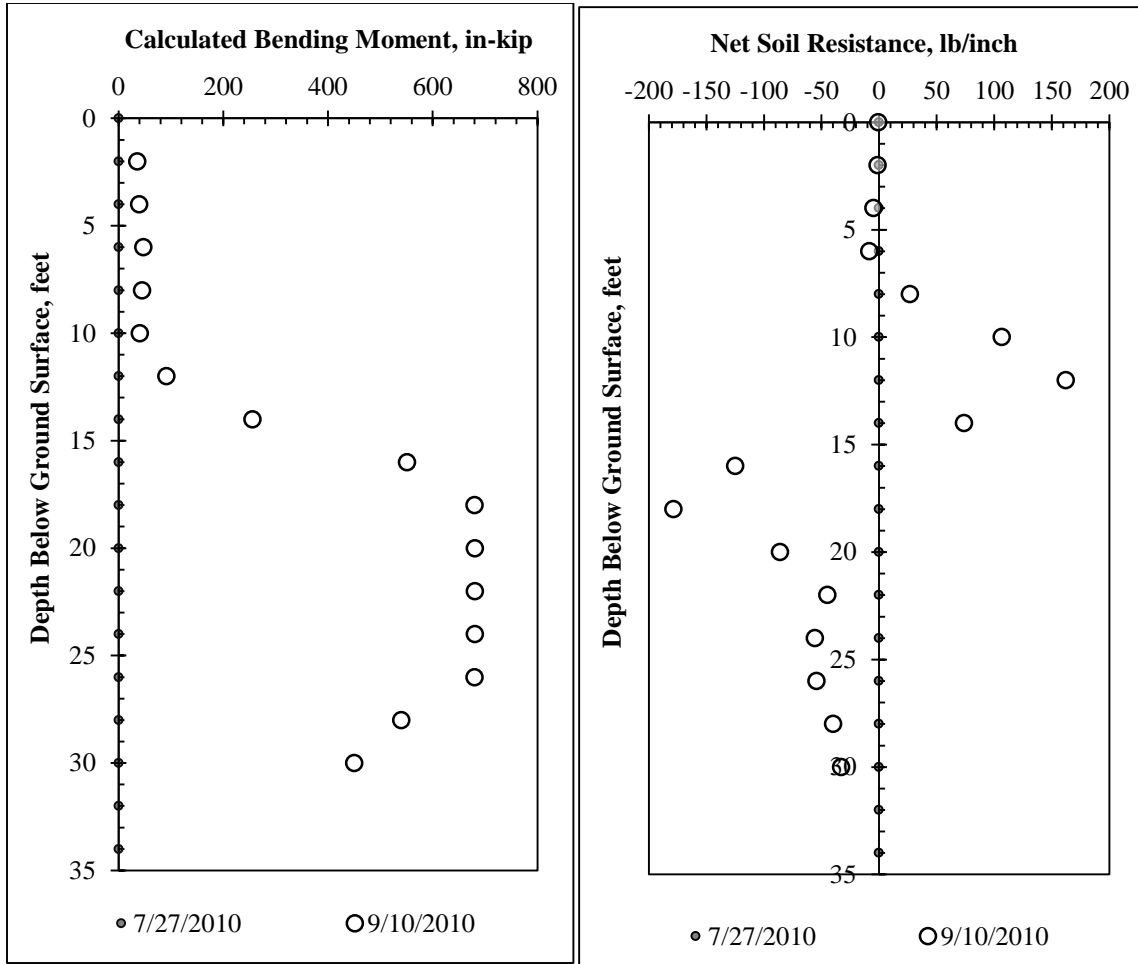
Figure 5.37: Calculated values of bending moment and net soil resistance during excavation, based on measured rotation profiles from inclinometer data.

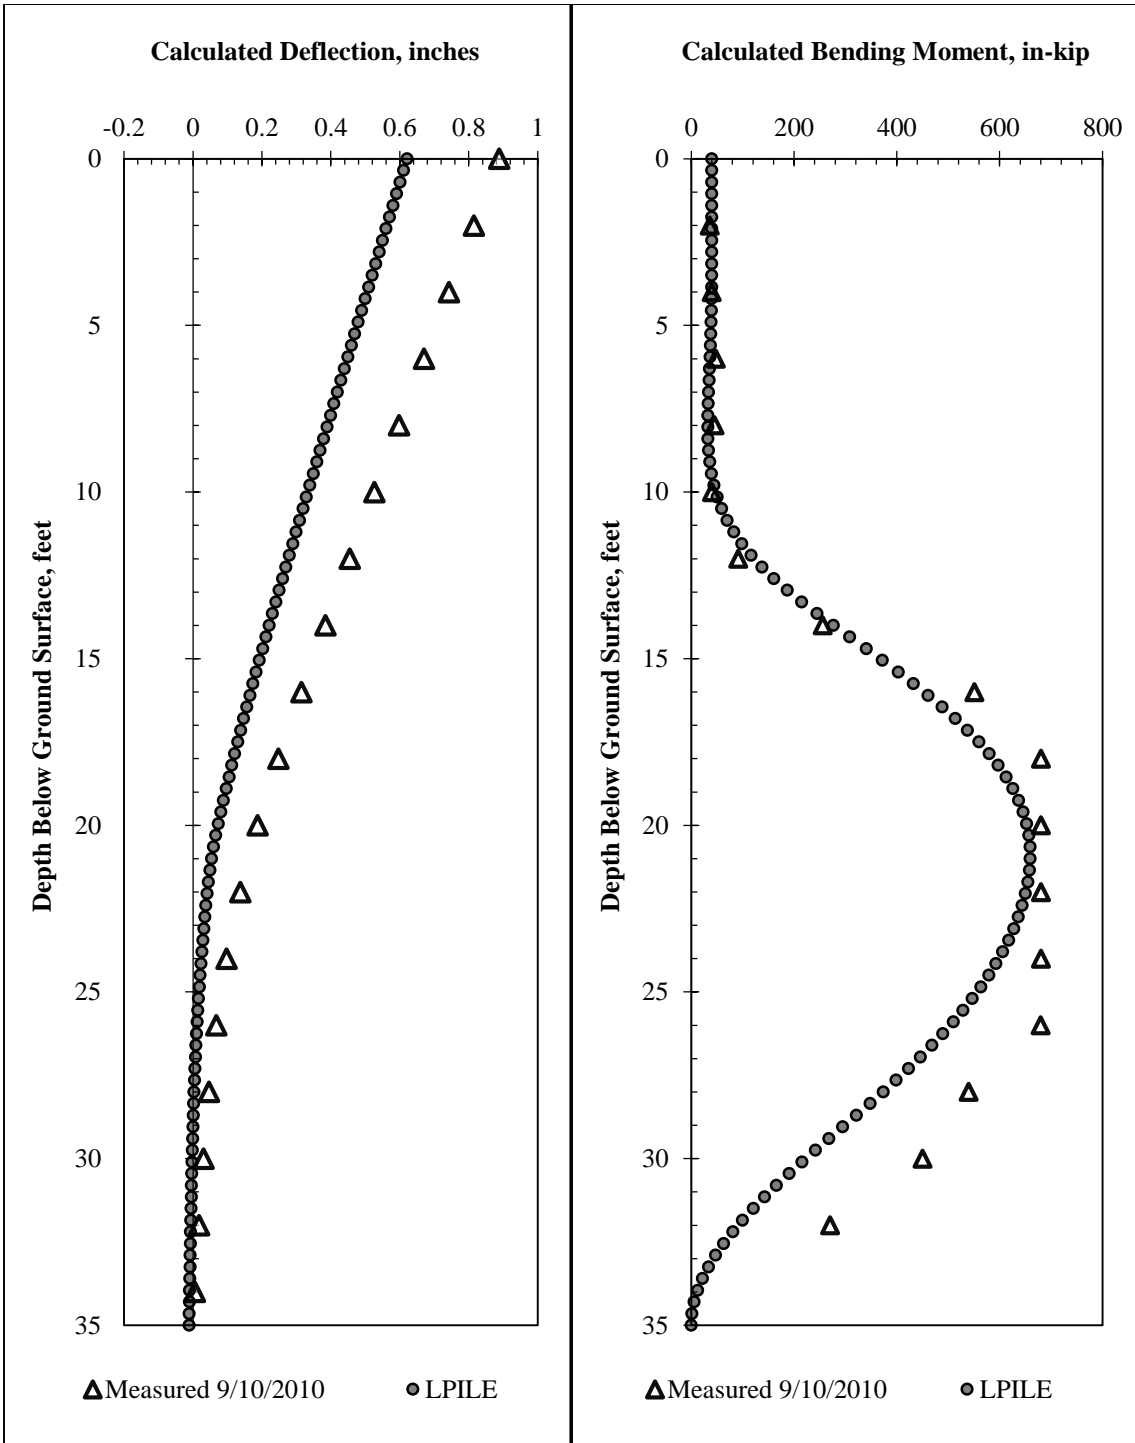
Figure 5.42: Comparison of measured and calculated profiles of deflection and bending moment in advanced LPILE analysis.

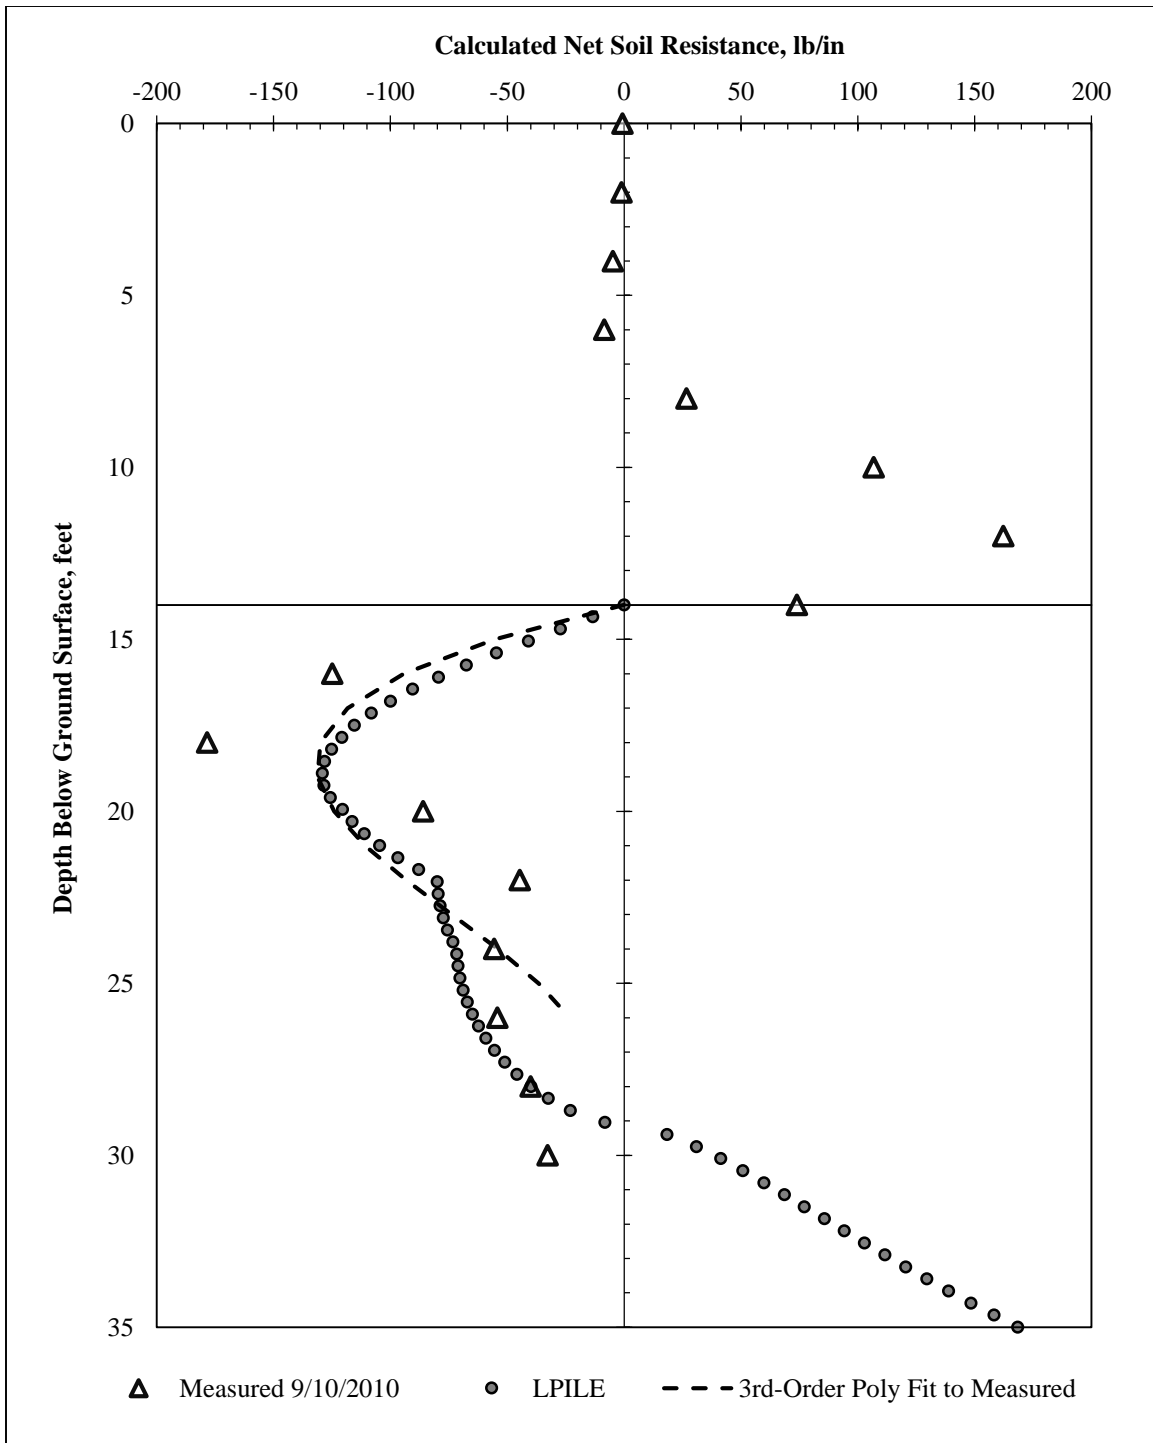
Figure 5.43: Comparison of measured and calculated profiles of soil resistance in advanced LPILE analysis.

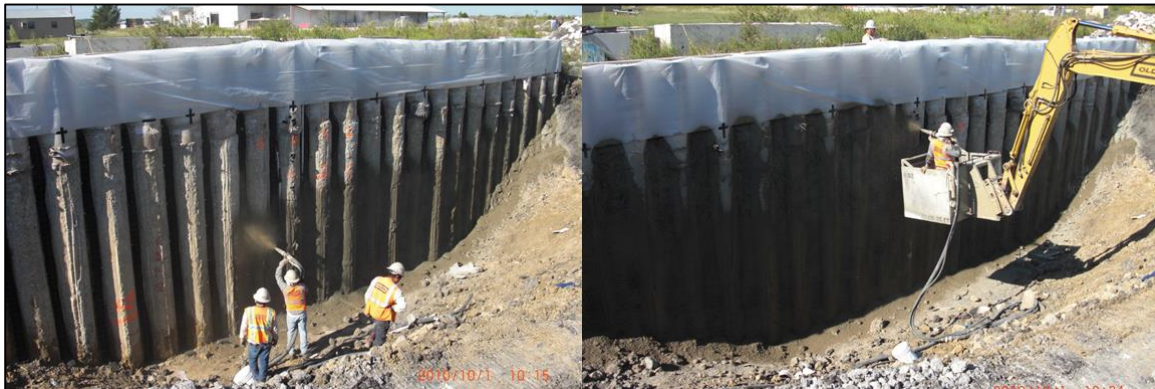
Figure 6.1: Installation of Shotcrete Facing on October 1, 2010.

To prevent soil erosion from between the shafts and provide consistency with design practice, shotcrete facing material was installed on October 1, 2010 (Figure 6.1).

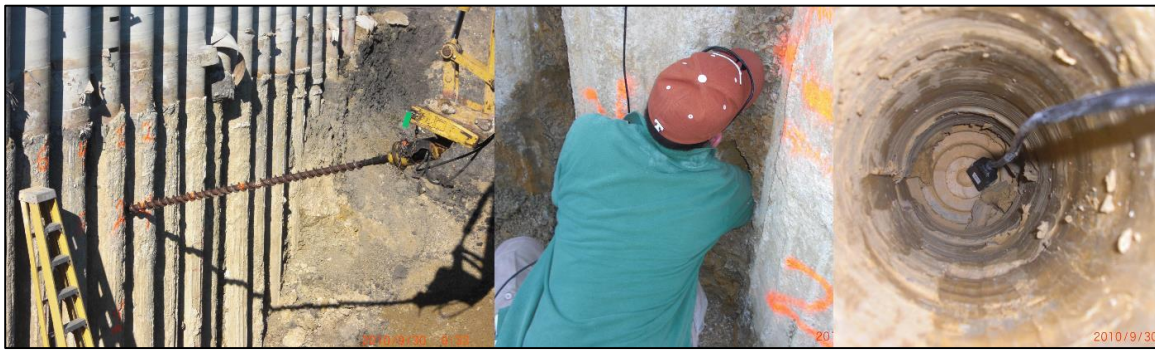
Figure 6.2: Installation of TDR Moisture Probes Behind Wall Facing.

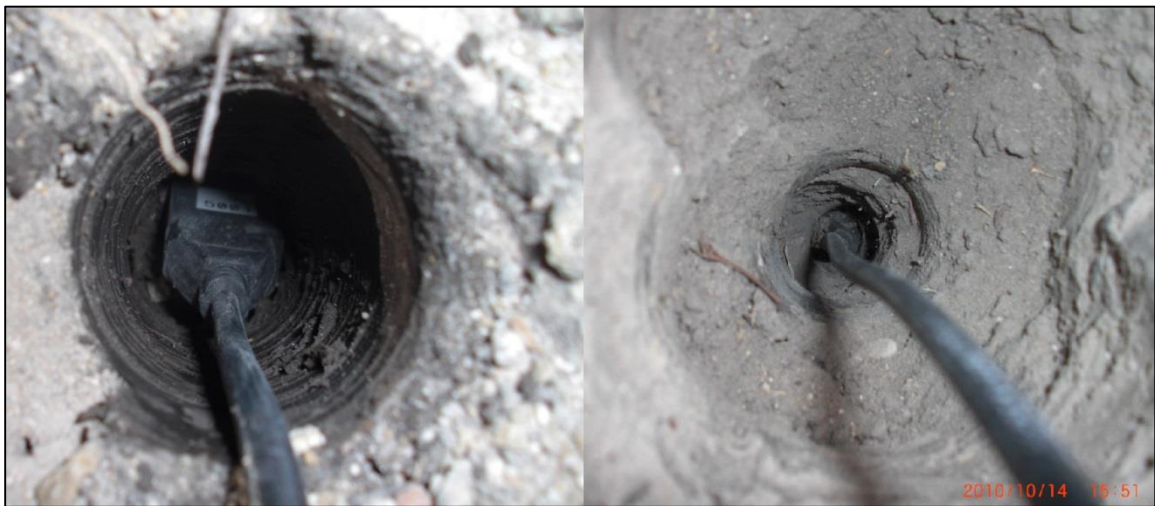
Figure 6.3: Installation of TDR Moisture Probes Through Ground Surface.

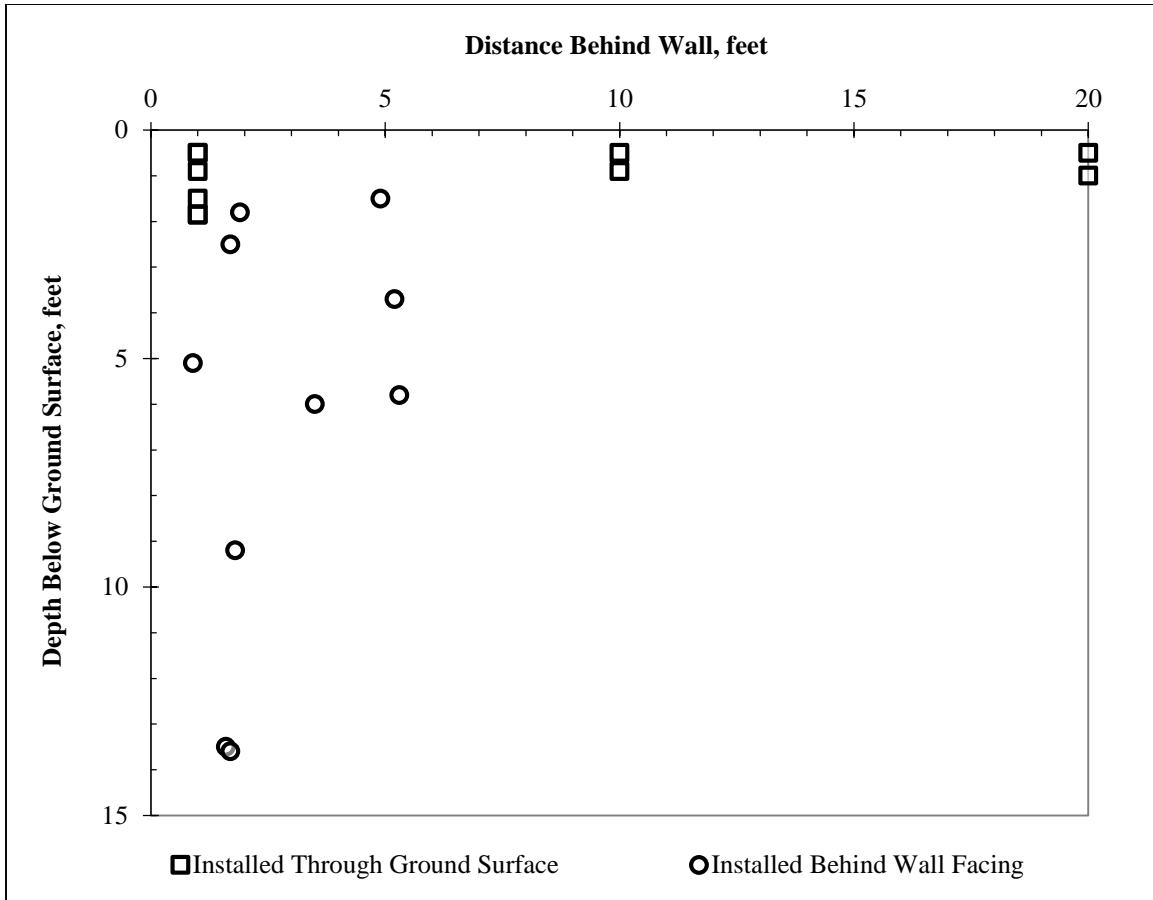
Figure 6.4: Approximate Locations of TDR Moisture Probes.

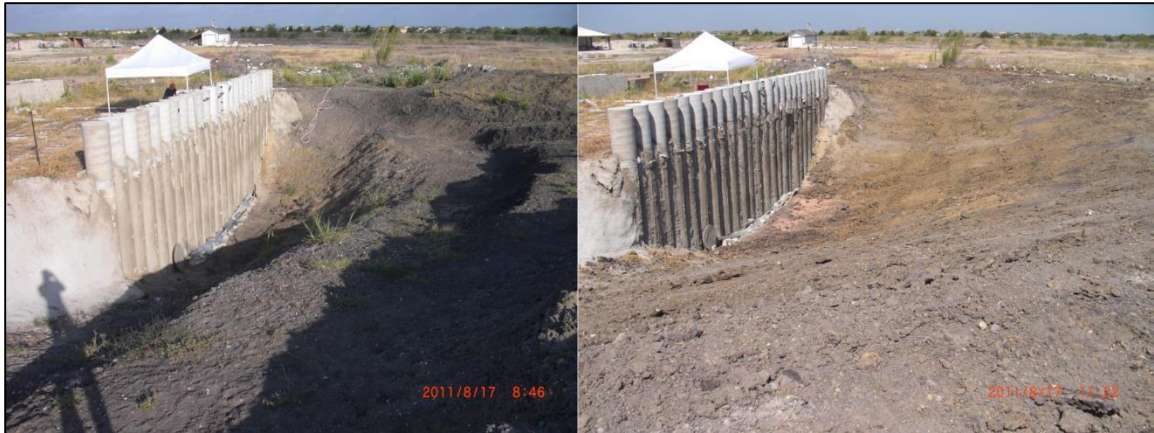
Figure 6.5: Excavation slopes are reshaped on August 17, 2011.

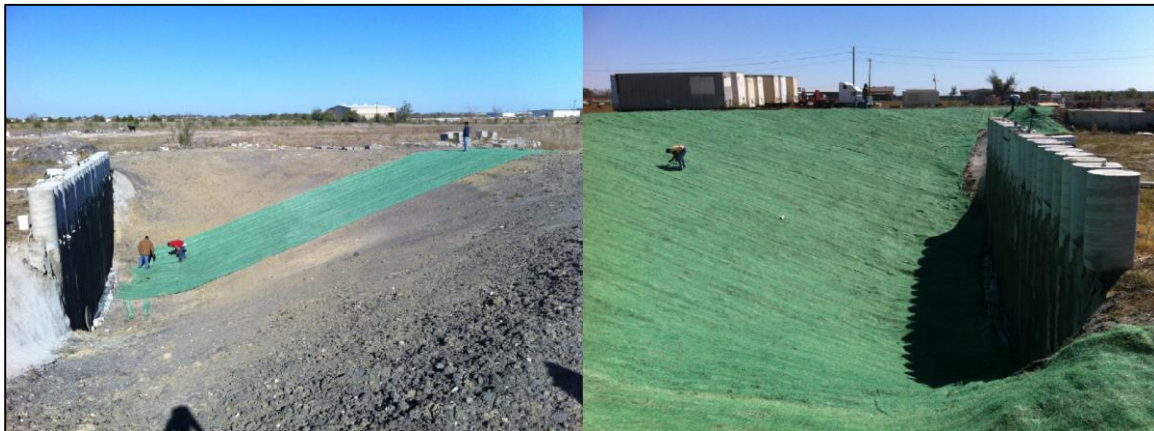
Figure 6.6: Erosion control material is installed on October 18, 2011.

On August 17, 2011, the slopes were reshaped to reduce erosion and prevent surface water from draining into the excavation (Figure 6.5). On October 8, 2011, erosion control material was installed (Figure 6.6).

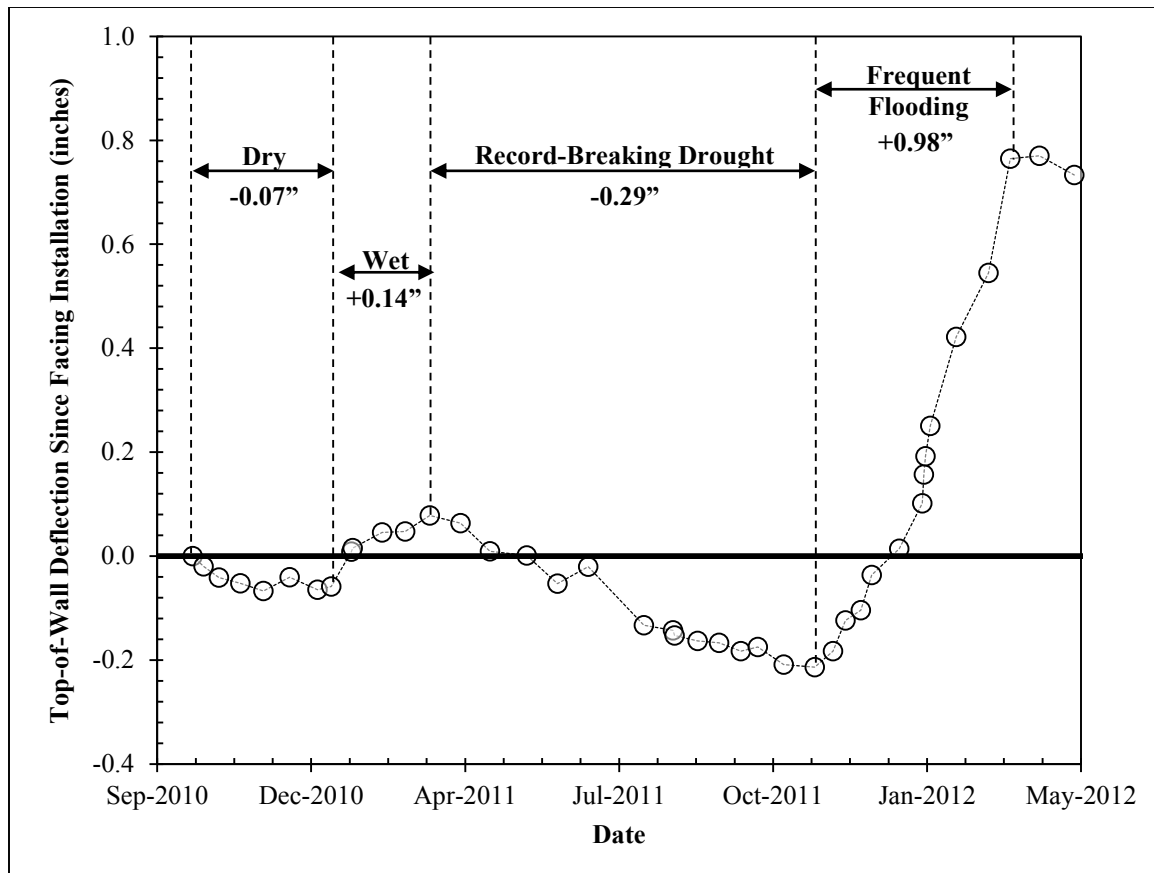
Figure 6.9: Variation of top-of-wall deflection with natural moisture cycles. Deflections are referenced to installation of facing on October 8, 2010.

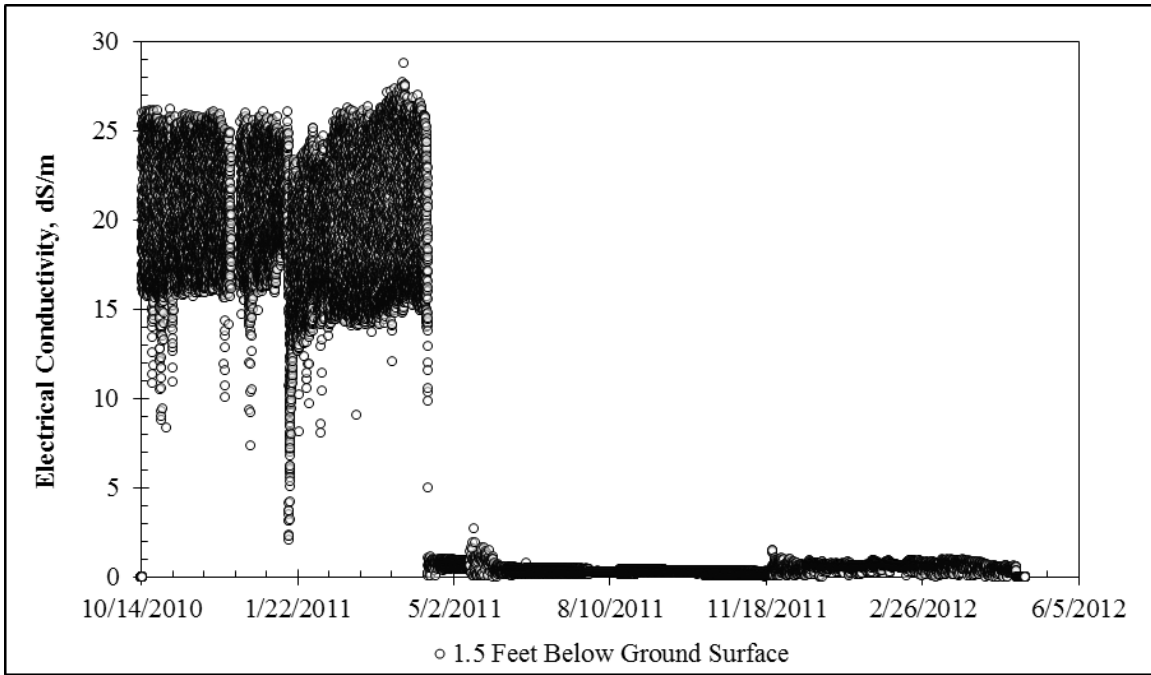
Figure 6.10: Electrical conductivity data from a TDR probe located 1.5 feet below ground surface (Oct. 2010 – Apr. 2012).
