**The Behavior of Drilled Shaft Retaining Walls in Expansive Clay Soils**

**Dissertation**

The University of Texas at Austin

**August 2013**

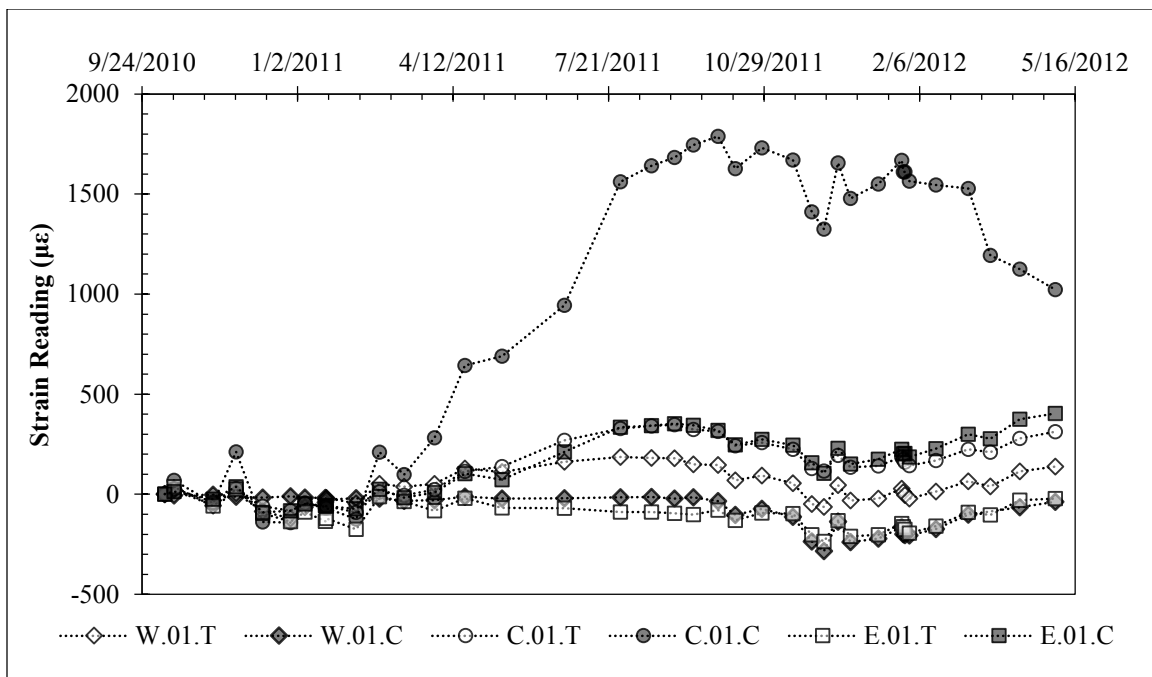
Figure 6.12: Strain Data 1 Foot Below Ground Surface (Oct. 2010 – Apr. 2012).

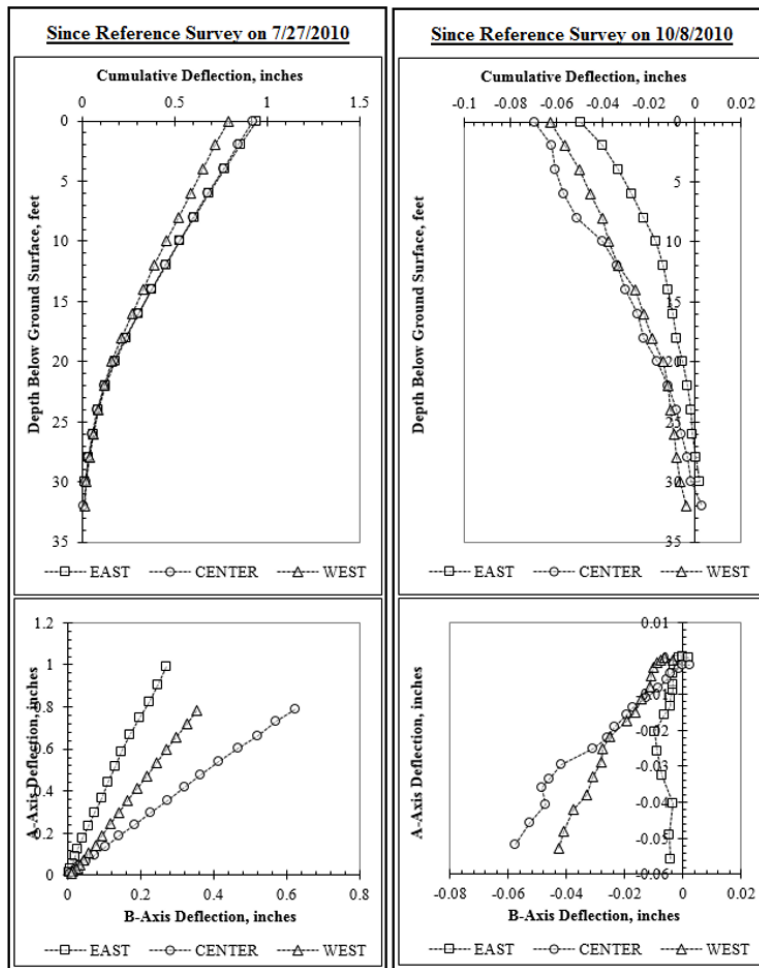
Figure 6.27: Inclinometer Data from January 6, 2011.

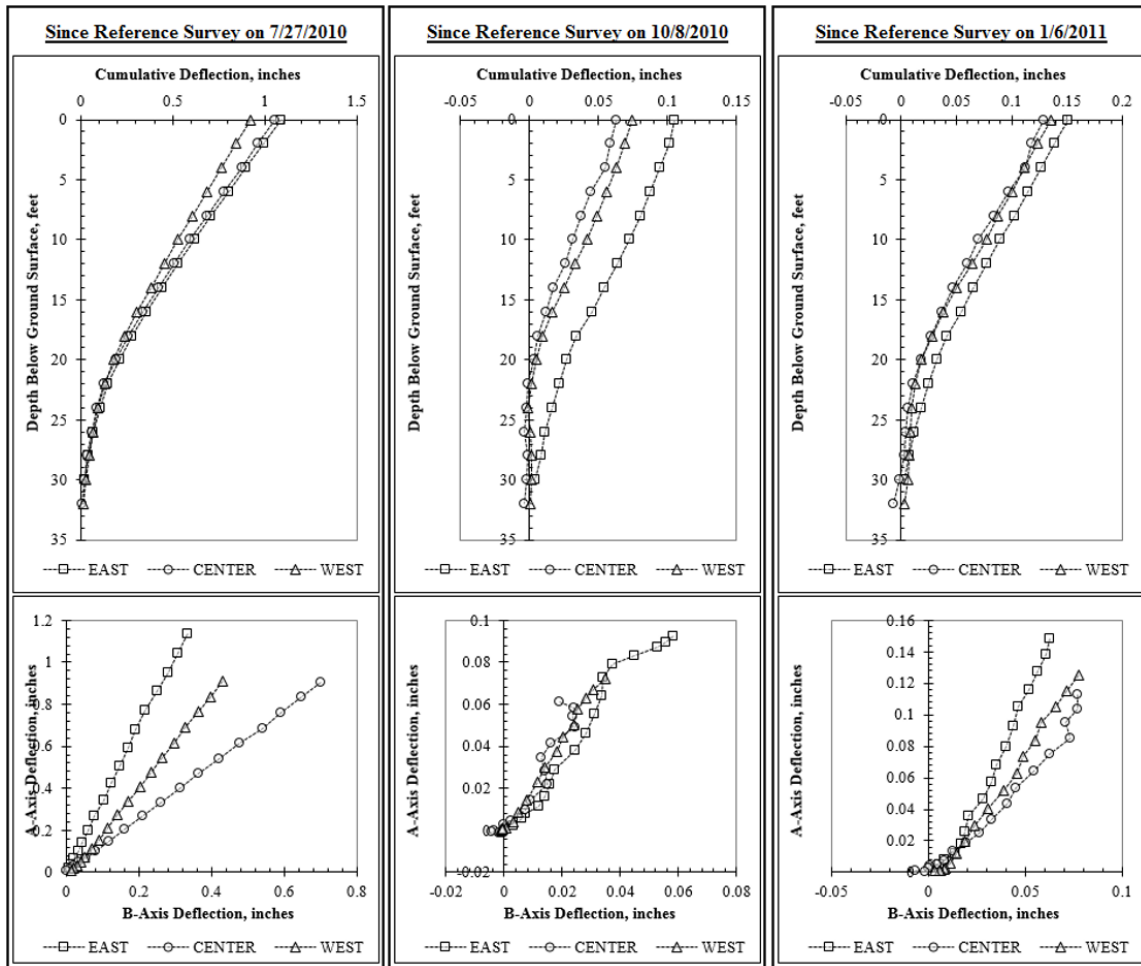
Figure 6.28: Inclinometer Data from March 11, 2011.

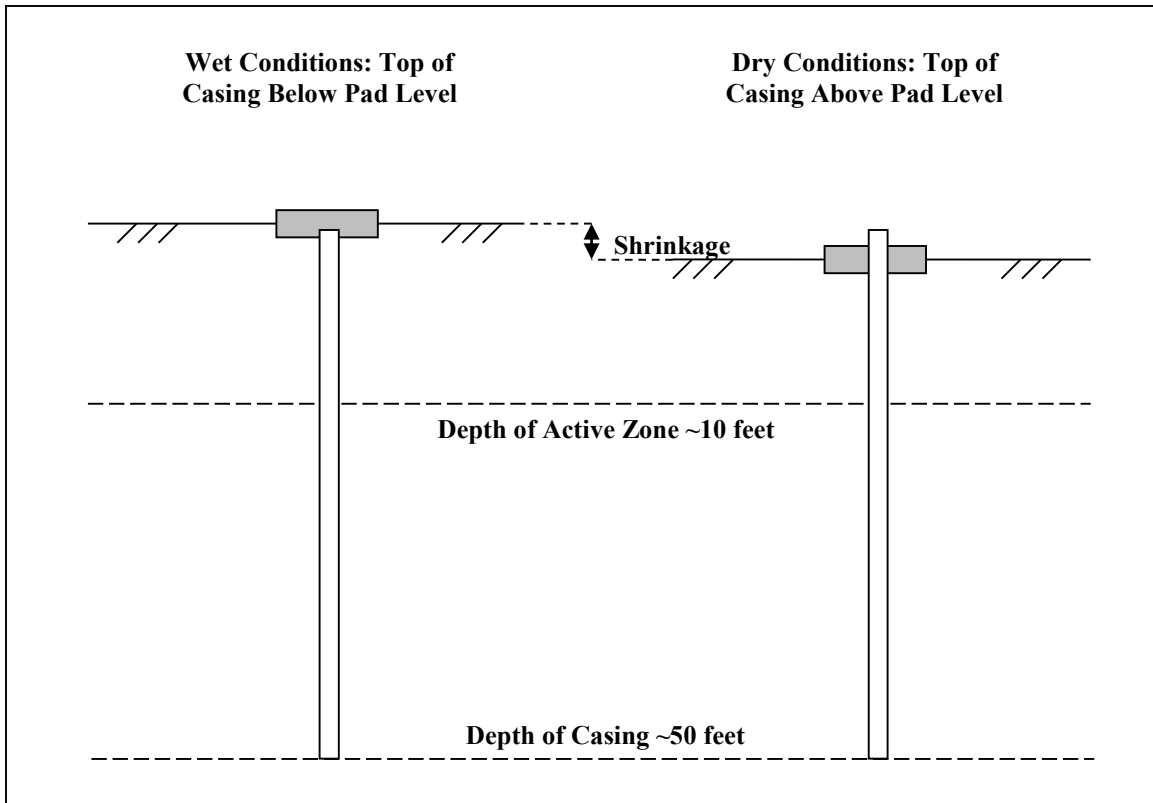
Figure 6.29: The use of a deep inclinometer casing and concrete pad as a qualitative indicator of soil shrinkage near the test wall (not to scale).

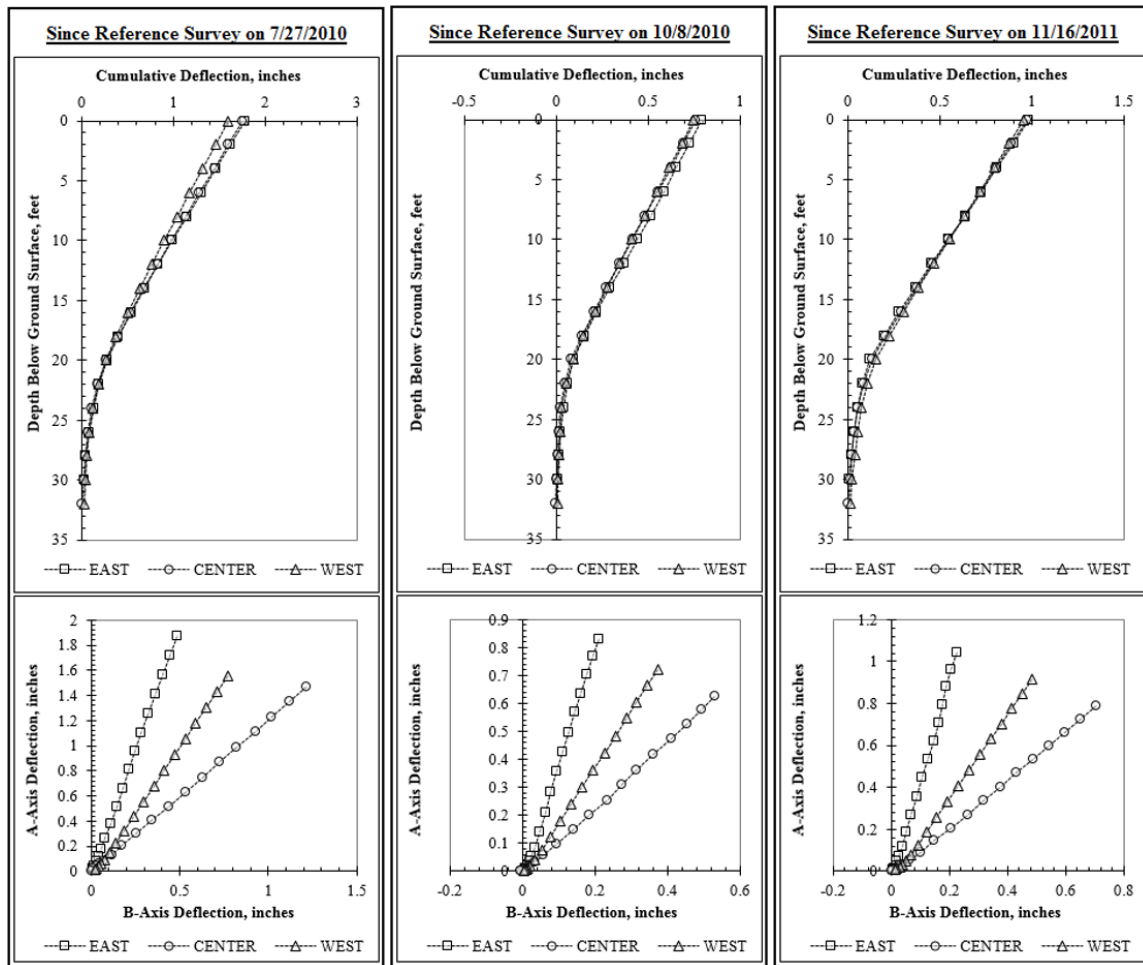
Figure 6.31: Inclinometer Data from April 10, 2012.

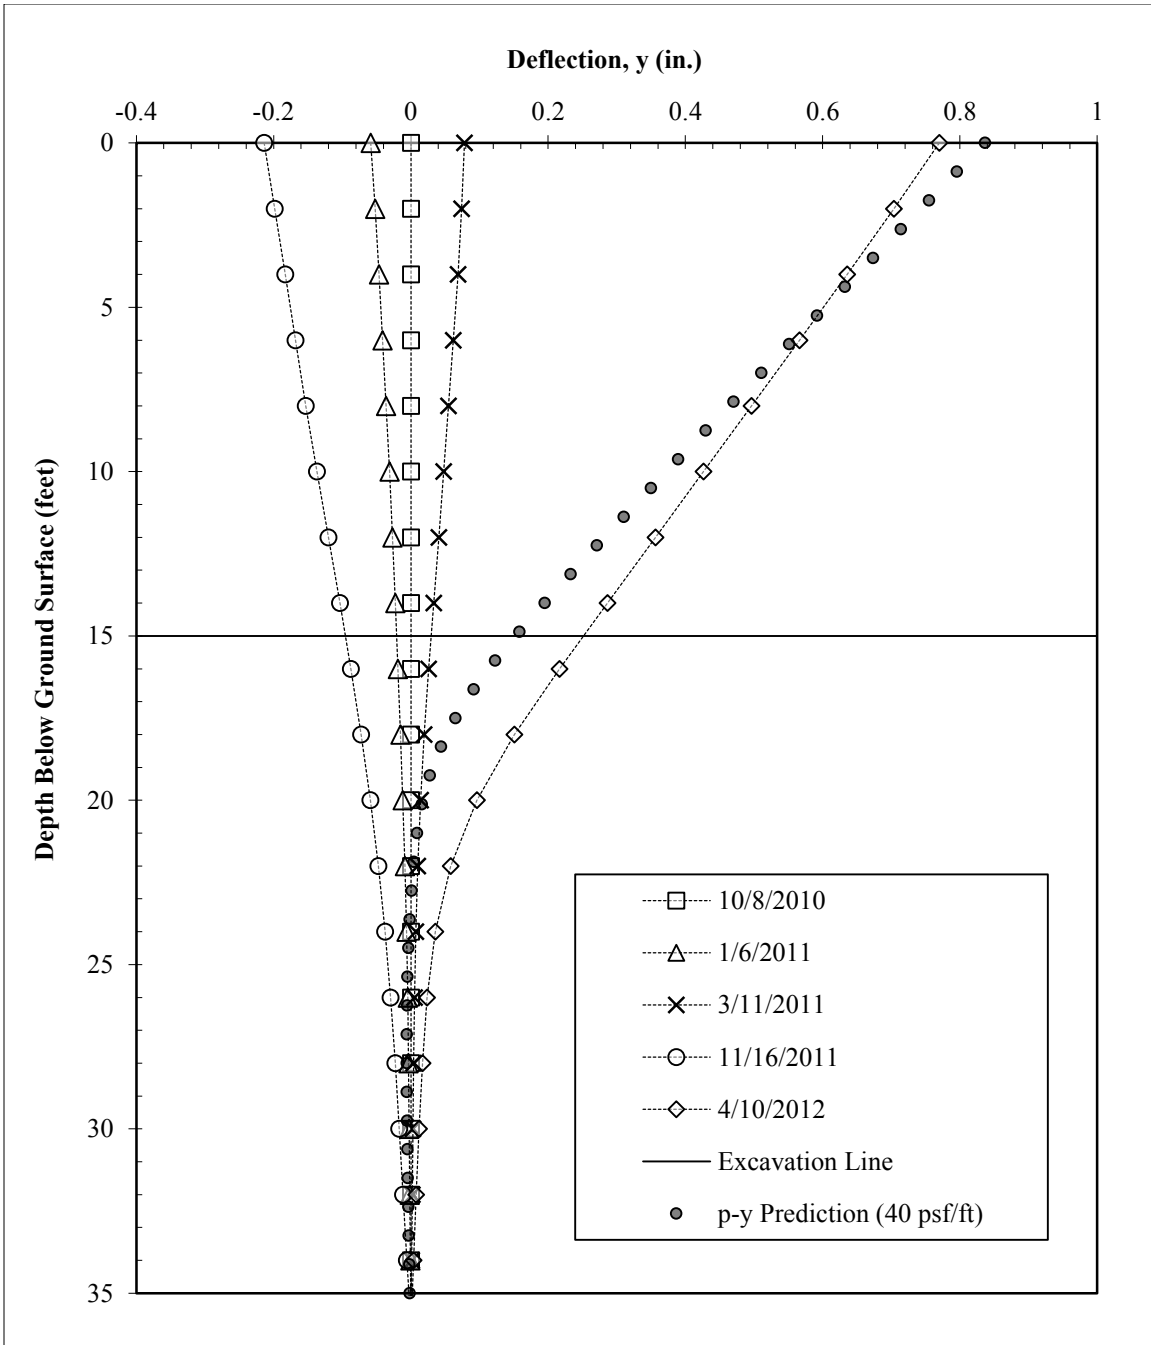
Figure 6.32: Deflected shapes of test wall at key dates, referenced to the installation of facing on October 8, 2010, compared with the initial p-y design analysis.

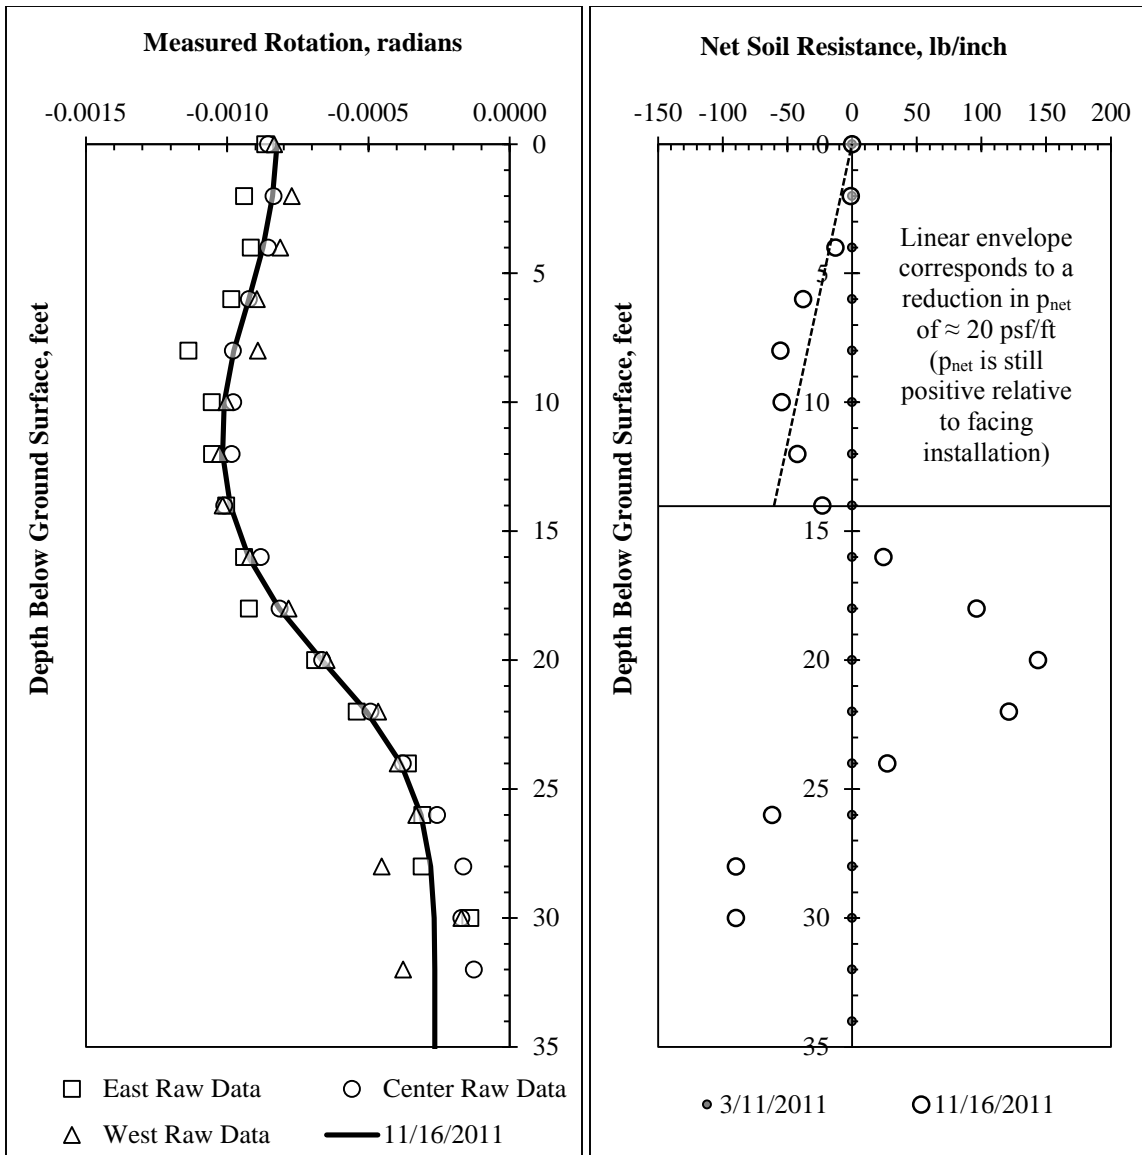
Figure 6.33: Profiles of shaft rotation and estimated reduction in net earth pressures in response to soil shrinkage between March 11 and November 16, 2011.

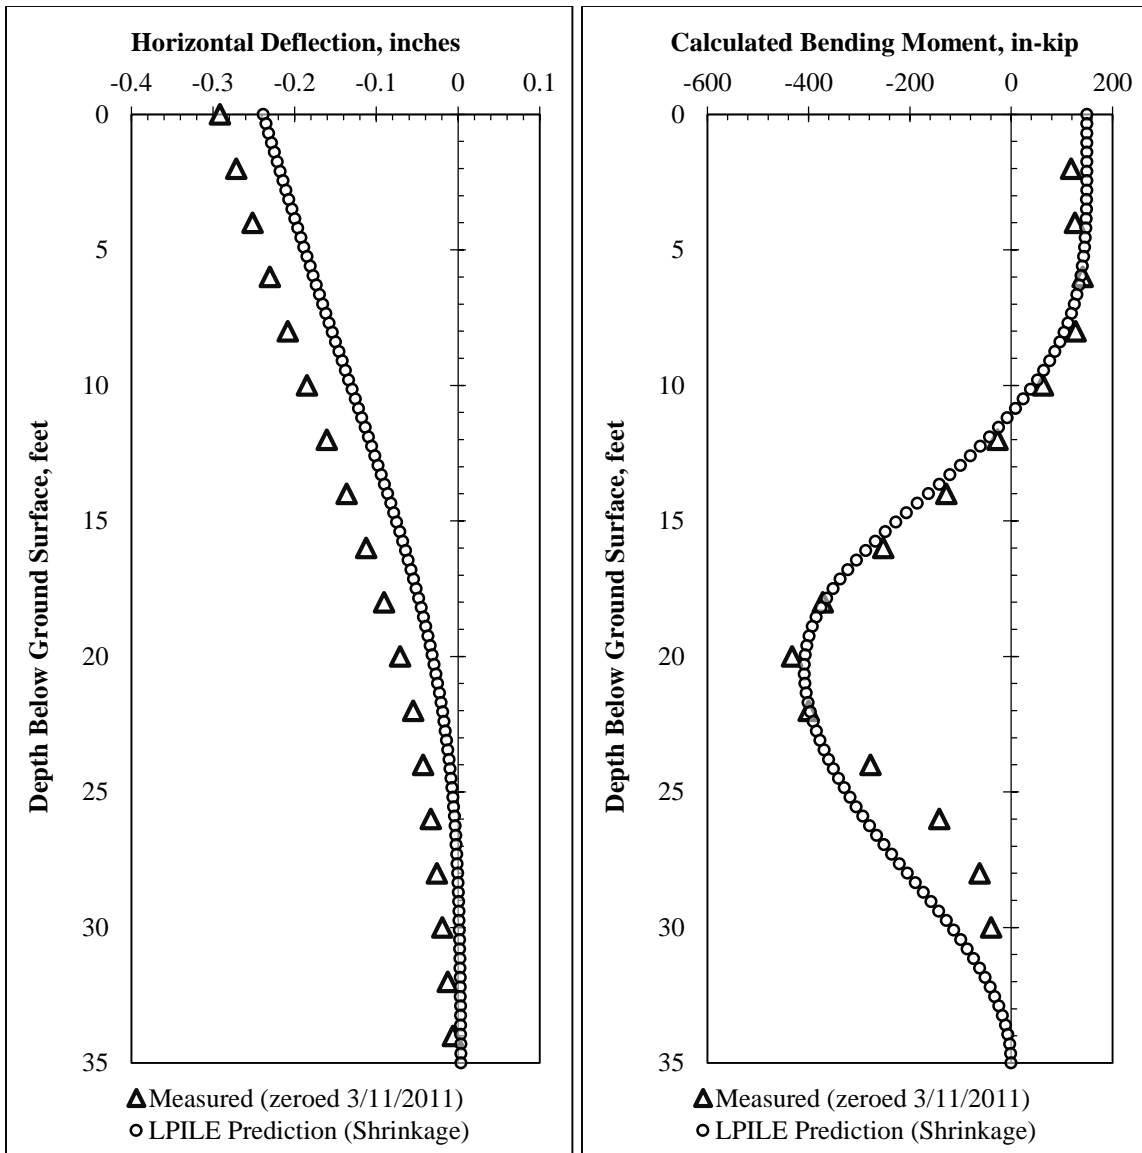
Figure 6.38: Comparison of LPILE prediction with horizontal deflections and bending moments between March 11 and November 16, 2011. A bending moment of 150 in-kip was applied at the top of the shaft to simulate thermal effects.

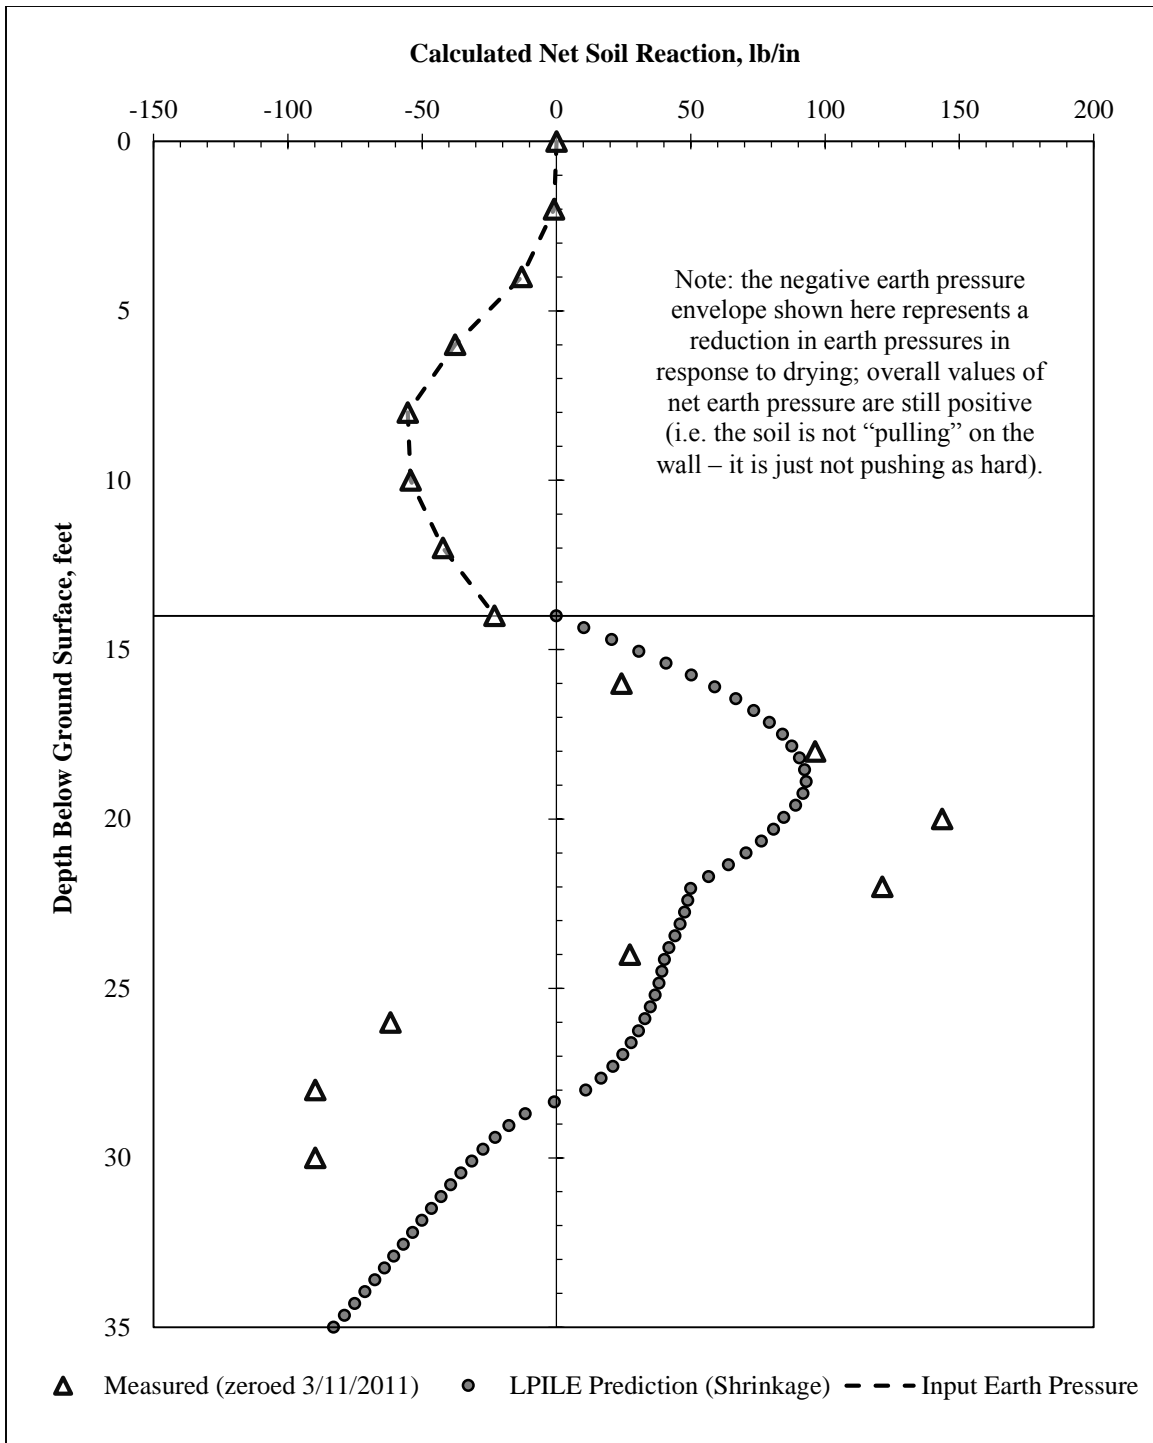
Figure 6.39: Comparison of measured and calculated soil reaction forces due to expansive soil shrinkage.

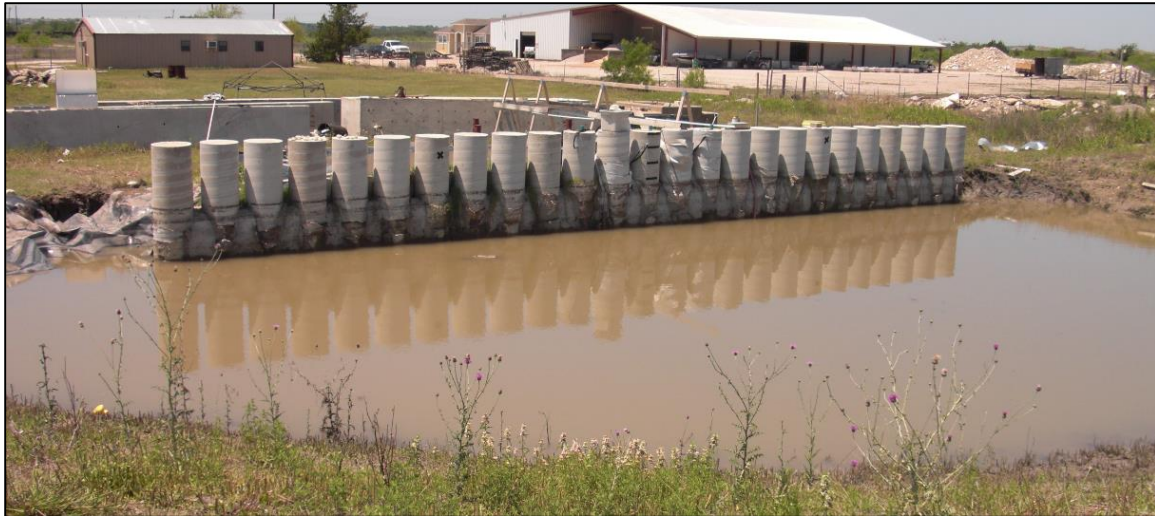
Figure 7.4: Flooding in response to a large storm before the May 6, 2013 data surveys. Water level in the excavation reached ground surface.

Beginning on February 5, 2013, the inundation zone was filled a second time. After approximately four months of inundation, the wall deflections and piezometer water levels stabilized. In response to a large storm event, a major flood occurred in which the water level in the excavation reached the ground surface prior to the inclinometer and strain gauge data surveys recorded on May 6, 2013 (Figure 7.4). During this flood event, significant erosion of the excavation slopes occurred; due to additional soil transported to the excavation base, the excavation depth had decreased to approximately 13.5 feet below ground surface.

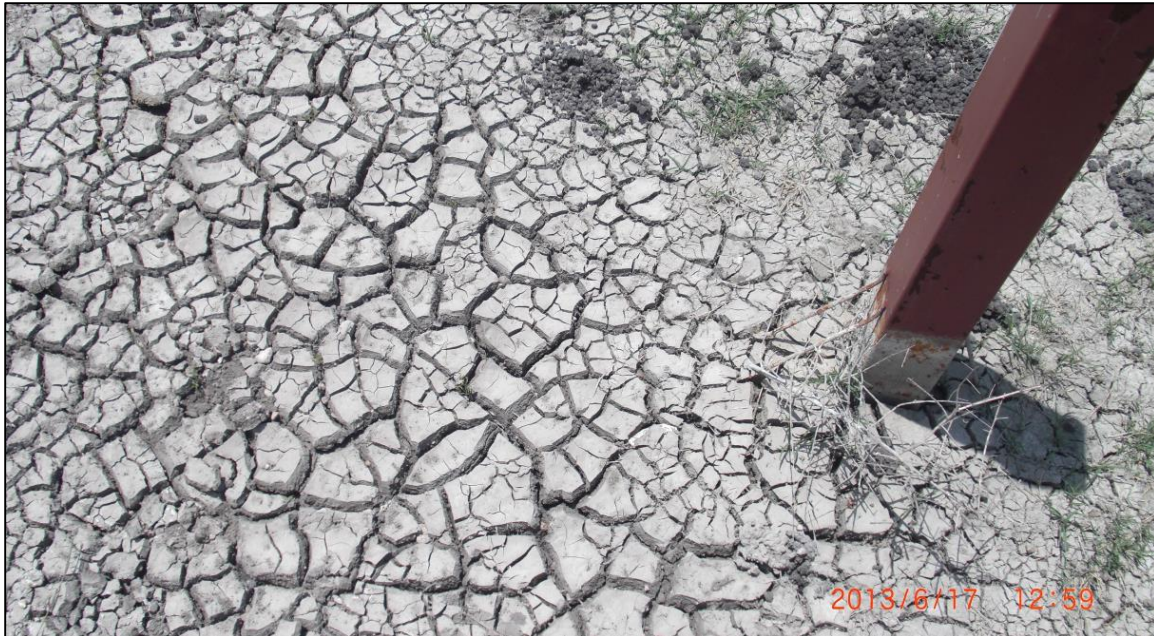
Figure 7.5: Inundation zone on June 17, 2013, two weeks into second drying cycle. Stand pipe piezometer casing is 4" across.

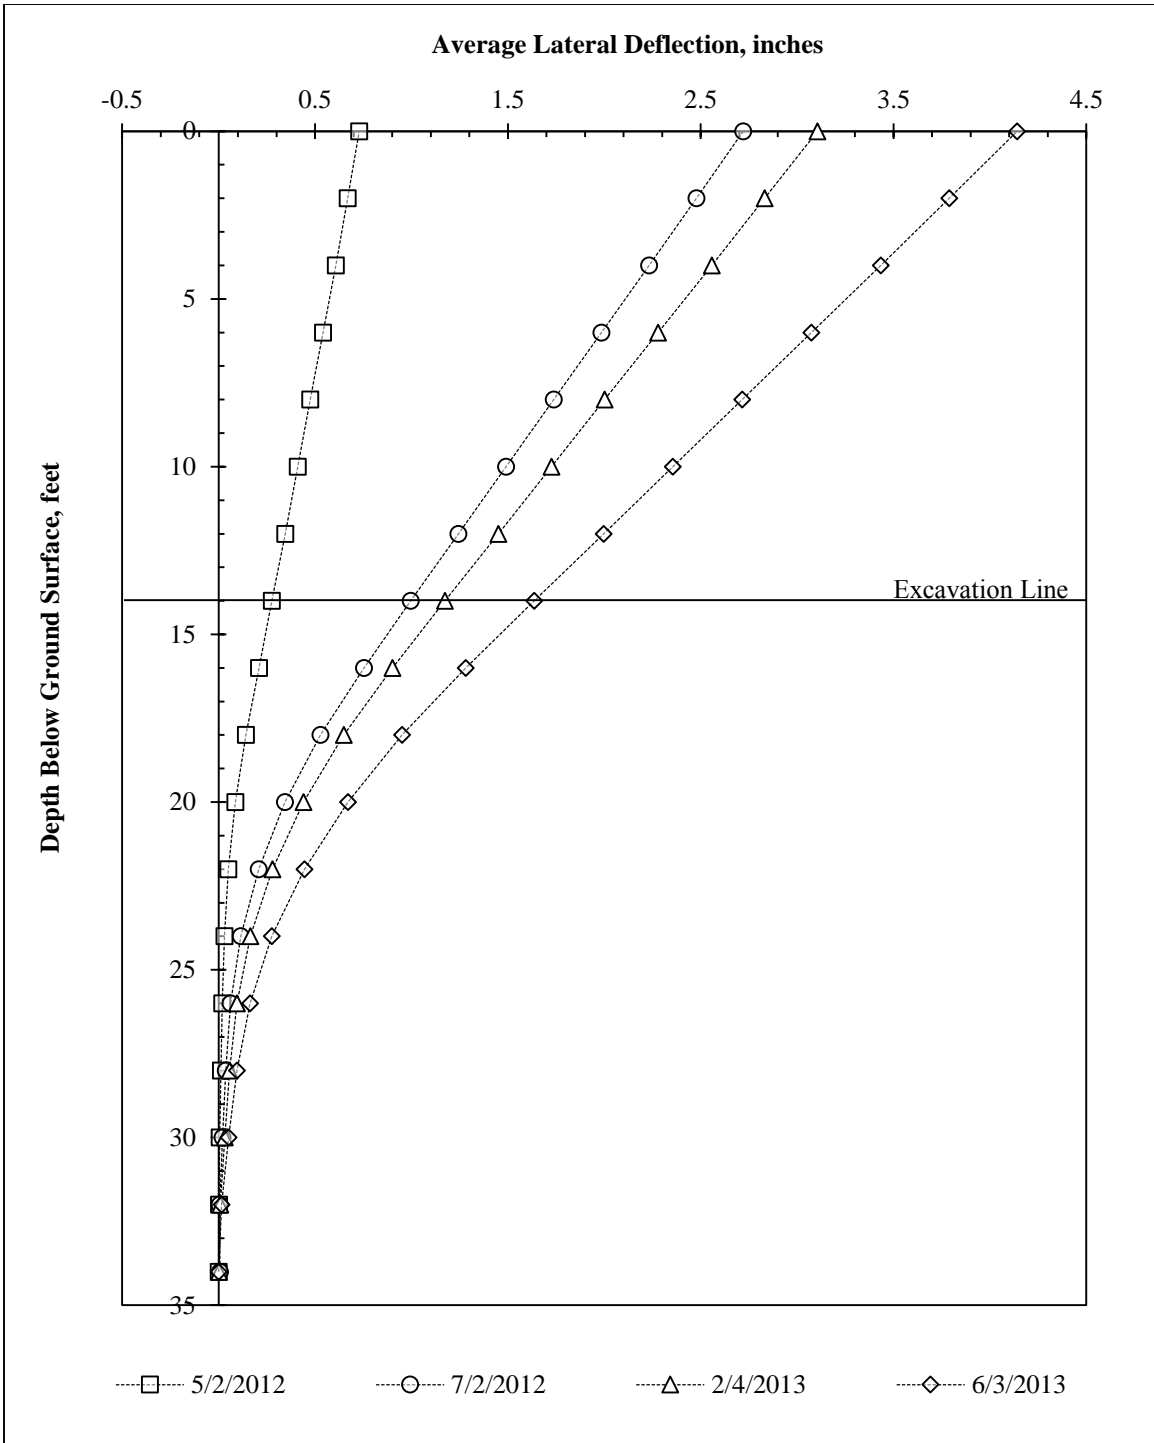
Figure 7.8: Average deflected shapes at key dates during inundation testing. Data is referenced to installation of facing in October, 2010.

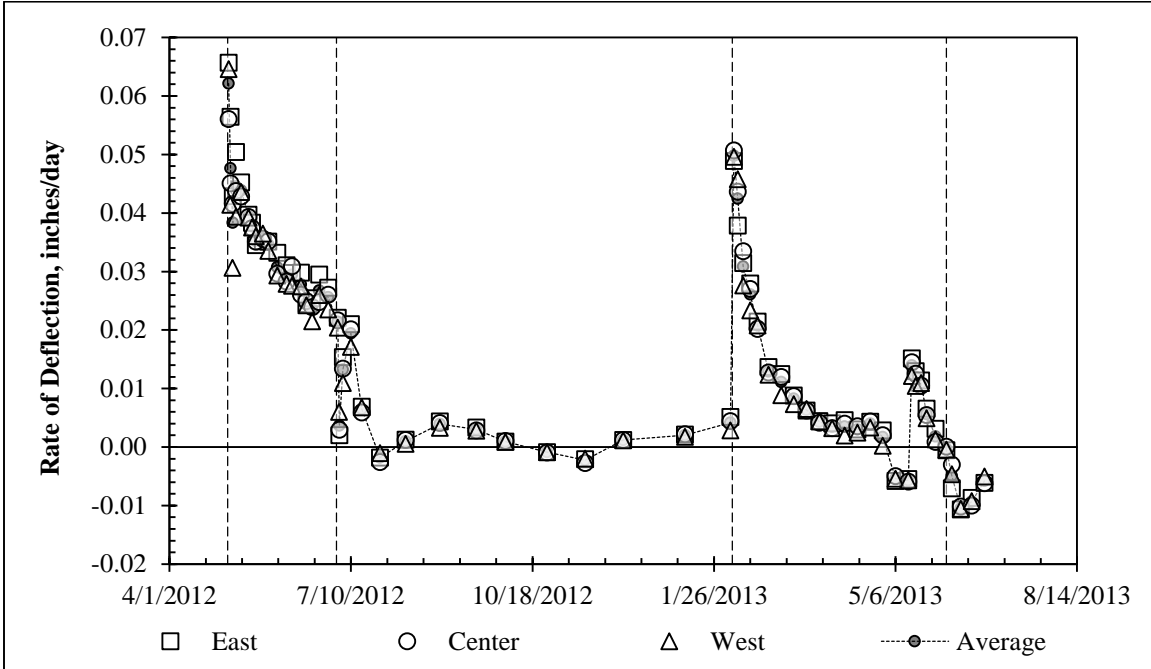
Figure 7.10: Rate of deflection at ground surface during inundation testing (key dates indicated by vertical dashed lines).

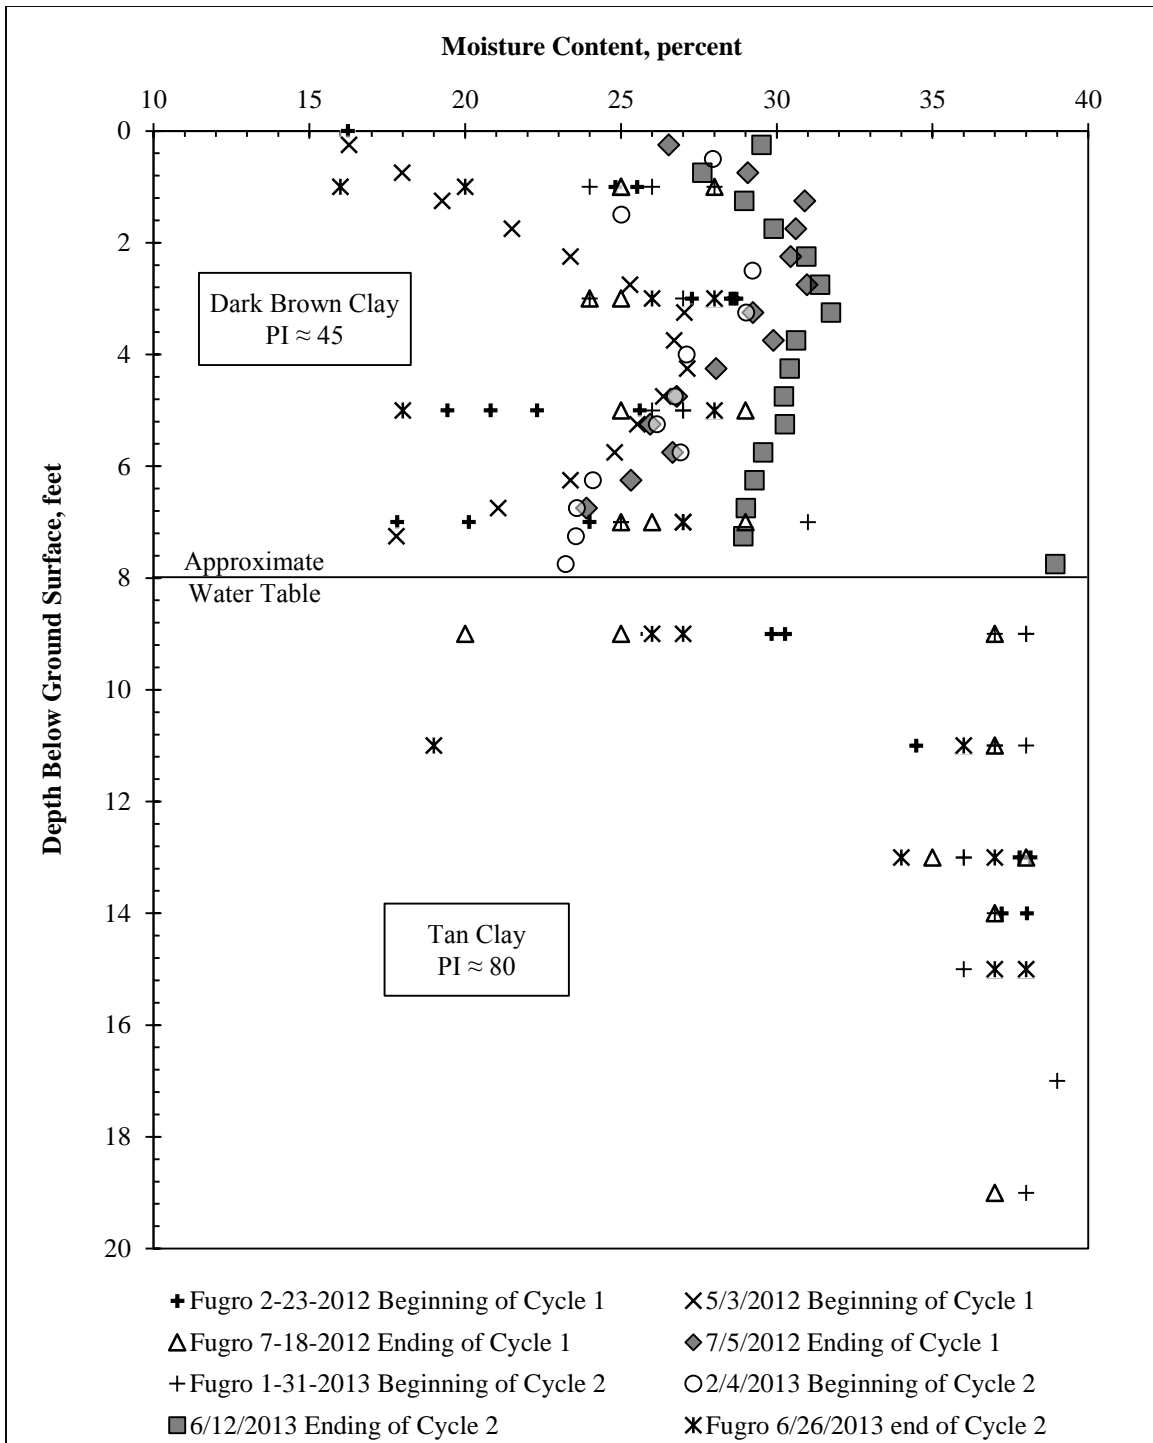
Figure 7.11: Summary of measured soil moisture contents during controlled inundation testing.

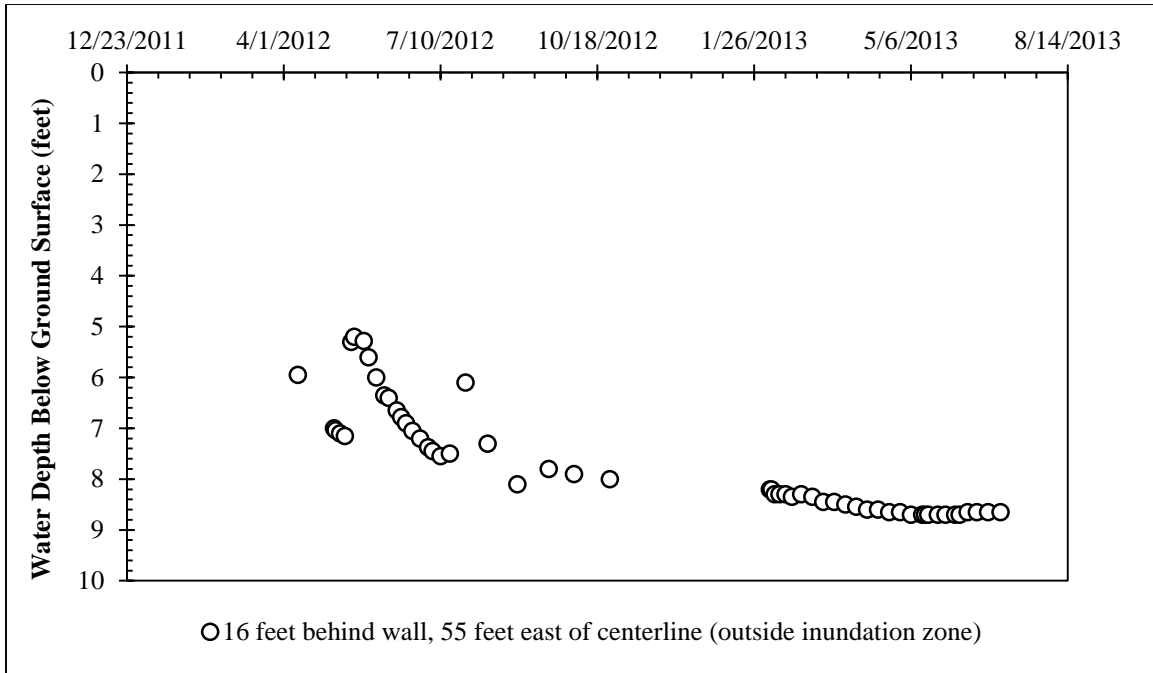
Figure 7.12: Water level in Piezometer B-3 (outside inundation zone) during inundation testing.

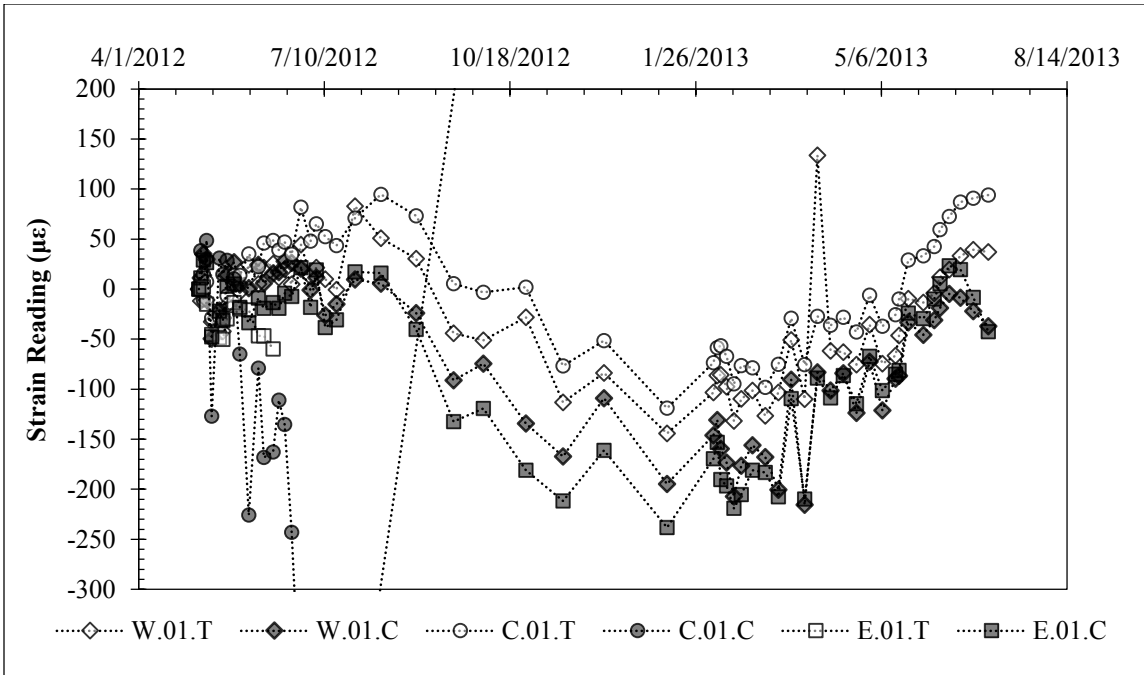
Figure 7.20: Strain Data 1 Foot Below Ground Surface (May 2012 – July 2013).

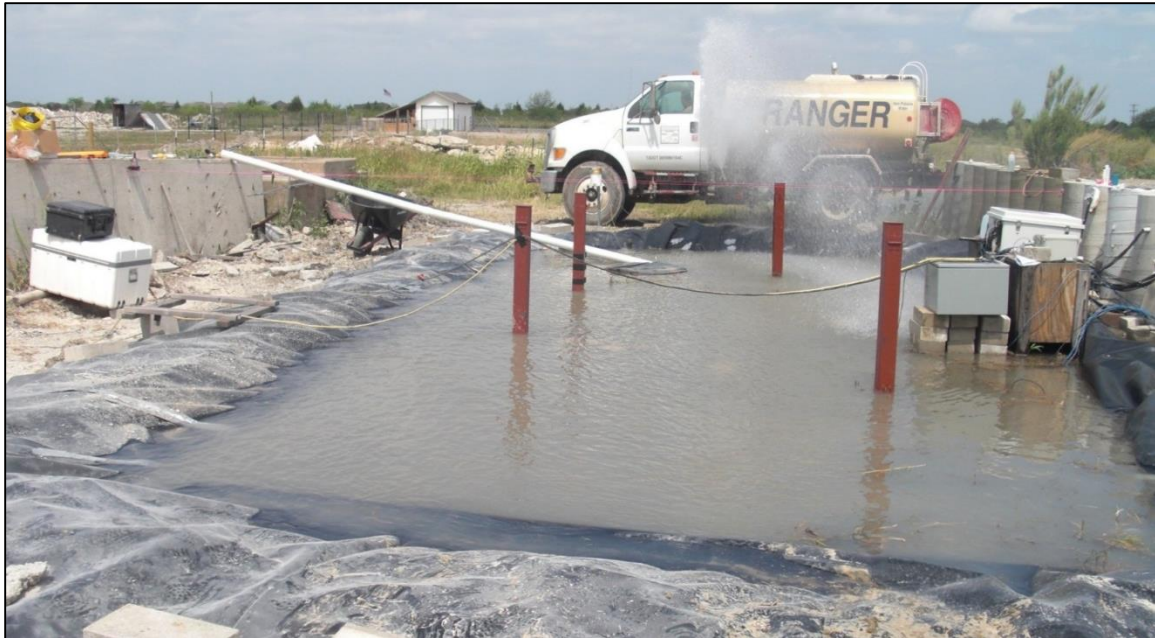
Figure 7.35: The inundation zone is filled on May 3, 2012.

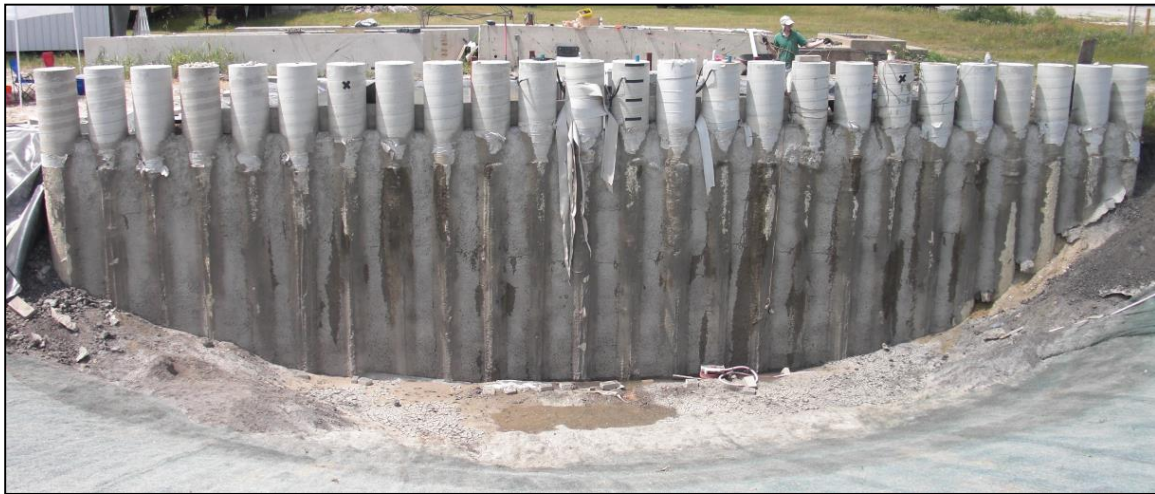
Figure 7.37: Water infiltration into the excavation was first observed 90 minutes from the start of inundation.

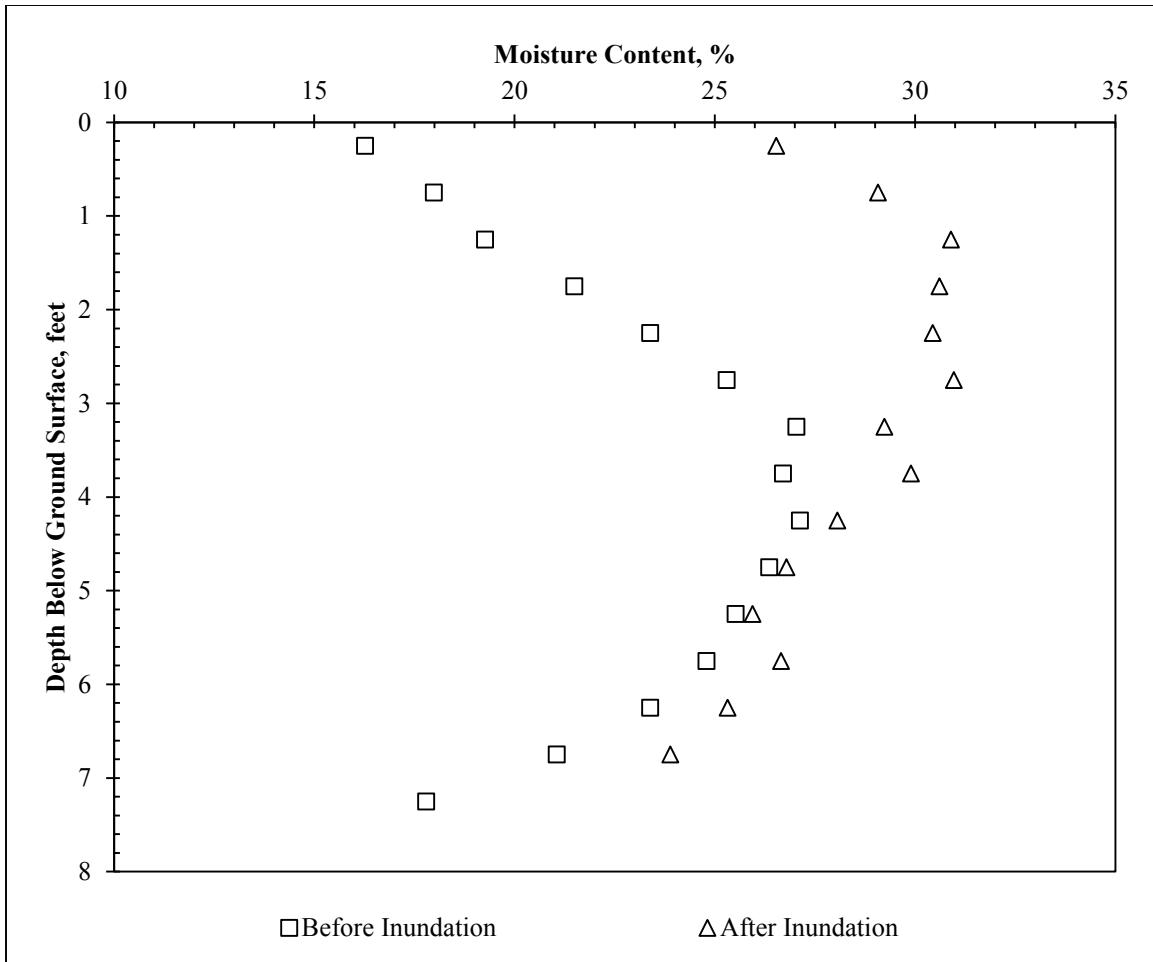
Figure 7.38: Moisture content profiles immediately before and after first inundation cycle. Natural water table is located at a depth of approximately 8 feet.

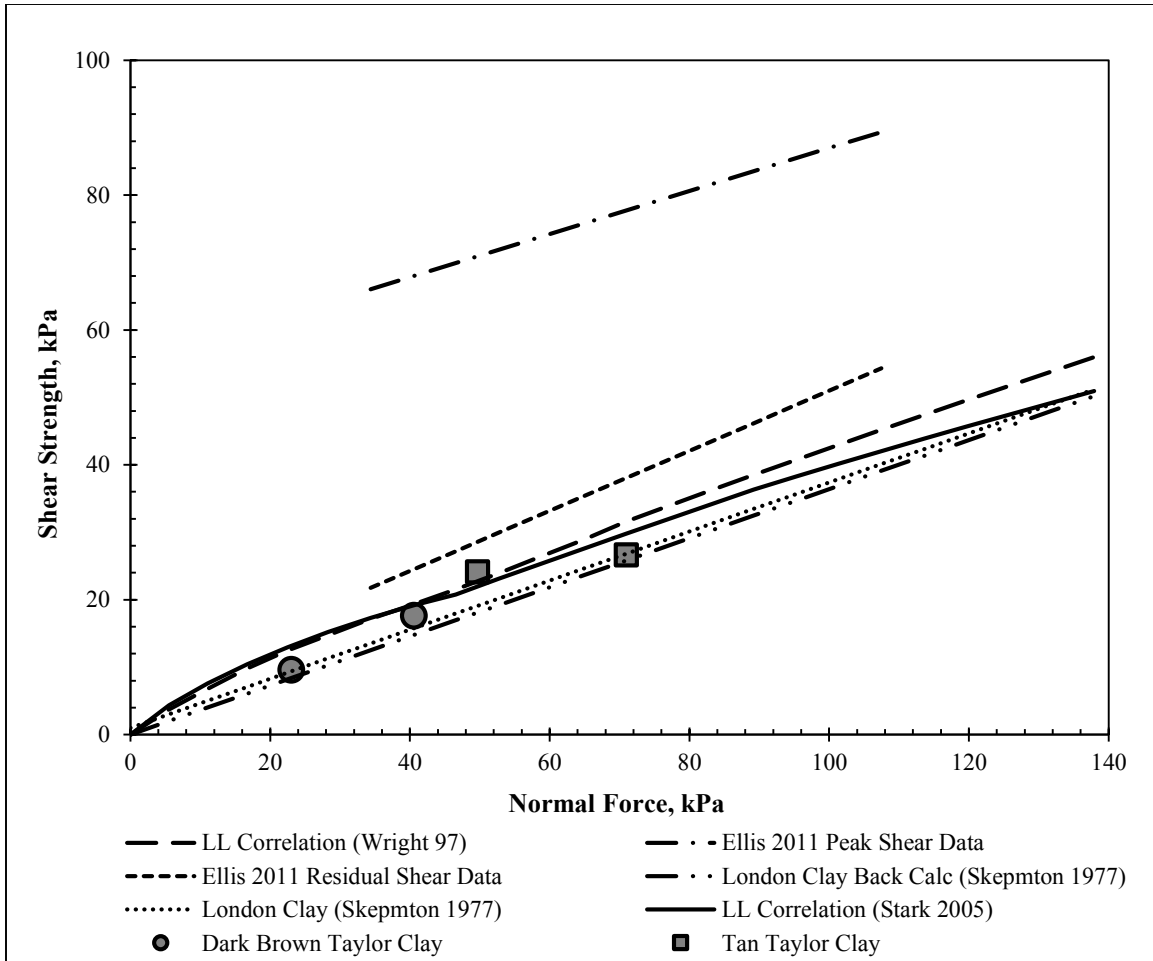
Figure 7.39: Comparison of measured fully softened strength test data from the project site with data from Ellis (2011) and established correlations.

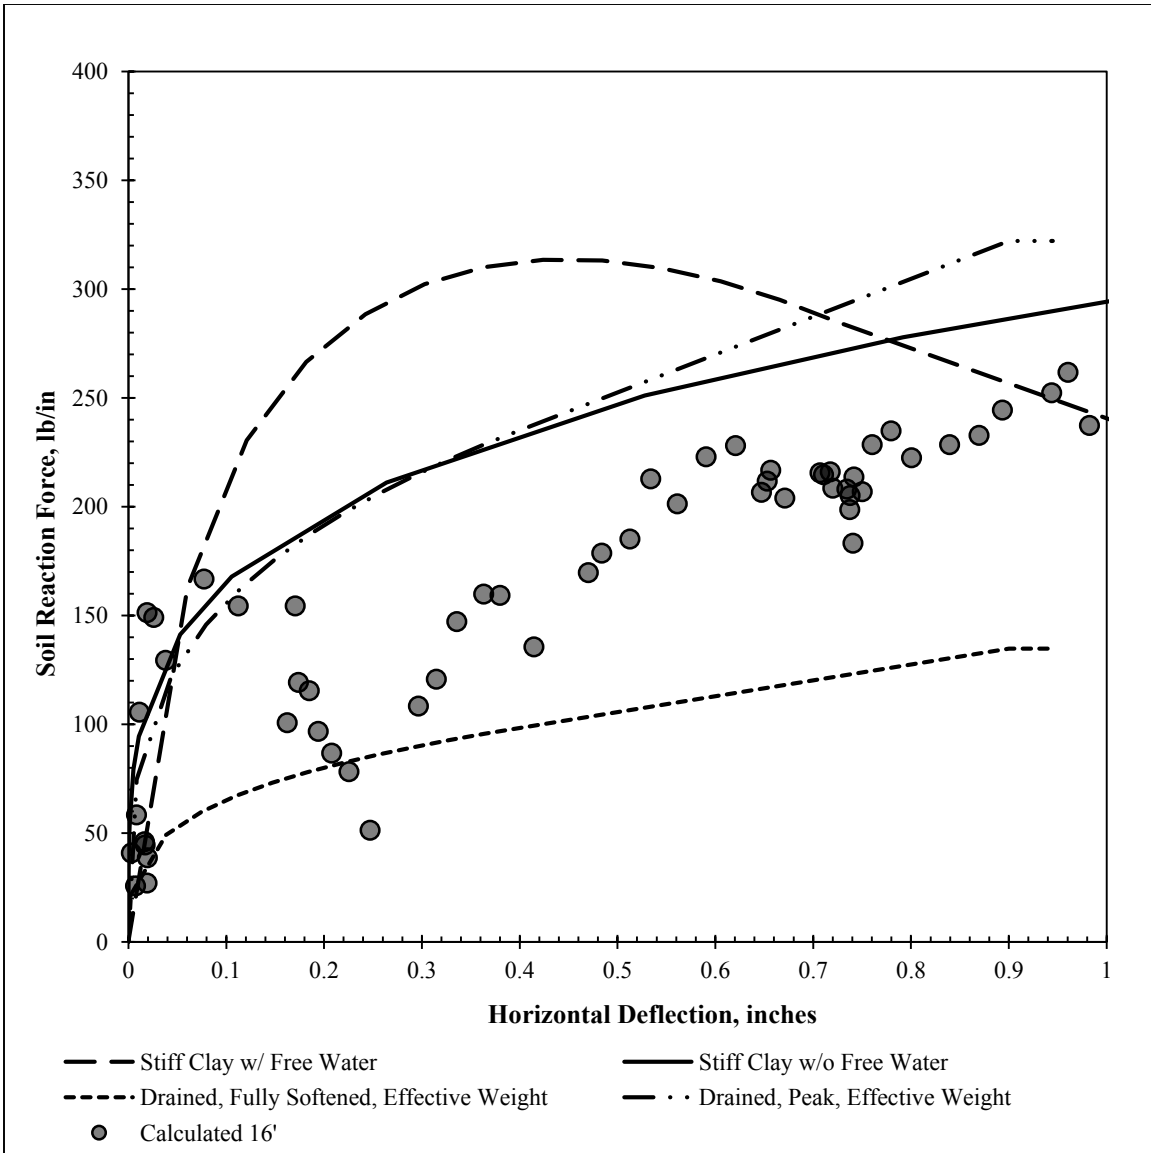
Figure 7.40: Comparison of calculated long-term p-y curves during inundation testing with proposed p-y curves at a depth of 16 feet below original ground surface.
