**The Behavior of Drilled Shaft Retaining Walls in Expansive Clay Soils**

**Dissertation**

The University of Texas at Austin

**August 2013**

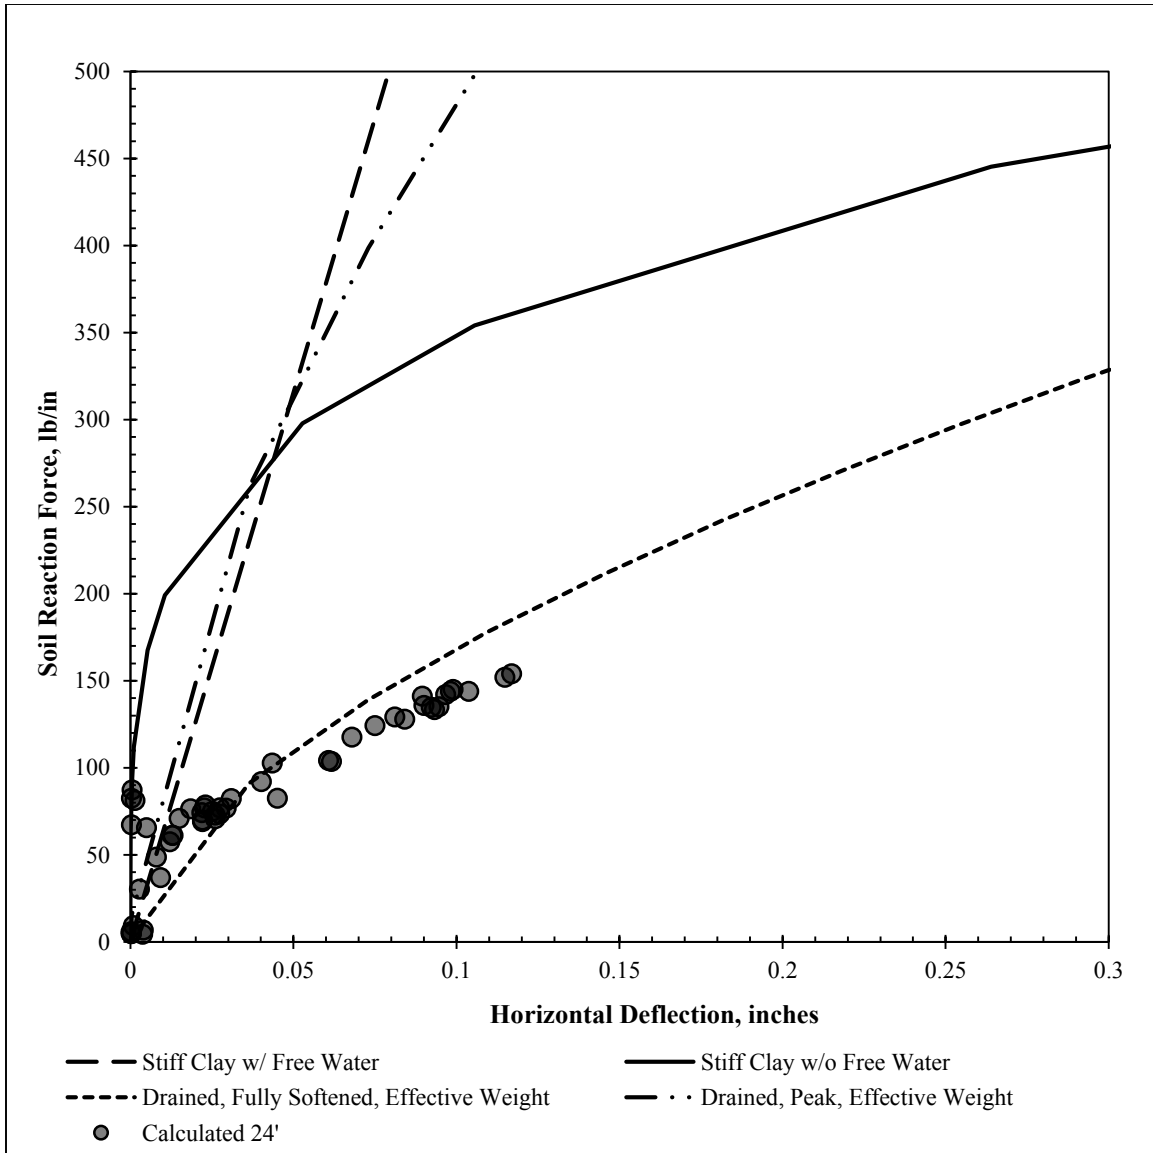
Figure 7.44: Comparison of calculated long-term p-y curves during inundation testing with proposed p-y curves at a depth of 24 feet below original ground surface.

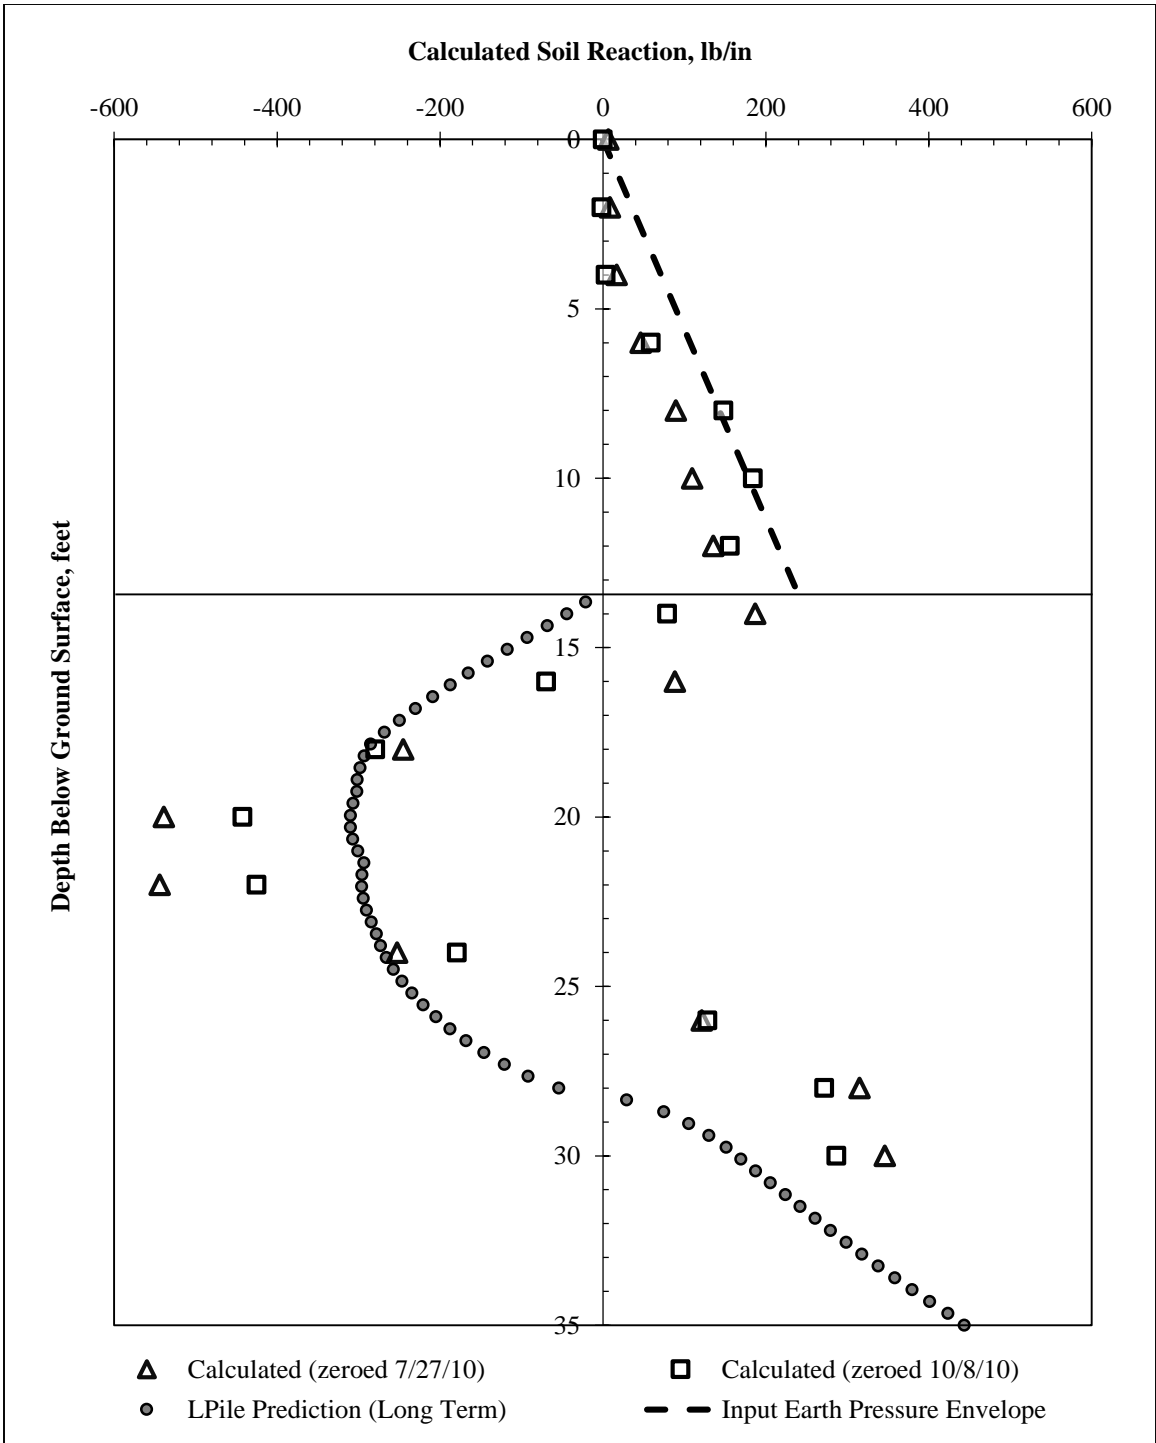
Figure 7.45: Comparison of long-term LPILE Prediction and calculated soil reaction forces.

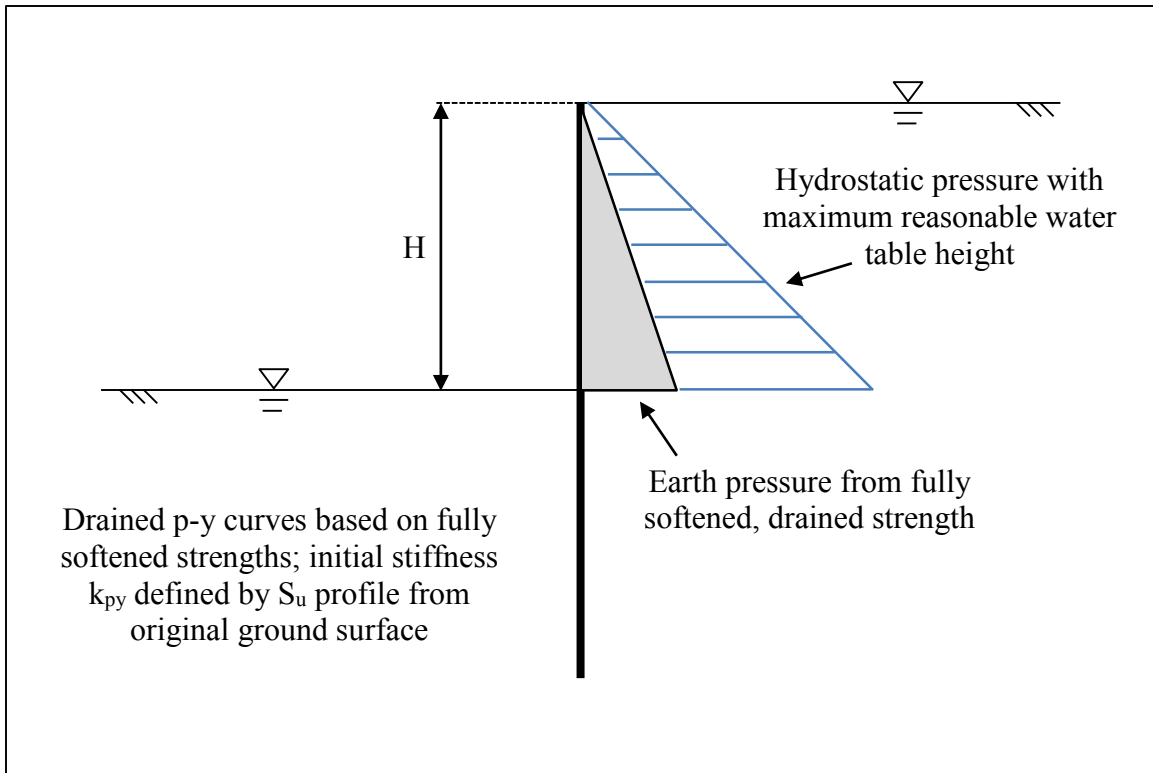
Figure 8.1: Summary of long-term design guidelines.

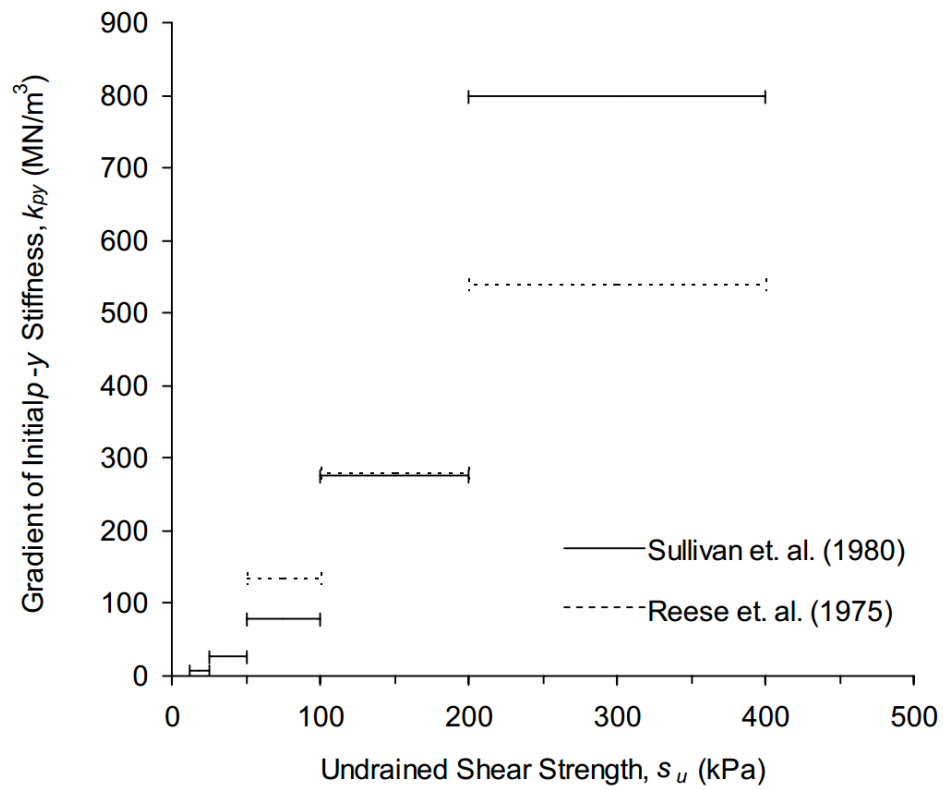
Figure 8.2: Typical  $k_{py}$  values for clays (after Dodds and Martin 2007).

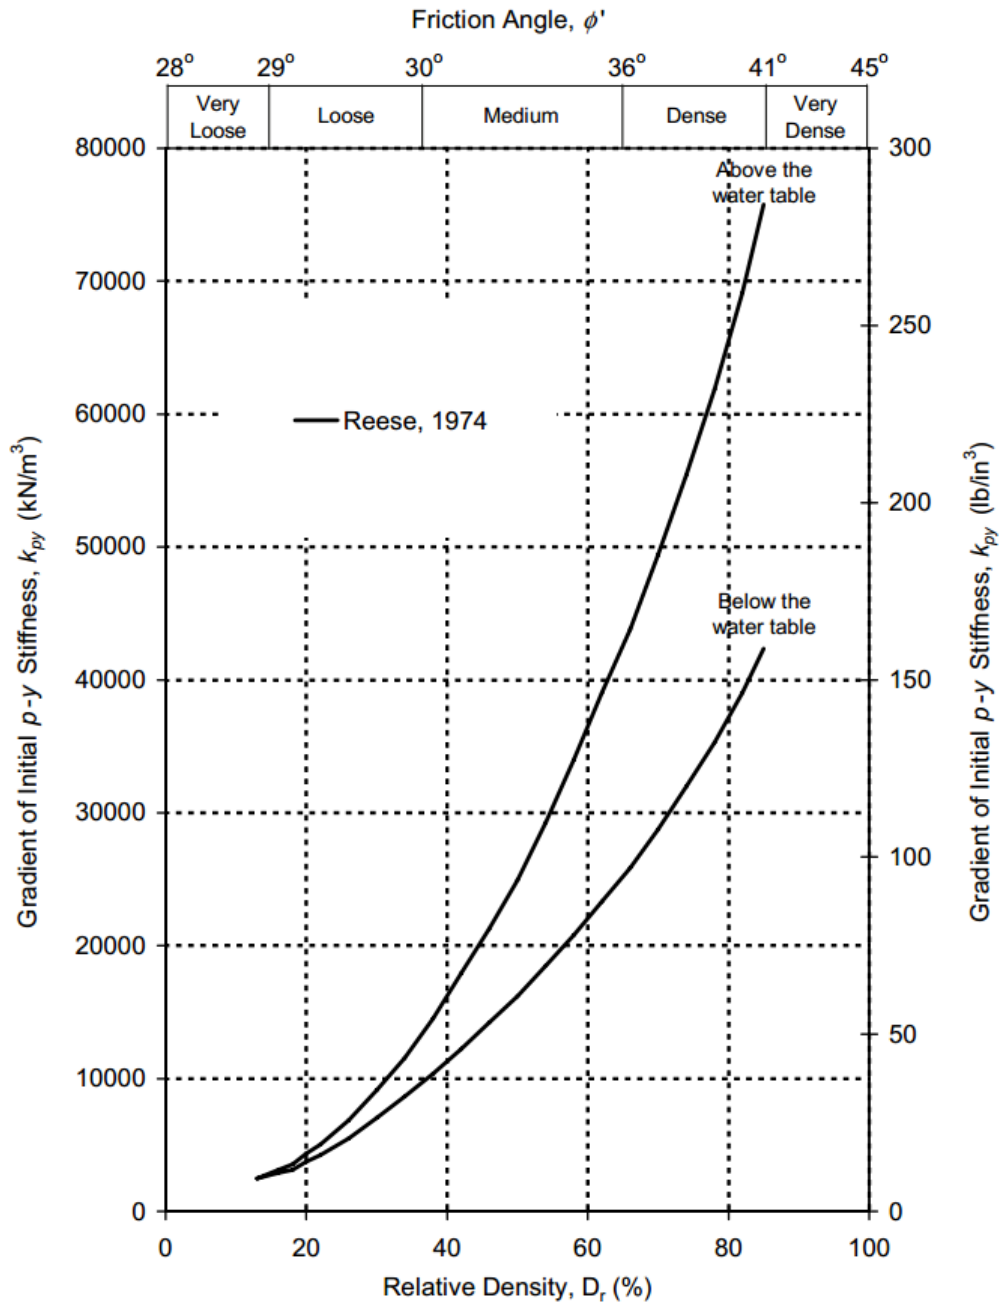
Figure 8.3: Typical  $k_{py}$  values for sands (after Dodds and Martin 2007).

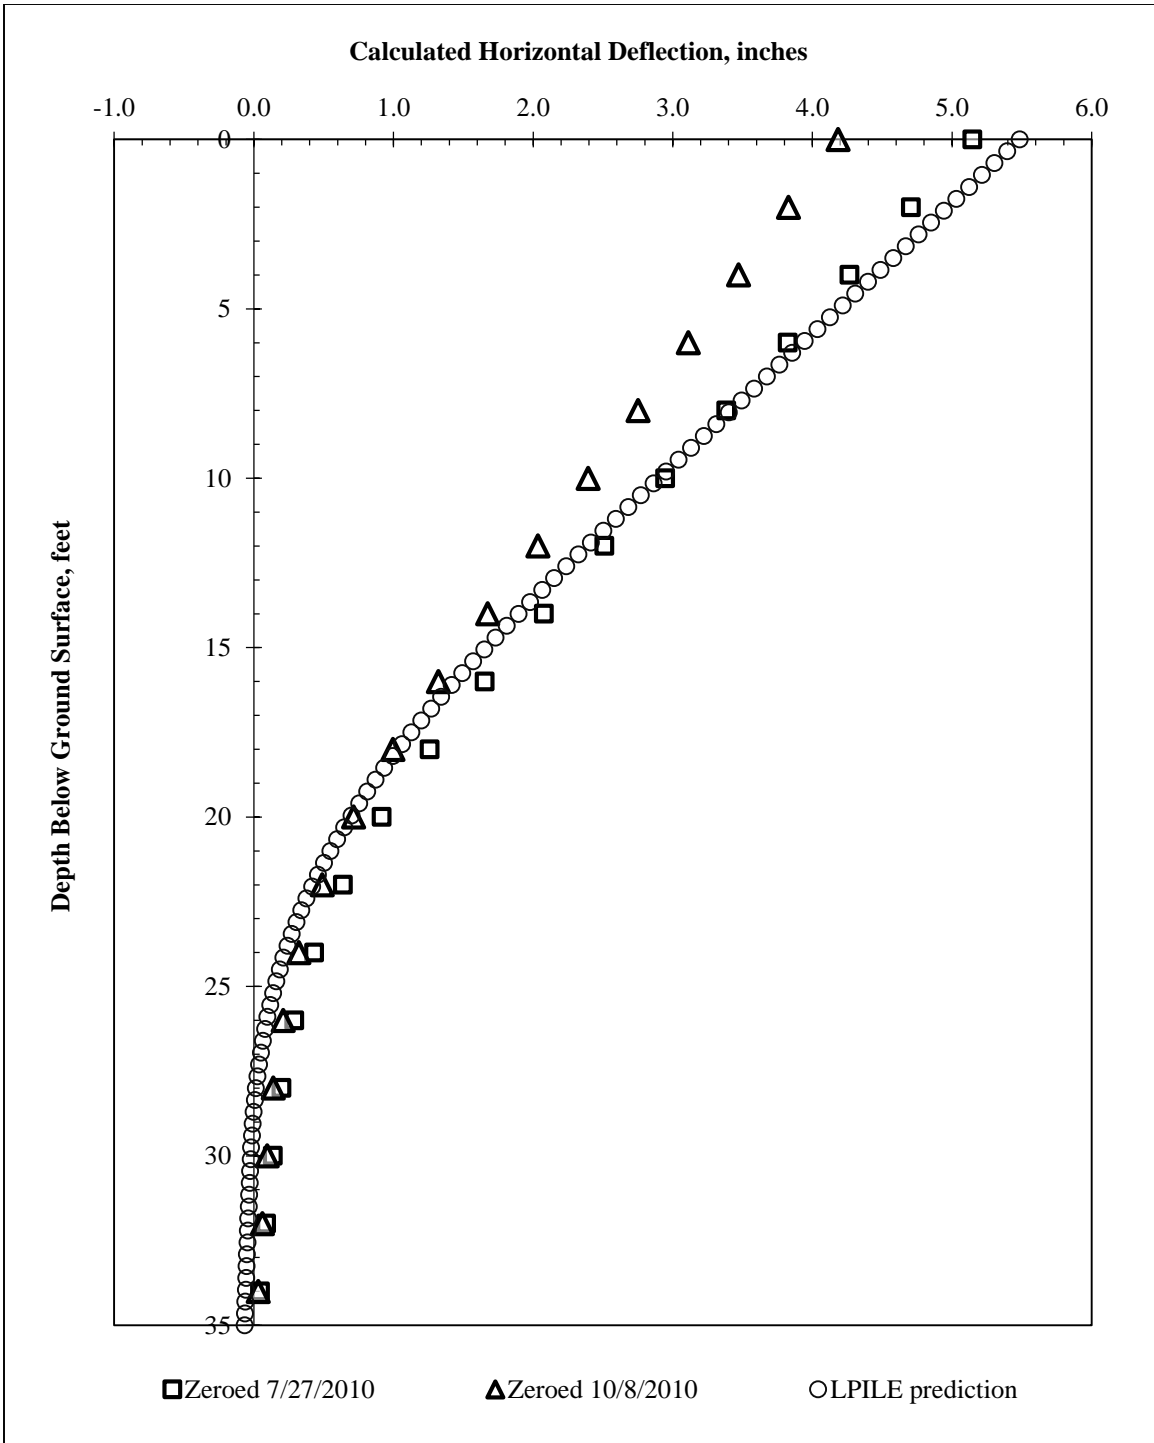
Figure 8.4: Summary of measured and predicted values of deflected shapes using long-term design guidelines.

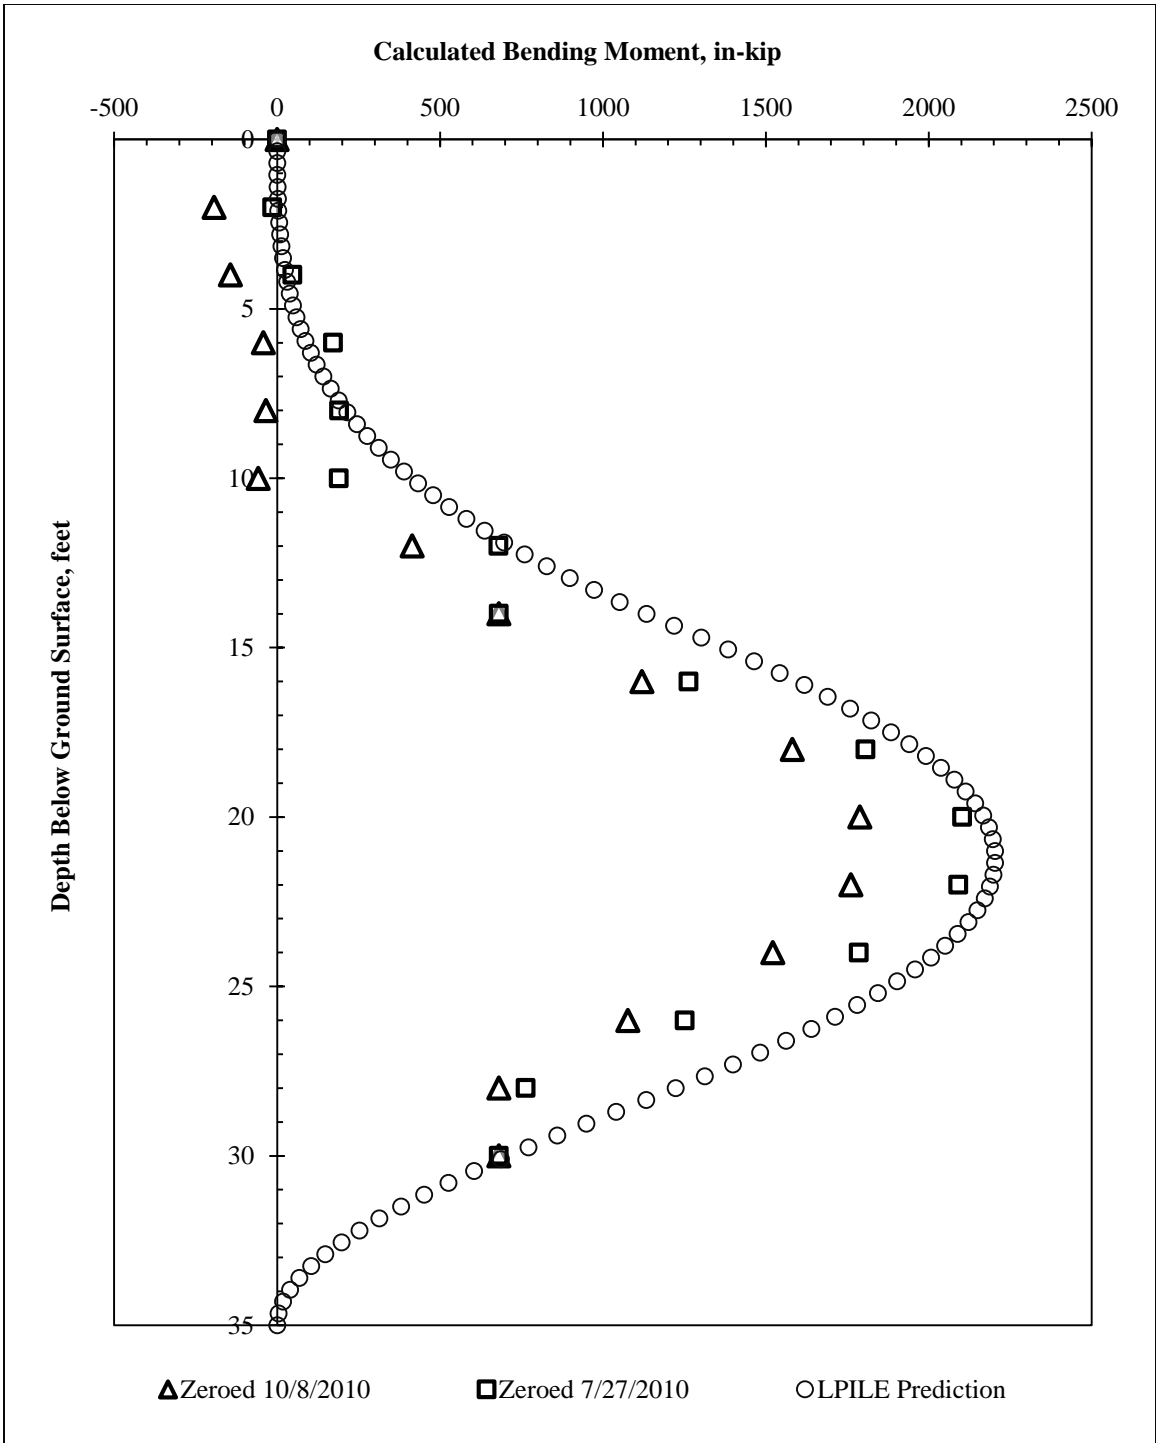
Figure 8.5: Summary of measured and predicted bending moments using long-term design guidelines.

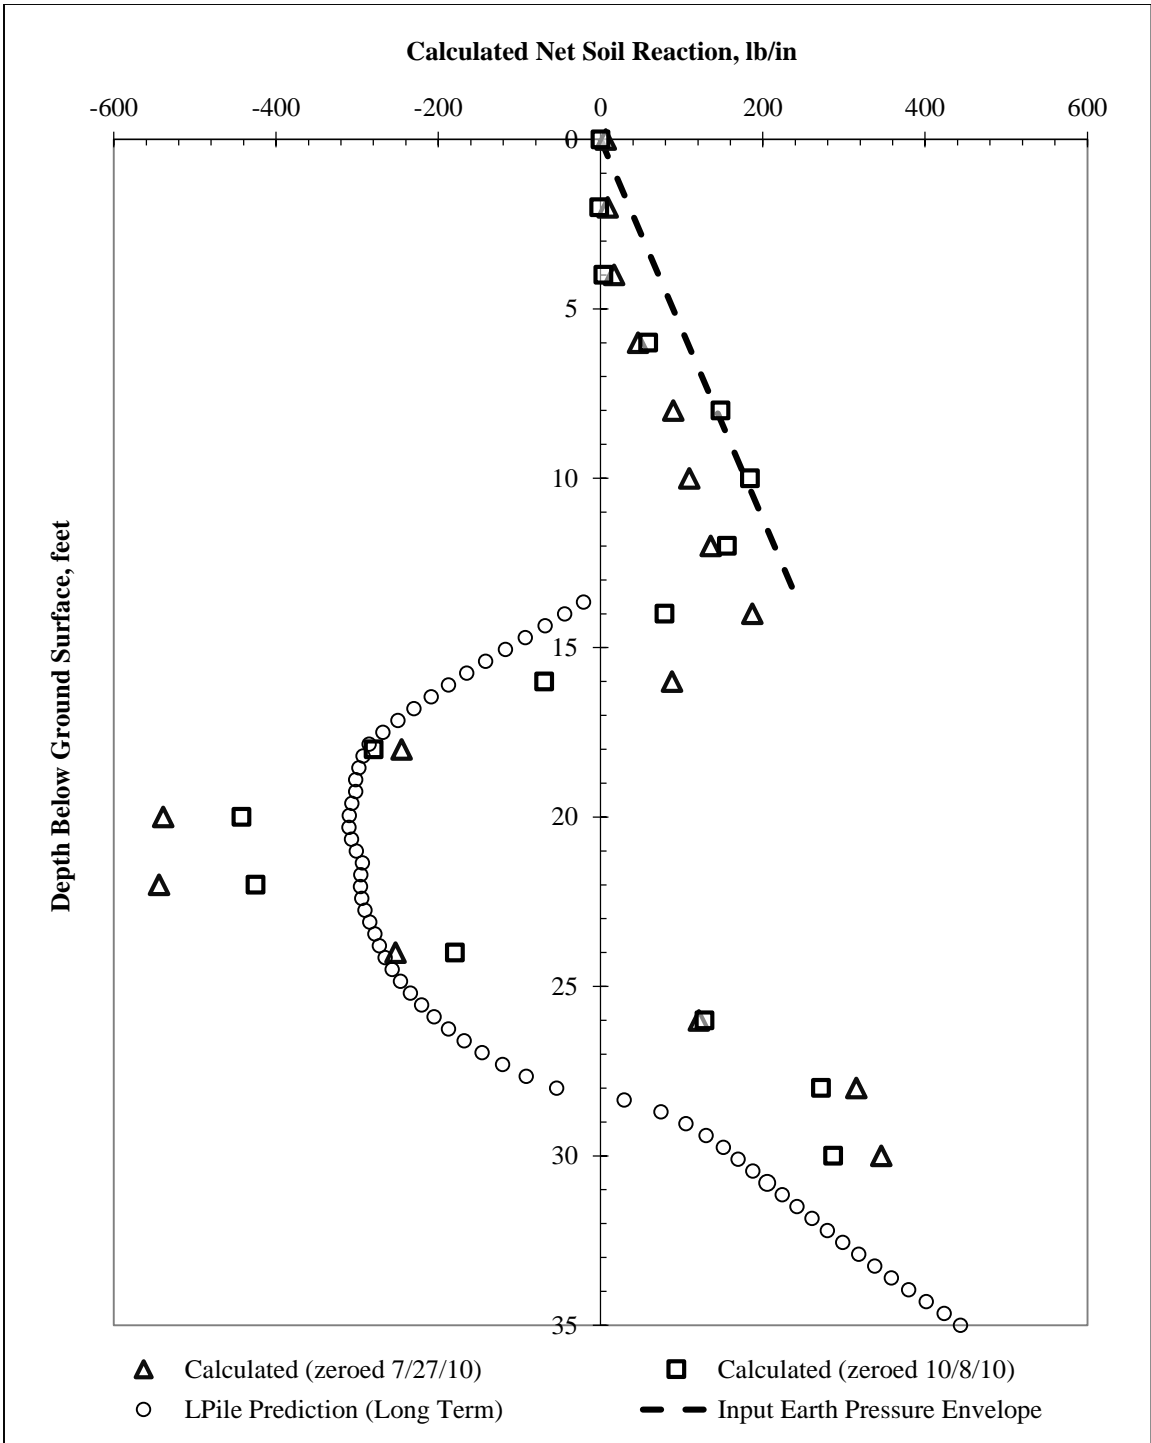
Figure 8.6: Comparison of Long-Term Modified LPILE Prediction and Calculated Soil Reaction Forces.

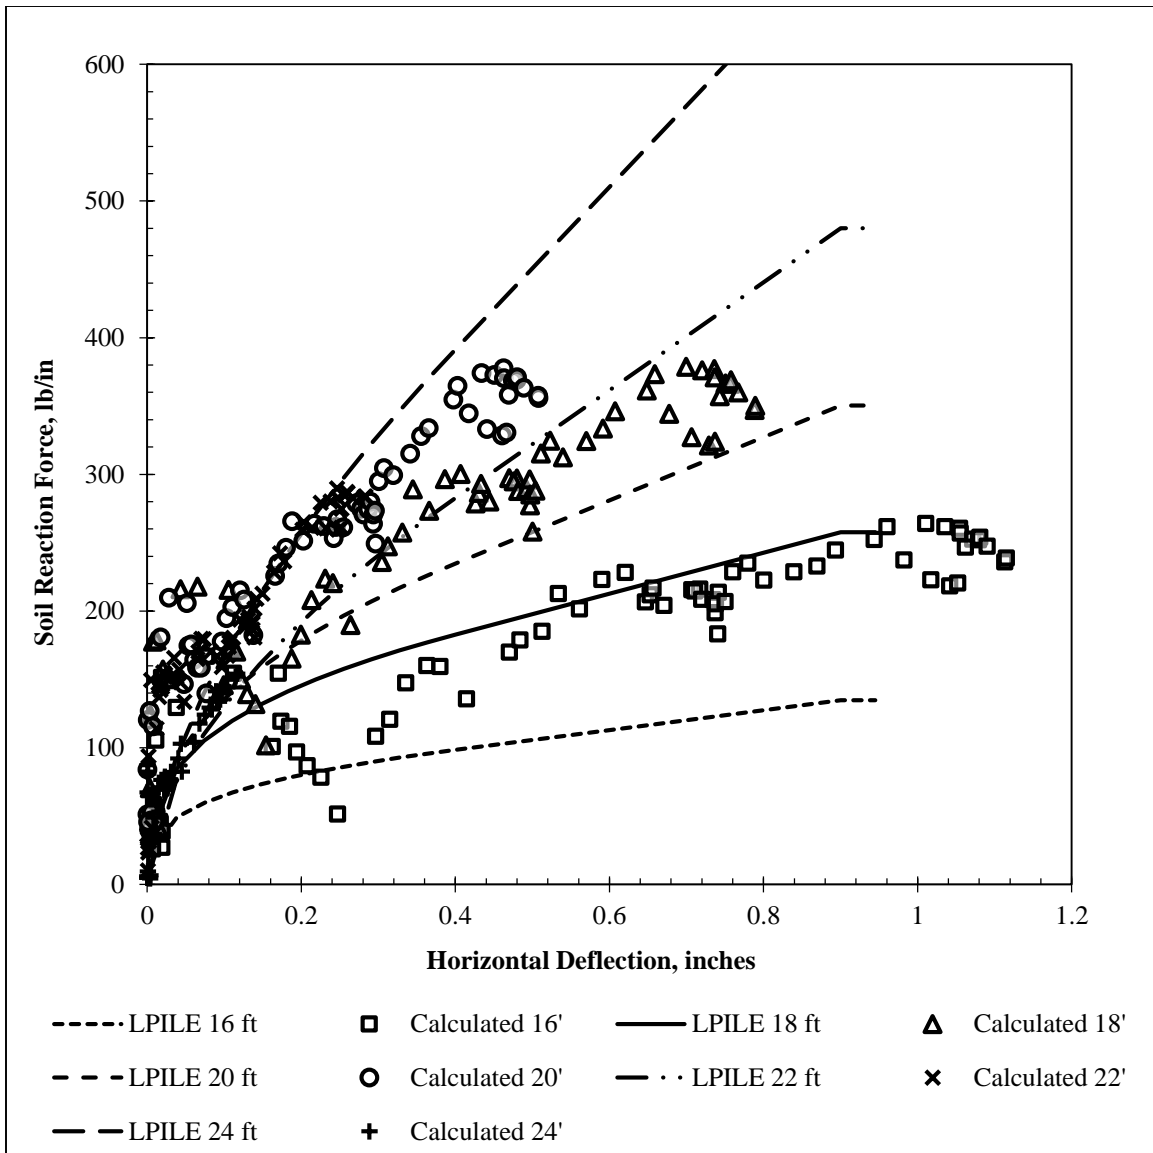
Figure 8.7: Comparison of long-term p-y curves predicted by modified LPILE analysis with p-y curves estimated from field data (reference survey is after installation of shotcrete facing on October 8, 2010).

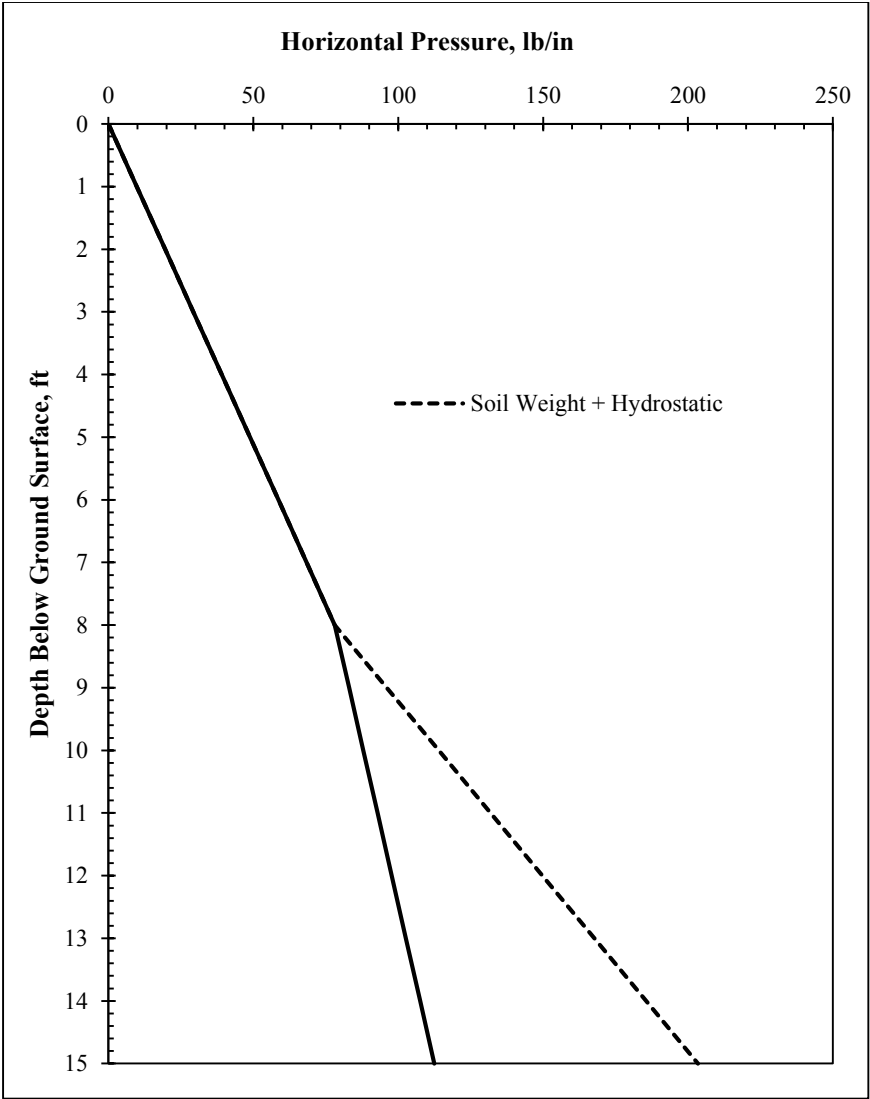
Figure 8.8: Input earth pressure envelope for wettest test wall conditions prior to inundation testing (natural groundwater table at 8 feet below ground surface).

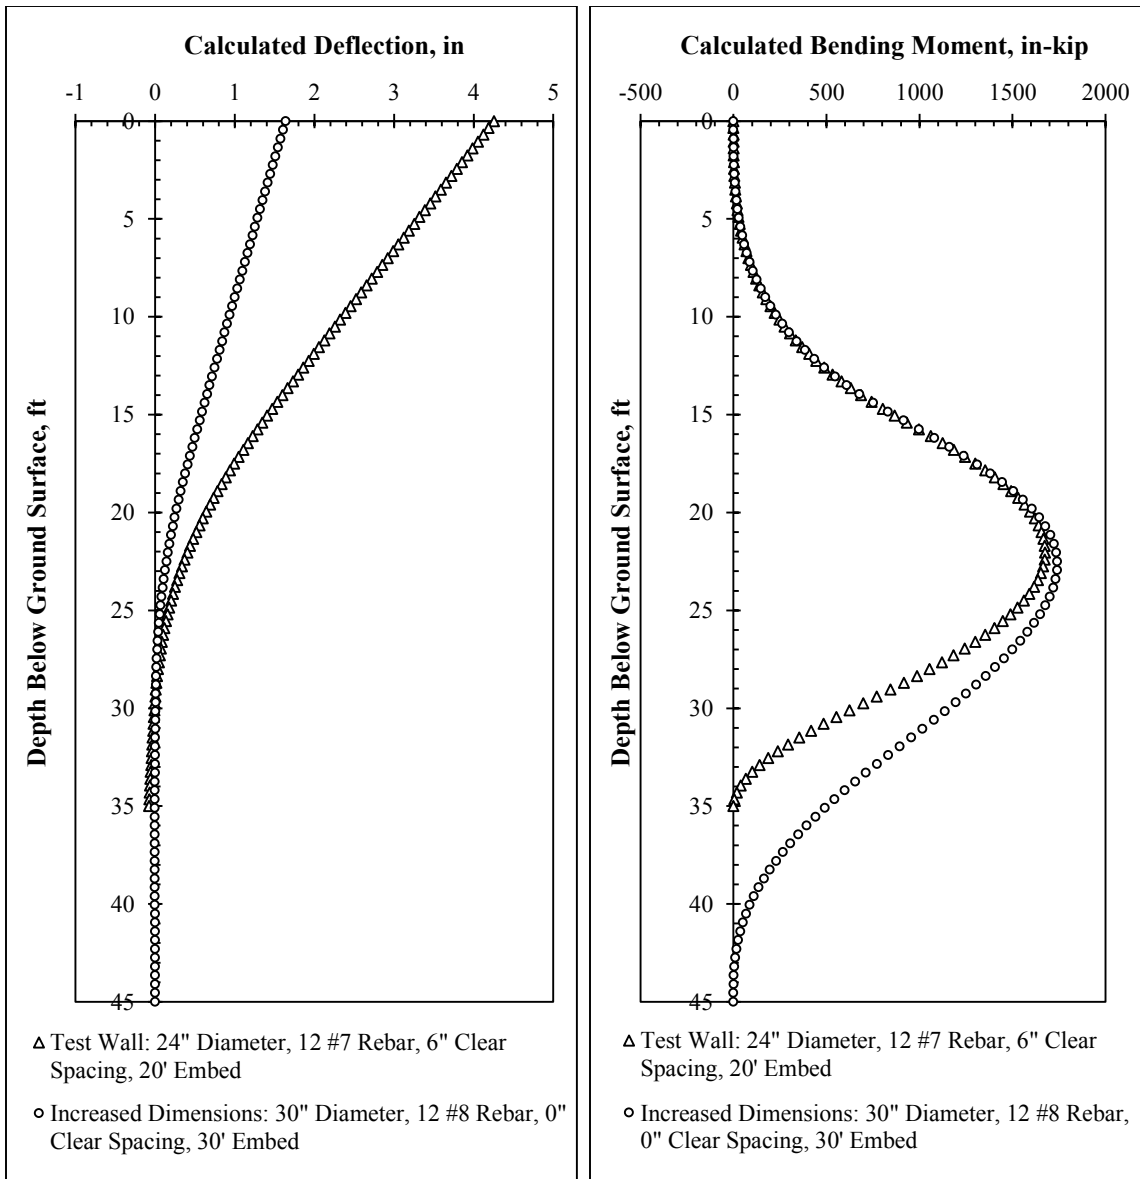
Figure 8.9: Comparison of deflected shapes and bending moments for hypothetical test wall redesign using proposed long-term conditions.

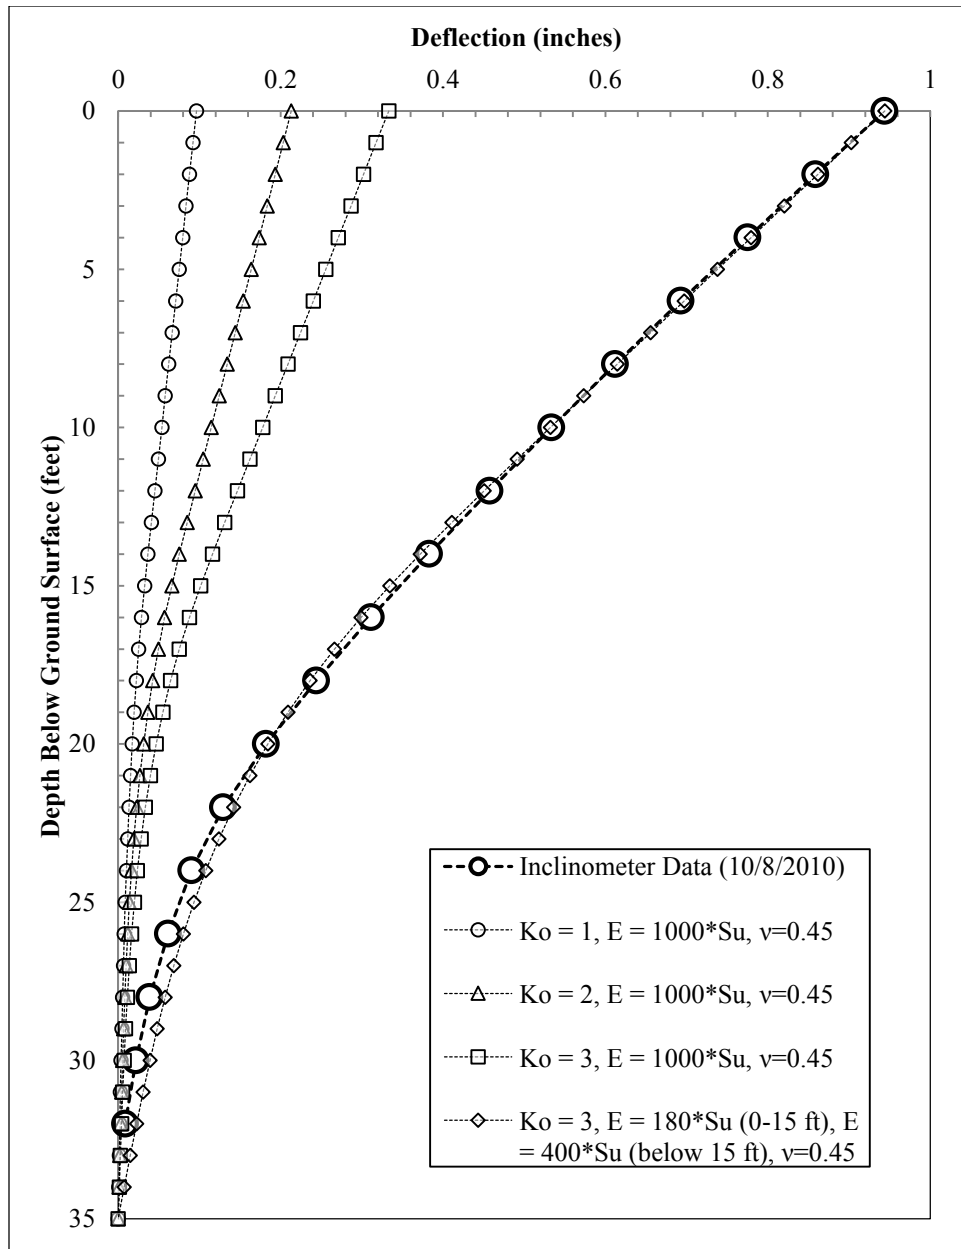
Figure 8.10: Comparison of measured data with predictions from linear elastic finite element model including anisotropy and stiffness reductions.
