Article

## ***In Vivo* Degradation Behavior of the Magnesium Alloy LANd442 in Rabbit Tibiae**

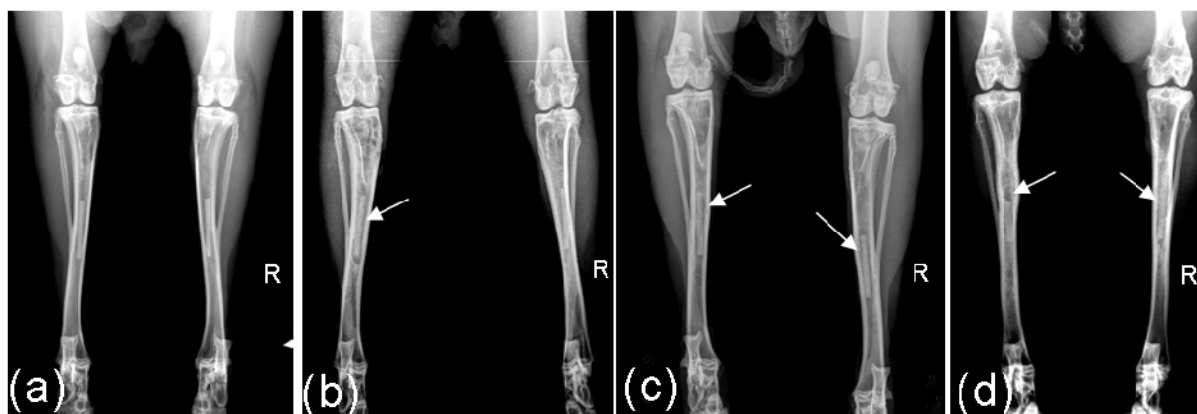
**Figure 1.** Radiological images of implants: (a) after 4 weeks implantation period: Score left 0, right 0; (b) after 8 weeks implantation period: Score left 1, right 0; (c) after 13 weeks implantation period: Score left 1, right 1; (d) after 26 weeks: Score 3 and low level of gas formation left, score 2 right.

In the 4 weeks groups no implants demonstrated radiological changes. In the other three groups, three of the 26 implants were assessed with a score of 1 after 8 weeks. After 13 weeks, 8 of the remaining 16 implants obtained the score 1 and one implant the score 2. Following 26 weeks implantation, five of the remaining ten implants were assessed with the score 1, two with score 2 and two with the score 3 (Figure 1). During the entire 26 weeks monitoring time, only one implant remained radiologically unchanged.

In only two implants during the 8th and the 26th week, respectively, a low level of gas development could be detected.

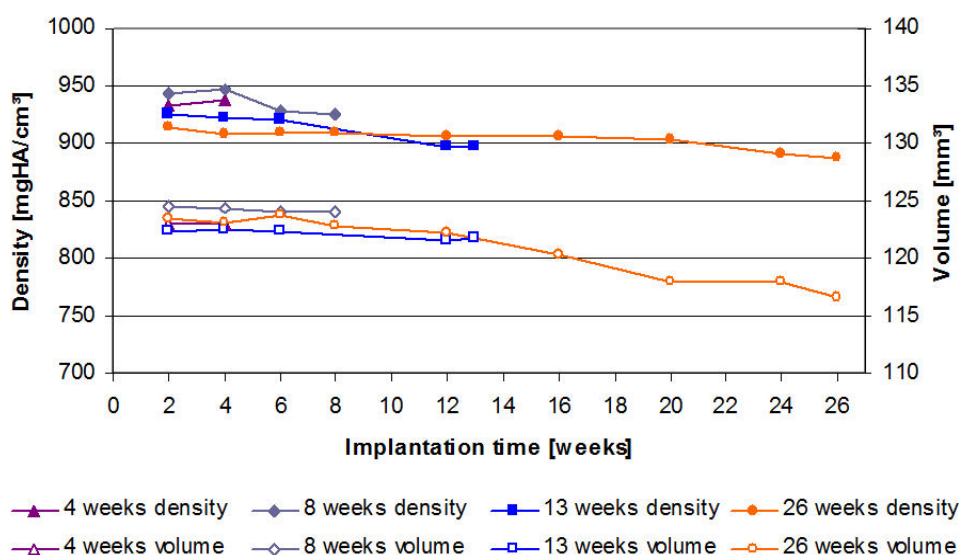
**Figure 2.**  $\mu$ -computed tomographically educible reductions of implant volumes (open symbols) and densities (full symbols) of the LANd442-implants introduced into the rabbits' tibiae plotted against the test period of up to 26 weeks.

For the 4 weeks groups, the volume of the implanted LANd442-pins remained relatively constant ( $123.0 \text{ mm}^3$  to  $122.9 \text{ mm}^3$ ). From the 8th week, it was possible to observe a continuous low loss of volume (Figure 2) which, after 13 weeks, amounted to 0.6% (from  $122.4 \text{ mm}^3$  (SD 2.1) to  $121.7 \text{ mm}^3$  (SD 2.7)) compared to the initial scan. After 26 weeks, it was possible to determine a loss of volume of 5.5% (from  $123.4 \text{ mm}^3$  (SD 2.93) to  $116.6 \text{ mm}^3$  (SD 15.05)). One implant from the 26 weeks groups could not be evaluated owing to a loss of data. Neither significant differences between the groups, nor over the course of time occurred.

The density's evaluation resulted in a low but significant ( $p = 0.03$ ) increase in density for the 4 weeks groups ( $n = 10$ ) of 0.5% from  $933 \text{ mgHA/ccm}$  (SD 82) to  $937 \text{ mgHA/ccm}$  (SD 84) from week 2 to week 4 (Figure 2). For the 8 weeks groups ( $n = 10$ ), it was also possible to observe a low level of elevated density of 0.3% from the 2nd to the 4th week. This was, however, not significant

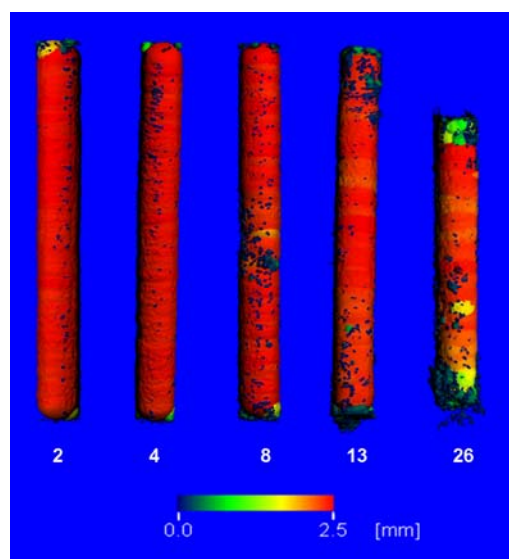
**Figure 3.** Images of the LANd442 implants' true 3D-thicknesses following different implantation durations in the rabbits' tibiae: from left to right: after 2 weeks, 4 weeks, 8 weeks, 13 weeks and after 26 weeks implantation periods. The colors correspond to the maximum diameters of the inserted balls; from red, yellow, green to blue, the diameter becomes smaller (red = 2.5 mm; blue = almost 0).

The mean 3D-thickness (Figure 3) did not change in the 4 weeks groups.

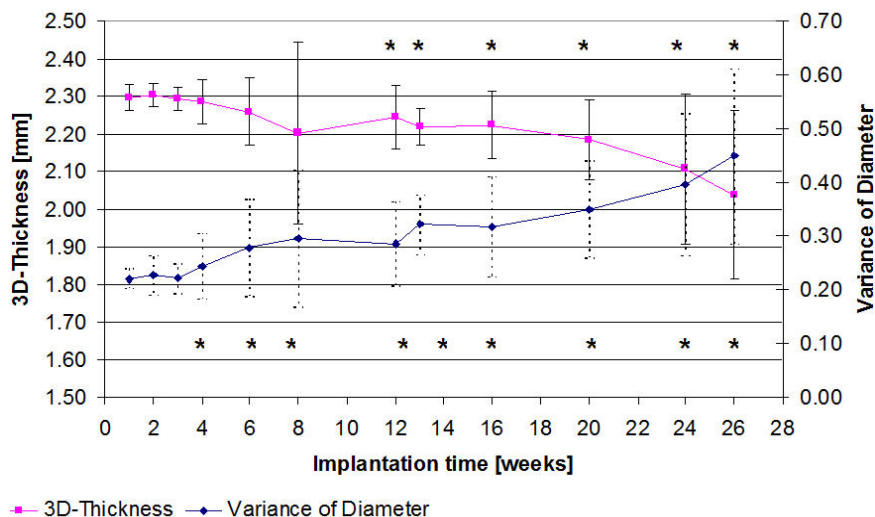
**Figure 4.** Representation of the 3D-thickness development and the variance of the implant's diameter determined by  $\mu$ -computed tomography plotted over the course of 26 weeks. Significant changes ( $p \leq 0.05$ ) compared to the second post implantation week are identified by a \*.

The diameter's variance mainly increased continuously from the initial scan (Figure 4). Across all the time groups, it was possible to observe significant ( $p = 0.032$ ) elevations from the 4th week in comparison to each of the initial scans. The mean diameter's variance was 195.7% of its initial value (0.23 to 0.45) after 26 weeks. It was possible to establish a significant difference ( $p = 0.035$ ) between the final values of the 4 and 8 weeks groups but not between the 8 and 13 weeks or the 13 and 26 weeks groups. This was due to higher standard deviations.

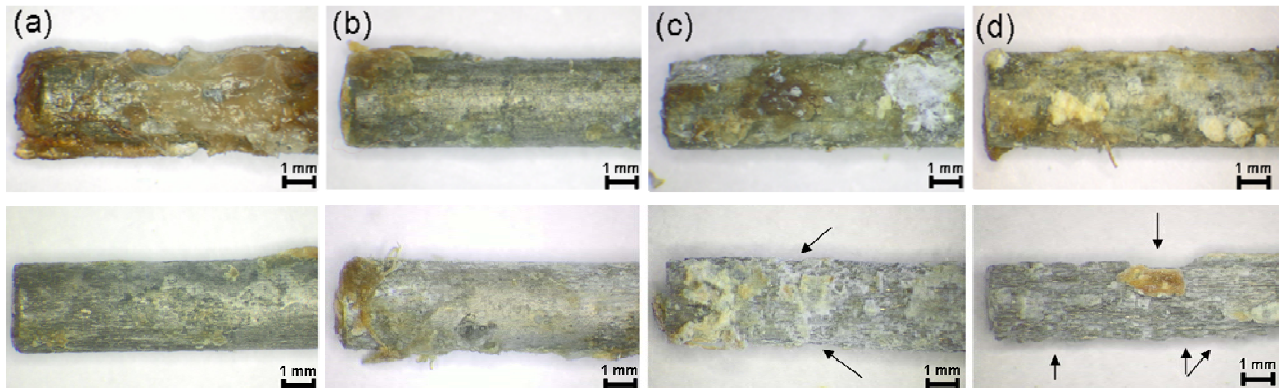
**Figure 5.** Stereomicroscopy images of explanted pins ( $\times 2$  magnification): (a) 4 weeks; (b) 8 weeks; (c) 13 weeks; (d) 26 weeks; each prior to (top) and following (bottom) the hydrofluoric acid treatment: The arrows indicate the more severe corrosion.

Subsequent to explantation, it was possible to observe a brown-red mass on the implants, which almost covered the entire surface. In addition to this, white crystalline-like regions were found on the surface (Figure 5). These were most pronounced in the 13 and 26 weeks groups. All the pins exhibited an almost cylindrical shape after explantation. One implant from the 26 weeks groups exhibited eroded ends, significant corrosion pitting and a shorter length in comparison to the other implants from the same group.

After the treatment in hydrofluoric acid, bright silvery surfaces possessing longitudinal grooves were discernible on all the implants. These were least formed in the 4 weeks groups. The corrosion increased with increasing implantation duration. One implant from the 8 weeks groups showed a rounded end and was more severely corroded than the remaining implants after 8 weeks. However, this did not involve the implant which was radiologically more proximally situated in the tibia. The implants of the 13 weeks groups demonstrated, on average, a more severe corrosion than the implants in the 8 week group. It was possible to discern few, very shallow cavities after 13 weeks.

In comparison to the other groups, the implants in the 26 weeks groups demonstrated the most severe corrosion. They exhibited a rough and uneven surface possessing longitudinal grooves as well as the previously described white, crystalline regions. The implants' ends showed a tapered form and several shallow cavities on the surface (Figure 5(d) below).

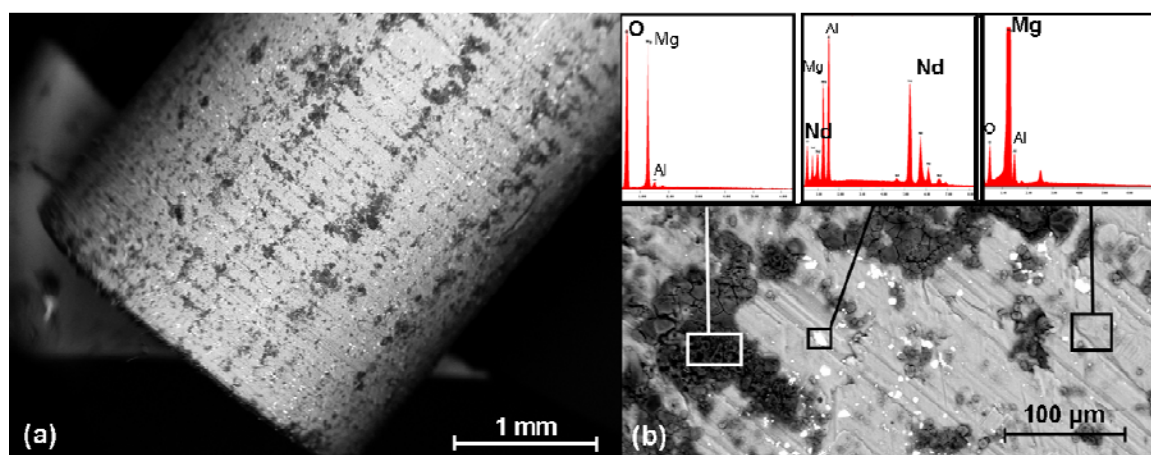
**Figure 6.** SEM images prior to implantation: (a) Overview of the pin's surface prior to the test; (b) EDX analysis of the pin's surface: preferentially detected Mg, Al, Nd and O. Each of the boxes mark the regions selected for the EDX analysis.

In the SEM, the pins showed a relatively smooth surface prior to implanting (Figure 6(a)), only the grooves due to manufacturing were discernible. In the EDX analysis, it was possible to identify oxygen and neodymium rich areas as well as magnesium and aluminium (Figure 6(b)).

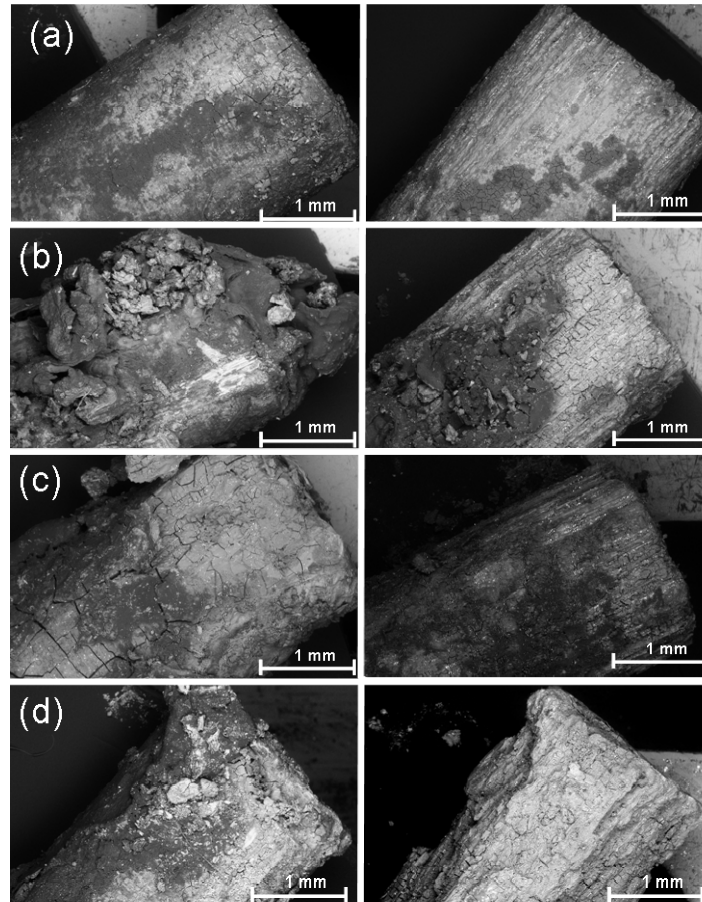
**Figure 7.** SEM images of the pin ends: (a) 4 weeks; (b) 8 weeks; (c) 13 weeks; (d) 26 weeks; each prior to (left) and following (right) hydrofluoric acid treatment

Following explantation, but prior to the hydrofluoric acid treatment, it was possible to observe an undulating and clump-like surface with cracks for all the implants (Figure 7, left column). In the EDX analysis, this surface contained above all magnesium, carbon, oxygen, phosphorus and calcium (Figure 8(a)). It was also possible to find small amounts of sodium, potassium and neodymium. In the

Following the hydrofluoric acid treatment (Figure 7, right column), implants from all the time groups exhibited different degrees of longitudinal grooves. In the 4 weeks groups, no changes in the cylindrical shape could be seen. In the 8 weeks groups, one implant exhibited eroded ends and an uneven surface. In this case, it involved the implant which was also noticeable in the stereomicroscope (however, not the implant which was radiologically more proximally situated in the tibia). The remaining implants retained their approximate cylindrical shape after 8 weeks as well as after 13 weeks. In the 26 weeks groups, two implants demonstrated eroded and jagged ends and corrosion pitting at several locations (Figure 7 (d) right column). It was possible to observe, particularly after 26 weeks, distinct grooves in the longitudinal direction, an uneven bumpy surface as well as clumps. In the EDX analysis, neodymium was partly found in the longitudinal grooves (Figure 9).

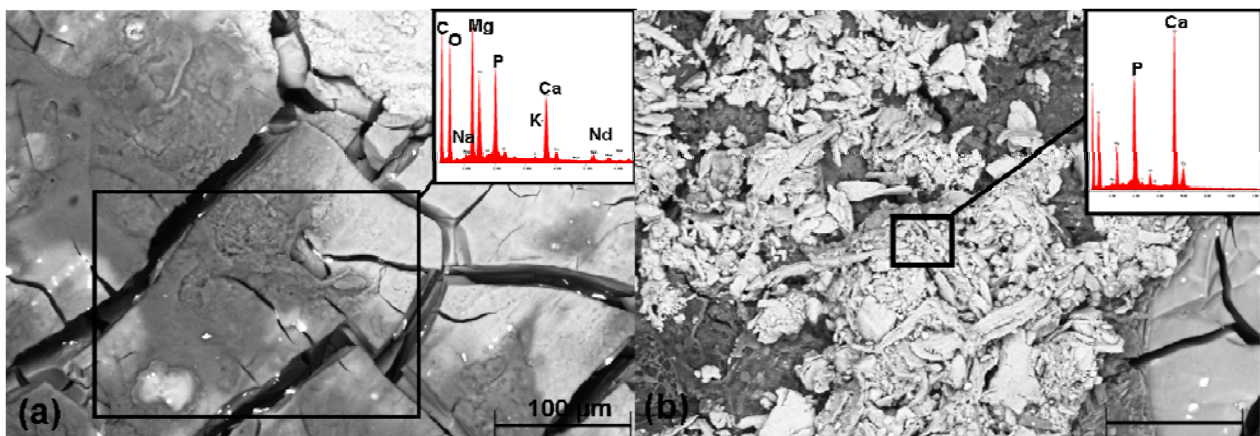
**Figure 8.** SEM images of the pin's surface using a pin following 26 weeks implantation prior to the hydrofluoric acid treatment and the EDX analysis of the individual elements in the marked regions: (a) clump-like structures; (b) crystalline structures, verification of Ca and P on the pin's surface. Each of the boxes mark the regions selected for the EDX analysis.

13 and, even more so, in the 26 weeks groups, it was possible to observe crystalline, brittle surface structures which exhibited high amounts of calcium and phosphorus (Figure 8(b)).

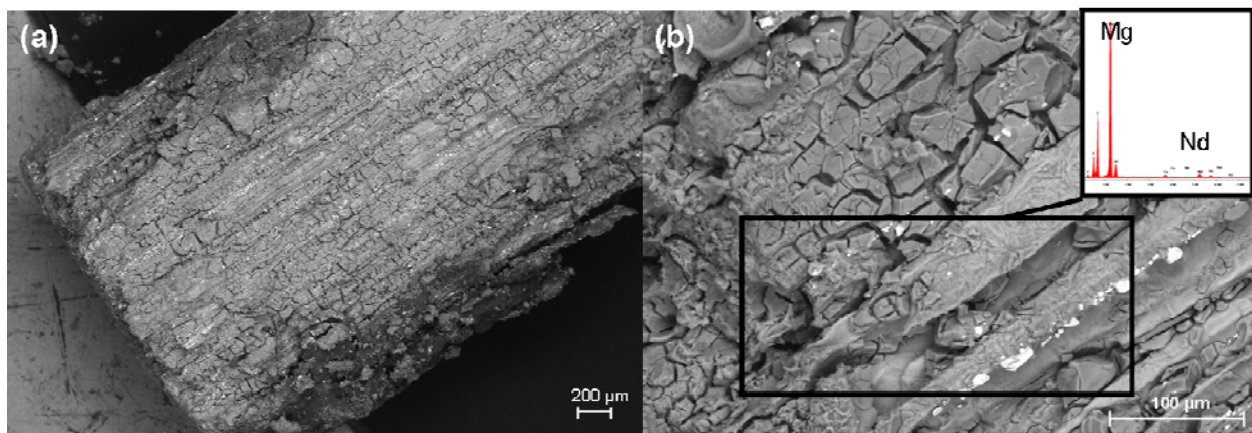
**Figure 9.** SEM images of the pin's surface following hydrofluoric acid treatment, using a 26 weeks implant: (a) Distinct longitudinal grooves and clumpy structures; (b) EDX analysis: magnesium and neodymium in the grooves and clumpy structures

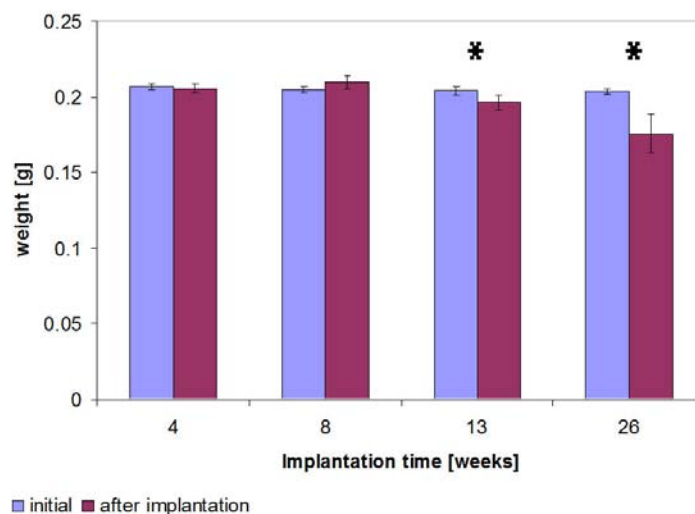
**Figure 10.** Implants' weight measurements following hydrofluoric acid treatment for the different implantation times 4, 8, 13 and 26 weeks, significant weight reductions ( $p \leq 0.05$ ) in comparison to the initial values are verifiable from the 13th week and are identified by \*.

Subsequent to explantation and to hydrofluoric acid treatment, the implants' weights for the 4 and 8 weeks groups were not significantly changed in comparison to the initial weight of 0.21 g (SD 0.002), but a slight weight gain after 8 weeks of 0.005 g could be found. In contrast to this, after 13 weeks the weight significantly ( $p = 0.035$ ) reduced by 3.7% in comparison to the initial weight of 0.20 g (SD 0.005) and was significantly ( $p = 0.01$ ) lower than the weight after eight weeks 0.21 g (SD 0.004). After 26 weeks, the weight loss in comparison to the initial weight increased by 13.7% (to 0.18 g (SD 0.013)) (Figure 10) and was thus significantly ( $p = 0.05$ ) higher than that after 13 weeks.

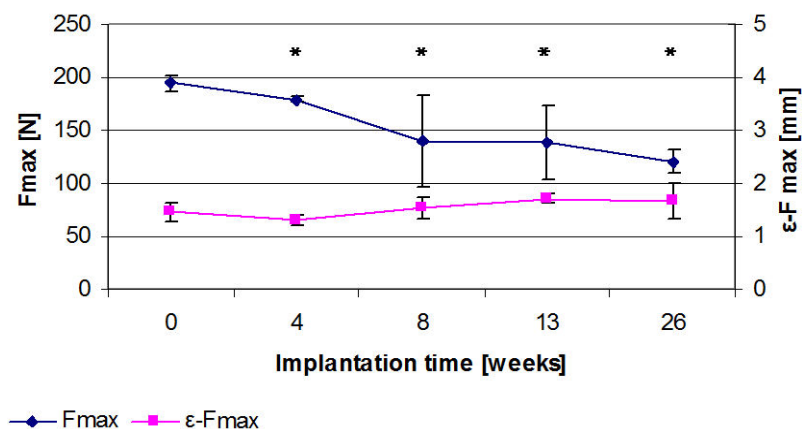
**Figure 11.** Three point bending tests for different implantation times after 4, 8, 13 and 26 weeks, the maximum force ( $F_{max}$ ) shows a distinct drop over the course of time but no significant change in elongation at fracture ( $\epsilon-F_{max}$ ) (significant changes ( $p \leq 0.05$ ) in comparison to the initial value are identified by \*).

For the initial implants, the maximum force ( $F_{max}$ ) was 194.5 N (SD 7.3) and the displacement ( $\epsilon-F_{max}$ ) was 1.5 mm (SD 0.2). A distinct drop in  $F_{max}$  was exhibited for all points in time following the respective implantation period (Figure 11). After 4 weeks,  $F_{max}$  was reduced by 7.2% to 179.0 N (SD 2.7) ( $p = 0.002$ ), after 8 weeks by 28.3% to 139.5 N (SD 43.5) ( $p = 0.026$ ) and after 13 weeks by 28.9% to 138.2 N (SD 34.9) ( $p = 0.01$ ). After 26 weeks, a loss of 38.3% (to 120.1 N (SD 10.8)) of the initial force was observed ( $p < 0.001$ ). In all time groups, the  $\epsilon-F_{max}$  did not significantly change with respect to the initial value but showed a trend of increasing values. After 4 weeks, the  $\epsilon-F_{max}$  was 1.3 mm (SD 0.1) ( $p = 0.203$ ), after 8 weeks 1.52 mm (SD 0.2) ( $p = 0.623$ ), after 13 weeks 1.72 mm (SD 0.09) ( $p = 0.099$ ), and after 26 weeks 1.7 mm (SD 0.3) ( $p = 0.108$ ).

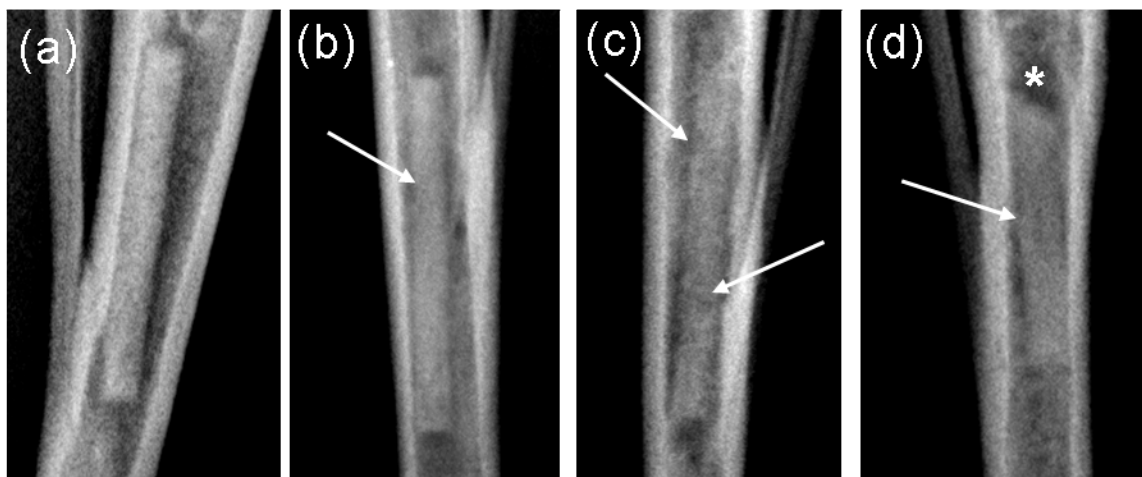
**Figure 12.** Assessment of the implant's degradation by means of anterior-posterior x-ray images: (a) Score 0: as on the day of implantation; (b) Score 1: low structural loss without shape change; (c) Score 2: marked structural loss without shape change; (d) Score 3; significant structural loss with shape change. Arrows indicate the structural loss, stars indicate shape changes.

Post operatively, the location of the implants was radiologically controlled. Digital x-ray images (Practix 160, Philips, Hamburg, Germany) of the tibiae were recorded weekly in the mediolateral and anterior-posterior beam path using 48 kV and 6.3 mAs. By means of the x-ray images, the appearance of the implants were assessed using semi-quantitative scores [23] from 0 (no change), 1 (low structural loss of the implant without shape change), 2 (marked structural loss of the implant without shape change) and 3 (significant structural loss with shape change of the implant). Besides this, the occurrence of gas (low to high levels) was assessed on a computer (dicomPACS<sup>®</sup> vet Version 5.2.4; Oehm und Rehbein GmbH, Rostock, Germany) (Figure 12).
