**CONSERVATION
OF
WALLPAPERS
FROM
ST PANCRAS
CHAMBERS**

*By
Lynda Skipper*

St Pancras Chambers, originally known as the Midland Grand Hotel (Figure 1) was designed by Sir George Gilbert Scott and opened in the 1870s in the St Pancras area of London. The building was commissioned by the Midland Railway Company, who also commissioned the neighbouring St Pancras Station, enabling Midland Railway to run their own rail route into London [1]. The hotel was in use until 1935, and was then converted to offices and staff accommodation, but then stood empty for over 20 years until a recent redevelopment project into a hotel and apartments by the Manhattan Loft Corporation [2]. The building reopened as a hotel in 2011. As part of this redevelopment, Crick Smith Conservation, a commercial arm of the University of Lincoln's Conservation Department, carried out in depth investigations to determine the historic paint schemes used in the building. When evidence of wallpapers was also found, this project was set up in conjunction with English Heritage to investigate, rescue and conserve wallpapers from the building.

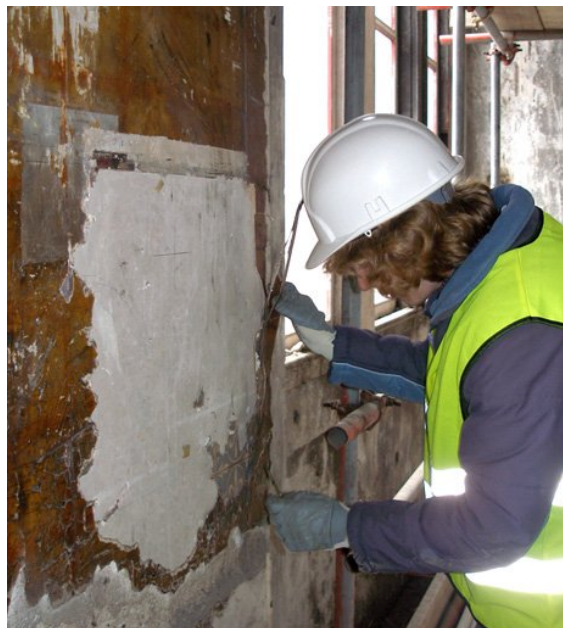
Figure 2. The author retrieving a fleur-de-lis style wallpaper from the 2nd floor of the building.

Four days were spent at St Pancras by the author, retrieving papers that had been found during building works (Figure 2). While the visits took place over 12 months (with a delay due to a fire which prevented access) it was necessary to act quickly as new wallpapers were uncovered, because these were areas that were actively being renovated by the building teams. Due to the short time frame and the large number of wallpapers (spread around more than 500 rooms) the wallpapers had to be removed from the walls as rapidly as possible. To illustrate the urgency of the task and need for a rapid removal, in one incident the author was surrounded by builders waiting to knock down a wall, but as the wallpaper was still attached, they were asked to wait until after the removal had taken place!

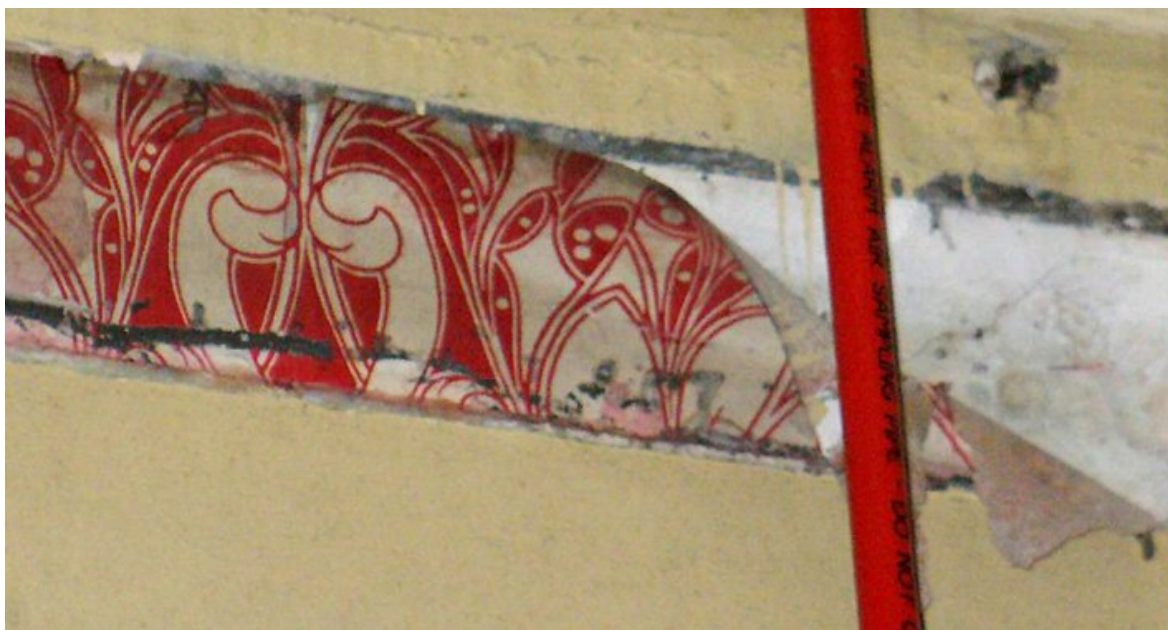
Figure 3 (above). Paper in the 3rd floor corridor, exposed by removal of ducting, is very poorly attached to the wall.
 Figure 4 (left). Wallpaper from room 2.023 showing vertical staining pattern.

(Figure 3), the paper was already almost entirely detached from the wall and was easily removed dry, using only a scalpel where necessary.

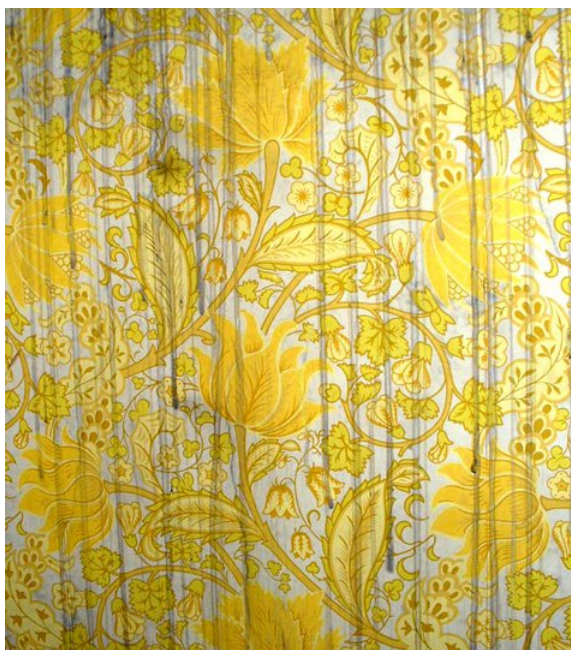
Dirt and discolouration was a common problem with the wallpapers. The building generally was very dirty and dusty, partly due to ongoing renovation work and partly due to years of neglect and lack of cleaning. An example of this is the wallpaper shown in Figure 4, where dirt has run down the wallpaper, carried by water. As the water dried, it left the dirt behind.

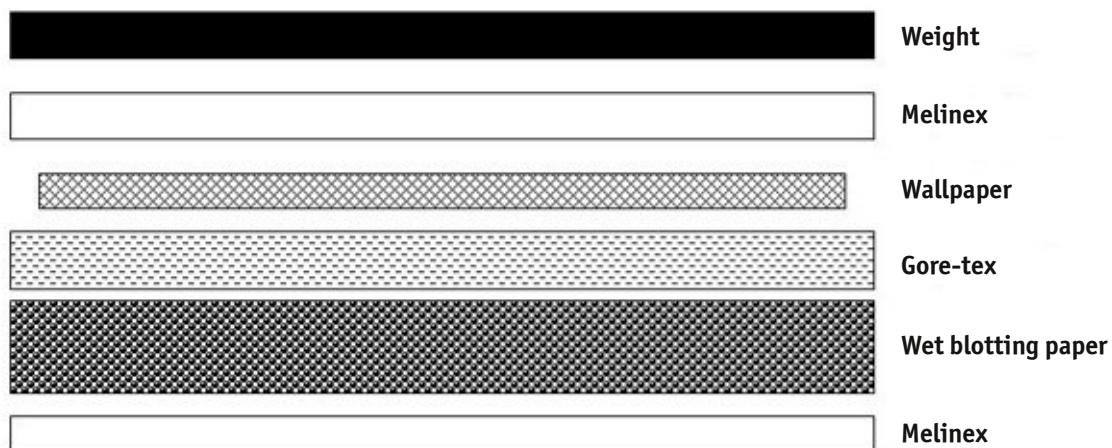
Figure 5. Schematic showing use of Gore-tex to separate layers via single sided humidification.

Gore-tex was successfully used to introduce controlled levels of moisture to separate layered water sensitive papers, as shown in Figure 5 [4]. The wallpapers gradually became humidified and separated without damaging the papers or causing excessive bleeding of colours. The wallpapers were

left in the Gore-tex for between 30 minutes and overnight, depending on the thickness of the layers and the amount of humidity needed to soften the adhesive.

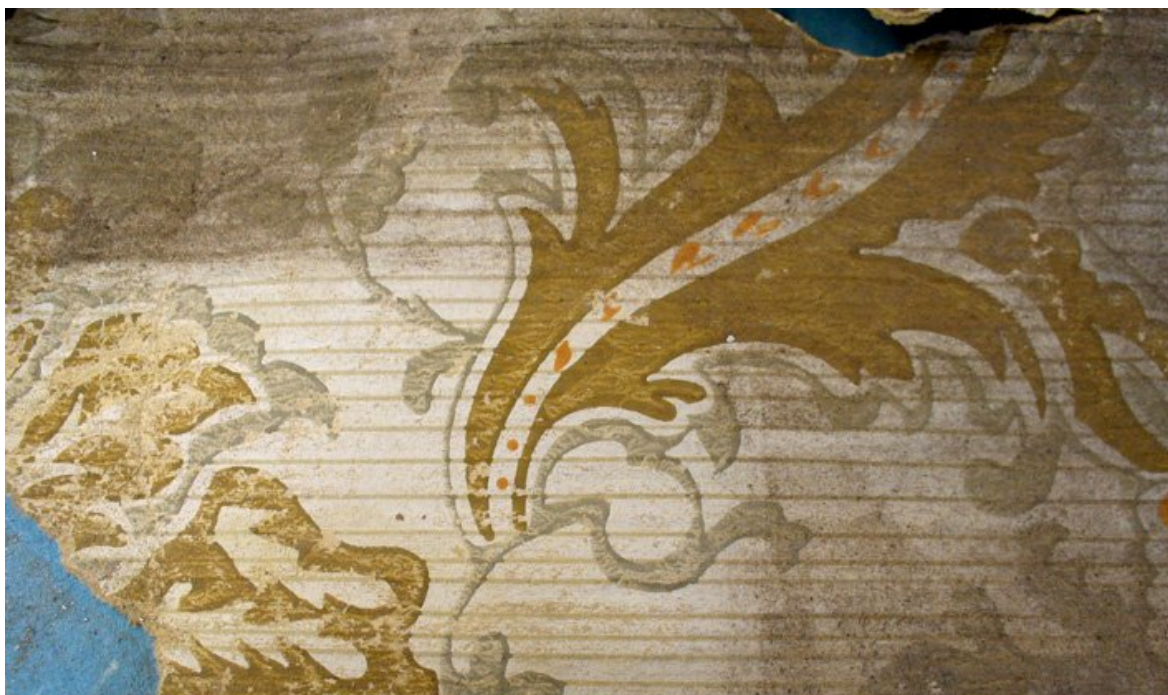
Figure 6. Using a smoke sponge for dry cleaning of wallpaper. The area bottom left of the photograph has been cleaned with a smoke sponge. The remaining areas are uncleaned.

After separation, cleaning was necessary. Loose dirt was removed with a brush unless friable pigments were present. A cleaning sponge (smoke sponge) was then used, which quickly removed the majority of the surface dirt on the papers (Figure 6).

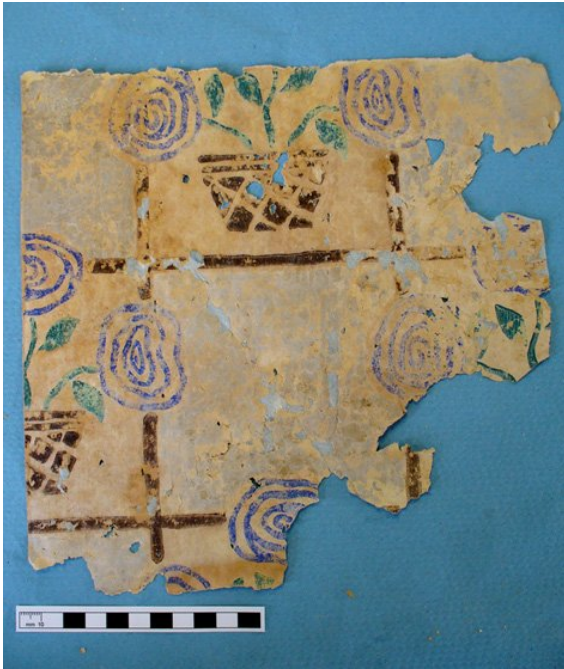
Figure 7. Wallpaper during conservation treatment. An example of a wallpaper from the ground floor with numerous tears and holes, which has been partially backed with Japanese tissue to support damaged areas.

Other conservation treatments carried out included consolidation of flaking pigments with carboxymethyl cellulose at 0.5% concentration, and paper repairs using Gampi and Minogami Japanese papers (Figure 7).

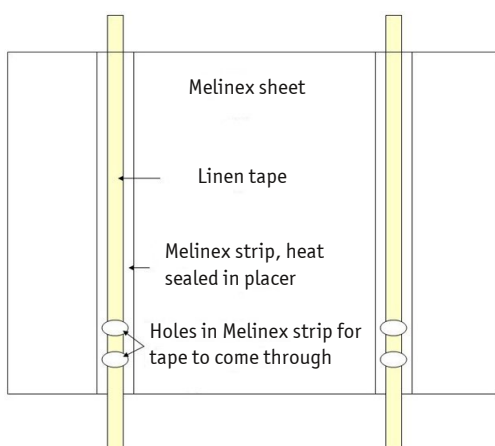
Figure 8 (above). Schematic of Melinex storage design for rolled wallpapers.

Larger papers needed rolled storage. After a visit by the author to examine the Mylar rolls at the Whitworth Art Gallery in Manchester, this appeared to be a suitable storage solution for the St Pancras papers. The Whitworth needed a large number of these outer wrappers, so had them custom made, with the tapes able to be pulled through punched holes to adjust for the size of roll [5]. As a much smaller number were needed for this project, it was decided to make these in house, using two grades of Melinex sheet with linen ties. Thick Melinex was used for the main body of the roll, with thinner Melinex used to hold the linen ties in position. A plan of these rolls is shown in Figure 8.

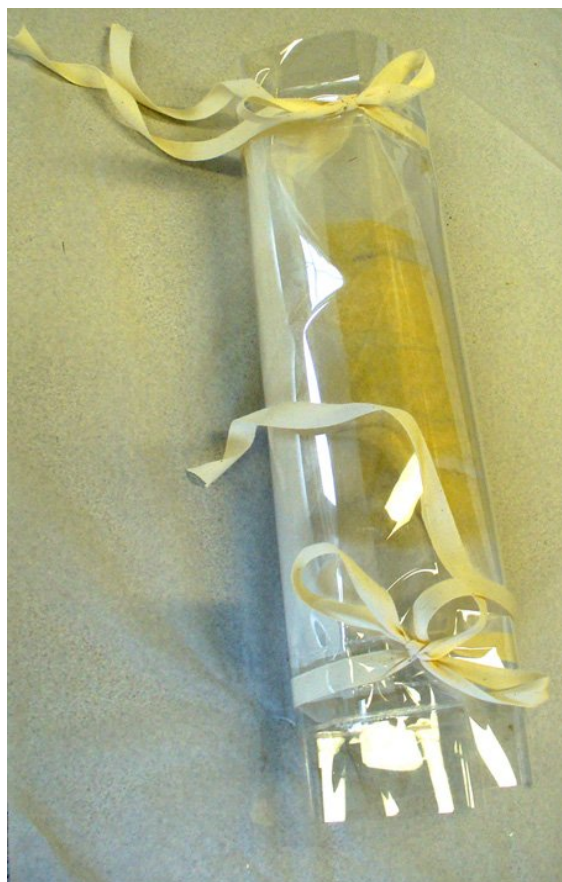
Figure 9 (right). An example of the wallpaper stored around a Melinex roll.

them circular, but this meant a fairly large diameter was needed in order to fit them onto the heat sealer. The advantage of heat sealing the inner roll was that no added chemicals or adhesives are involved, so there was no chance of any reaction with the wallpapers during storage. Figure 9 shows a completed storage roll in use.

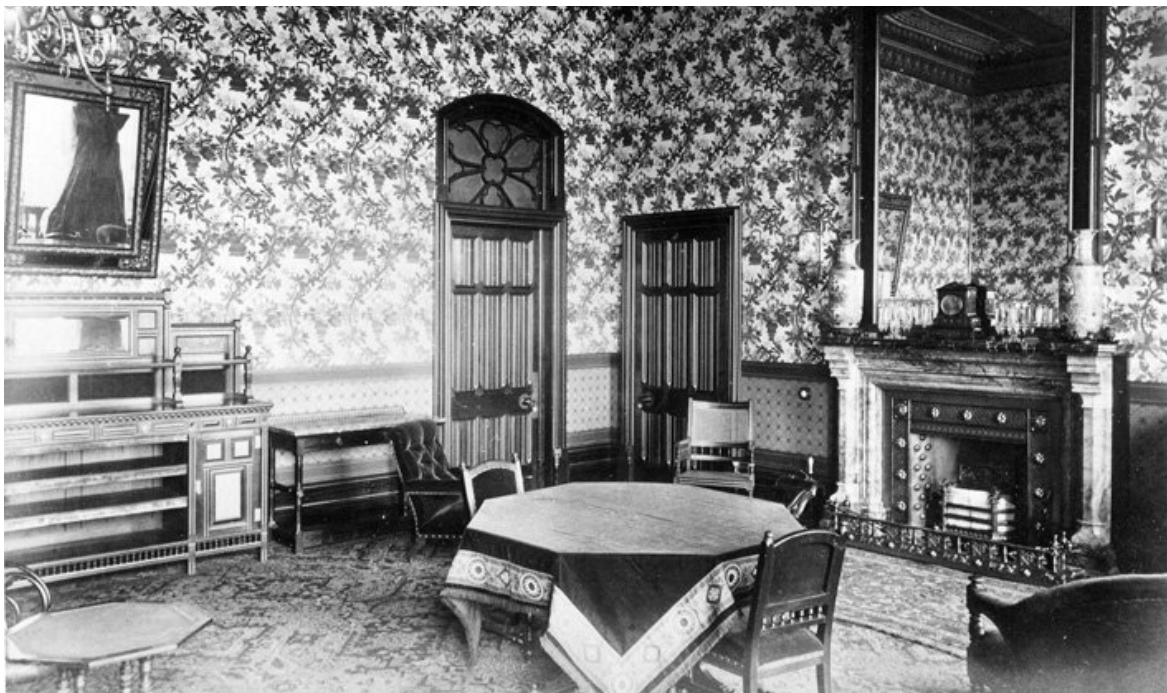
The earliest primary evidence of wallpaper being used in St Pancras is from a photograph depicting a 1st floor sitting room in 1876 (Figure 10). Previous investigations by Crick Smith Conservation found no trace of this original paper, except for traces of paste and lines on the wall where the dado used to be. This was probably stripped when electricity was installed around 1886 with just traces of paste remaining. Given

Figure 10. Sitting room, Midland Grand Hotel, St Pancras Station, c 1876. © National Archive for Historic Decoration, University of Lincoln.
