Engineering Historic Futures

Stakeholders Dissemination and
Scientific Research Report

May Cassar and Chris Hawkings

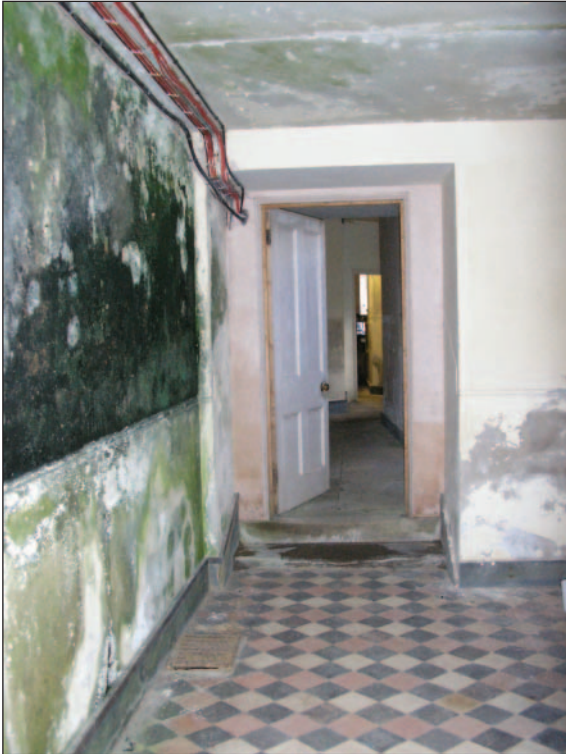
Figure 1 North-east wall of basement

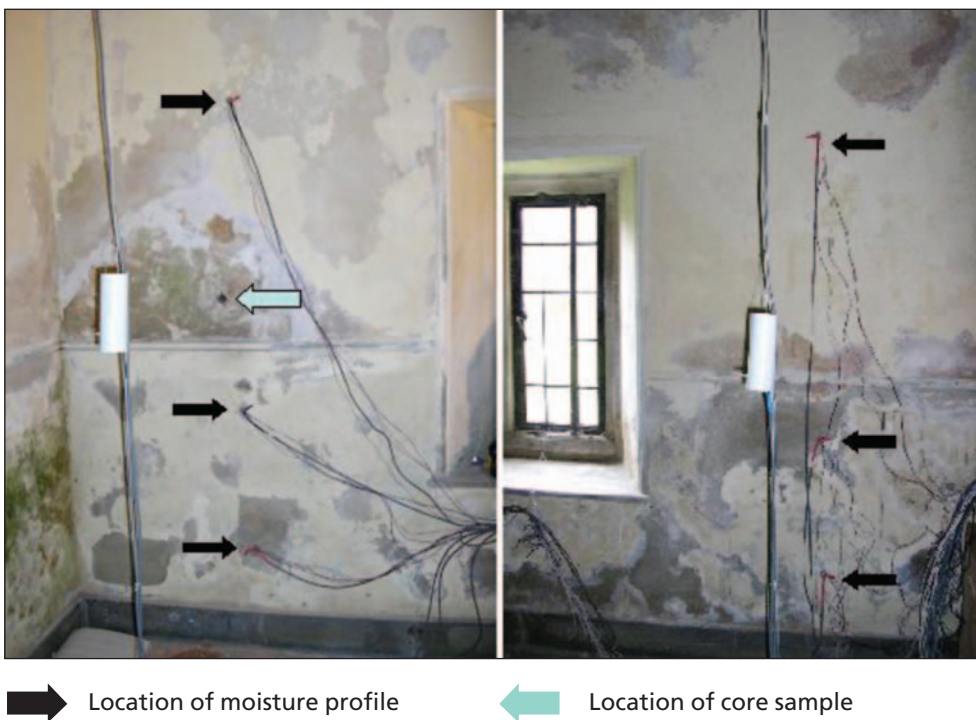
Figure 3 Location of holes drilled for core sample and moisture content profiles. Two of the radiation shields holding the basement air temperature and relative humidity sensors are also shown.

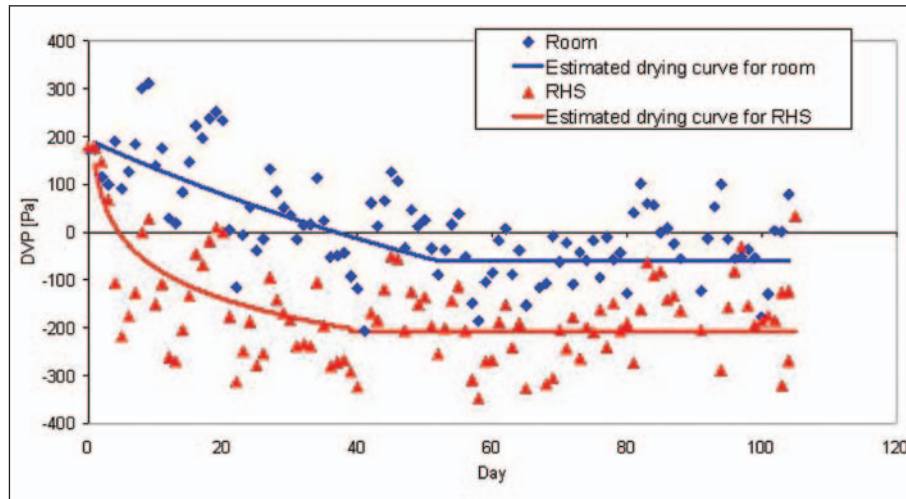
Figure 27 Room-external and RHS wall surface-external vapour pressure differences during de-humidification and estimated drying curves

Although targeted at the section of the wall with the tanking removed, the effect of the de-humidifier warms up the basement as a whole with an average temperature of 12K above external. The room relative humidity falls to an average over the intervention period of 38%. The average vapour pressure falls to below the external value. Figure 27 shows an estimated drying curve for the room based on the internal-external vapour pressure difference. A new equilibrium in the room occurs after about 50 days of de-humidification.

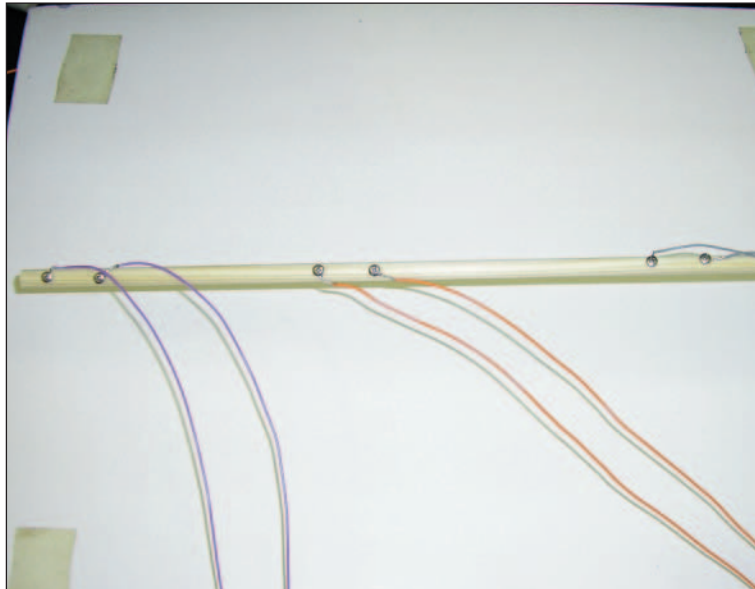
Figure 7 Moisture content sensor showing electrical connections

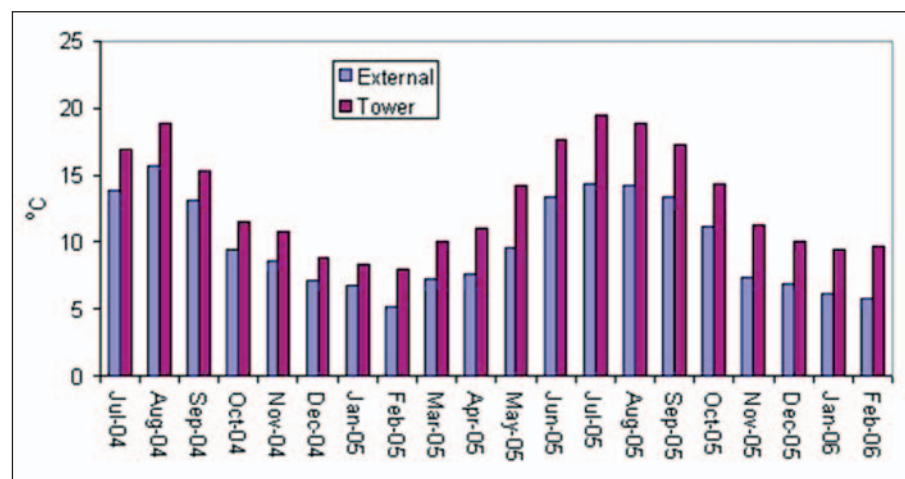
Figure 11 External and Tower air temperature

The main climate parameters are shown in Figures 11–17 and where appropriate the corresponding conditions in the Tower, i.e. temperature, relative humidity and vapour pressure. Monthly averages or totals are given for clarity.

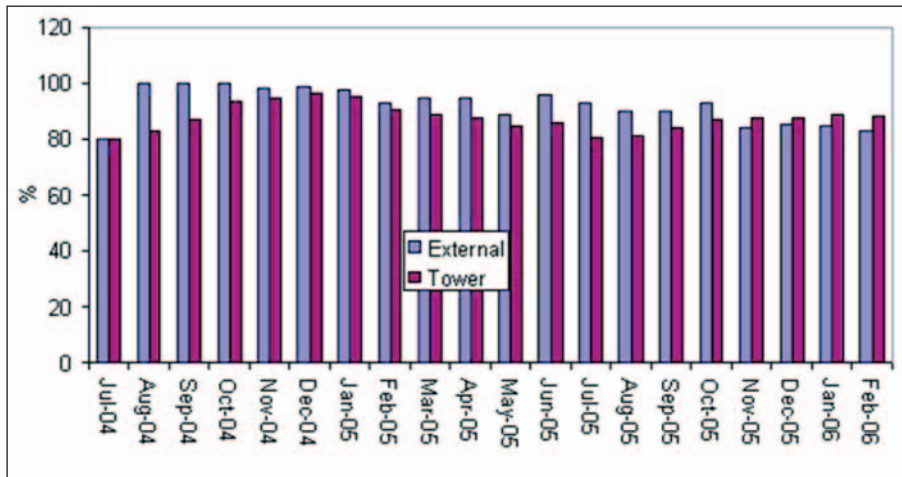
Figure 12 External and Tower relative humidity

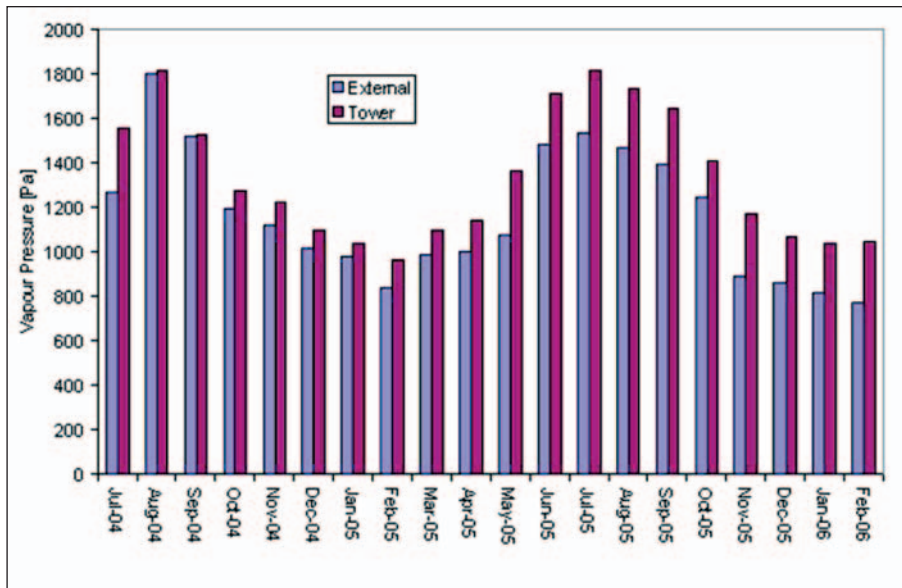
Figure 13 External and Tower vapour pressure

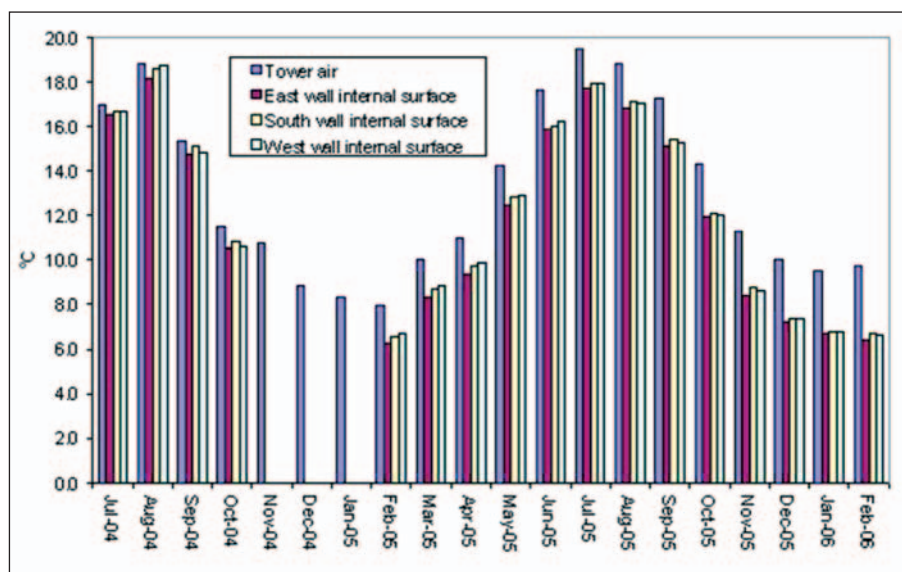
Figure 18 Temperatures at internal surfaces of south, east and west walls compared with ambient

The internal wall surface and ambient conditions within the Tower are compared in Figures 18–20. Note that due to a data logger fault, data for most of the period November 2004 to January 2005 are missing for the surface conditions.

Partitioning results in an increase in the Tower air temperature compared to the interior wall surfaces (Figure 18): before partitioning the temperature difference is 0.9K and after 2.4K for the average of the three surface measurement locations. However, there is a seasonal effect, with the temperature difference increasing in the winter and decreasing in the summer, which overlays this trend. Figure 26 shows the monthly averages of the Tower air, wall internal surface, wall external surface and external ambient temperatures with solar radiation. The walls warm up relative to the external temperature as solar radiation levels increase from February 2005 and reach a peak temperature in July. The walls then begin to cool as solar radiation levels fall and the wall temperatures converge with the external temperature over autumn and winter.

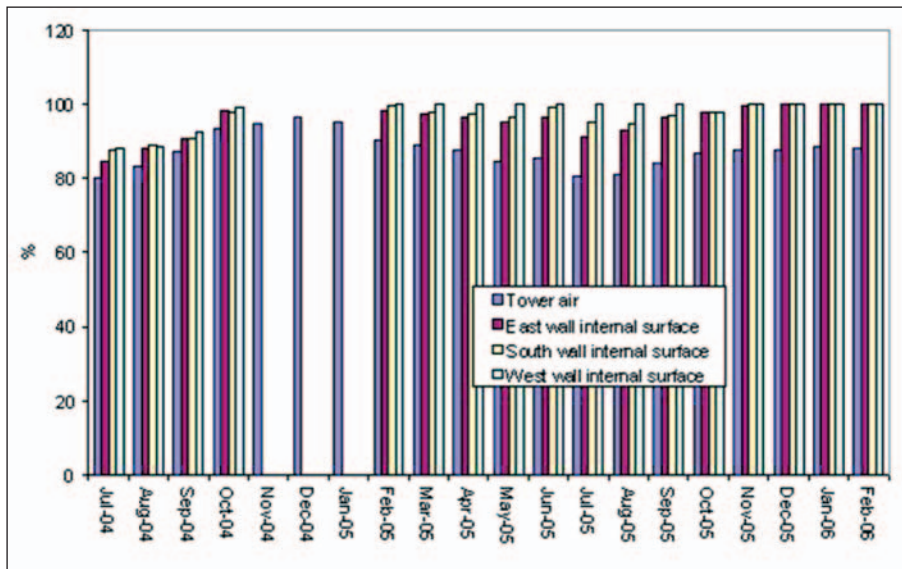
Figure 19 Relative humidities at internal surfaces of south, east and west walls compared with ambient

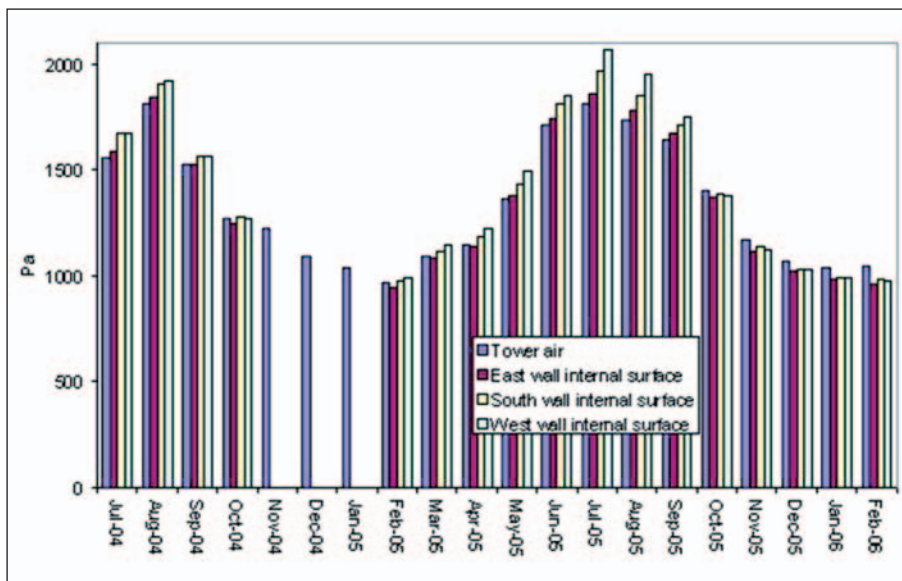
Figure 20 Vapour pressure at internal surfaces of south, east and west walls compared with ambient

Whilst the average vapour pressure difference between the wall surface and the room is small (~30Pa) and does not appear to be influenced by partitioning (Figure 20), there are large seasonal fluctuations which depend on wall orientation and solar radiation (Figure 27). Figures 26 and 27 suggests that the wall surface vapour pressures increase relative to the room as the walls warm up and then fall as solar radiation levels and wall temperature fall. The change in vapour pressure at the west wall surface is greatest as it remains at or near saturation for most of the monitoring period.

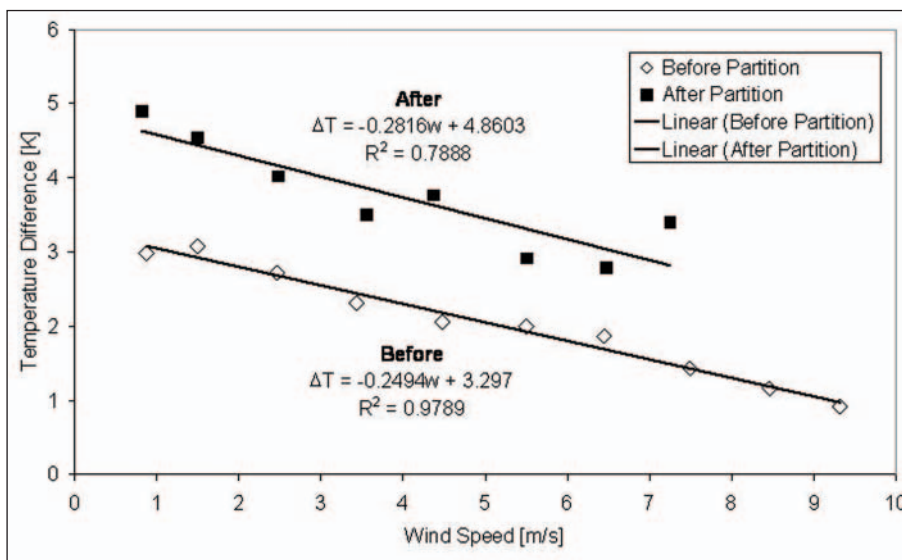
Figure 21 The relationship between internal-external temperature difference and wind speed before and after partitioning

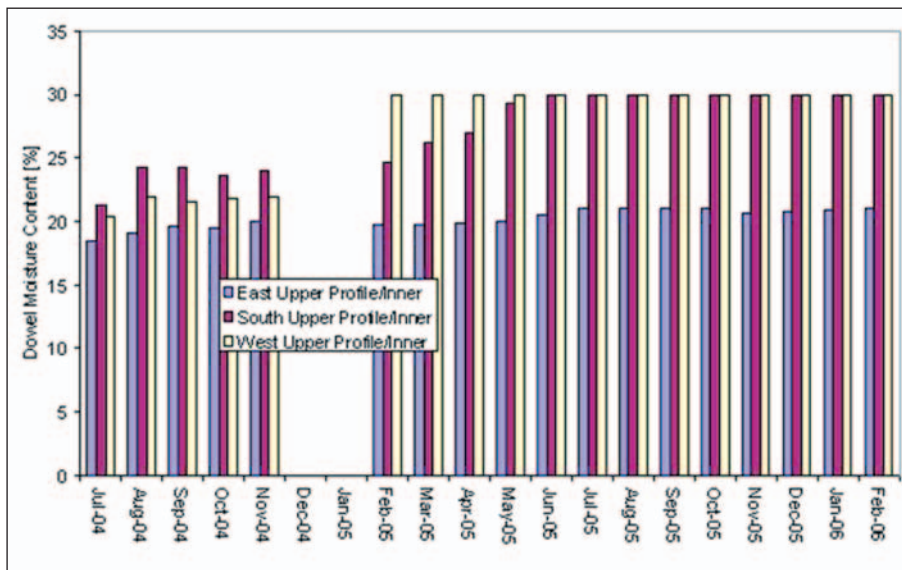
Figure 28 Dowel moisture contents upper profile near inside surface of wall

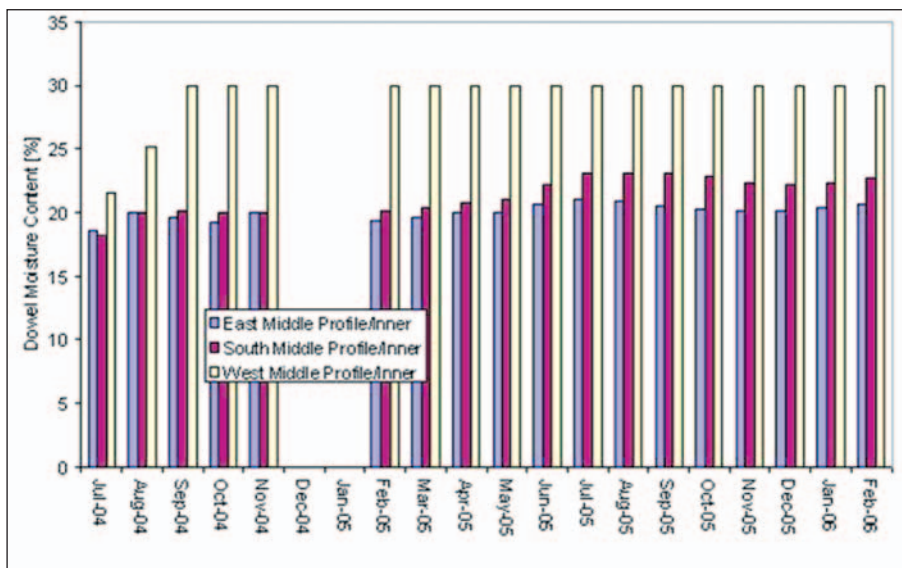
Figure 29 Dowel moisture contents middle profile near inside surface of wall

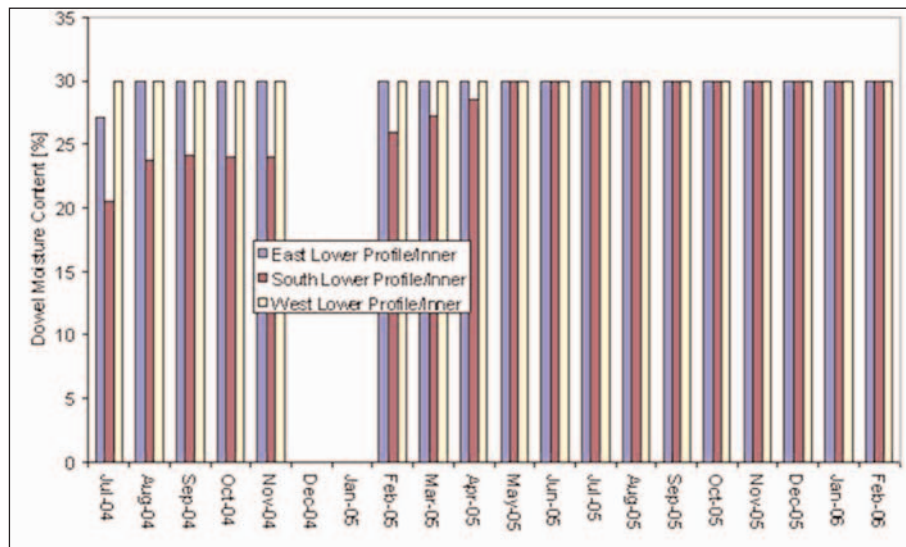
Figure 30 Dowel moisture contents lower profile near inside surface of wall

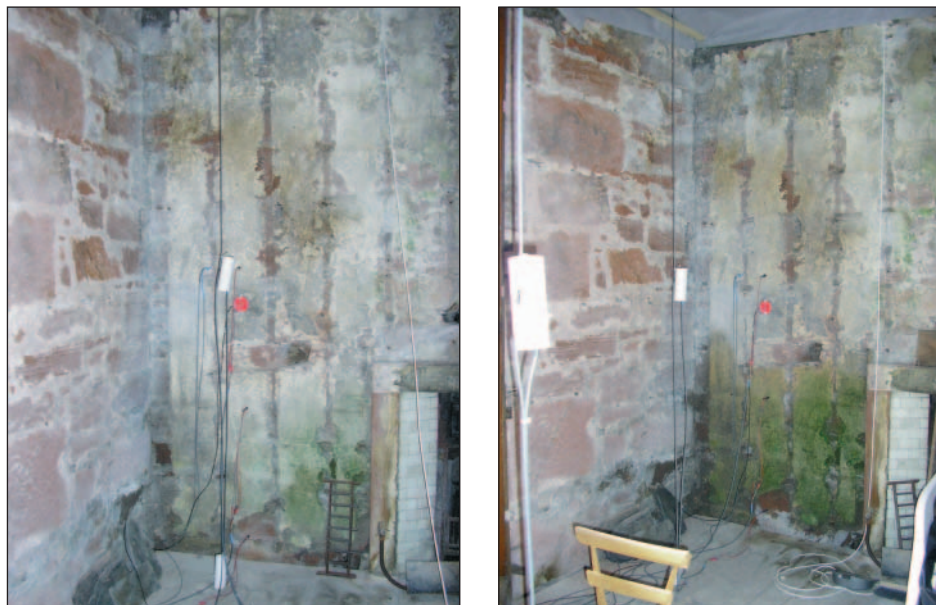
Figure 31 Spread of algae on west wall: (left) July 2004; (right) May 2006

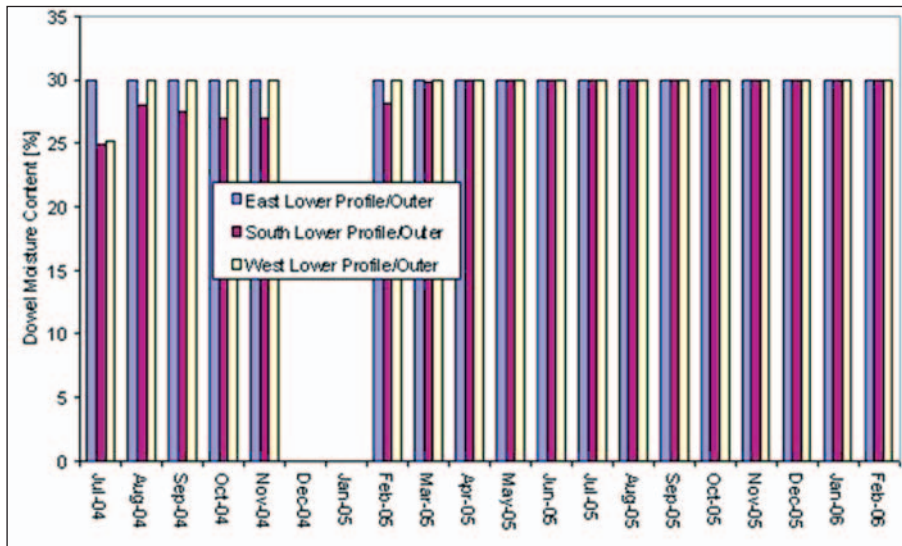
Figure 32 Dowel moisture contents lower profile towards the outside of wall

By the end of the monitoring period it was evident that the three walls were getting wetter, particularly below the gutter level. The dowel moisture content measured toward the outside of the wall (Figure 32) give a similar indication.

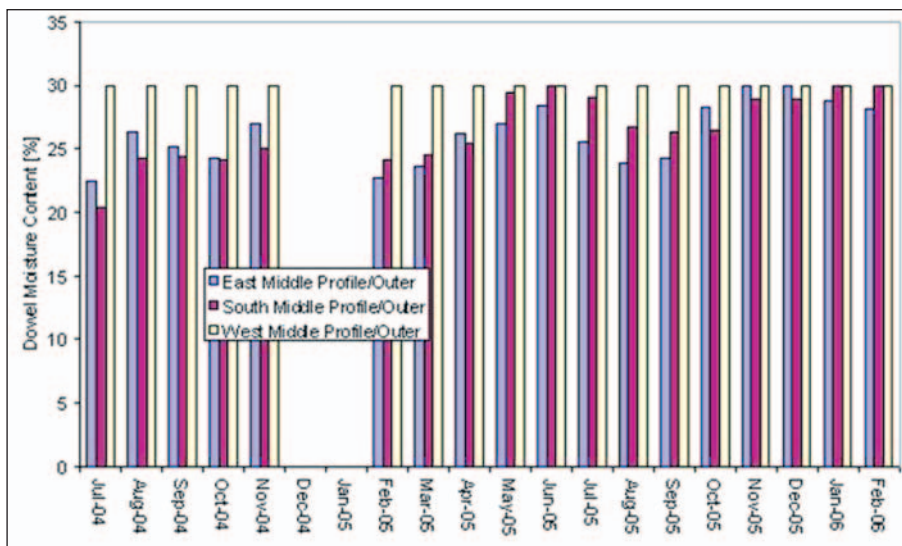
Figure 33 Dowel moisture contents middle profile towards the outside of wall

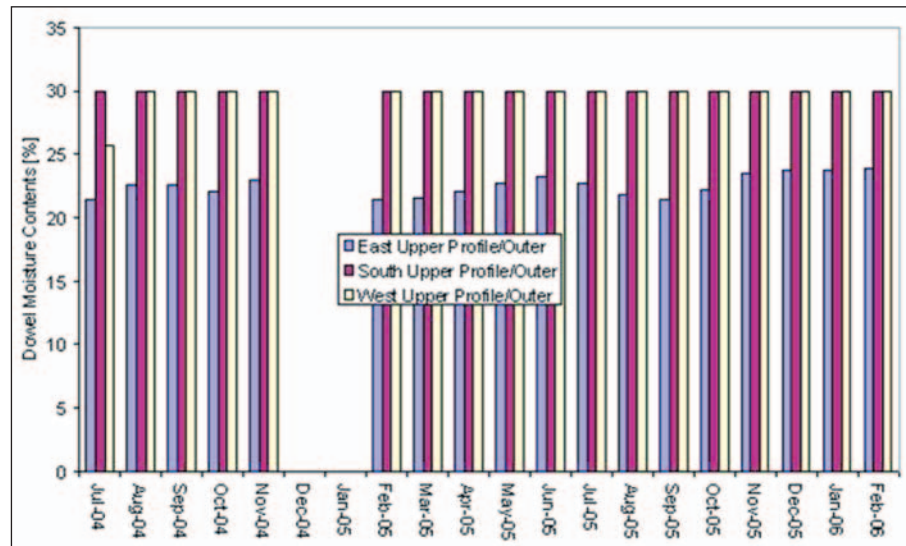
Figure 34 Dowel moisture contents upper profile towards the outside of wall

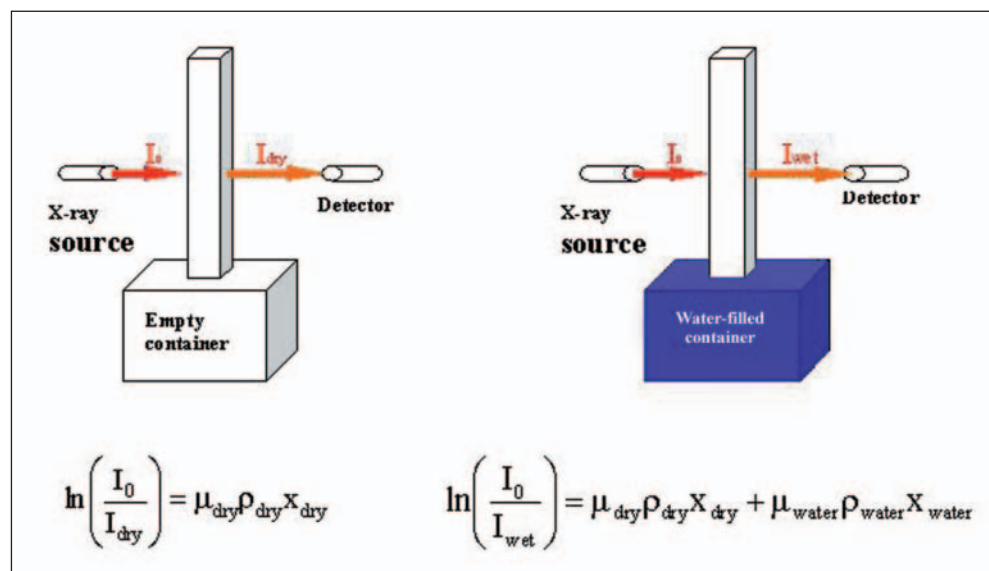
Figure 3 Procedure for moisture content determination

The adaptation of Equation 2 to yield an expression for the moisture content of an initially dry material sample can be achieved by applying this relation to various possible experimental configurations between the X-ray source and the detector. As described by Bailly *et al.*¹ this procedure allows the isolation of the various parameters which contribute to the overall absorption process and enables the moisture content to be defined in terms of the dry and wet conditions. Consider a dry sample of material and the same sample after wetting (Figure 3).

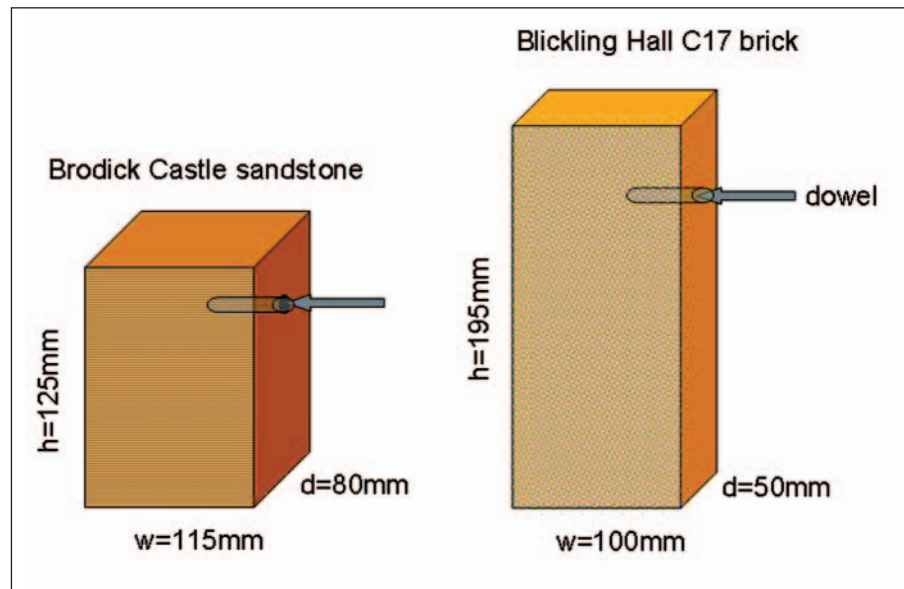
Figure 4 Dimensions and location of dowels of the Brodick Castle sandstone and Blickling Hall clay brick

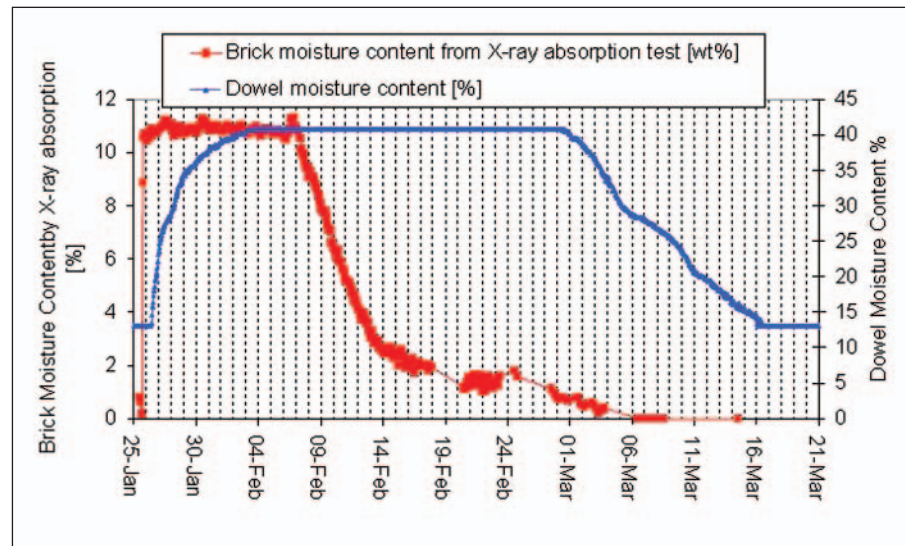
Figure 7 Brick and dowel moisture contents

The results of the tests on the brick and sandstone are shown in Figures 7 and 8.

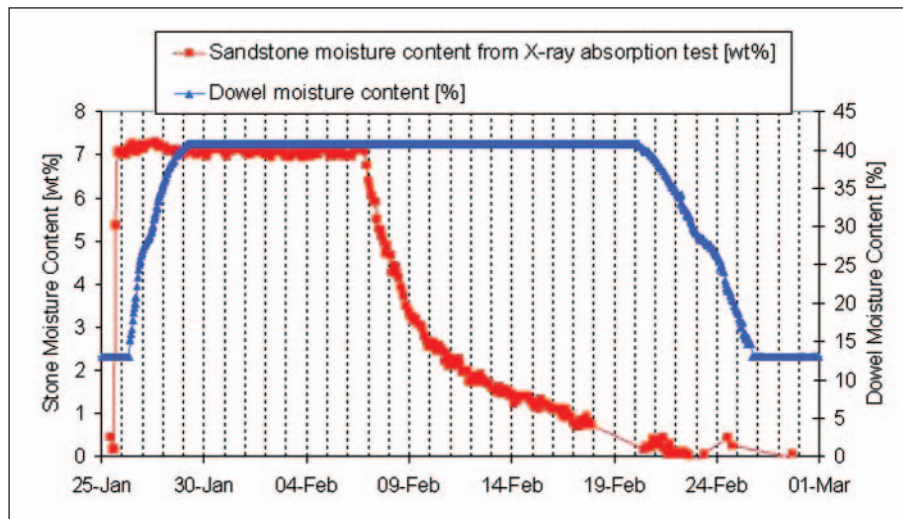
Figure 8 Sandstone and dowel moisture contents

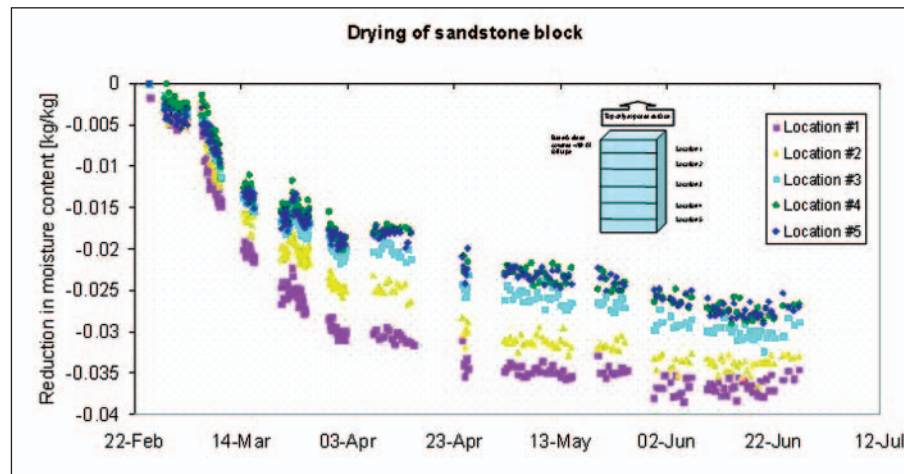
Figure 9 Reduction in moisture content estimated from X-ray scan results of the five locations

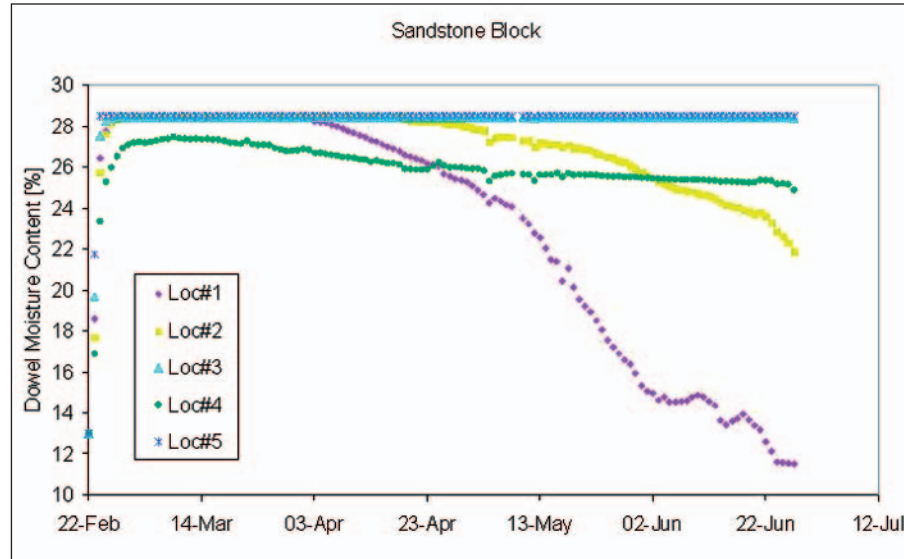
Figure 10 Dowel moisture contents measured using Protimeter data logger. Note that the upper limit is 28.5%.

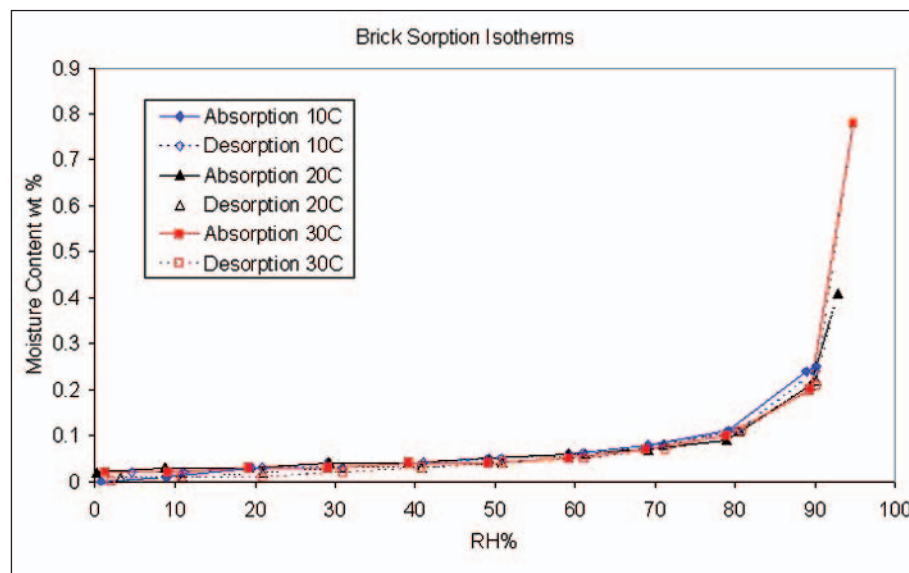
Figure 6 Sorption isotherms for brick sample

The sorption isotherms of the brick and stone samples were also measured at 10, 20 and 30°C (Figures 6 and 7). The Figures represent the equilibrium moisture

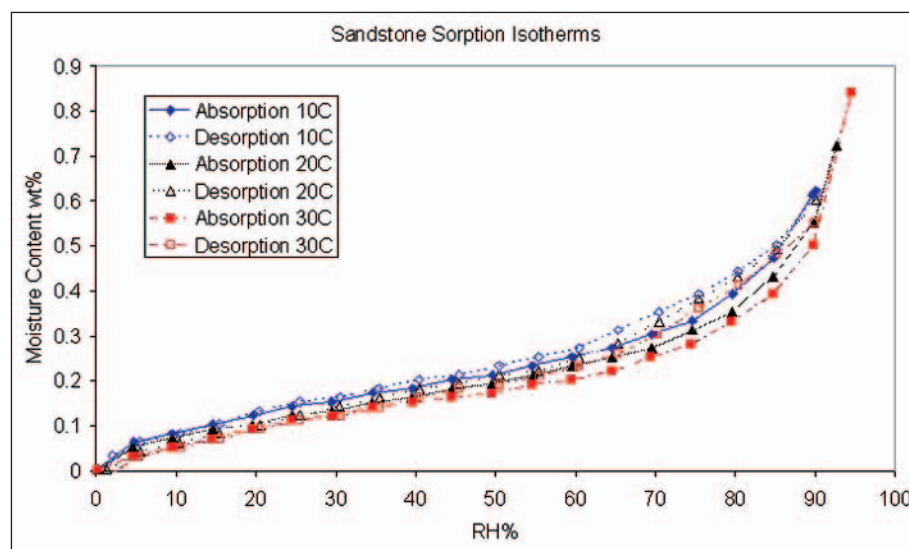
Figure 7 Sorption isotherms for sandstone sample

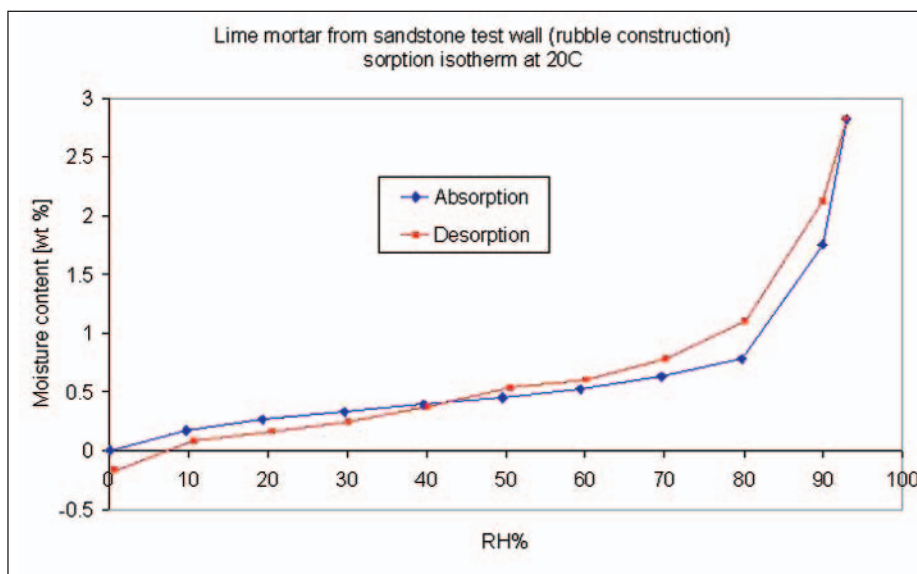
Figure 8 Sorption isotherm of lime mortar used in sandstone wall

Generally, in the hygroscopic region (below <98% relative humidity) the brick and stone samples have a low moisture content <1% by weight. Whilst the properties of the mortar were not generally measured due to the difficulties in producing satisfactory samples which were crack free and of suitable dimensions, the sorption isotherm of a sample of the mortar used in the construction of the sandstone walls was measured (Figure 8). This shows higher moisture contents over the range of relative humidities. The negative value obtained at 0% relative humidity during desorption may indicate the loss of chemically bound moisture.

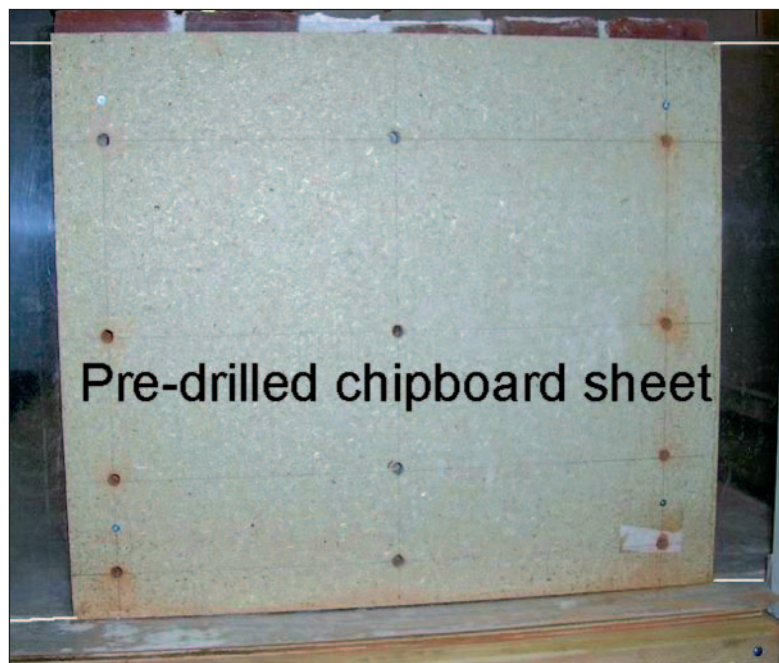
Figure 9 Template for drilling holes for sensors

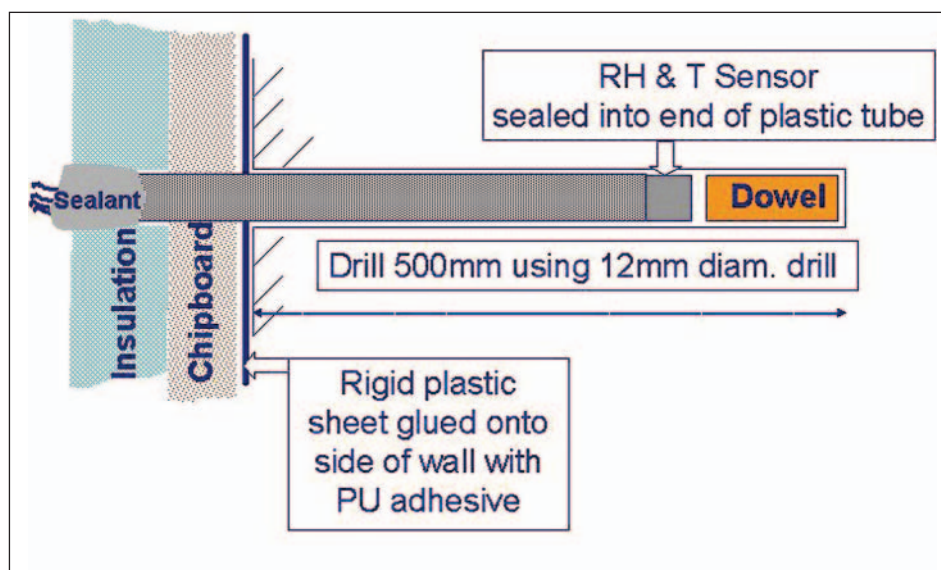
Figure 10 Sensors assembly inserted into wall

depth of about 500mm, i.e. half-way into the wall, and the side of the wall finished off with a sheet of insulation. A sensor assembly was inserted into each of the holes (Figure 10).

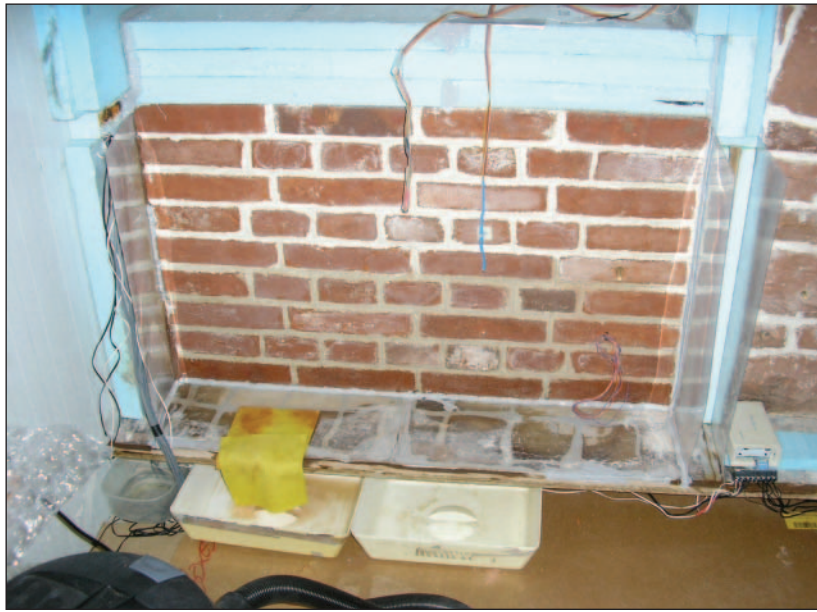
Figure 20 Warm side of brick wall showing penetration of water and evidence of damp after flooding (1 December 2005)

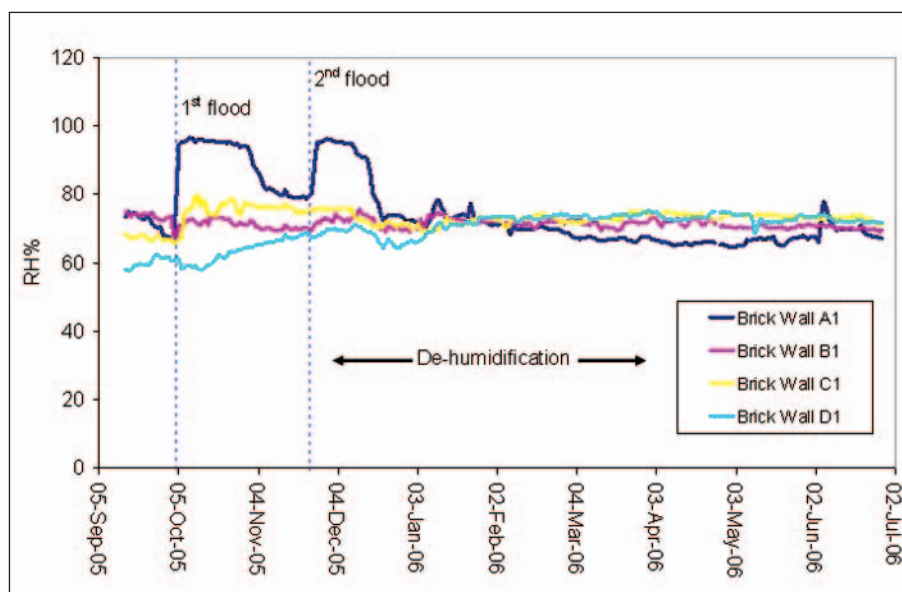
Figure 24 Relative humidities measured in the first vertical profile 50mm from cold surface of the brick wall

The relative humidities in the wall measured from September 2005, prior to the first flood, are shown in Figures 24–26.

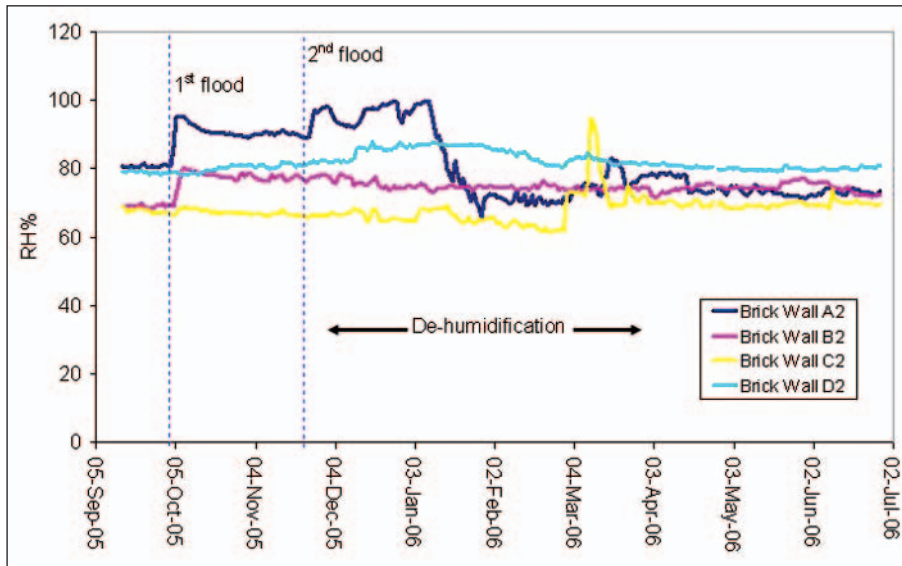
Figure 25 Relative humidities measured in the second vertical profile in the core of the brick wall

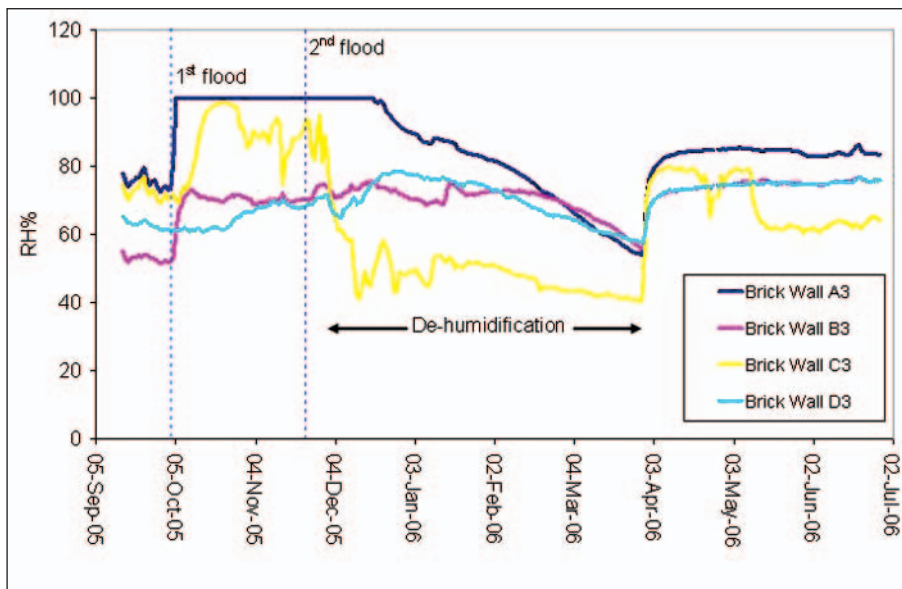
Figure 26 Relative humidities measured in the third vertical profile 50mm from warm surface of the brick wall

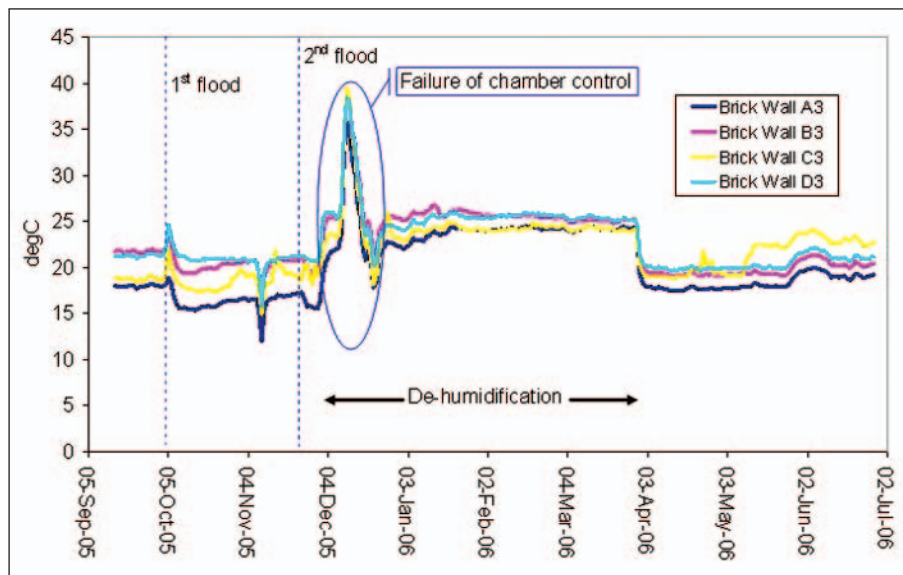
Figure 27 Temperatures measured in the third vertical profile 50mm from warm surface of the brick wall

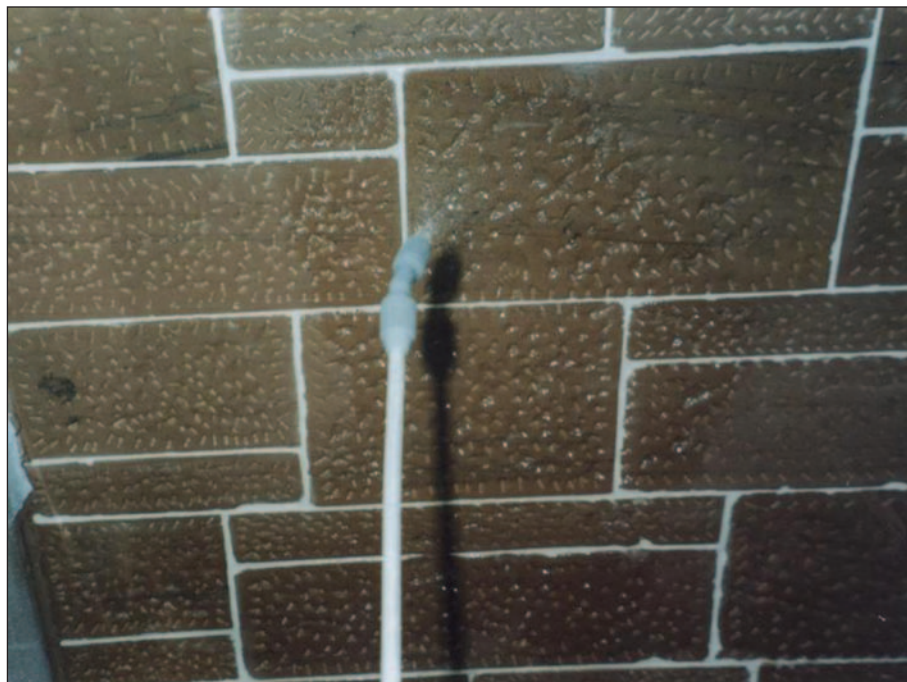
Figure 28 Spraying of stone wall

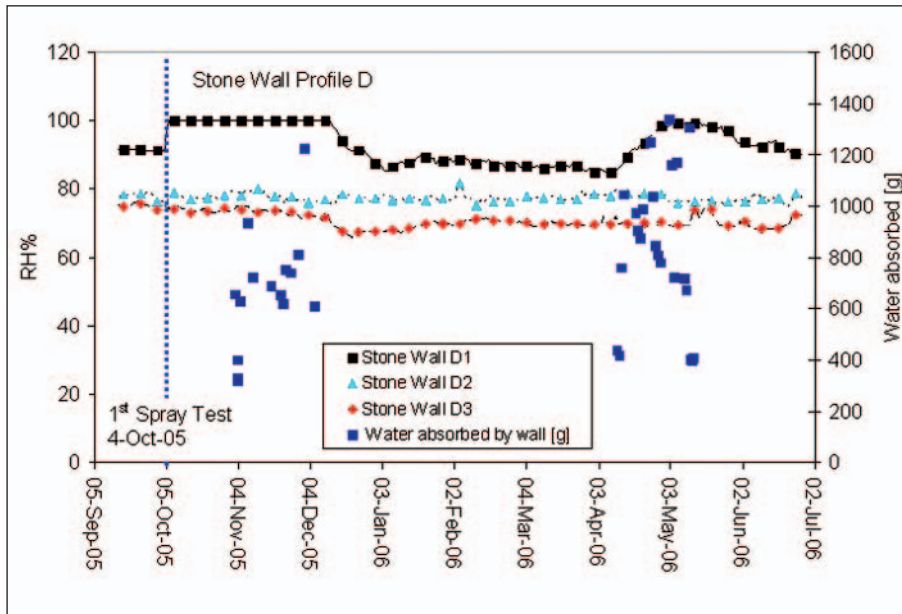
Figure 29 Relative humidities measured along profile D of the stone wall and the quantities of water absorbed during spray testing

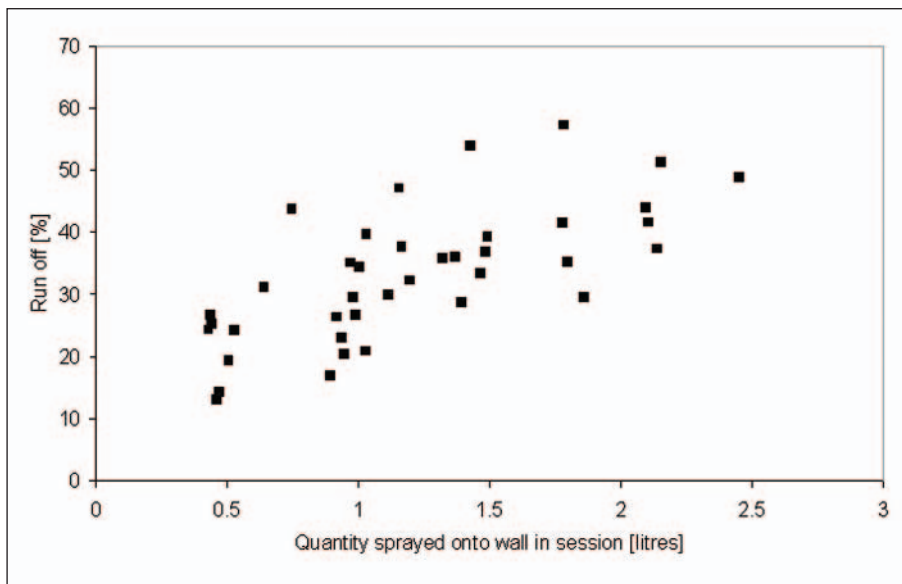
Figure 30 The amount of run-off of water from stone wall surface compared with the total amount of water sprayed onto the wall in one session

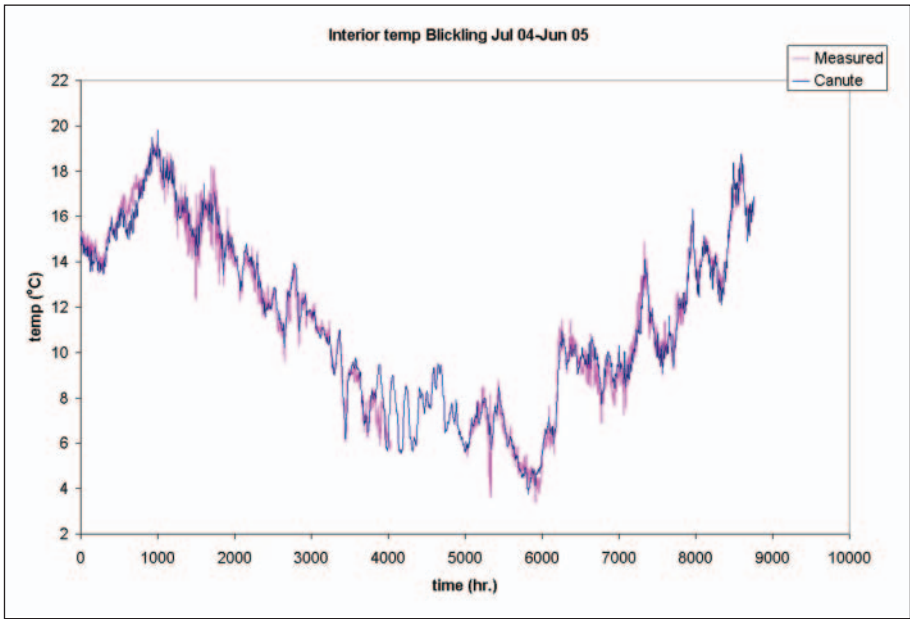
Figure 1 Comparison of Canute modelled and measured temperature for Bickling basement, for a complete annual cycle.

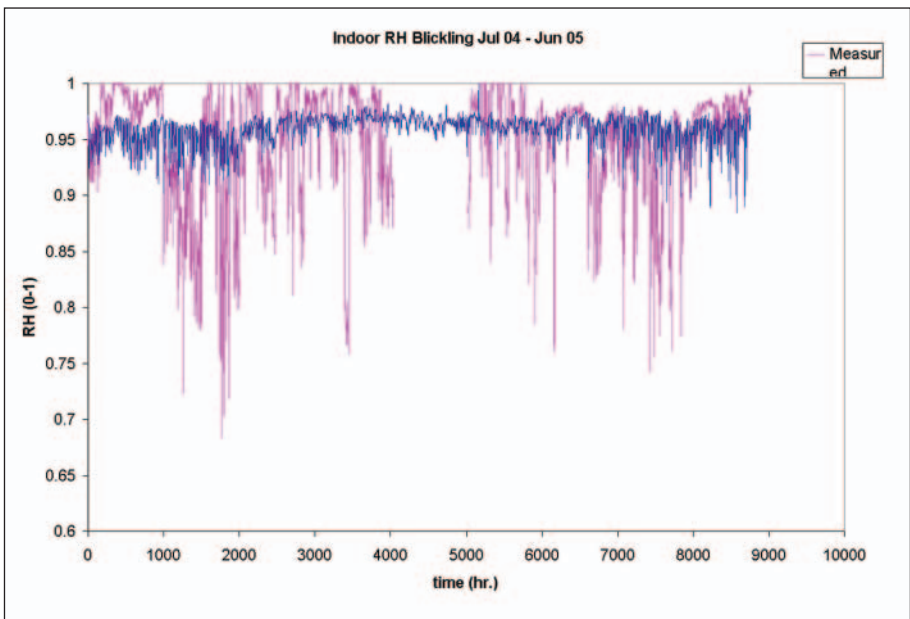
Figure 2 Comparison of Canute modelled and measured relative humidity for Bickling basement, for a complete annual cycle.

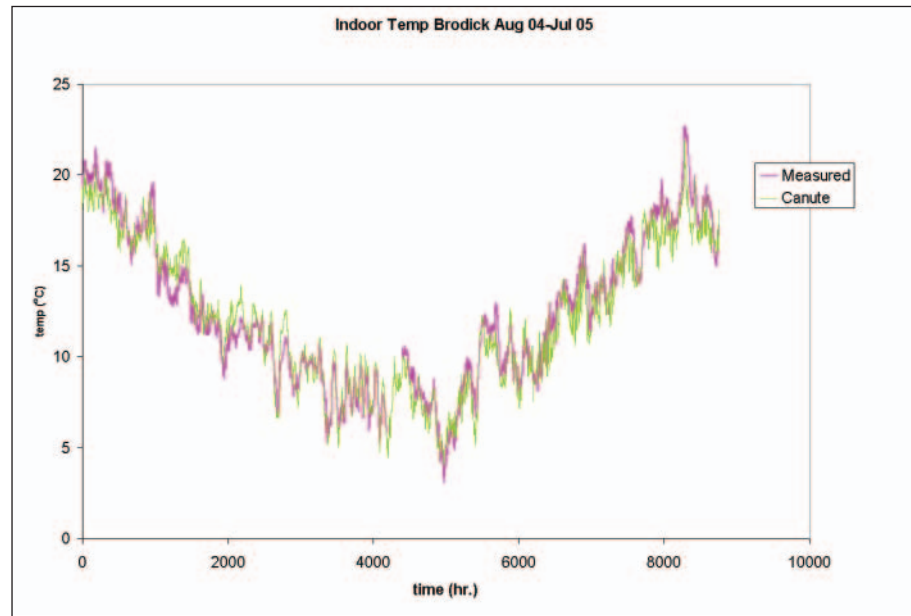
Figure 3 Comparison of Canute modelled and measured temperature for Brodick Castle tower room, for a complete annual cycle.
