Engineering Historic Futures

Stakeholders Dissemination and
Scientific Research Report

May Cassar and Chris Hawkings

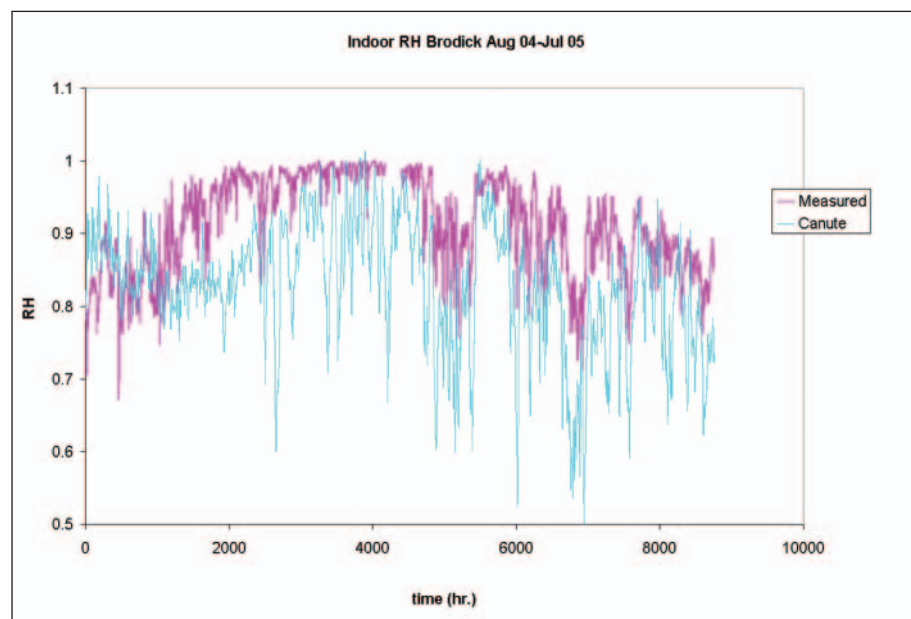
Figure 4 Comparison of Canute modelled and measured relative humidity for Brodick Castle tower room, for a complete annual cycle.

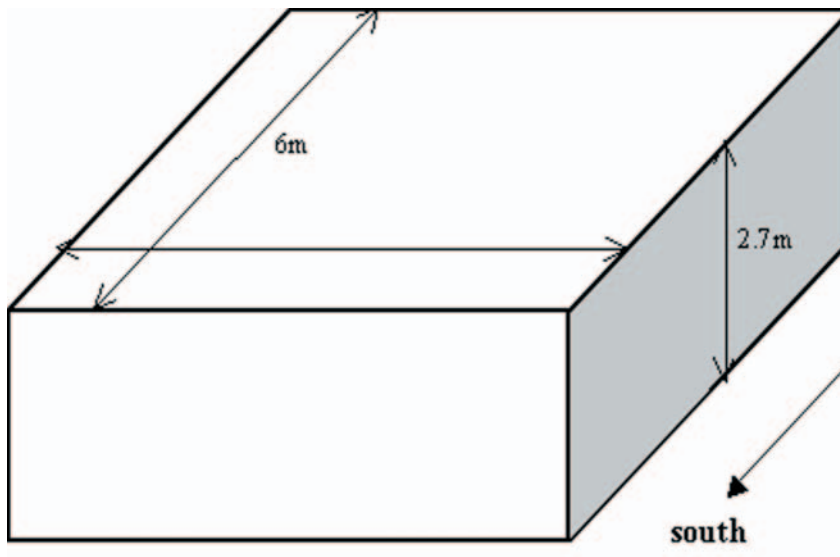
Figure 9 Annex 41 sub-task case study building.

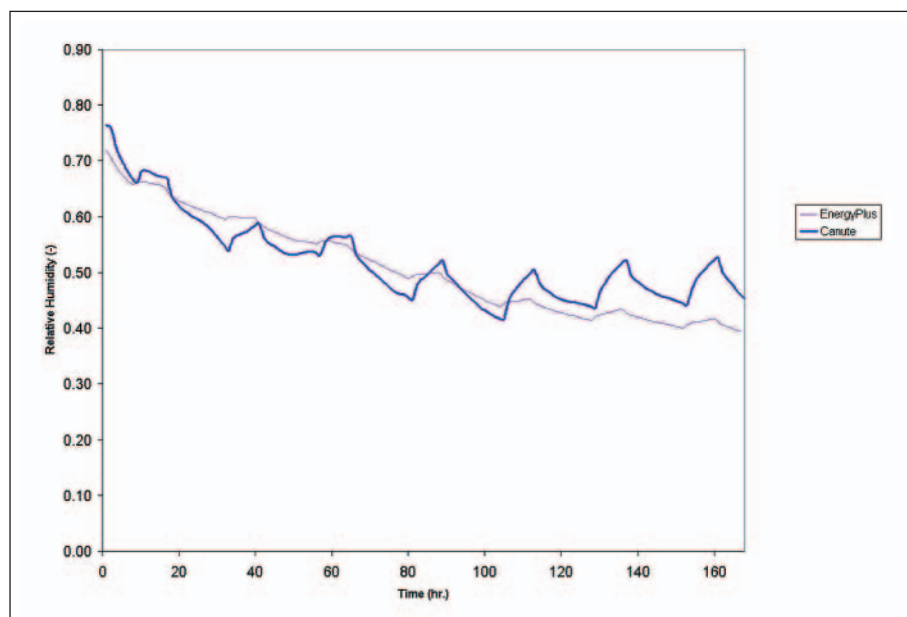
Figure 10 Comparison of indoor relative humidity simulated by Canute and EnergyPlus.

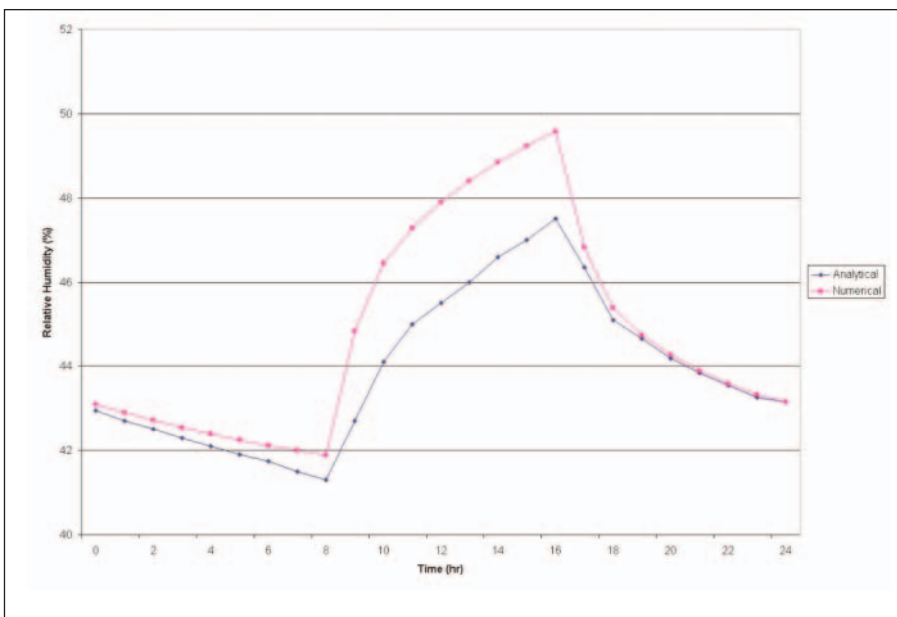
Figure 11 Comparison of RH predicted by Canute, numerically (i.e. solved by model iteration) and solved analytically (i.e. from building physics first principles).

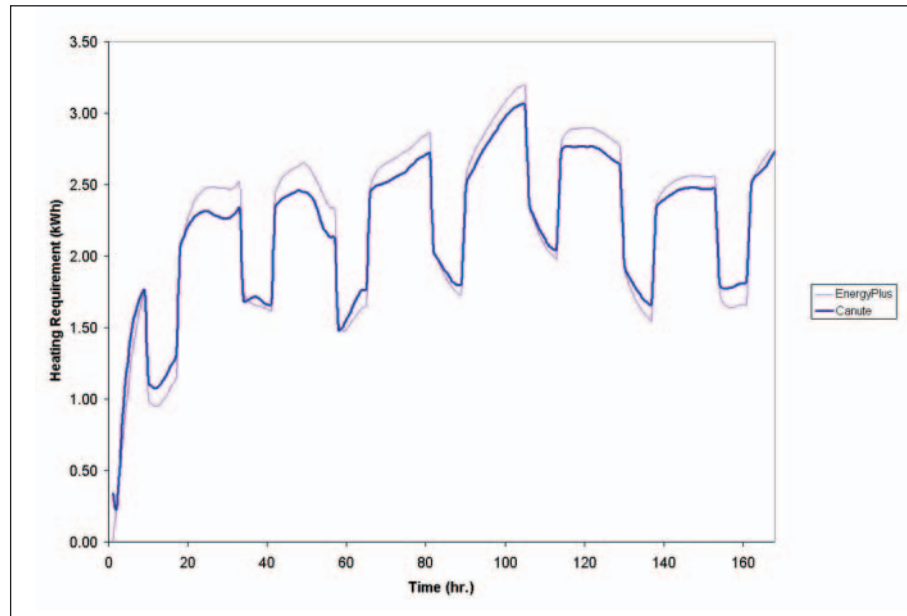
Figure 12 Comparison of Canute and EnergyPlus simulated indoor energy requirements

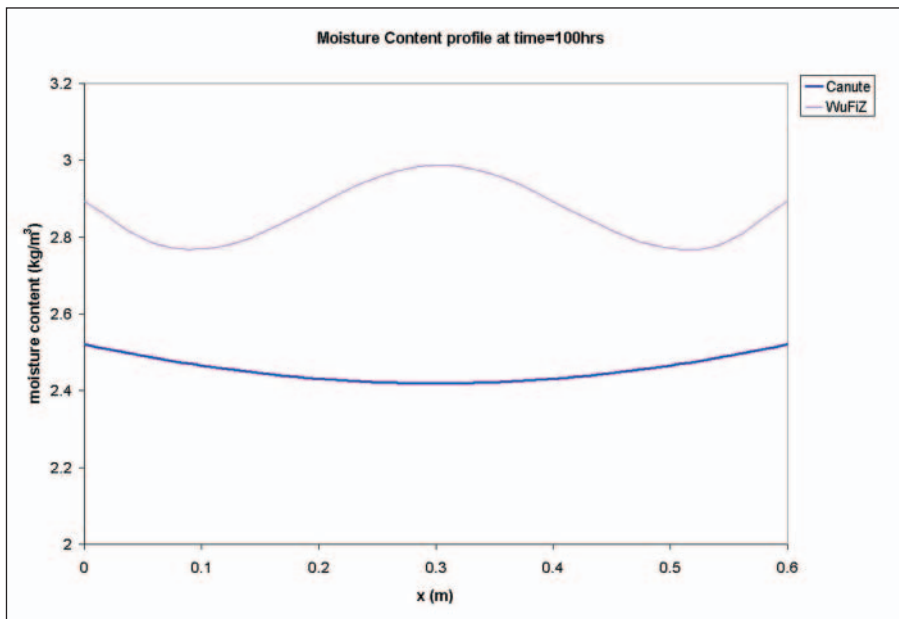
Figure 13 Comparison of simulated moisture profiles of the wall (Region 2, $y=1.5$) at $t=100$ hrs for Canute ('our model') and WuFi.

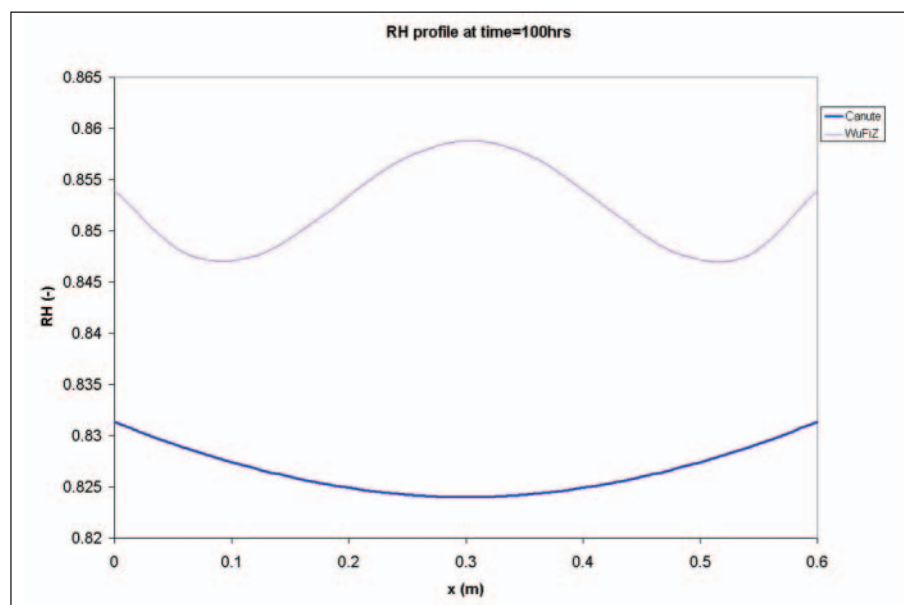
Figure 14 WuFi comparison of the relative humidity of the left wall (Region 2, $y=1.5$) at $t=100$ hrs.

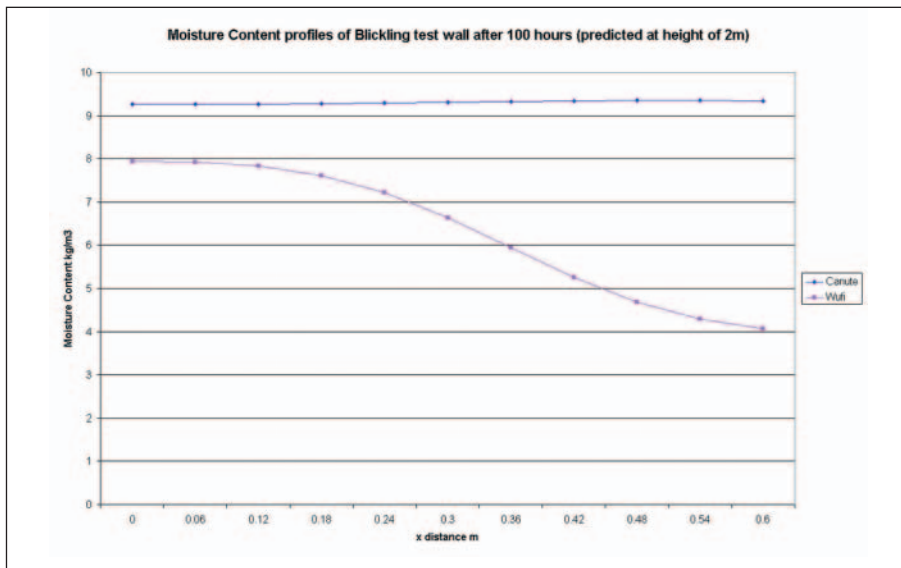
Figure 15 WuFi comparison of the moisture content of the right wall (Region 2, $y=2$) at $t=100$ hrs. x distance=0 is the internal wall, $x=0.6$ m is the external wall. It is assumed the external wall is open to the air.

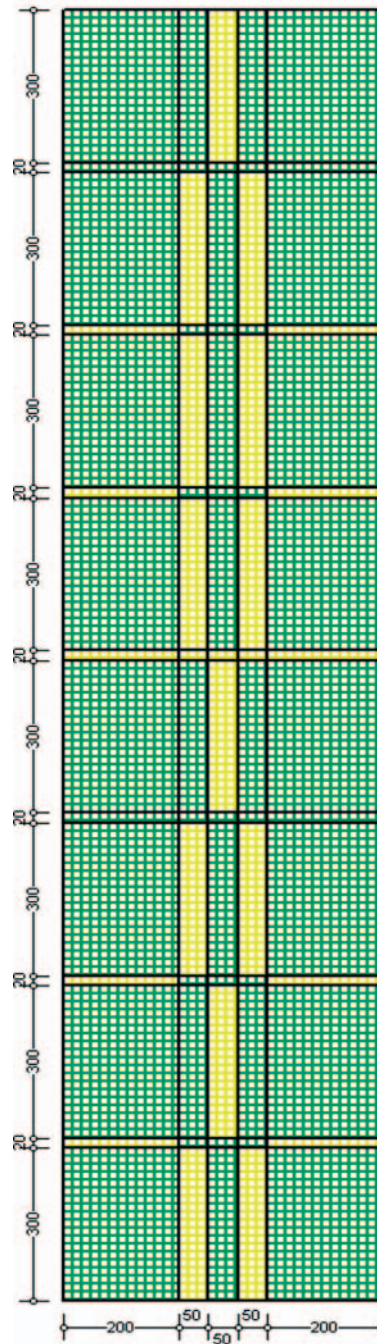
Figure 17 Schematic diagram of the sandstone wall of Brodick Castle, as simulated in WuFi with dimensions of the elements in mm. Note that mortar joints between the sandstone blocks are part of the simulation. A rubble core is included in the model, based on experimental observations of the Brodick wall.

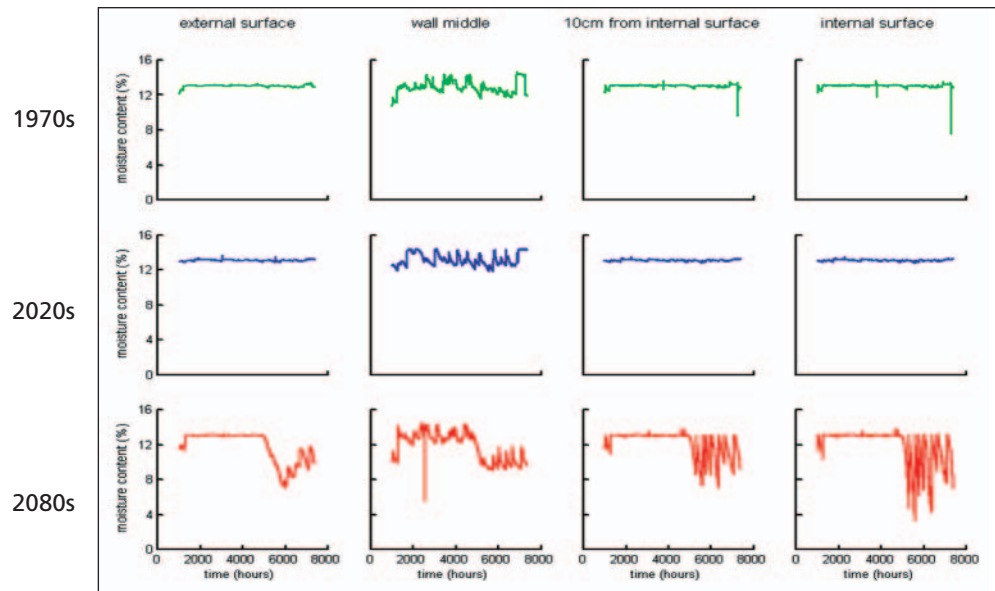
Figure 19 WuFi annual simulations of the effect of climate change on the Blickling Hall wall moisture profile, using BETWIXT data. The 1970s baseline period is shown in green, top; near future (2020s) are in blue, middle; and far future (2080s) are in red, lower. The major changes are anticipated for the 2080s when there is a considerable increase in drying at or close to the wall surfaces in the second half of the year.
