# ***An assessment of Pant-y-Llyn, Wales' only turlough and comparison to Irish sites***

Gareth Farr<sup>1</sup>, Owen Naughton<sup>2</sup>, Tristan Hatton-Ellis<sup>3</sup>, and Jamie Bevan<sup>4</sup>

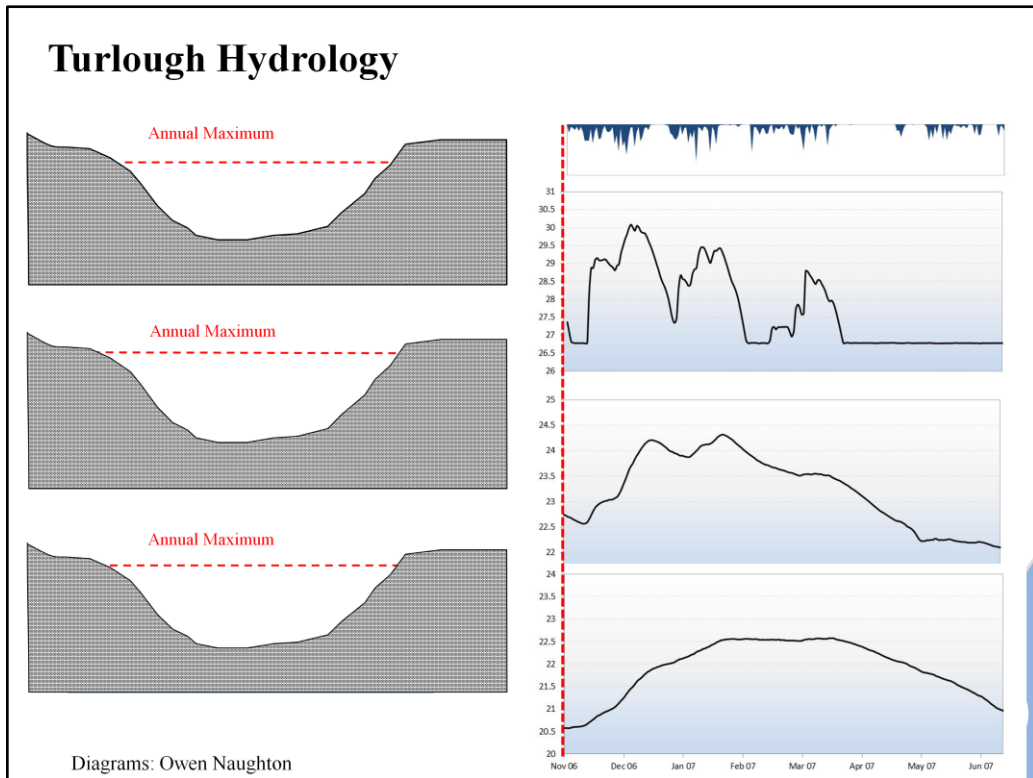
The timing and extent of the annual groundwater flooding can vary significantly between turloughs.

- 1) can respond quickly or slowly to recharge
- 2) can have anything from short distinct flood events to a more seasonal flood
- 3) can peak at different times of the year even if same receiving same rainfall

- 1) Rapid filling and emptying in response to rainfall events shows a number of distinct flood events, with the annual maximum early in the flood
- 2) The middle turlough shows some peaks superimposed on a seasonal flood pattern, with the annual maximum in mid flood season
- 3) more seasonal flooding pattern at the bottom with poor definition of peaks and a late annual maximum

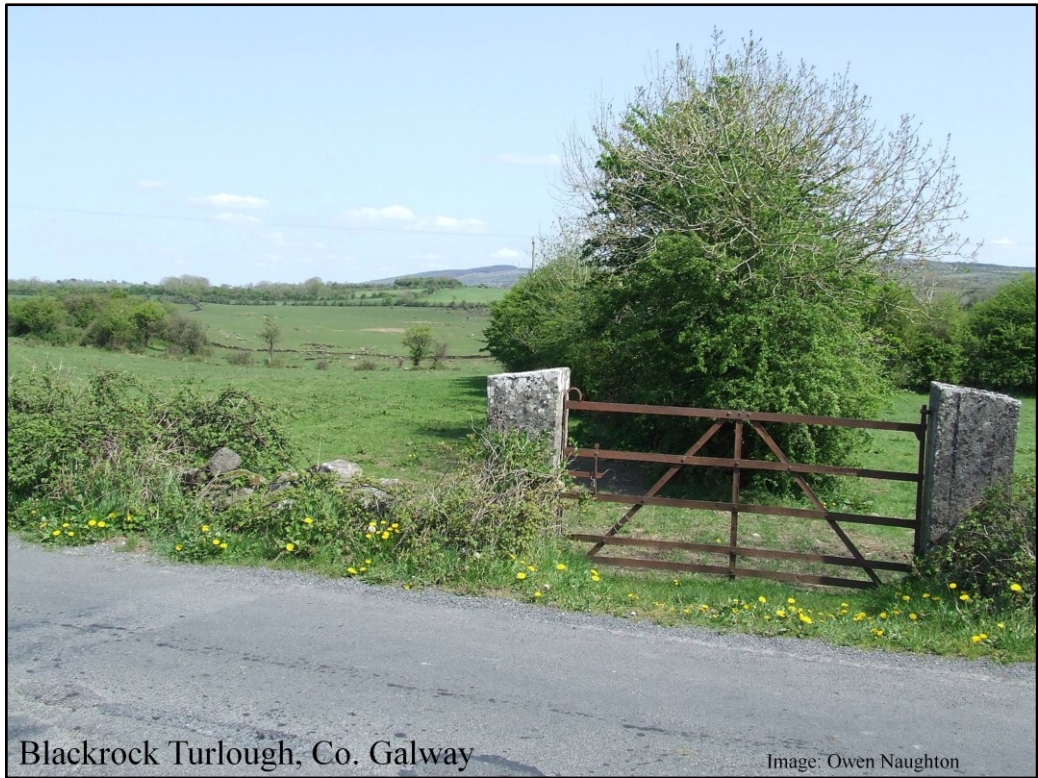
To give an example of groundwater flooding this is Blackrock Turlough, Co. Galway during a dry period.

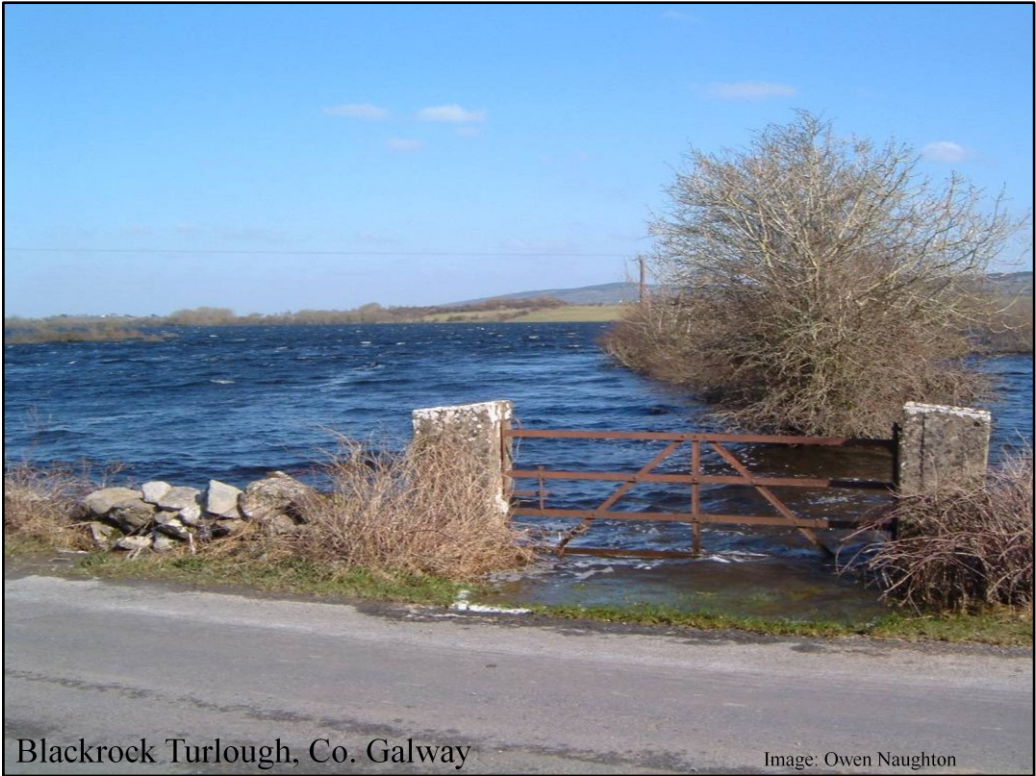
Blackrock Turlough, Co. Galway during a flood period.

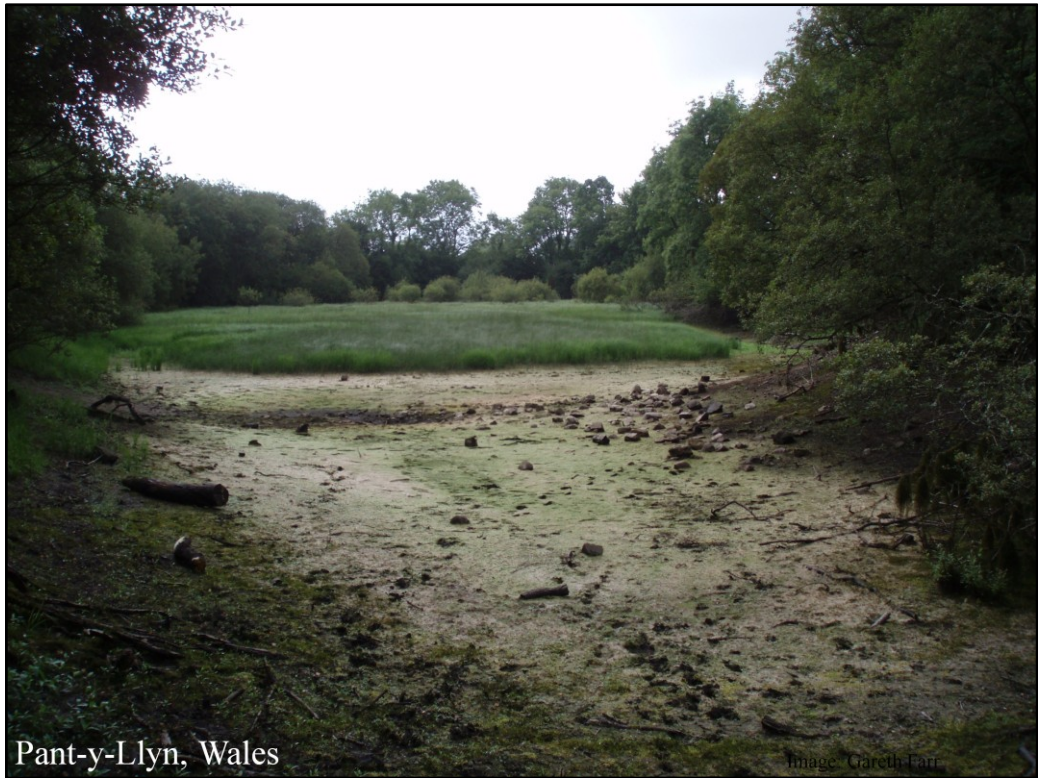
Pant y Llyn 17<sup>th</sup> August 2010

- Much smaller than many Irish examples
- You can see the estavelle in the midground

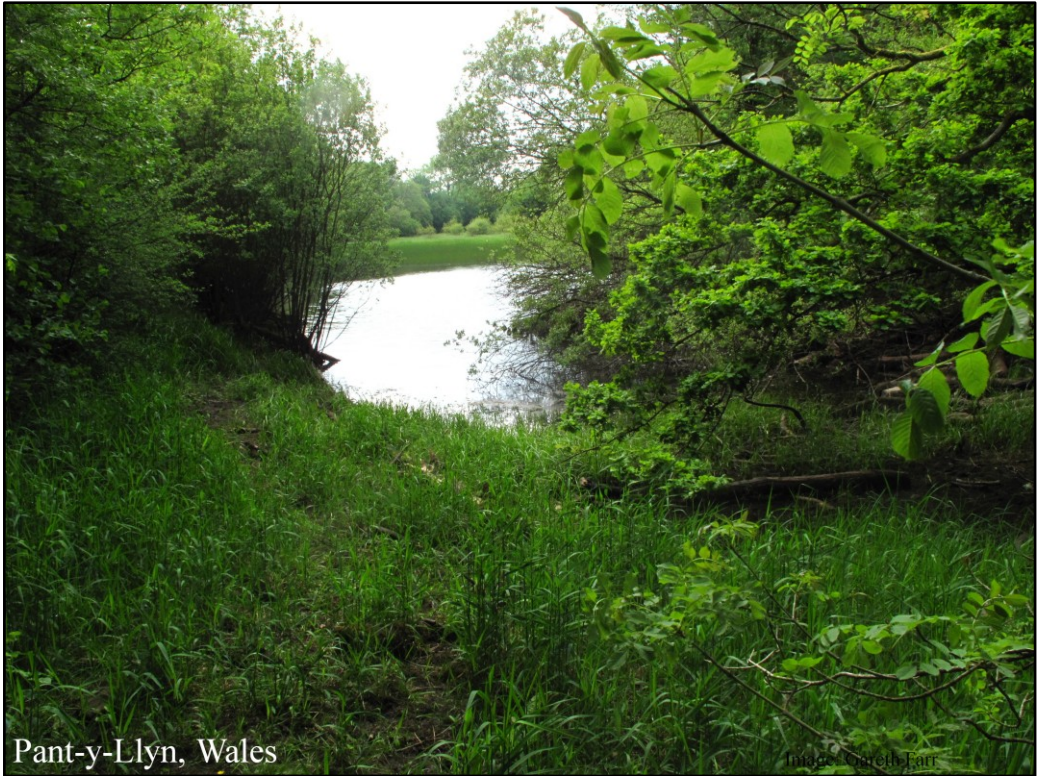
Pant y Llyn 3<sup>rd</sup> June 2010

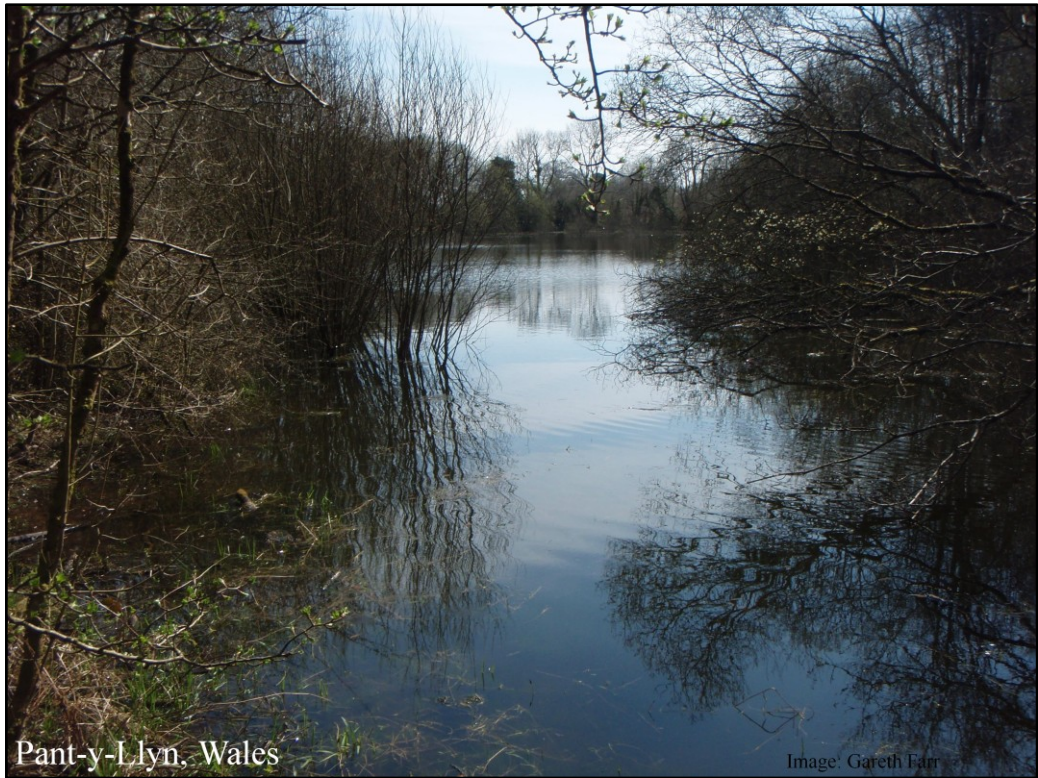
Pant y Llyn 15<sup>th</sup> April 2010

n.B we acknowledge the photographs are not in chronological order. They are displayed like this to best show the filling of PYL.

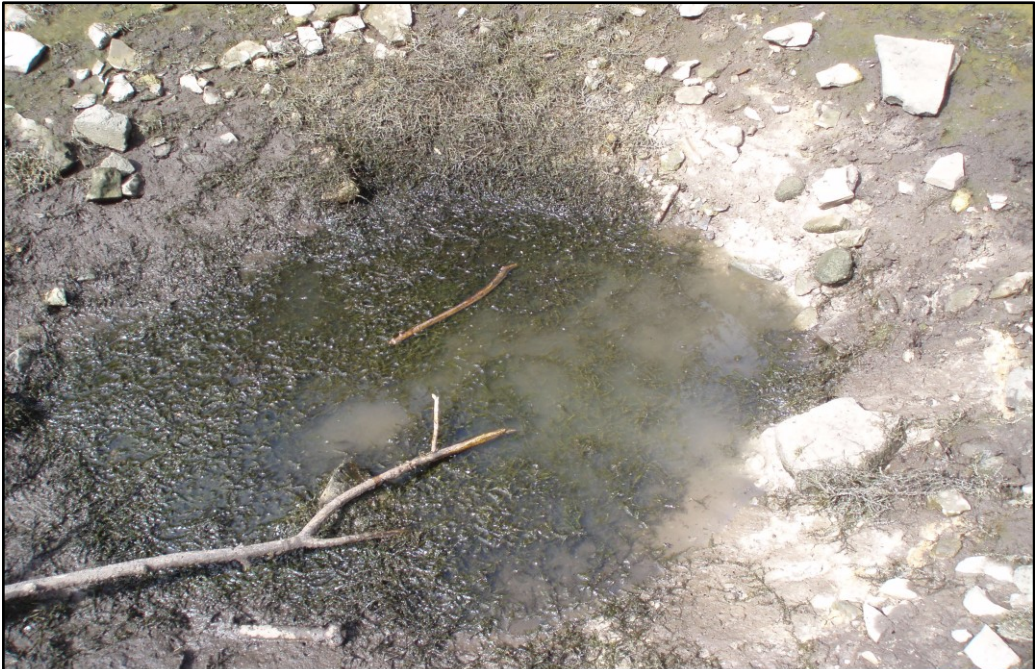
Estavelle – acts as both spring and sink

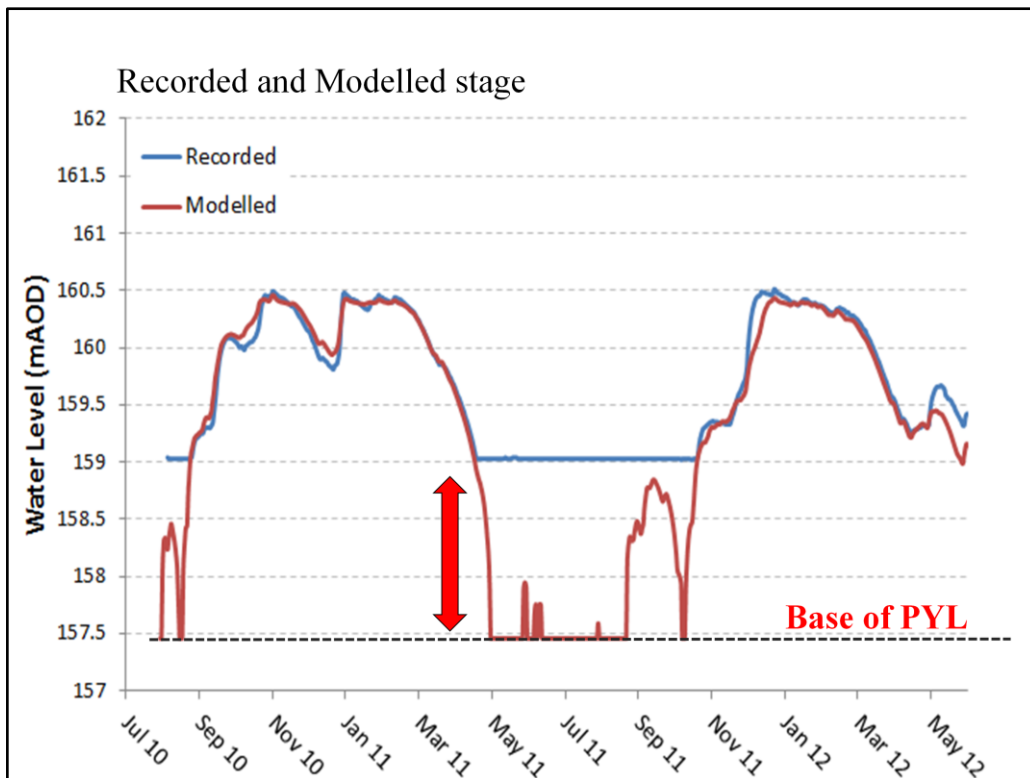
Here recorded data for almost 2 years is shown (blue) with modelled data (red) on top. You can clearly see the gap in recorded/modelled data (red arrow).

Developed by Owen Naughton and previously used for modelling Irish turloughs. It is a reservoir 'storage release model' and predicts volume and water level using:

- DTM
- hydrographs
- daily rainfall and evapotranspiration

Model allows us to '**fill in the gaps**' which are created by having to install the data logger in a more shallow part of the lake.

However it assumes constant drainage rate with depth however PYL probably drains slower

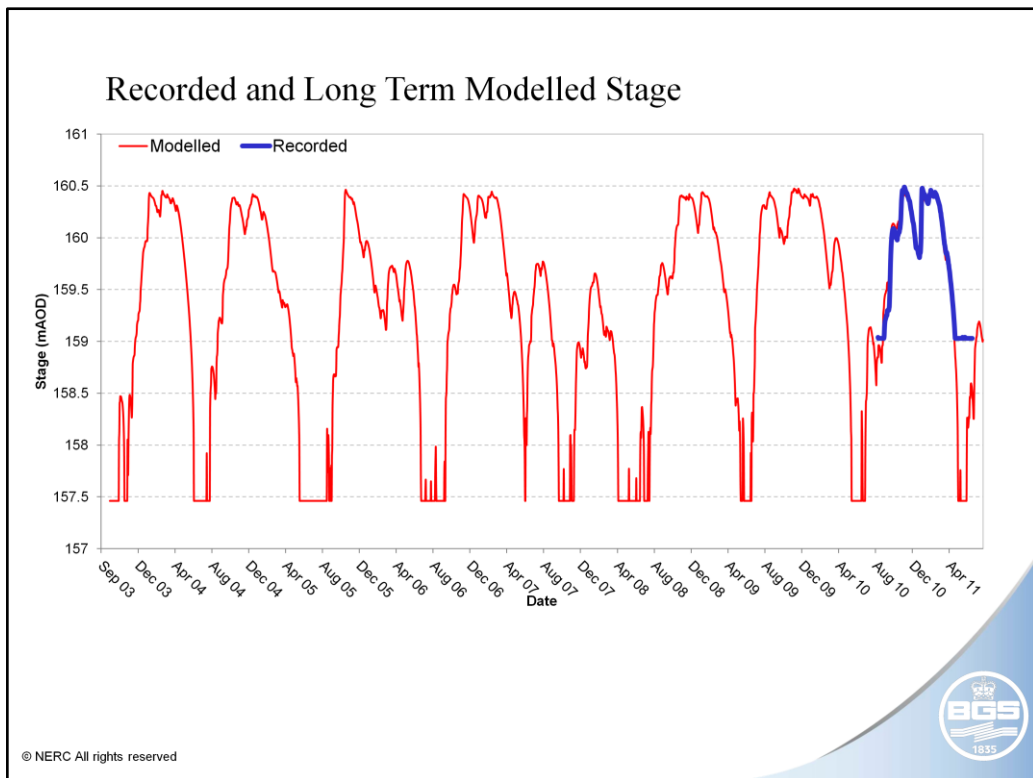
Using the Groundwater Level and Rainfall data PYL was back-modelled to 2003

This is important as it allows us for the first time to gain an understanding of relatively long time water levels at PYL.

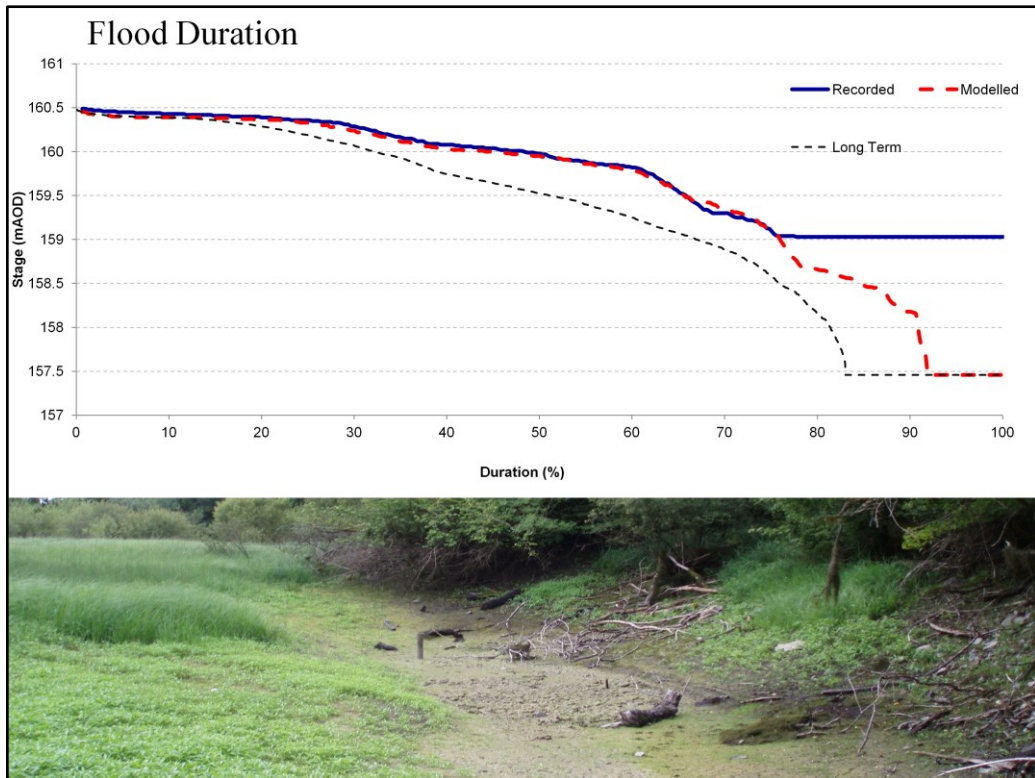
The duration that a turlough is flooded has a direct effect on the types of plants that occur within and on the more transitional margins of the turlough.

Now we have measured and modelled the flood duration at PYL we can relate this directly to the vegetation.

(Photo; G. Farr. Shows changes of vegetation across the western margin of PYL). The deeper parts are mostly devoid of significant vegetation.

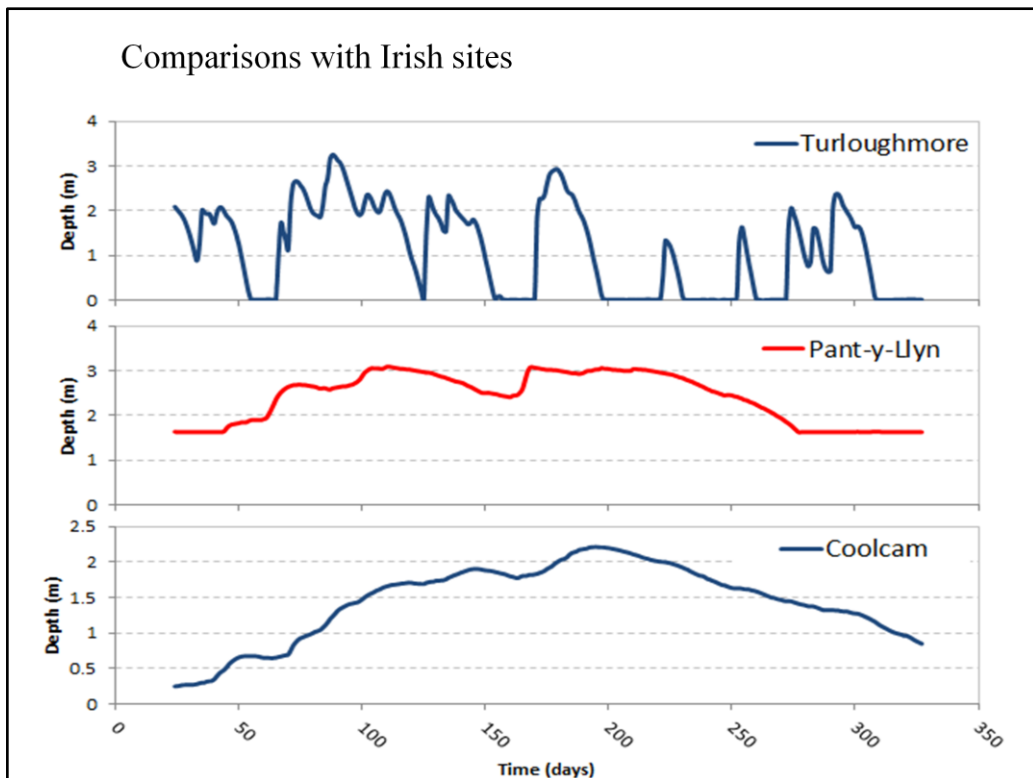
Comparison of Pant-y-Llyn hydrograph with Turloughmore (Co. Clare, Ireland) and Coolcam (Co. Galway, Ireland) (adapted from Naughton, 2011)

hydrology of turloughs does not naturally group into distinct types.

Short duration/rapid response to rainfall --long duration /longer response to rainfall

PYL is very small. At least an order of magnitude smaller than many Irish sites

PYL is higher than most if not all Irish turloughs = upland karst turlough. In Ireland 90% are below 150mAOD.

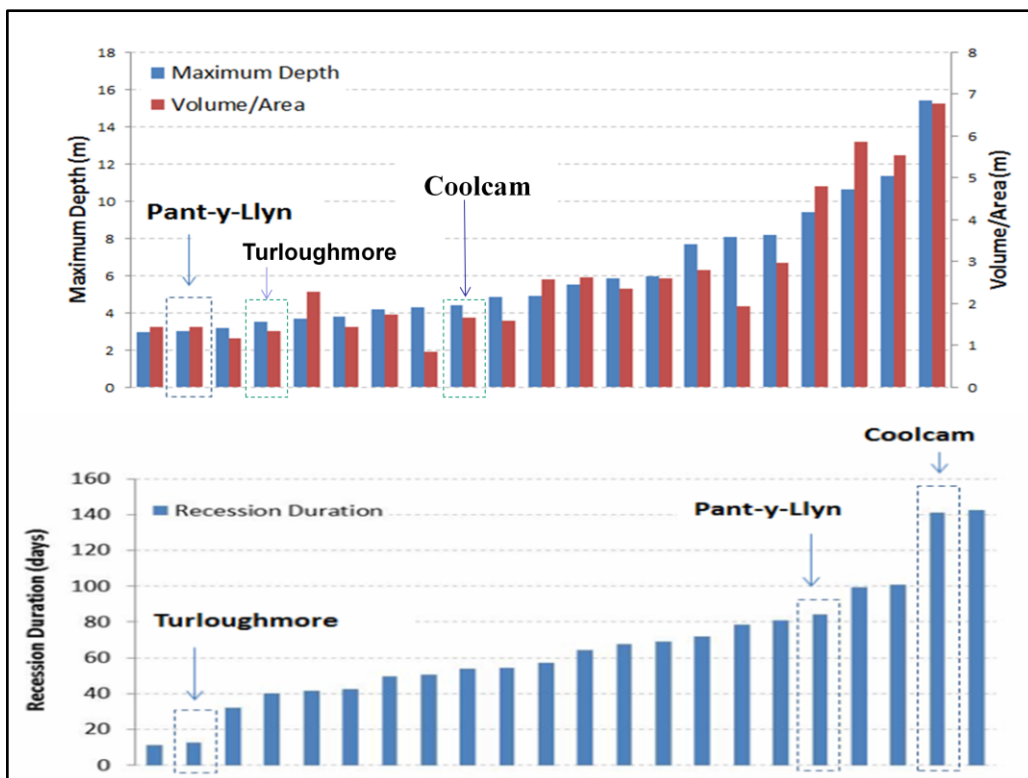
3m depth is very shallow. Irish sites range from 3.0 – 15.4m

has slow duration flooding events

This comparison shows that PYL lies towards the small slow recession end of turlough continuum. Characterised by a slower response to rainfall, smaller size and more shallow depth, when compared to the sites in ON work.
