Pozzolanic mortars for the conservation of old masonry structures

Professional paper

The design of repair mortars started from the characterization of the original mortar samples preserved in small areas in the floors of the Dungeon Tower, Bač Fortress. Two materials (waste brick and clay material) were investigated in order to select the pozzolan material which later was a component of the repair mortar. Based on the compatibility test of the examined old mortars and of the newly developed mortars, slaked lime based, the mortar with the ground waste brick as a pozzolan material was selected for the conservation treatment of the Dungeon Tower.

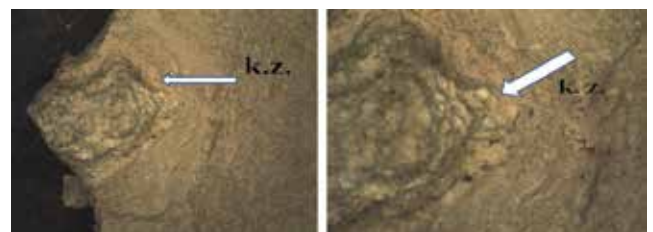
Figure 7. Contact zone *(k.z.) development between the old mortar sample TBM1 and the newly developed mortar DM 3 formed with the pozzolanic material Pozz3

Based on the carbonization/hydration process, a contact zone was formed between two types of materials, fragments of the old mortar and the newly developed mortar pastes, Figure 6. The morphology of these zones was analyzed with a stereo-optical microscope, Figure 7.

The morphology analysis of the contact zones shows that the formed area possesses a satisfied aesthetic value (without cracks) only in the case of the mortar DM 3, which was produced based on the pozzolanic material Pozz3. Taking into account the composition of this mortar sample (the presence of old crushed brick), the formation of a material with good hydraulic properties could have been expected [12]. These expectations were proven by the obtained results (Tables 3-5) and (Figure 7). Evidently, these characteristics distinguish the mortar sample DM3 from DM1 and DM2 as a potential finishing mortar for in situ application in the area of the Dungeon Tower floor.

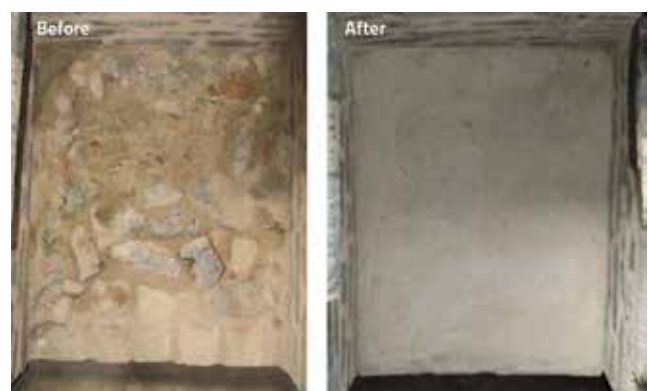
Figure 9. Appearance of the floor area before and after conservation treatment [4]

Taking into consideration laboratory results and results obtained by in situ testing of mortar samples, the M4 sample was finally selected for the conservation treatment of the Dungeon Tower floor area. This mortar satisfied numerous required properties such as: good hardening time and adhesion properties, good aesthetic appearance (colour, texture, surface finish), similarity to the authentic finishing mortar, and good workability without any cracks during the hardening process. After the mortar production and selection, the conservation treatment of the floor was performed. The following procedures were applied: the joints were carefully cleaned (by washing with water, and by removal of all loose parts of the bricks and mortars) and the base mortar M4 was applied, Figure 9.

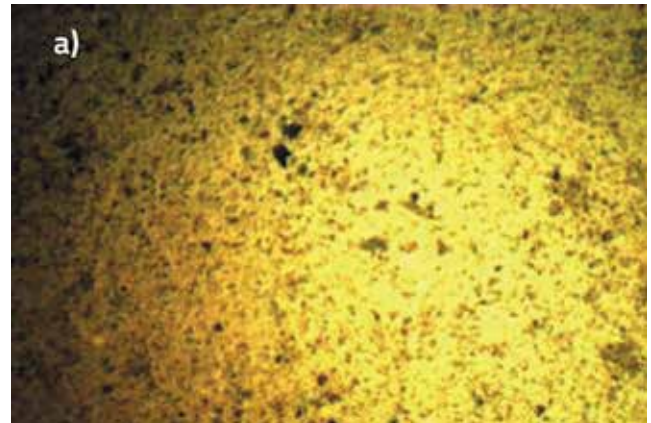
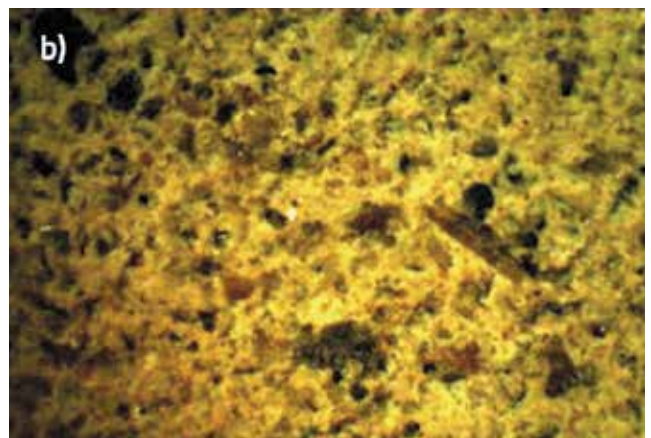
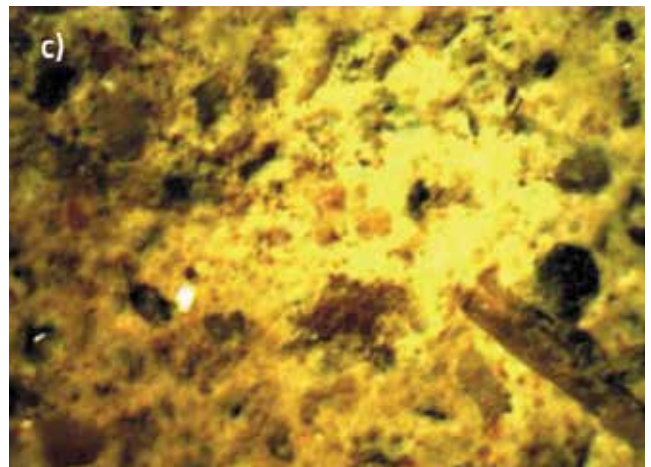
Figure 11. Stereo-optical micrographs of the applied mortar M4 after four years: a) magnification x 6.5; b) magnification x 25; a) magnification x 45

The obtained stereo-optical micrographs, Figure 11, show that the area is a compact zone without any visible cracks or micro cracks. These results suggest that the conservation treatment was successfully completed, and that the applied mortar M4 is characterised by a satisfactory performance, without visible anomalies throughout its exploitation in real-life conditions over the past four years.
