e-ISSN 2421-4574
Vol. 4, No. 1 (2018)

Textile mills in Friuli (XIX-XX century). Building technique analysis and seismic refurbishment

Giorgio Croatto, Angelo Bertolazzi*, Umberto Turrini

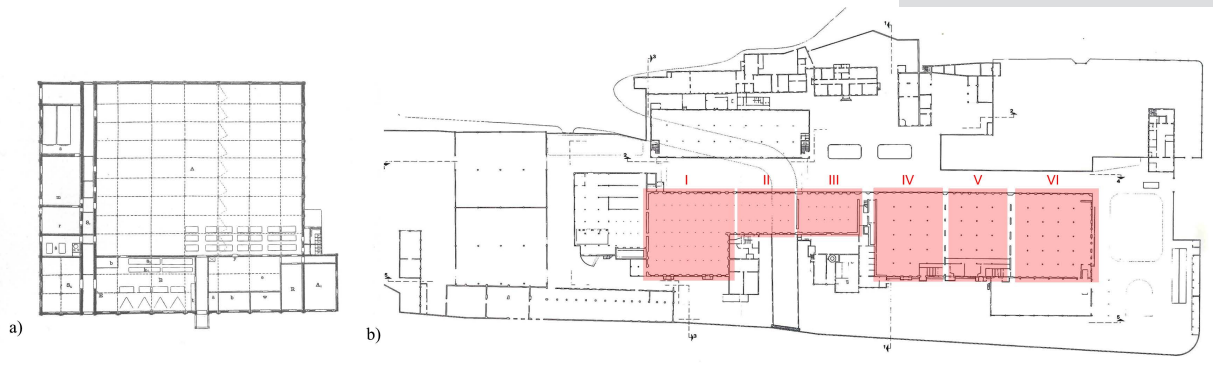
Figure 2. a) Sketch of a medium-sized cotton-weaving mill [Utz, 1911]; b) Plan of the Torre di Pordenone Cotton Mill, where the joined four-sided modules making up the mill can be seen (I-VI)

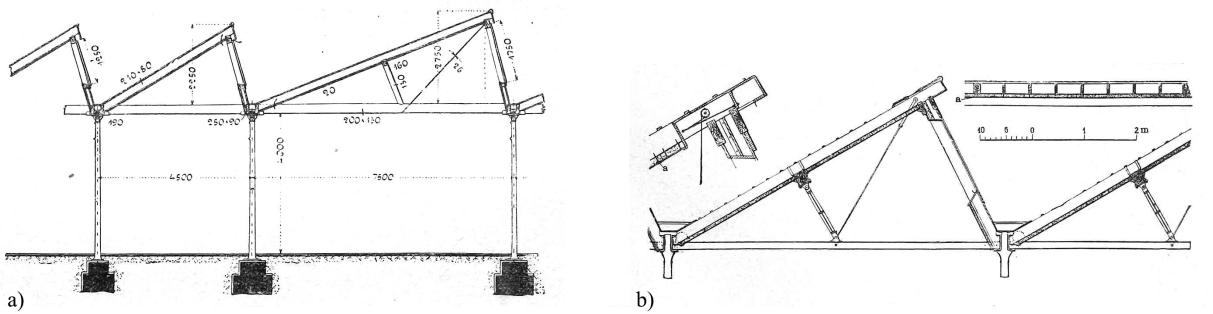
Figure 3. a) Wooden shed ceiling for textile mills, with between 4.50 and 7.50 metres high openings; b) shed ceiling with wooden joists and metal connecting rods [Utz, 1911].

The columns supported above all the large shed ceilings, affording the best lighting to the rooms below. Their wooden and iron structure was held up by continuous beams, in their turn supported by the columns, while some metal connecting rods and cast iron brackets made the overall system more rigid.

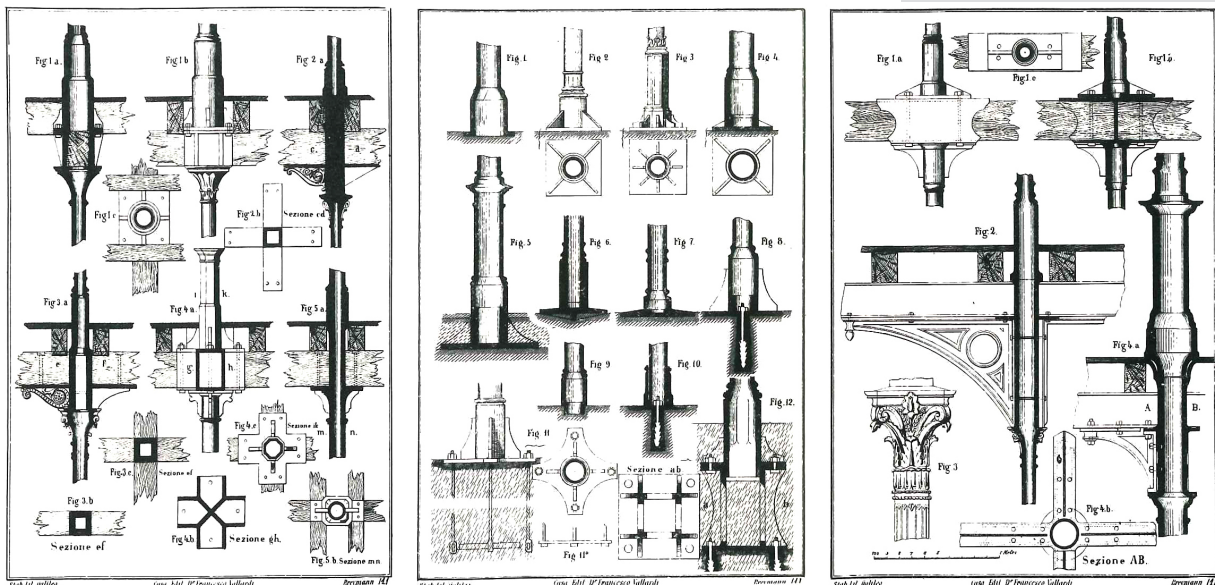
Figure 4. Cast iron columns details, [Bremmann, 1884].

The vertical structures generally consisted of cast iron columns. Their stems were hollow, generally 2.50- 3.00 m. high, 2-3 cm. thick, their sections varied between 140 and 200 mm, and had a 20-30 mm. marked thickness. Their capitals were provided with mantels where ledges were placed, while at the bases there were slabs connecting the columns to the foundation, generally consisting of a stone or concrete block, beneath the walking surface area. If the shed was higher, columns were split in two and co-axially joined by means of flanged joints secured by bolts or rivets; two-or-more-storied buildings were provided with harnesses or bridles that supported the main beams on top of which the floors were laid and with stems polished inside where the polished foot of each column was fitted and therefore held upright.

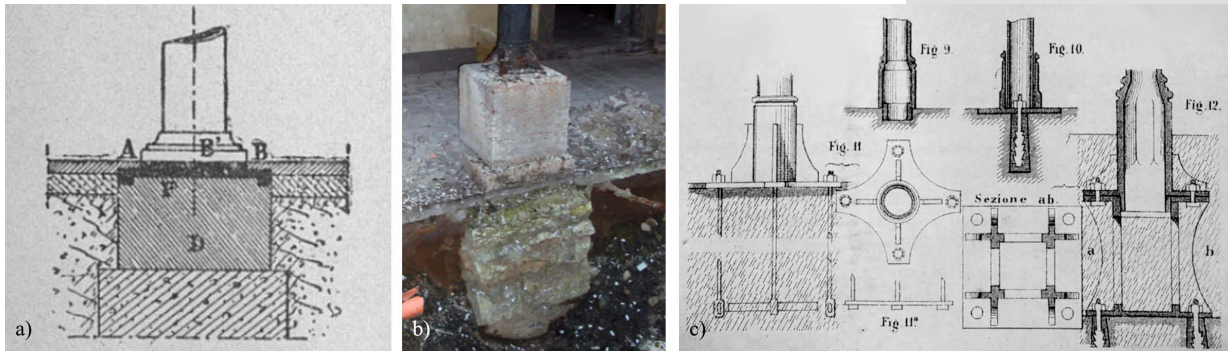
Figure 5. a) The base of the column resting on a weight-spreading metal plate (B) on top of a squared stone block (D) lying on a mortar-concrete substrate [Oslet 1898]; picture taken during a probe; various kinds of ground fastening [Oslet 1898].

A first analysis, mainly based on the handbooks of those times [21], reveals the widespread resort to both simply hinged brackets on the ground gravity working that is to say capable of ensuring that the foot of the foundation would be kept in place only if subjected to axial stress, and to semi-fitted joints, - the forerunners of modern fastening elements such as cast iron stud bolts able to withstand – though partially – seismic compound stresses.

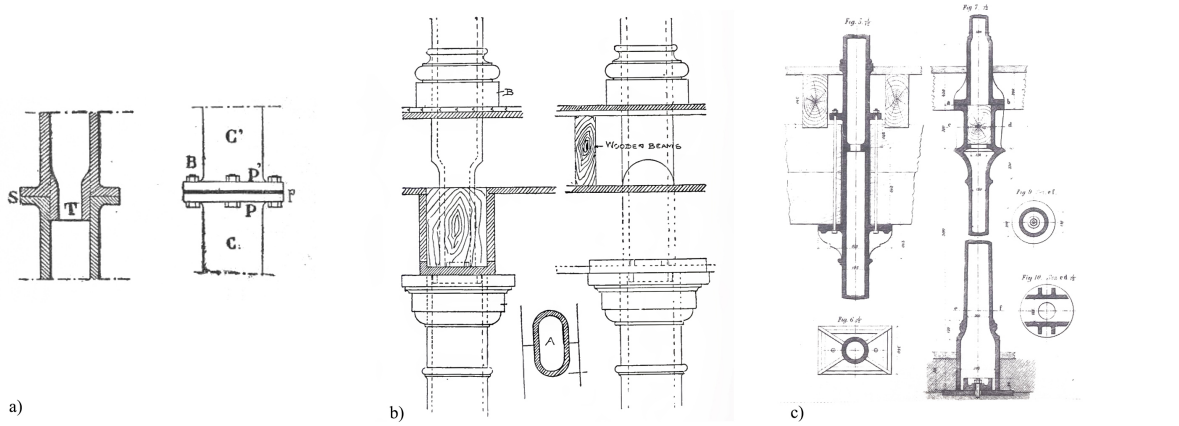
Figura 6. a) Detail of the connection of the column outside the column-floor joint [Oslet 1898]; b) and c) detail of the connection of the column inside the column-floor joint [Birkmire 1892, Curioni, 1896].

On the other hand, from a geometrical point of view, the cast iron weight-bearing columns present rather thin sections if compared to the whole length of the columns. On average, their circular sections vary between 140 and 200mm., though they are between 20 and 30 mm thick, being made of cast iron. Flanged joints secured by bolts all around may be present, wherever there are in-between floors not allowing the floor to be directly secured to the column, or there are construction related or building yard hindrances such as not having easy access to the site or needing to move the element.

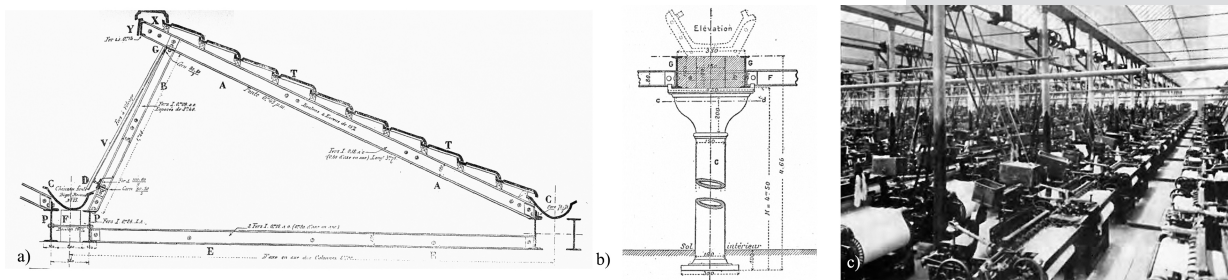
Figure 7. a) Section of the roof employing non-standardized profiles, where the connecting rods of the horizontal plane of the roof can be seen [Oslet 1898]; b) columns detail [Oslet 1898]; c) shed ceiling Amman & Wepfer mill (Pordenone).

Thanks to the cast iron capitals, the weight-bearing columns support roof elements named shed. As regards the material used, one can notice how the construction technique of those times largely resorted to thin metal frames, which were either normalized or simple metal profiles of non-standardized sections. Trusses were connected to the columns underneath by means of cast iron capitals, horizontally connected to one another between each span by means of chain tie-beams that compensated the geometrical thrust.
