Bacterial Source Tracking to Support the Development and Implementation of Watershed Protection Plans for the Lampasas and Leon Rivers

Lampasas River Watershed Final Report

Texas Water Resources Institute Technical Report 442

April 2013

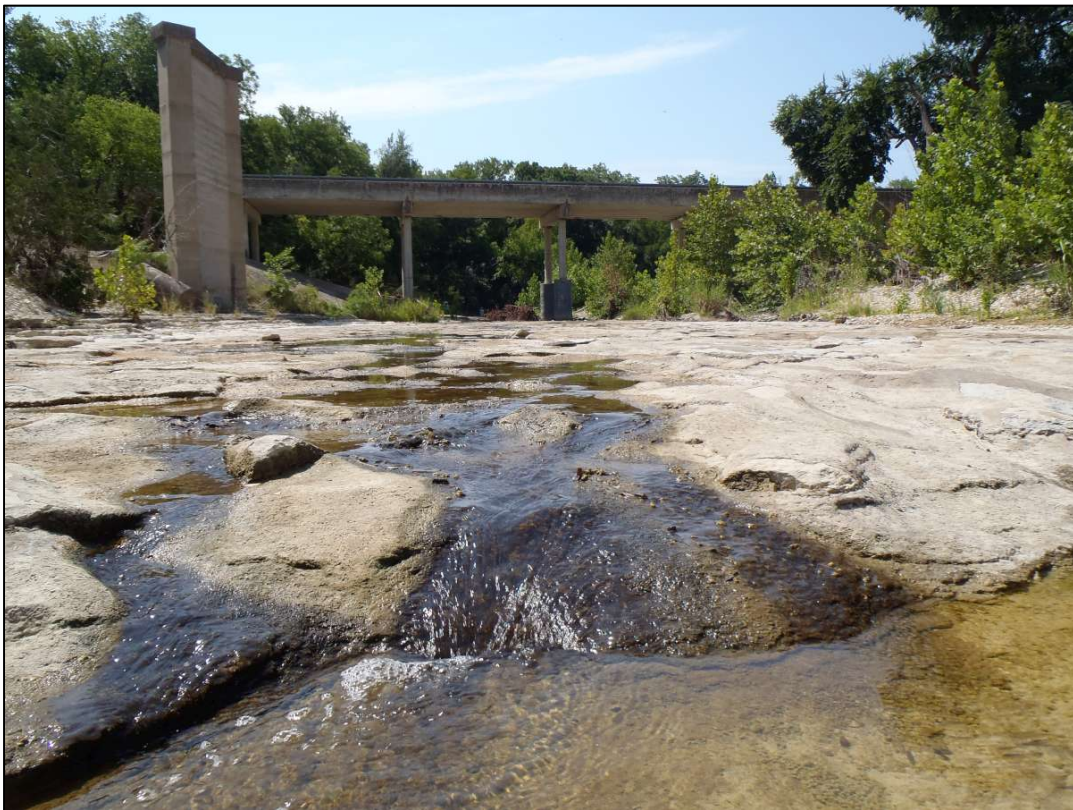
Low flow conditions on the Lampasas River during the 2011 drought.

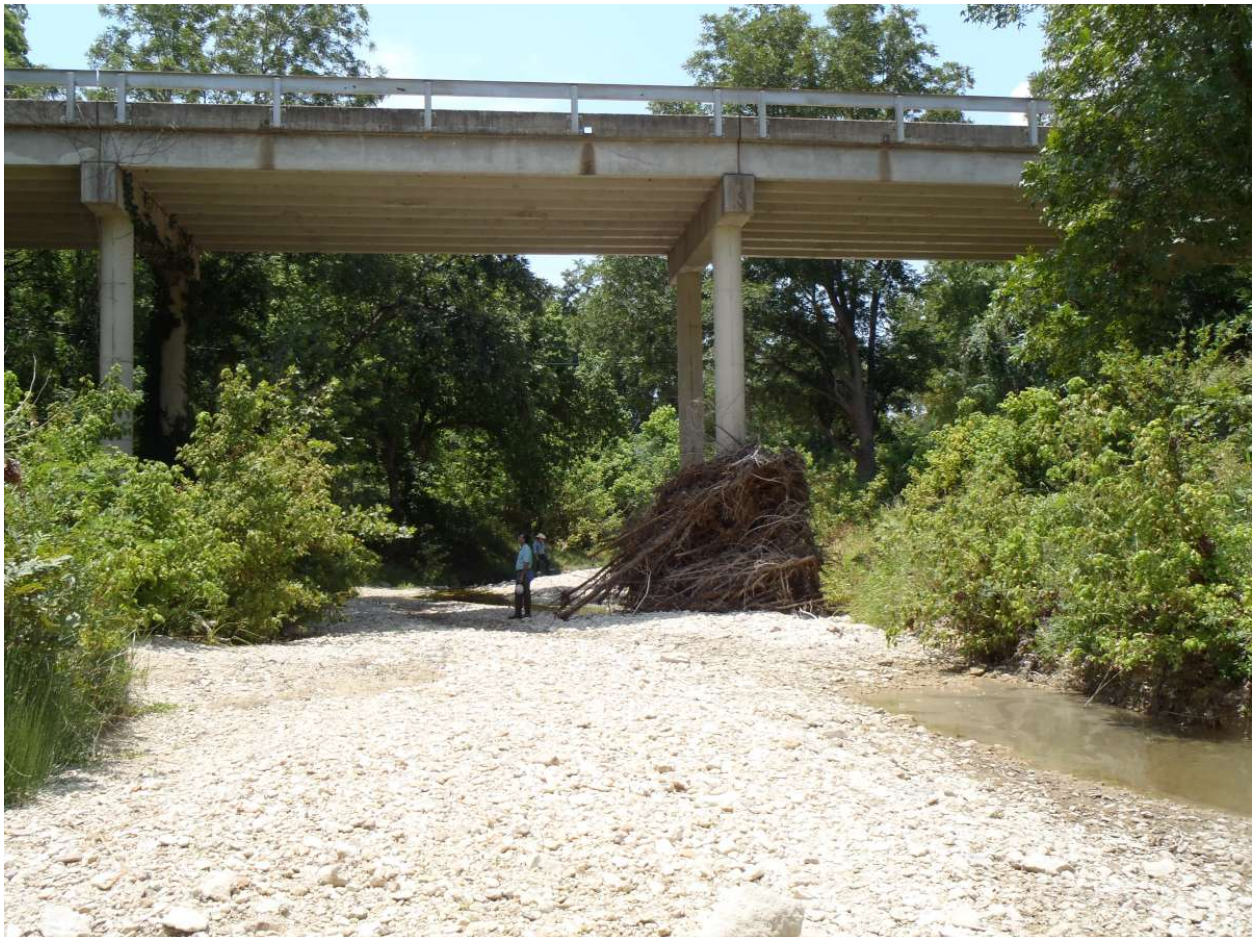
No flow condition (ponded) in Reese Creek, Bell County.

portion of the study, several locations exhibited surface flow with areas of subsurface flow above and below sampling sites. Flow conditions were noted in the field data sheet (i.e., flow, subsurface, pooled, dry, etc.). Over the course of the study, 76% of the samples were flowing, 17% ponded and 7% dry.

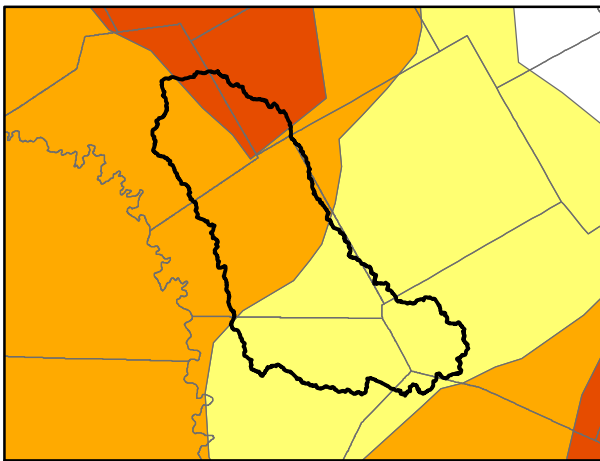
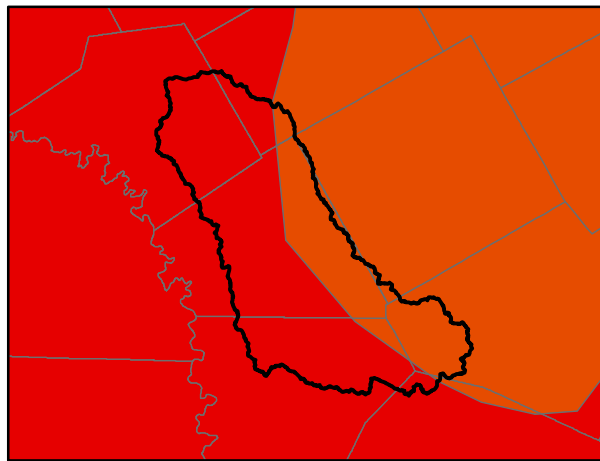
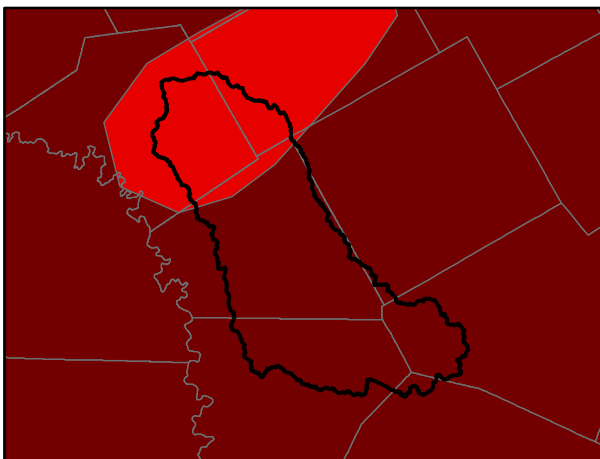
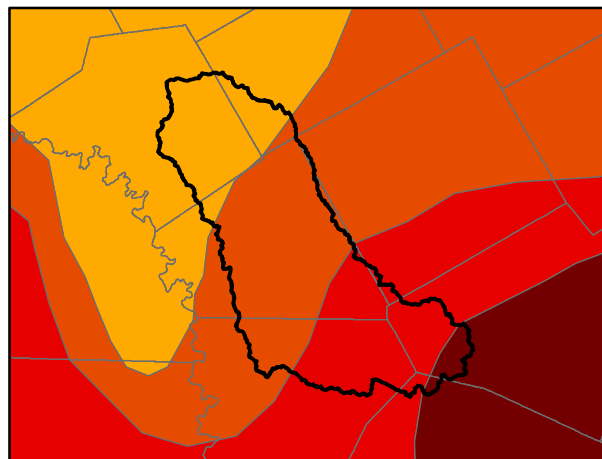
Figure 2. Texas drought monitor maps. Source: <http://droughtmonitor.unl.edu>

As monitoring commenced in February 2011, Mills, Hamilton, and Lampasas Counties were experiencing moderate to severe drought conditions; Bell, Burnet, Coryell and Williamson Counties were rated as abnormally dry. By August 2011, all counties in the study area exhibited extreme to exceptional drought conditions, as reported by the National Drought Mitigation Center located at the University of Nebraska (web site: <http://droughtmonitor.unl.edu>). Figure 2 depicts quarterly drought progress during the monitoring period from February 2011 to January 2012. The project documents water quality and quantity conditions observed in the Lampasas River under drought conditions that meteorologists characterized as the worst 1-year dry spell

Texas has seen since records began in 1895. During 2011, 100 percent of the state experienced drought conditions and 86 percent recorded “exceptional drought”, the most severe category. As a result, many LRW monitoring locations experienced intermittent flow. Precipitation amounts were obtained from the Comanche, Hamilton, Gatesville, Fort Hood, and Lampasas airport records between January 1, 2011 and January 24, 2012. Normal average annual rainfall for the area is approximately 30 inches. Average precipitation recorded by area airports during the monitoring period was 13.44 inches. The longest period without significant daily rainfall was 125 days (note: “significant daily rainfall” is defined in this report as 0.5 inches, or more, per day). Precipitation between February 1 and September 30, 2011 averaged 4.33 inches. Precipitation between October 1, 2011 and January 24, 2012 averaged 7.34 inches.

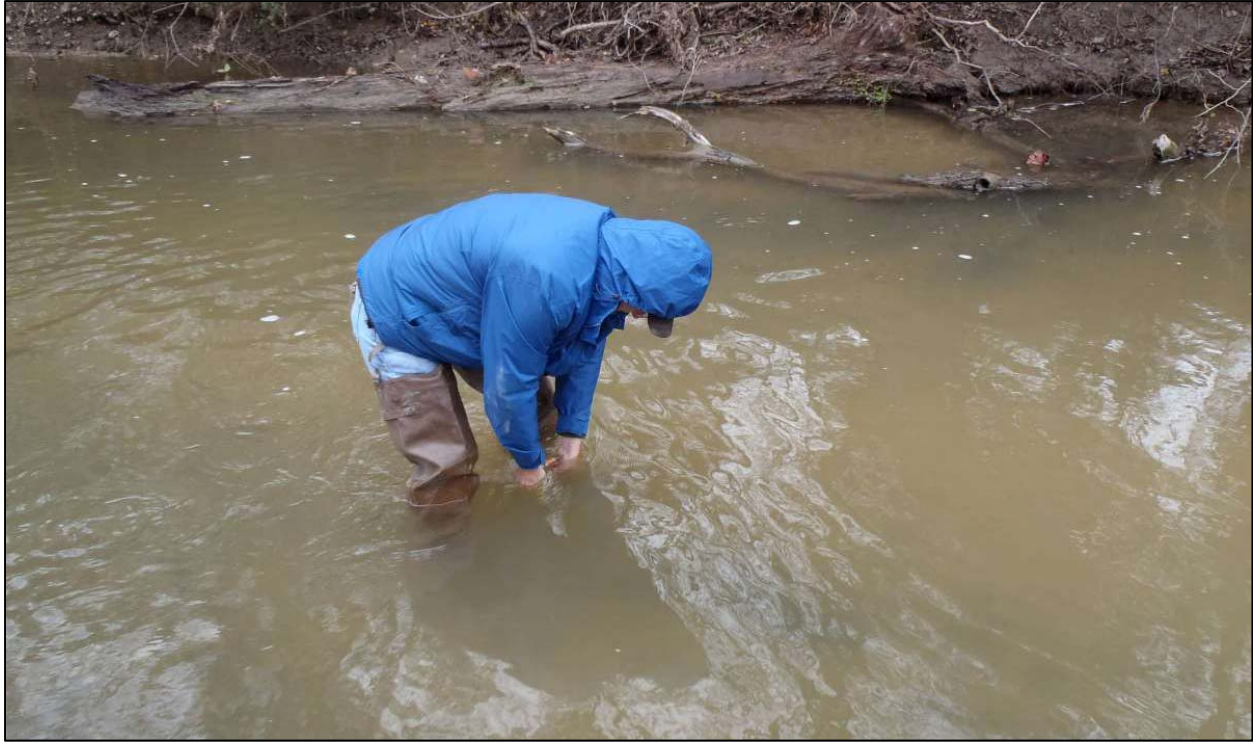
Collecting water sample mid-stream below surface and above stream bottom.

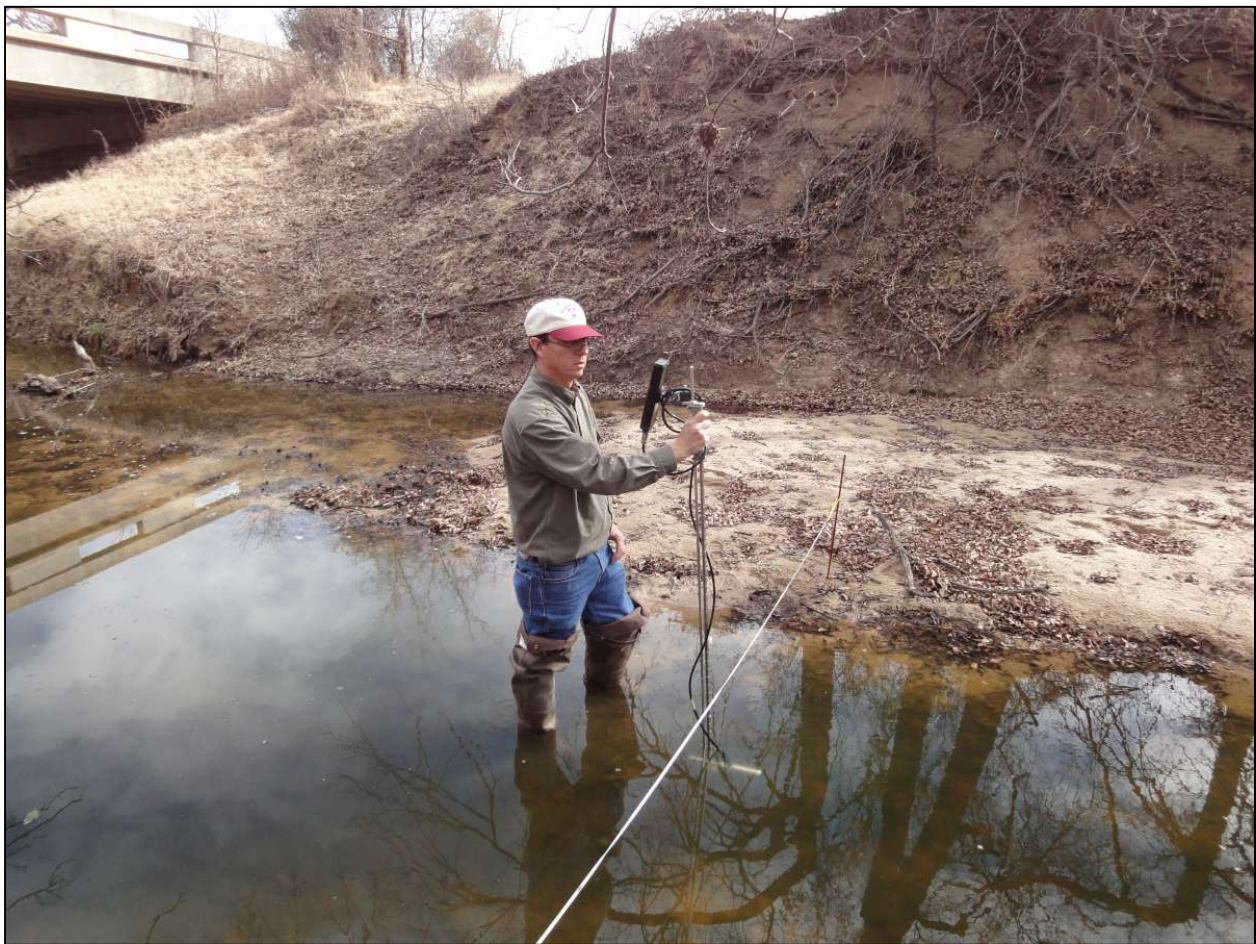
Measuring stream flow with Hach Acoustic Doppler Current (ADC) meter.

Stream flow volume or discharge was measured using an ADCM. Measurements were conducted in reaches free from obstructions (large rocks, vegetation, etc.) with good laminar flow (i.e., minimal turbulence). The ADCM concurrently measured vertical depth and integrated flow velocity across the channel to calculate the flow volume. Measuring stream flow under drought conditions presented several challenges. Stream flow at monitored sites was often very low. Under these conditions stream cross-section profiles were too shallow or narrow to accommodate a measurement with the ADCM. In some cases, the timed float method was utilized to measure flow volumes.

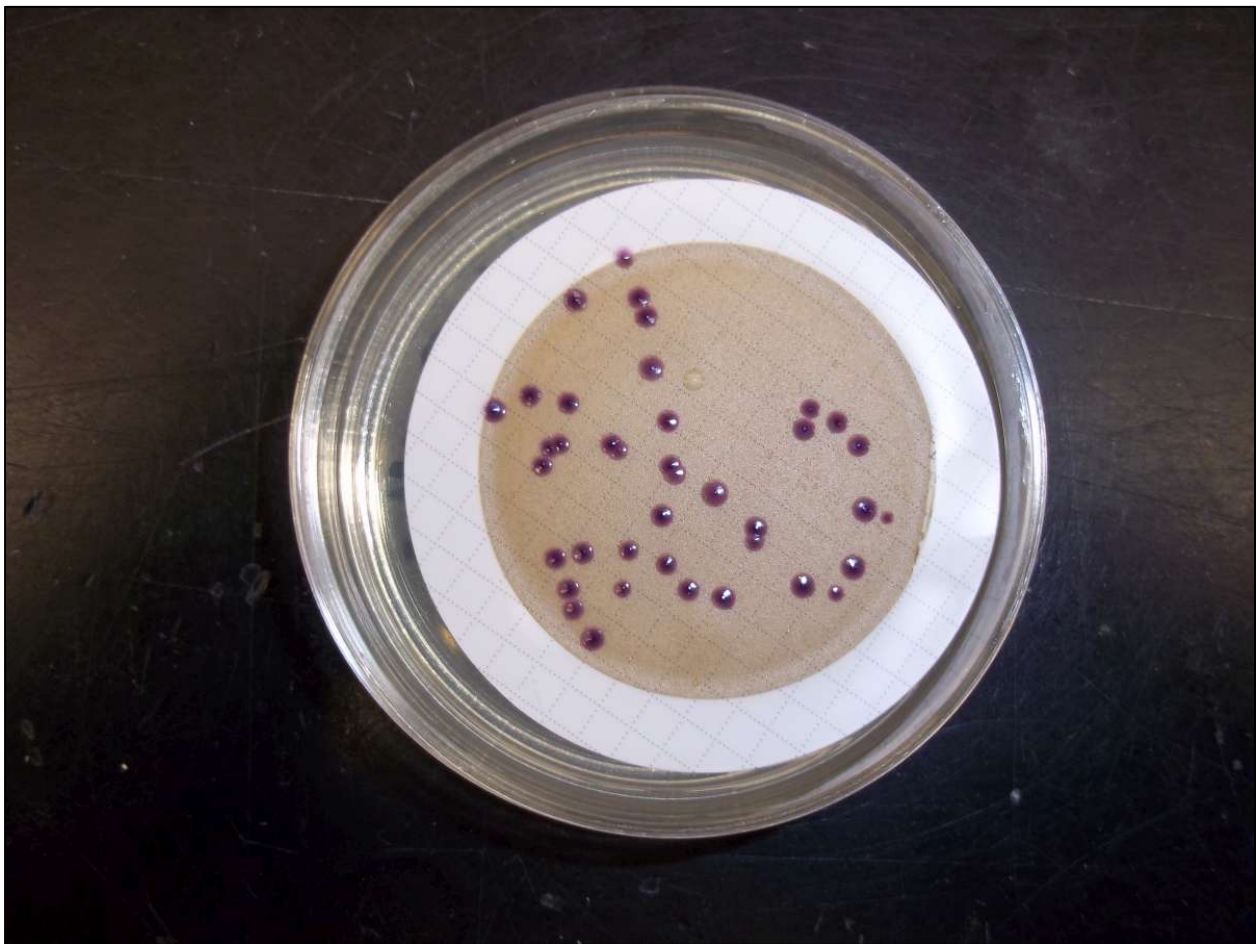
Petri dish with mTEC media and filter positive for *E. coli* (red colonies).

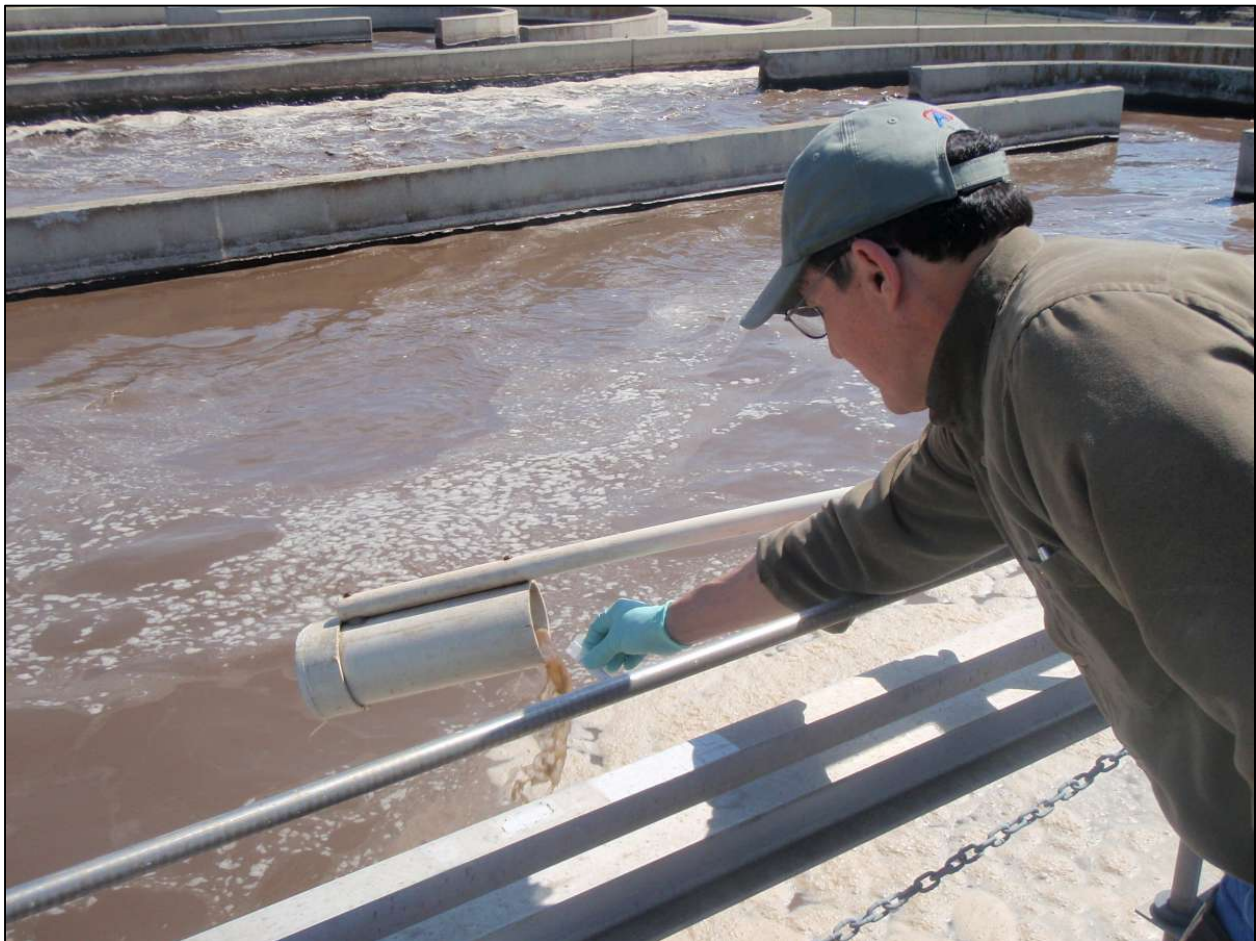
Collecting known source human sample at wastewater treatment plant.

Municipal wastewater samples were collected at the City of Lampasas and City of Copperas Cove wastewater treatment facilities. Multiple samples were taken at each facility. Two permitted facilities are present in the study area (Table 7). Individual samples were analyzed and positive plates were shipped to UTSPH-EP for genetic typing and inclusion in the Texas *E. coli* BST Library.

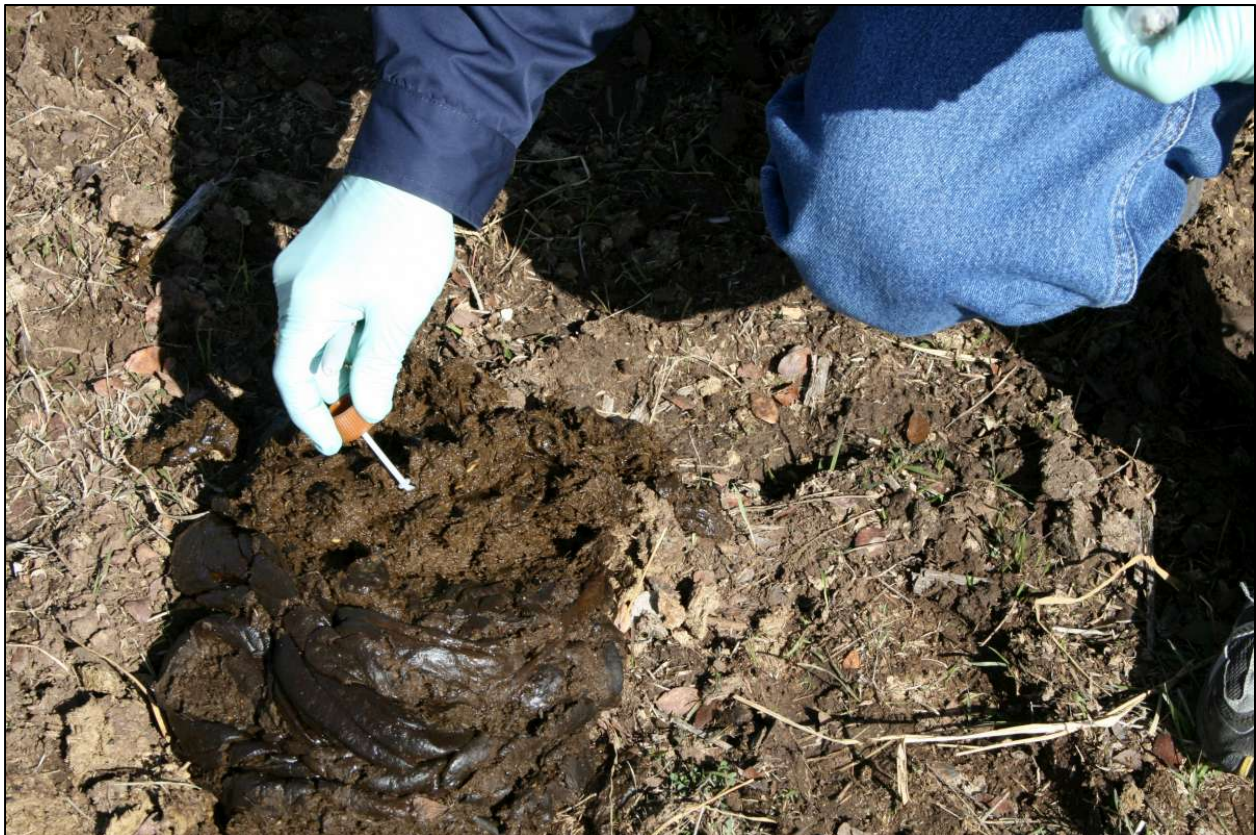
Collecting known source sample from fresh feces deposit.

Free ranging livestock in the watershed include cattle, horses, goats, sheep, and exotics. In total, 32 known source livestock samples were collected and submitted from the LRW. These included horse, sheep, and beef-cow samples.

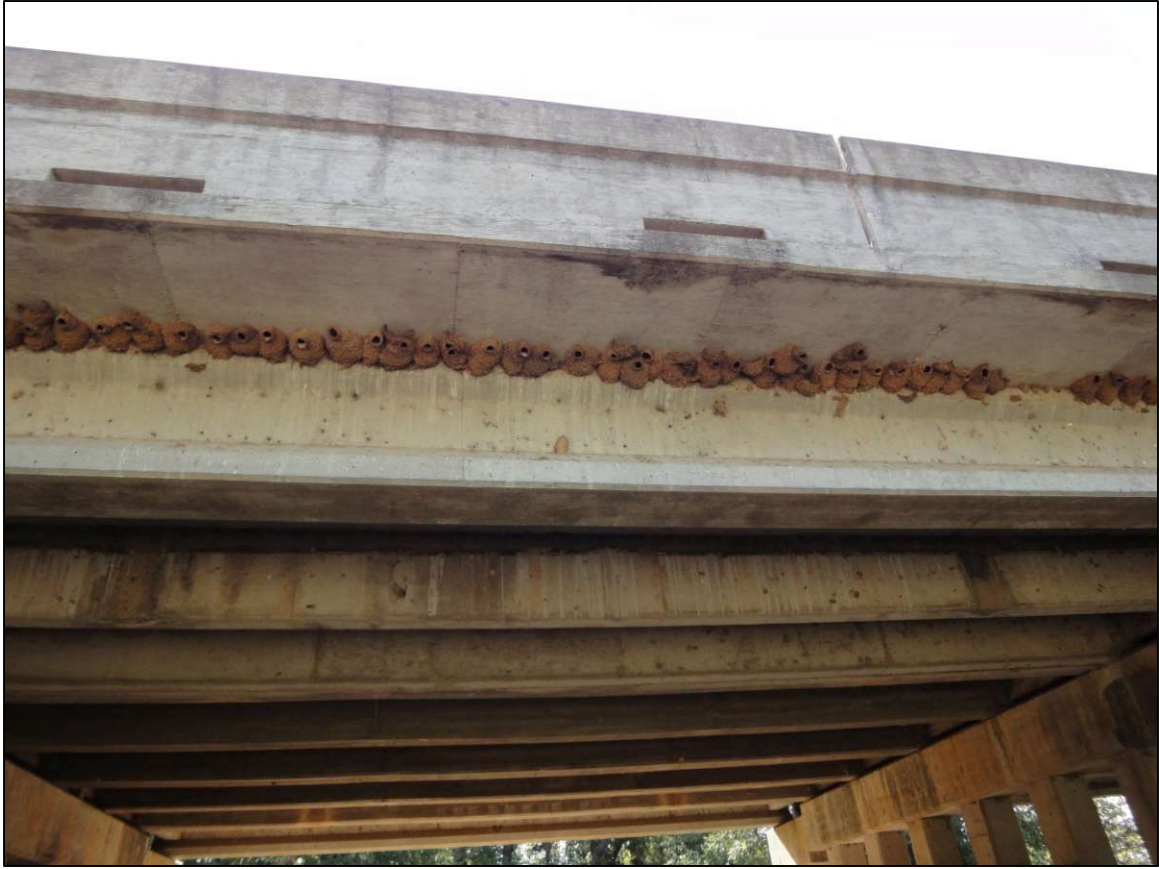
Cliff Swallow nests under bridge.

Avian sampling focused on species actively nesting on bridges at monitoring sites. Cliff Swallow samples were collected by placing plastic sheeting under bridge-nesting birds and checking the surface after birds had returned to normal activities. A total of 28 known source avian samples (i.e., Cliff Swallow) were submitted from the LRW.

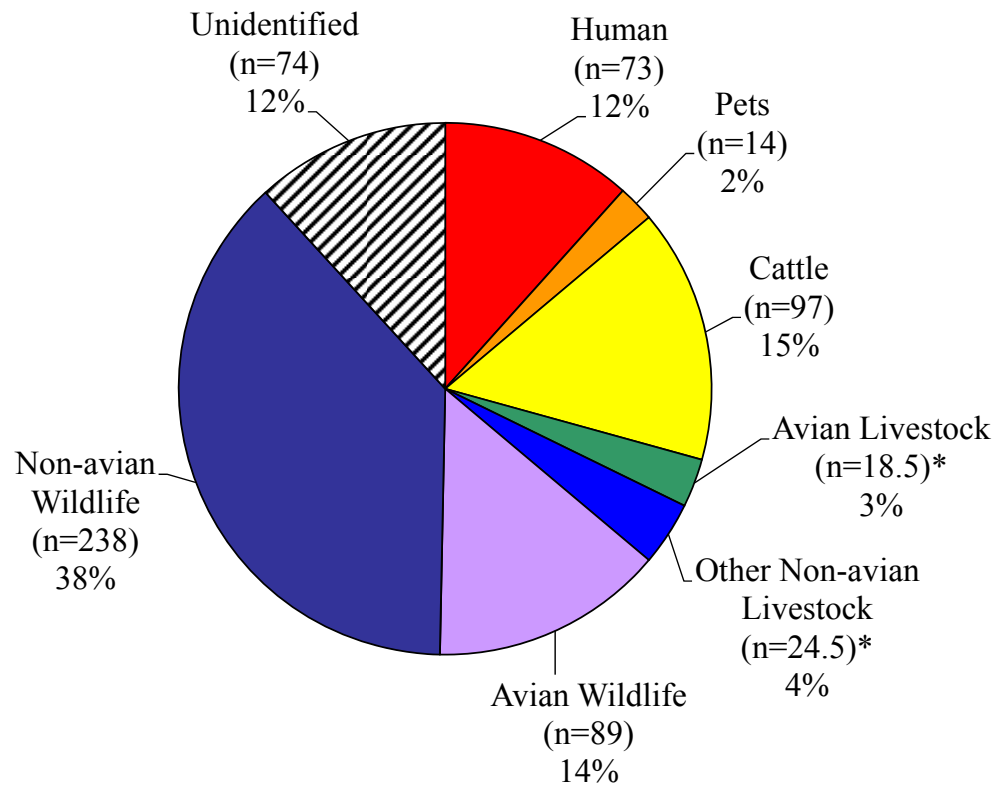
Figure 5. Identification of *E. coli* water isolates from the Lampasas River watershed using a 7-way split of source classes and an 80% similarity cutoff (n = 628 isolates from 131 samples). *One water isolate was equally similar to an “avian livestock” and an “other non-avian livestock” DNA fingerprint and so was considered a tie and split between the two source classes.

BST results for all 628 watershed isolates are presented in Figure 5. Note that 88% of the water isolates were identifiable using the Texas *E. coli* BST Library (ver. 10-12). Given the rural nature of the watershed it was not surprising that wildlife (both non-avian and avian) was the

leading contributor of *E. coli* in the Lampasas River. Approximately 12% of the isolates were identified as human and another 15% identified as cattle.

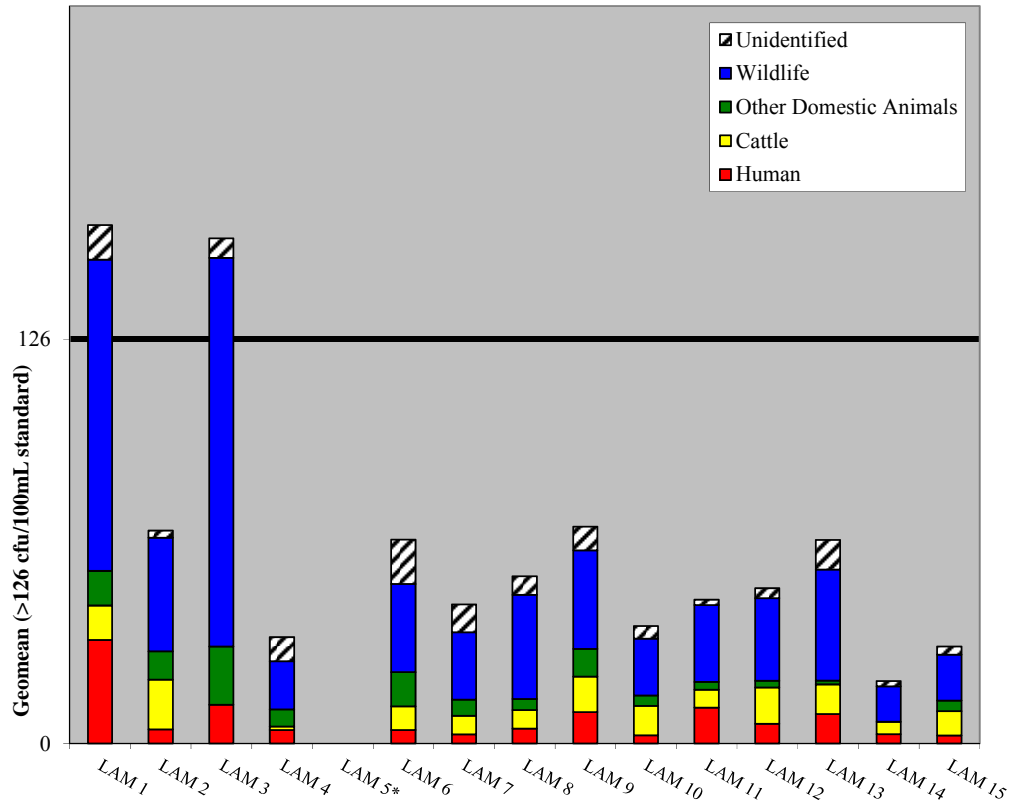
Figure 6. Four-way split BST results for each site scaled to the *E. coli* 12-month geometric means. * Note that LAM 5 was represented by only 2 flowing water samples, and therefore is not shown due to its limited data (see text).

A breakdown of the watershed by sampling station is given in Appendix A using a 4-way split of source classes, but generally all follow a similar pattern. Figure 6 presents BST results for each site scaled to their *E. coli* geometric means. Wildlife was the leading contributor at all sites. Twelve of the fifteen sites were below the regulatory *E. coli* geometric mean standard of 126 CFU/100 mL for the 12 months of the study, and therefore were in compliance with recreation standards.

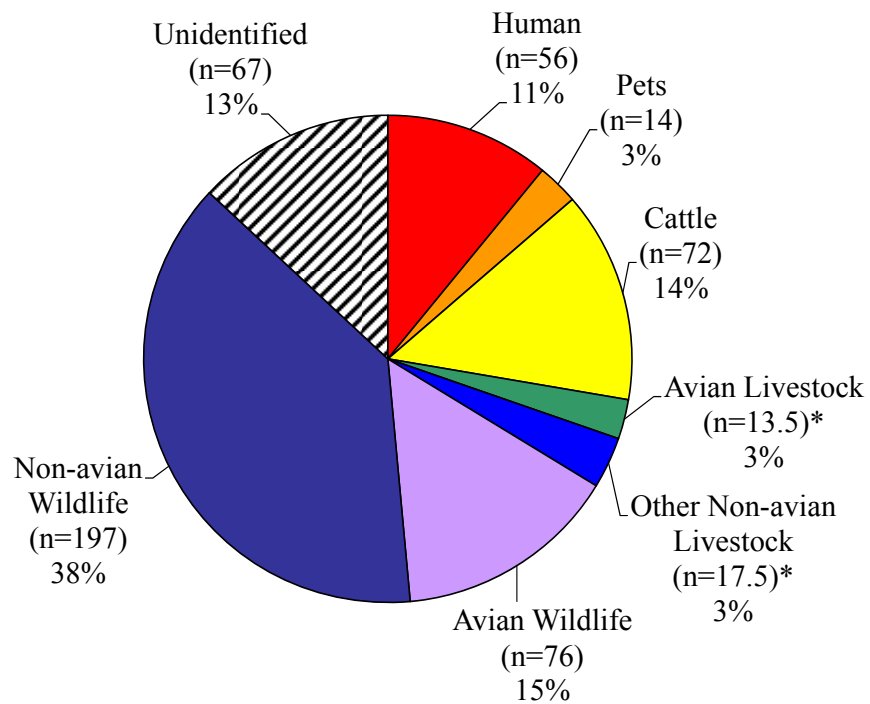
Figure 7. Identification of *E. coli* isolates from samples which were in compliance with the single sample maximum of $<394\text{ CFU}/100\text{ mL}$ (513 isolates from 108 sampling events--all eligible sampling sites and dates included). *One water isolate was equally similar to an “avian livestock” and an “other non-avian livestock” DNA fingerprint and so was considered a tie and split between the two source classes.

Over the course of the study, there were 23 single sampling events throughout the watershed that exceeded the individual sample limit of 394 CFU/100 mL (all sites except LAM 6). Source identifications for the isolates collected from samples in compliance were compared to those from exceedance samples (Figures 7 and 8, respectively). While there was a slight increase in the percentage of isolates identified as cattle-derived during exceedances, there were no significant differences in the source contribution profiles and wildlife was the leading contributor for both exceedance and compliance samples.

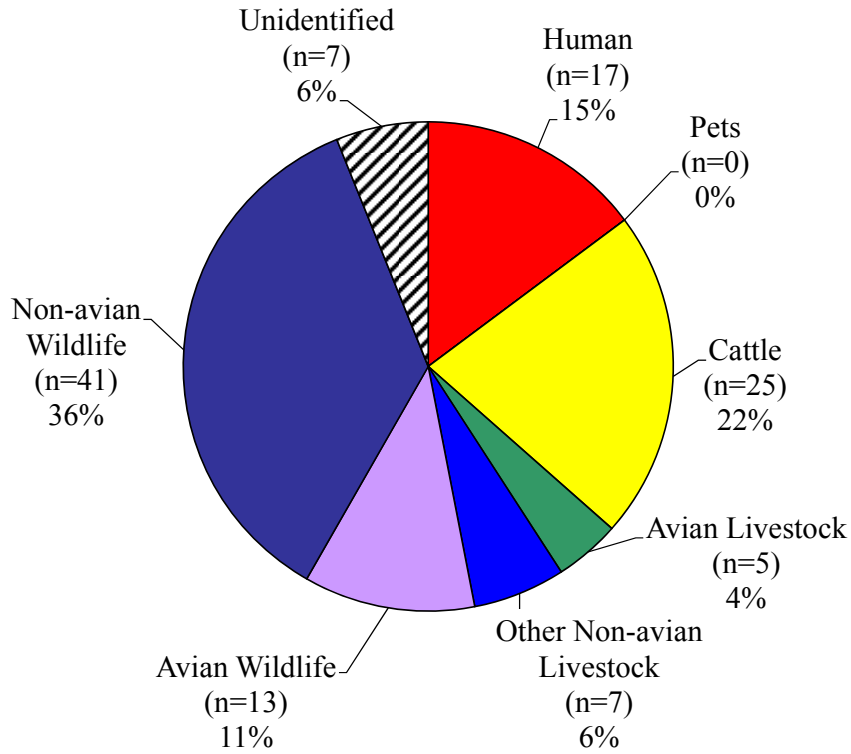
Figure 8. Identification of *E. coli* isolates from samples which were in exceedance of the single sample maximum of $<394\text{ CFU}/100\text{ mL}$ (115 isolates from 23 sampling events—all eligible sampling sites and dates included).

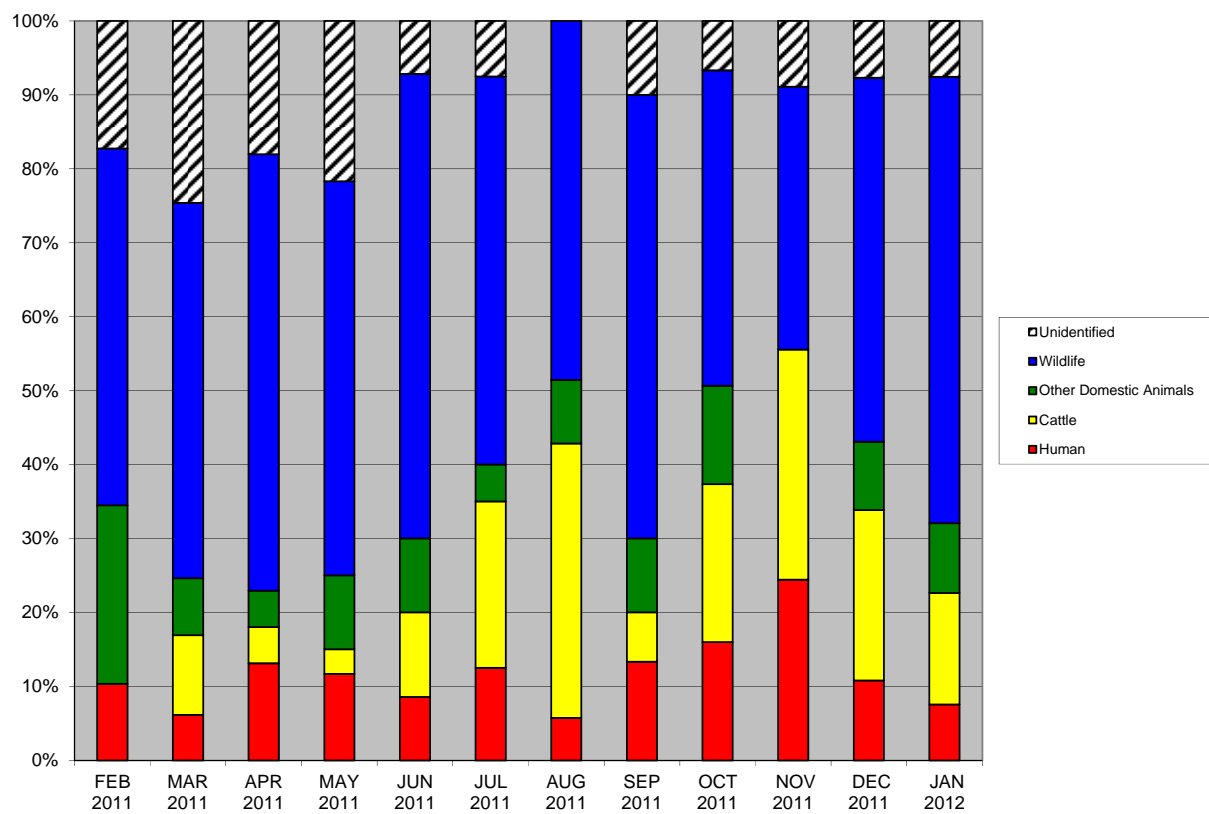
Figure 9. Four-way split of source classes by month for all sites combined.

UTSPH-EP also evaluated how source distributions changed over the study (Figure 9), although it should be noted that with only one year of data, strong conclusions cannot be drawn. October and December had heavy rainfall shortly before their water sampling dates and were therefore likely influenced by runoff. Not surprisingly, these samples had the highest *E. coli* counts, accounting for 20 of the 23 single samples in exceedance. As discussed above, there were no significant changes in the source distribution profiles, with wildlife as the leading contributor followed by cattle. Wildlife was also the leading contributor during the drier months. November did have a more even split between wildlife, cattle, and human contributions, and did have two samples (from LAM 11 and LAM 12) that were in exceedance with similar source contribution profiles.

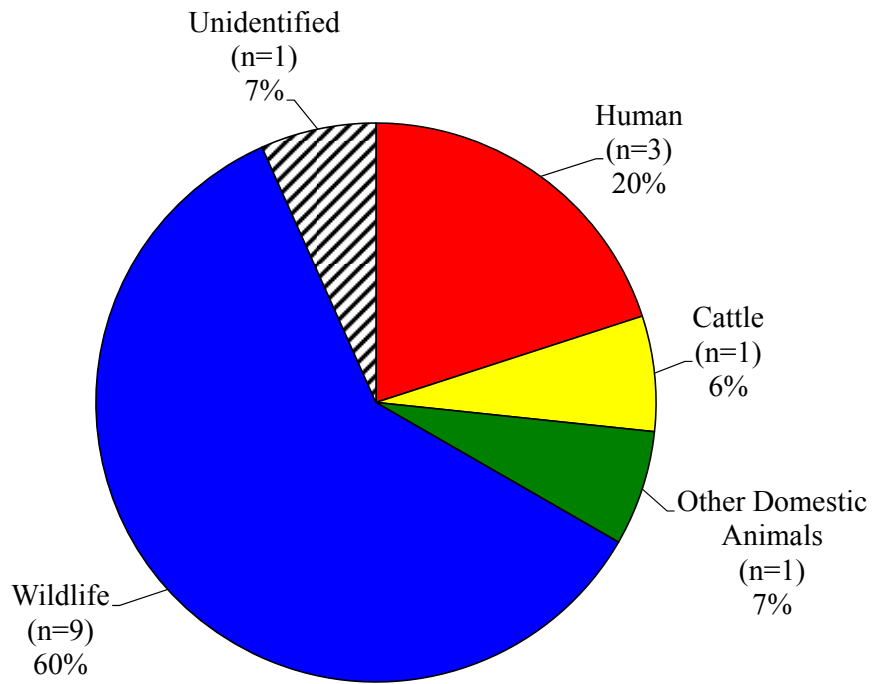
LAM 1 (15762) geometric mean = 162 CFU/100 mL (n=15 isolates; 3 samples)

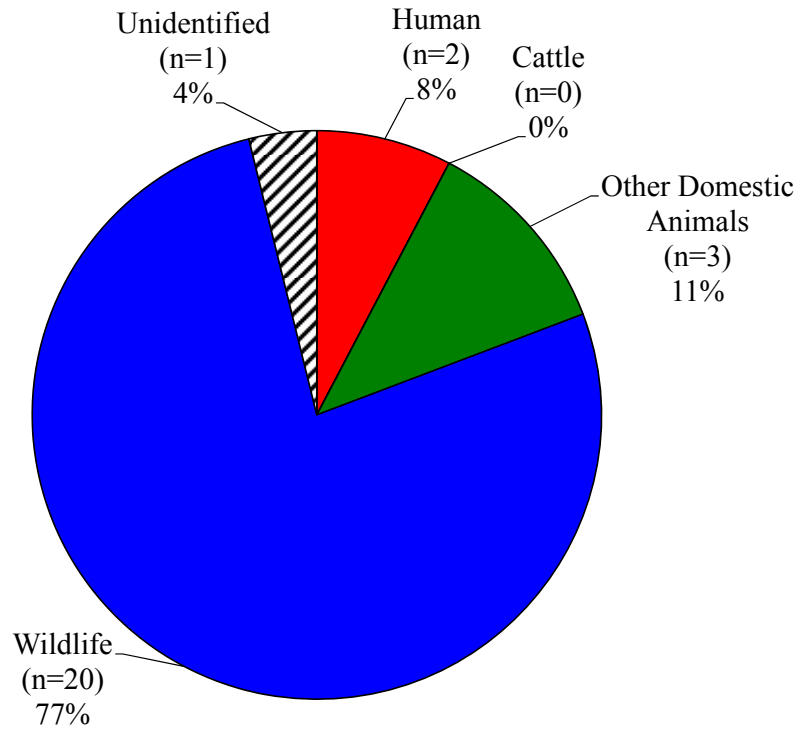
LAM 3 (15770) geometric mean = 158 CFU/100 mL (n=26 isolates; 6 samples)

LAM 3 was the other site that exceeded the standard, with an *E. coli* geometric mean of 158 CFU/100 mL. Represented by 26 isolates from 6 samples, LAM 3 seems especially impacted by wildlife, with 77% of the isolates identified to that source. Cattle seem to have very little impact on LAM 3, since no isolates were identified to that source class.
