Water Quality Monitoring in the Buck Creek Watershed and Facilitation of Buck Creek Watershed Partnership: Final Report

Final Report

TR-444, 2013

TSSWCB Project 10-06

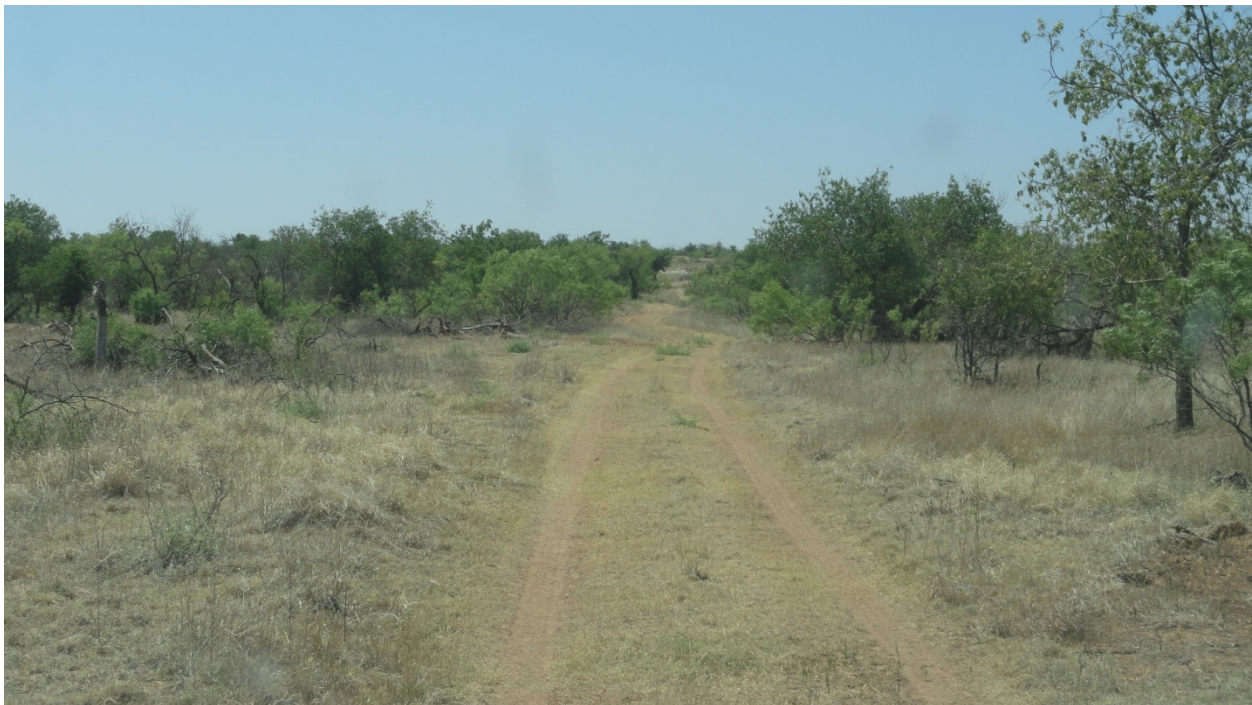
Deep dry grasses were typical on rangelands in late summer 2011. This was the beginning of the worst fire season Texas has seen in years.
