Citation: Corradi, Marco, Tedeschi, Cristina, Binda, Luigia and Borri, Antonio (2008) Experimental evaluation of shear and compression strength of masonry wall before and after reinforcement: Deep repointing. *Construction and Building Materials*, 22 (4). pp. 463-472. ISSN 0950-0618

Experimental evaluation of shear and compression strength of masonry wall before and after reinforcement: deep repointing

M. Corradi^{*1}, C. Tedeschi², L. Binda³ and A. Borri⁴

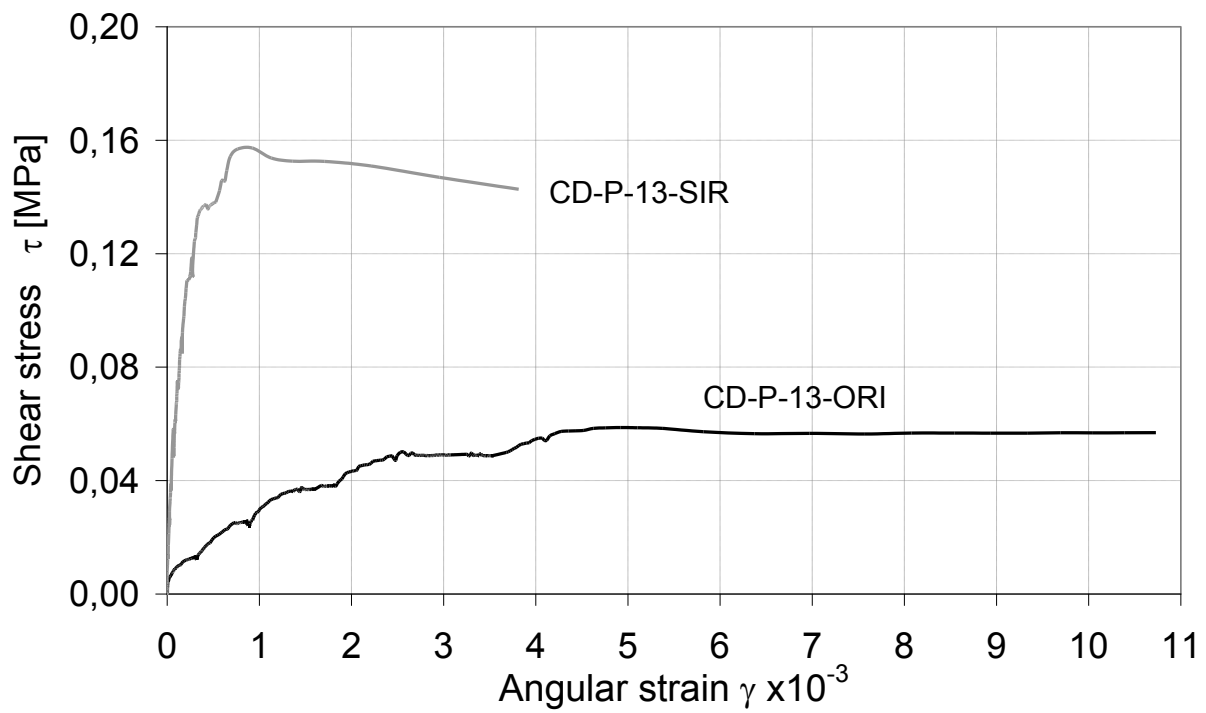
Figure 13 Angular strain vs shear stress for the Ponte panel before and after reinforcement.

These tests were carried out in the two buildings of Ponte and Trevi. The first two tests were performed on the Ponte building where a masonry panel was subjected to the diagonal tests before reinforcement (CD-13-P-ORI). The values are reported in Table 4. The shear strength was 0.059 N/mm^2 , while the shear modulus was 37 N/mm^2 . After repair by deep repointing and

injection (CD-13-P-SIR) the two values became, respectively, 0.157 and 731 N/mm². The high increase both in strength and stiffness is evident.
