THE USE OF THE T-CULVERT GUARD TO PROTECT ROAD CULVERTS FROM PLUGGING DAMAGE BY BEAVERS

K.J. Roblee

New York State Department of Environmental Conservation

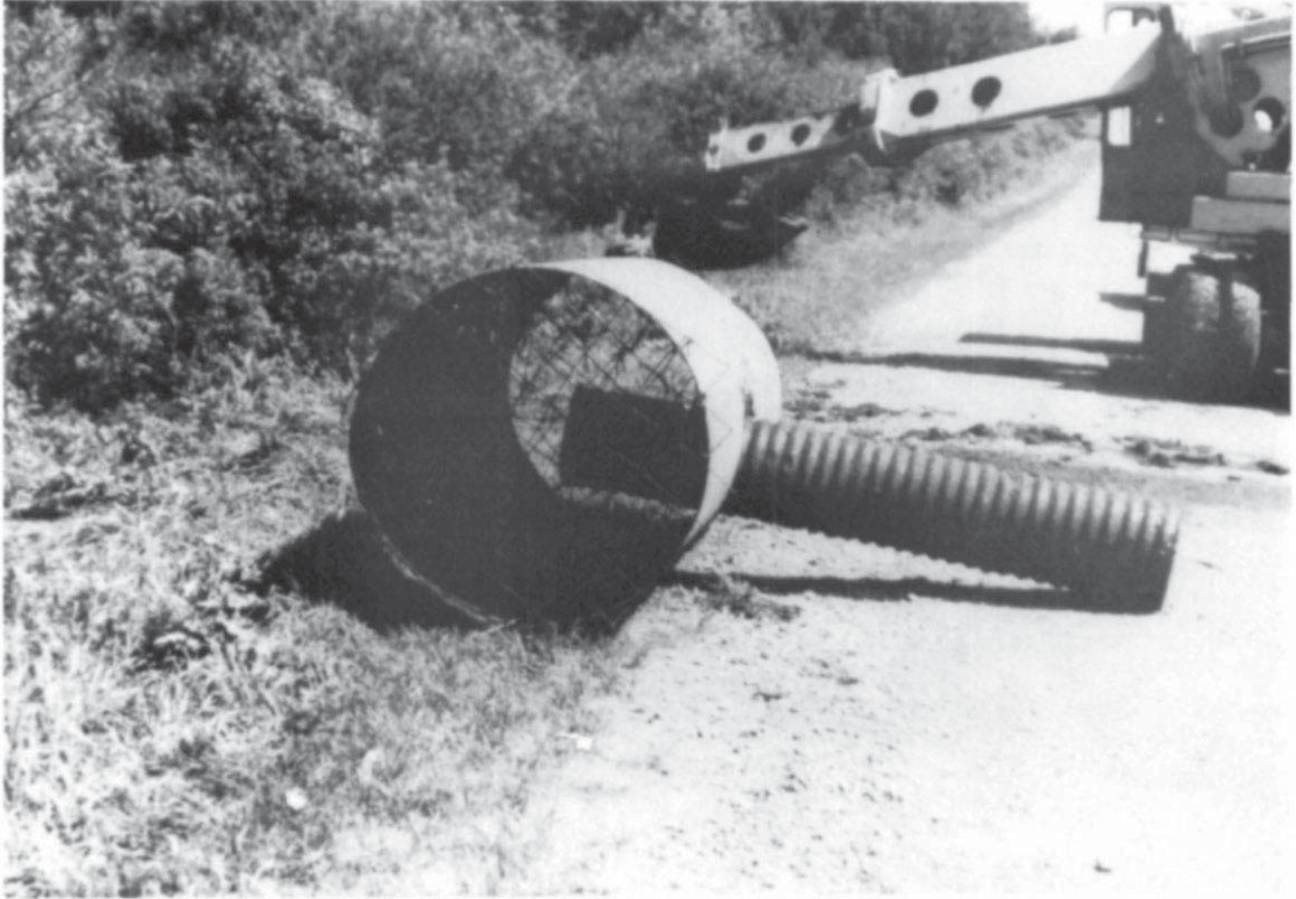
Figure 2. Large culvert showing placement of hole cut for smaller diameter connecting culvert. Wire mesh is in place on culvert ends.

space is available at a site the longer length is recommended. A hole is cut in the center of the side of the culvert at approximately 2/3 of the distance from the culvert's top. The diameter of this hole is large enough to allow the connecting culvert to pass into it at an angle approximated by Figure 1. Figure 2 shows the correct location of this hole. The ends of the large culvert are covered with No. 6-gauge reinforcing wire mesh. The mesh is attached with No. 10-gauge galvanized wire passed through holes drilled or burned through the large culvert. It may also be attached by passing the protruding ends of the mesh through premeasured holes and bending them over. Figure 2 shows mesh in place over the culvert ends.

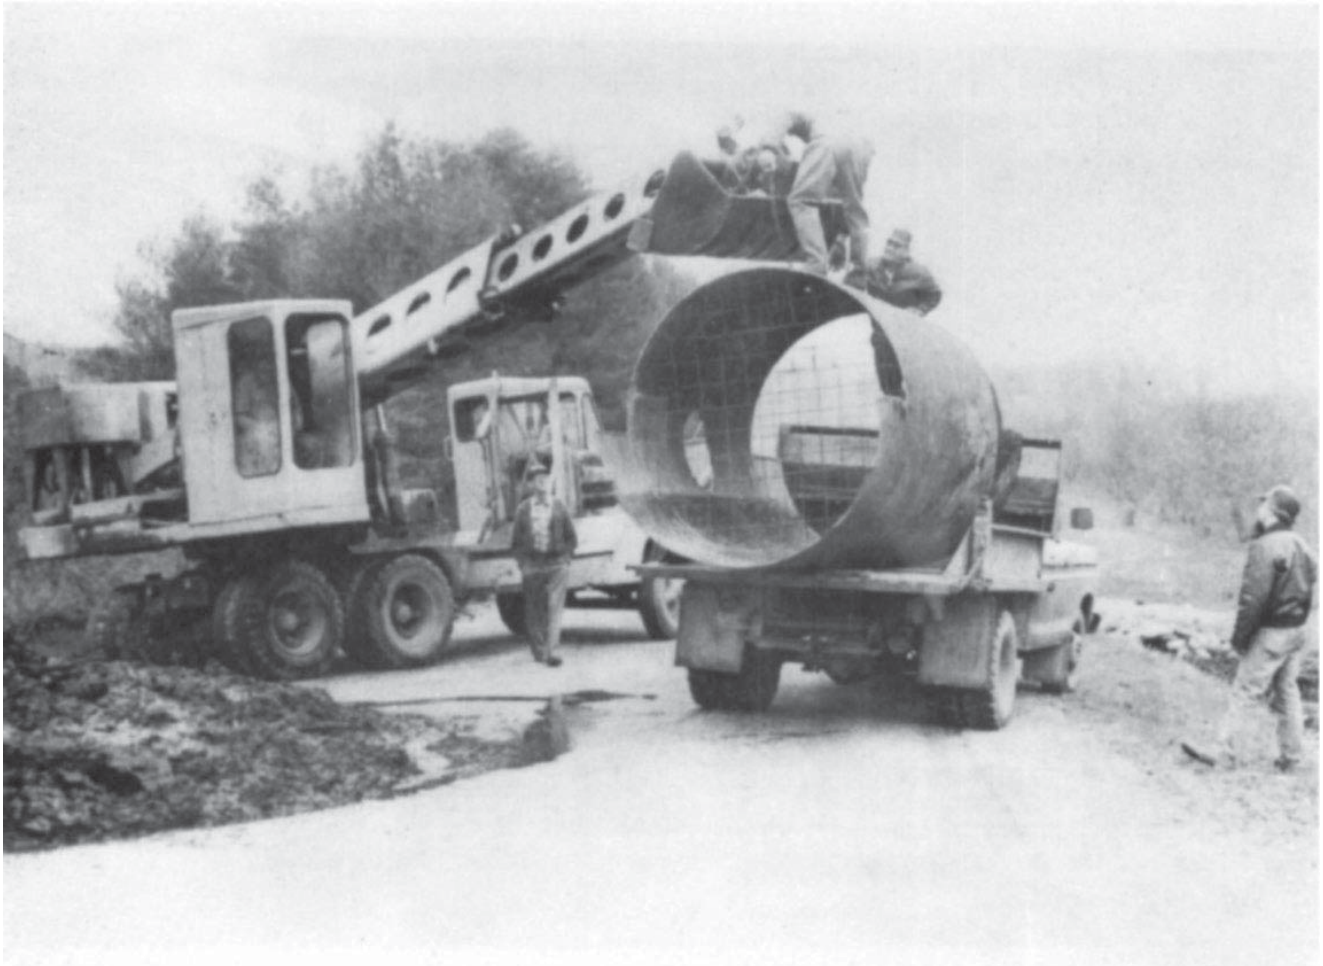
Figure 3. A 6 ft. diameter large culvert with extended ends used in fencing back unstable substrate.

Before the T-culvert can be installed at a site, sufficient water depth must be present in front of the road culvert to nearly submerge the large culvert and provide a similar water depth 6 ft. to 8 ft. outward from its ends. If this depth is not present then it must be provided by excavation. If this excavation is done in muck or gravel substrate, surrounding material may collapse or wash into the large culvert. This will reduce water depth and subsequently the effectiveness of the T-culvert. This can be prevented by fencing the unstable material back from the large culvert openings. One method of fencing is to place stone filled wire gabions around and 6 ft. distant from the openings. Another method is to cut the large culvert so that the bottom half of the culvert ends extend approximately 3 ft. beyond the wire grate coverings as shown in Figure 3. Plywood is then placed against the extended ends to hold back loose substrate.

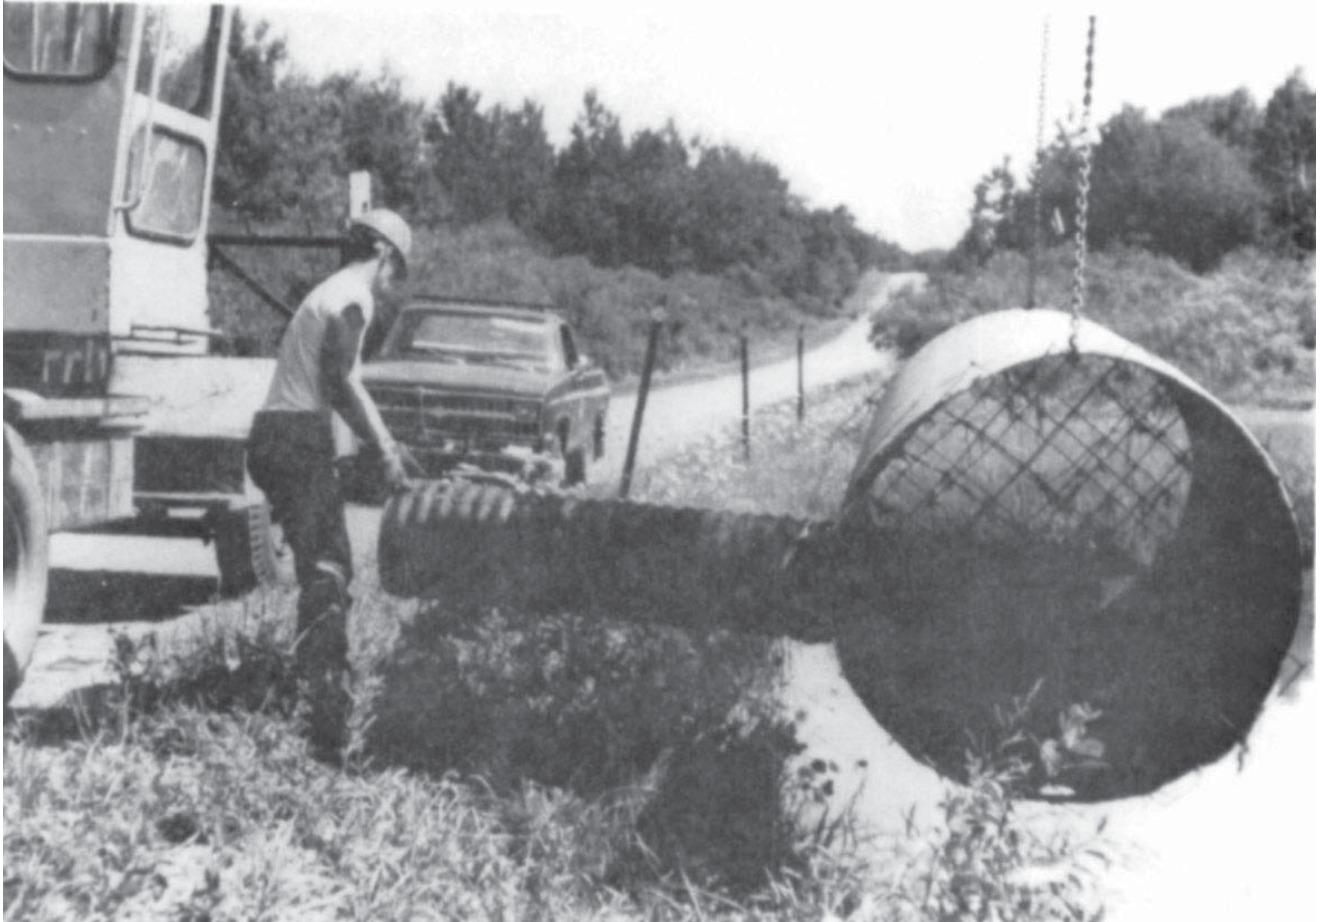
Figure 4. Lowering assembled T-culvert in place in front of road culvert.

The T-culvert assembly is most easily installed by placing 1 ft. to 2 ft. of the connecting culvert into the large culvert and then lowering the assembly into position (Figure 4). The large culvert is placed 4 ft. to 6 ft. from the inlet end of the road culvert in a position perpendicular to the road culvert and parallel to the road surface. The entire assembly is then moved toward the road culvert as the remaining end of the connecting culvert is placed 6 in. into the road culvert. Any remaining opening of the road culvert not covered by the connecting culvert should be covered with No. 6-gauge

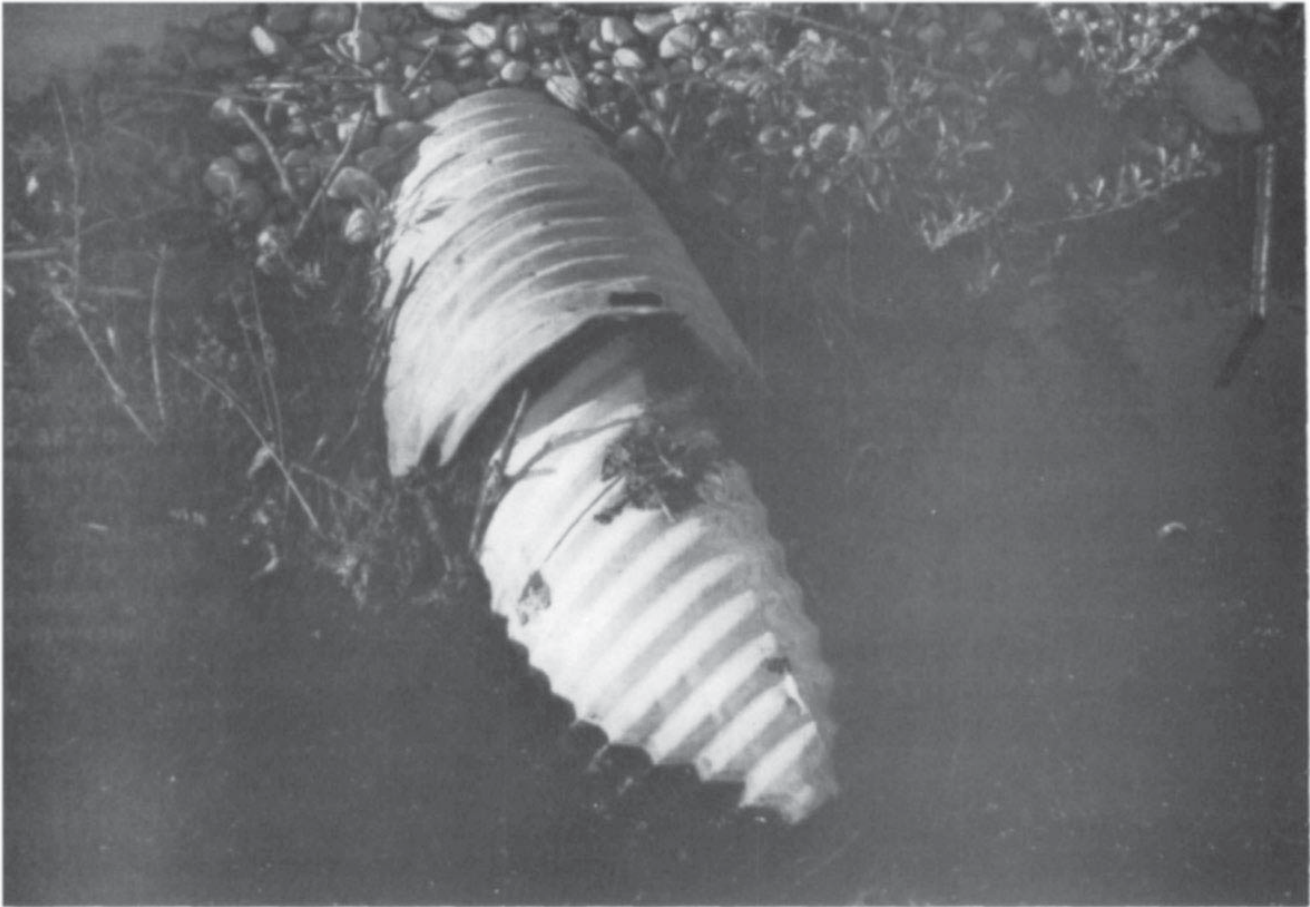
Figure 5. Smaller diameter connecting culvert in place in road culvert.

reinforcing mesh to exclude beaver. Figure 5 shows the proper placement of the connecting culvert into the road culvert. It may be necessary to place a small amount of excavated material behind the large culvert to prevent it from rocking. Figure 6 shows a completed T-culvert installation which uses extended ends and plywood fencing to exclude muck substrate.

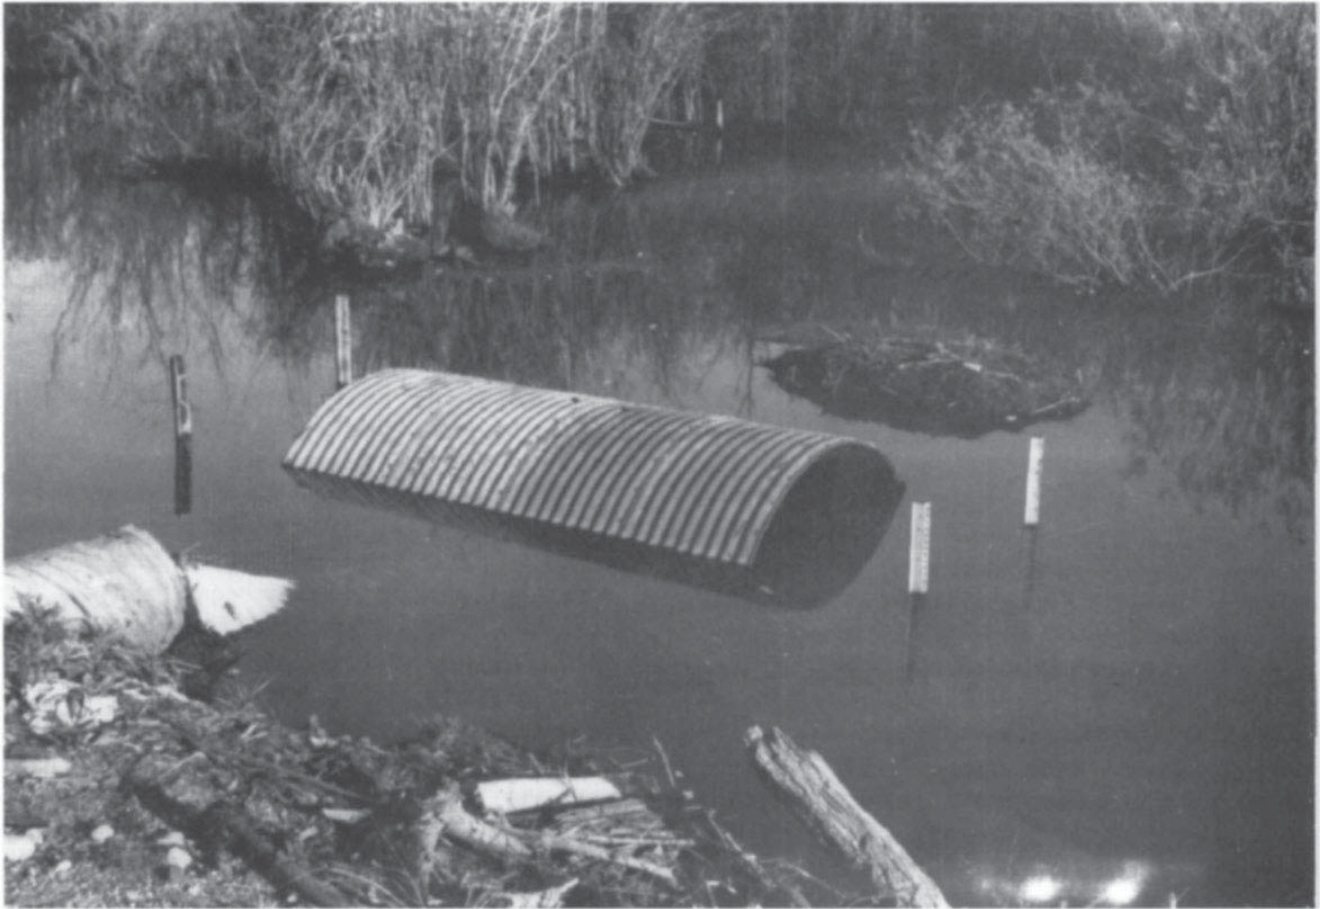
Figure 6. T-culvert shown in Figure 3 in place. Metal posts support plywood fencing against the extended culvert ends.
