Malaysian Technical Universities Conference on Engineering & Technology 2012, MUCET 2012
Part 3 - Civil and Chemical Engineering

Shear Behaviour of Pre-cracked Continuous Beam Repaired using Externally Bonded CFRP Strips

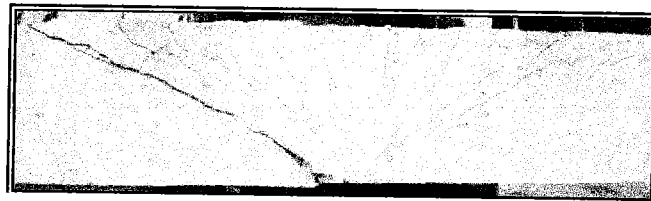
Figure 5: Shear failure of Beam 1-0 at load 286.10kN (shear force 93.70kN)

The control beam which was not strengthened with CFRP strips was tested and loaded till failure. It was observed that flexural cracks appeared initially at the bottom part of mid-span at load 96kN which was about 34% of the ultimate load of the beam. Shear cracks occurred later at load 204kN (at about 71% of the ultimate load). Further new cracks developed at the tension zone of the mid-span area during the occurrence of the shear crack. The flexural (or vertical) cracks widened and propagated to the compression zone of the beam as load was increased.

The first shear crack (or diagonal crack) appeared initially at the bottom part of the middle support area. The crack widened and propagated to the point load in a diagonal direction as load increased. Other shear cracks were also observed propagated in the same direction as the first diagonal crack. As the load increases, the shear cracks widened and propagated until the beam fails due to shear at a load of 286.10kN. Figure 5 shows Beam 1-0 fails in shear. Several vertical cracks were also observed at the negative moment region (middle support area). From observation during beam test, vertical cracks in the flexural zone stopped propagating much earlier than the cracks in the shear span. As expected, the beam eventually failed in shear rather than in flexure as the specimen was designed to have insufficient stirrups in comparison to the longitudinal reinforcements.

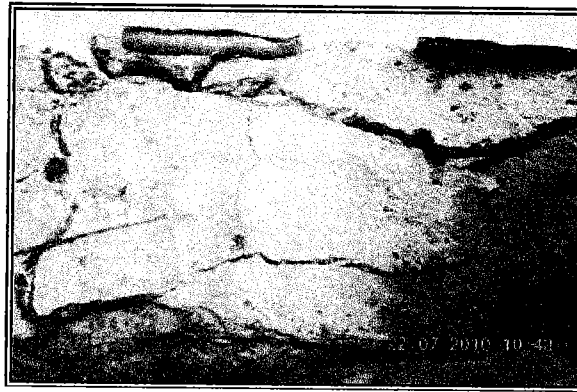
Fig. 9. Crushing of concrete (top-side view) of Beam 2-2

After repaired with CFRP strips, the beam was loaded to failure where the ultimate load achieved was 338.08kN. The mode of failure for this beam was shear with CFRP strips rupture and debonding of the CFRP strips from the concrete surface. Figure 8 and 9 shows the cracks of the beam at failure. Figure 9 shows the top view of the beam where the cracks were extended along the concrete covers.

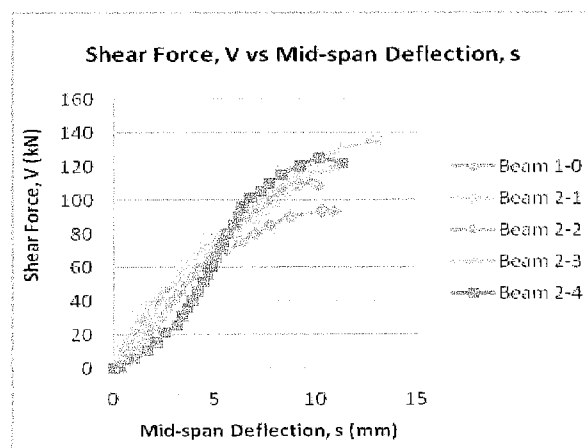
Fig.12. Shear Force – Deflection Behaviour

Figure 12 shows the shear force versus mid-span deflection ($V-\Delta$) of all beams. It can be observed that all beams exhibit almost similar behavior except for Beam 2-4 where the curve of the beam was the less steep at the beginning of the testing and at shear force of around 20kN to 100kN, the slope of the curve change to the steepest slope amongst all beams. Beyond that load until failure, the slope become less steep where the slope was almost similar with the other pre-cracked beams. This behaviour occurred because of the pre-cracked phase where the beam might be over pre-cracked which lead to the weak behaviour at the beginning of the testing.

The shear force-deflection profile for control beams shows linear elastic behaviour at the beginning of the testing until it reached one point where the slope of the curve started to change due to the development of cracks on the beam. It then started to behave non-linear with more cracks were observed until failure. The shear force – deflection behaviour for control beams acted as expected for a reinforced concrete beam.

For Beam 2-1, at the beginning of the loading process, the curves of Beam 1-0 and Beam 2-1 was close to each other with only small different between them. However, at shear force of about 55kN, it can be seen that the deflection of control beam was higher than Beam 2-1. The maximum deflection achieved for Beam 2-1 was 10.85mm where it was lower than control beam for only 0.015mm. This indicated that although the beam was pre-cracked before wrap with CFRP strips, it can still achieved higher load and shear force with lower deflection compared with the control beam. The same behavior was observed for Beam 2-2. Beam 2-3 recorded maximum deflection of 13.135mm which is an increase for about 2.27mm compared with control beam. Although the percent of increase of the deflection was about 20.89%, the beam reached shear force of about 43.74% higher than control beam. Although the deflection was higher than control beam, the allowable deflection was still lower than the permissible deflection.

For comparison of Beam 2-1 and Beam 2-3, it can be seen that Beam 2-3 shows slightly stiffer behaviour compared with Beam 2-1 from the beginning of the testing until failure of Beam 2-1, at the same load level, Beam 2-3 has recorded less displacement compared with Beam 2-1. It shows that 45°/135° orientation of CFRP strips shows stiffer behavior than 0°/90° orientation.

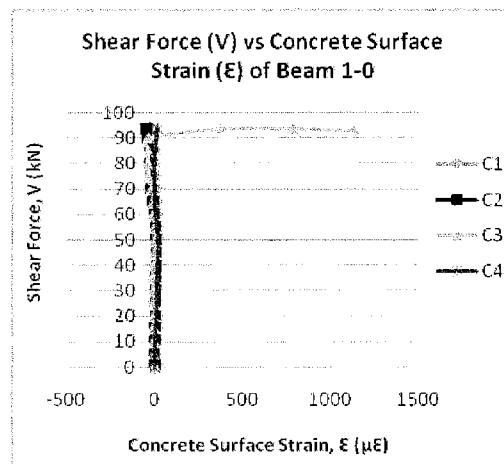
Fig.13. Shear force versus strain at concrete surface of Beam 1-0

Figure 13 shows shear force versus strain at concrete surface of Beam 1-0. Strain gauge at C3 attained the highest strain among all strain gauges due to a diagonal crack located nearby the strain gauge. It recorded a strain of $1130.52\mu\epsilon$ where it still in concrete strain limit. The measured strain increase suddenly just before failure at shear force of 93kN. This is due to the sudden failure of the beam.

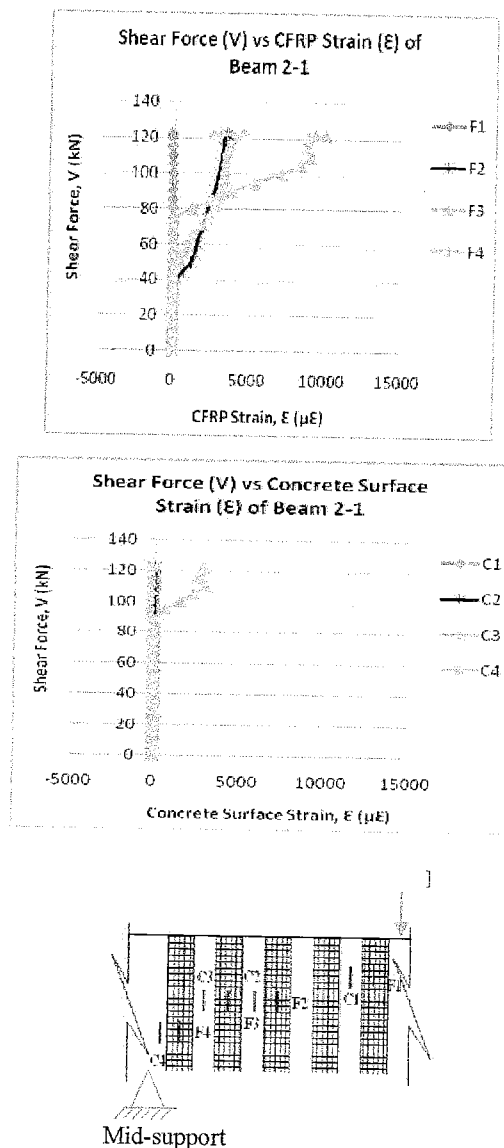
Fig. 14. Shear force versus strain at concrete surface and CFRP strips of Beam 2-1

The graph of shear force versus strain at concrete surface and CFRP of Beam 2-1 was as shown in Figure 14. For strain at concrete surface, it can be clearly seen that C3 attained the highest strain of $2864.79\mu\epsilon$ while the other strain gauges recorded lower strain which represent as linear line until failure. For strain at CFRP strips, F3 attained the highest strain of $9961.50\mu\epsilon$ or 66% from the ultimate strain of the CFRP. It started to show significant elongation at shear force of around 80kN. F2 and F4 also showed an elongation of CFRP strips and it started to behave non-linear at earlier shear force of around 40kN. All strains of concrete surface were within the concrete strain limit while the strains of CFRP were also within the CFRP strain limit.

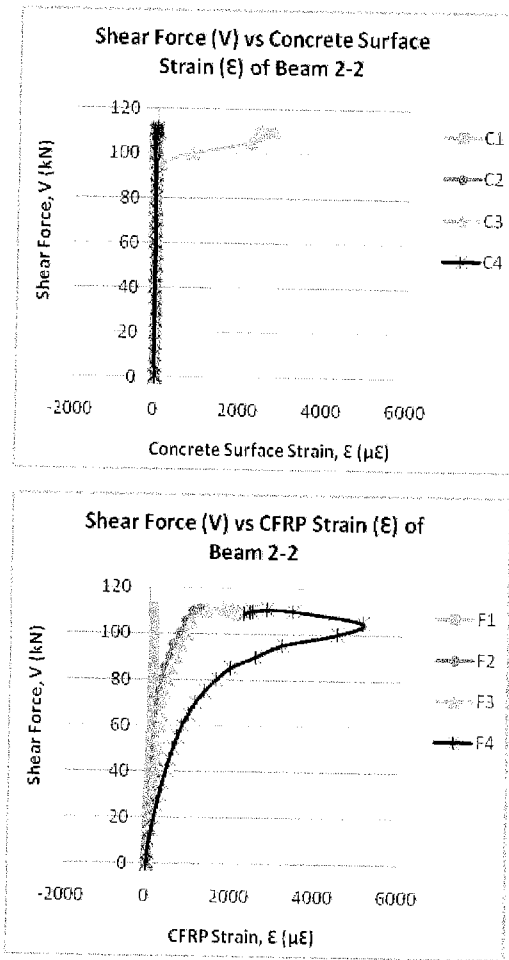
Fig. 15. Shear force versus strain at concrete surface and CFRP strips of Beam 2-2

Figure 15 shows shear force versus strain at concrete surface and CFRP strips of Beam 2-2. From the figure, it can be observed that strain at CFRP was higher than strain at concrete surface. The maximum strain recorded at concrete surface was C3 with the strain of $2774.65\mu\epsilon$ while the maximum strain recorded at CFRP strip was F4 with the strain of $5102.35\mu\epsilon$. F2, F3 and F4 shows nearly zero strain at the beginning of the loading and then increased gradually until failure. Just before failure, strain gauge F4 showed a decreased of strain when ruptured of CFRP strip occurred.

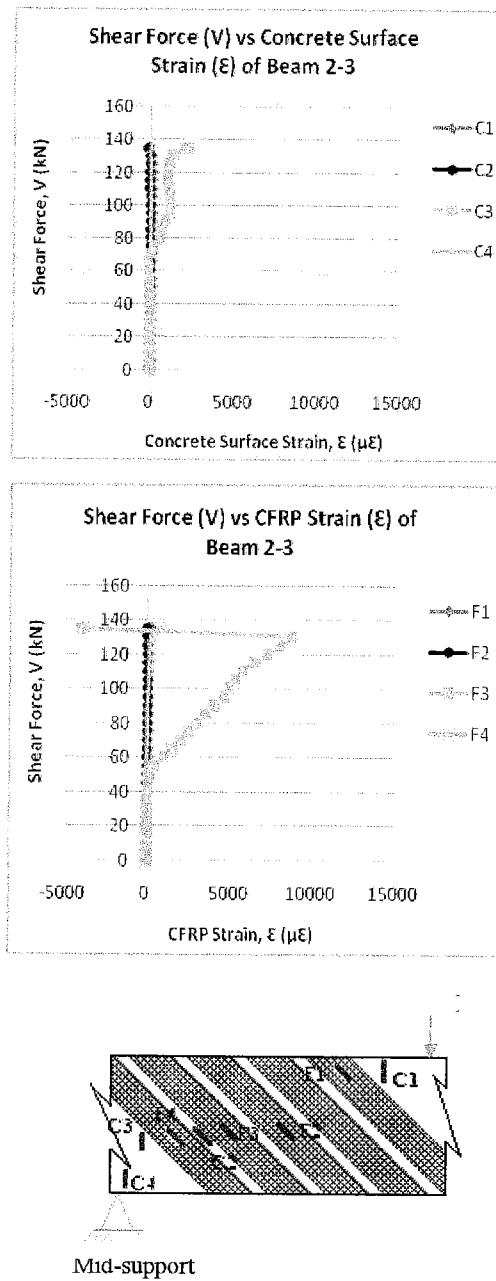
Fig.16. Shear force versus strain at concrete surface and CFRP strips of Beam 2-3

In Figure 16, a relationship of shear force – strain at concrete surface and CFRP strips of Beam 2-3 can be observed. C3 and F3 showed a significant increased of strain at concrete surface and CFRP respectively. A maximum strain of $2283.57\mu\epsilon$ was recorded at strain gauge C3 while a maximum strain of $8756.94\mu\epsilon$ was recorded at strain gauge F3. The other strain gauges showed a nearly zero value might be due to the strain gauge not located nearby the cracks on the beam.

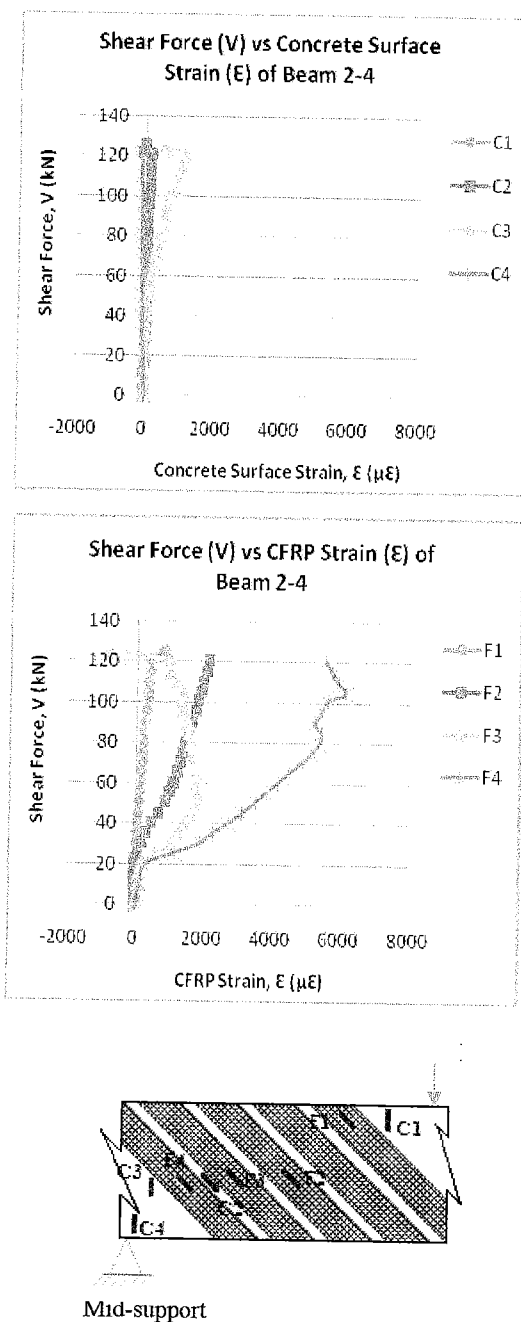
Fig. 17. Shear force versus strain at concrete surface and CFRP strips of Beam 2-4

Figure 17 shows shear force versus strain at concrete surface and CFRP strips of Beam 2-4. For concrete surface strain, as the other previous beams, only one of the strain gauge recorded an obvious increase of strain. For this beam, strain gauge C3 recorded the highest strain of concrete surface at $1160.56\mu\epsilon$. On the other hand, for strain of CFRP strips, all strain gauge showed an increased of strain with more complex behavior when dissimilar trend was observed in each strain gauge. F1 showed a gradually increased until failure while F2 while F2 starts to behave non-linear as early as 20kN. For F3, it also starts to behave non-linear at shear force of 20kN. After shear force 20kN, it gradually increased until at shear force of around 50kN, it then gradually decreased until at almost failure or around 120kN, a sudden decreased occurred. For F4, at shear force of 20kN, a sudden increased of strain occurs and it recorded the highest strain among all strain of CFRP strips at $6107.04\mu\epsilon$ or 41% from the ultimate strain of CFRP.
