## CAN SHARED SURFACES BE SAFELY NEGOTIATED BY BLIND AND PARTIALLY SIGHTED PEOPLE?

Childs<sup>1</sup>, Craig R; Thomas<sup>2</sup>, Carol; Sharp<sup>2</sup>, Sue; Tyler<sup>1</sup>, Nick

<sup>1</sup> Accessibility Research Group, UCL, London UK

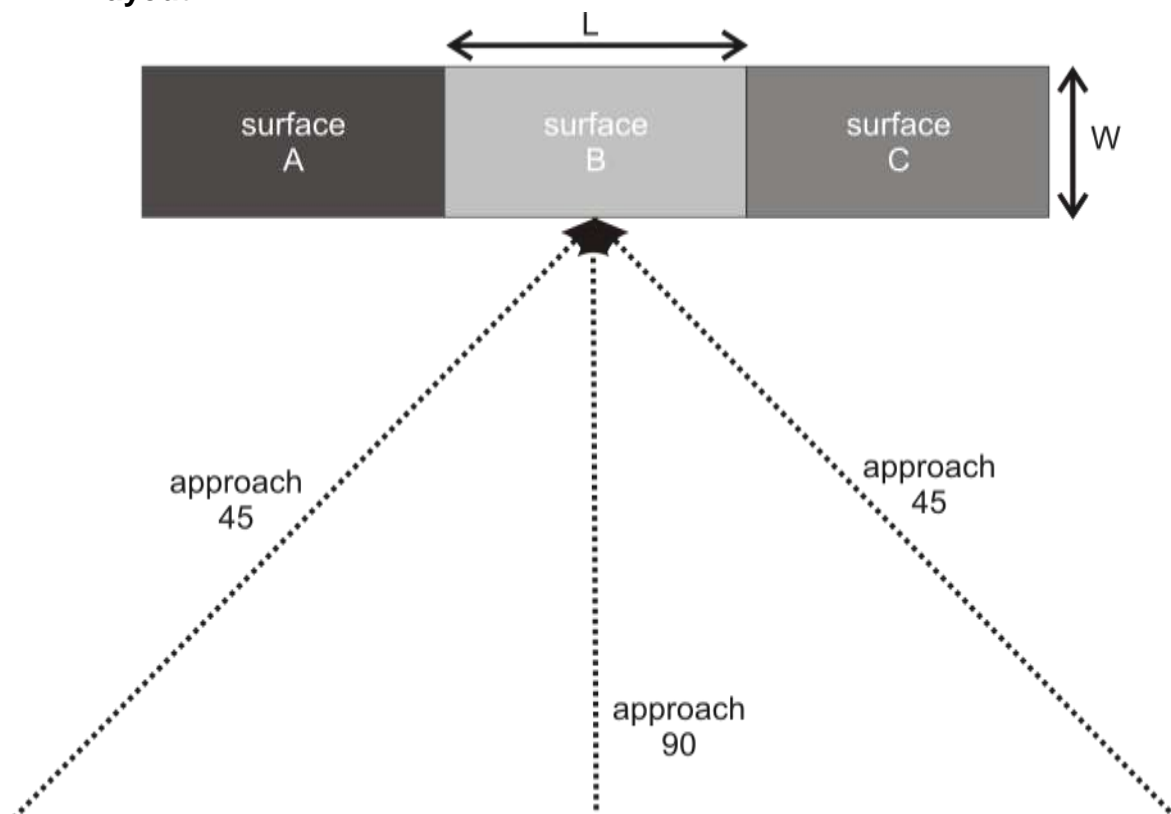
Figure 1 Task Diagram. Each surface was tested with a length (L) of 1.6m. The width (W) of each delineator is listed in Tables 5 and 6. The approach distance available for each surface was up to 4m, when approached from 90°. When approached from 45° greater than 4m was available. The approach distance was varied between trials. The surrounding surface was covered in chamfered concrete pavers.

The experiments were all performed at the Pedestrian Accessibility and Mobility Environment Laboratory (PAMELA) [Childs et al. 2007]. This facility was arranged with an 80m<sup>2</sup> test surface laid out as a simulated street environment including different surfaces. With an available area of 80m<sup>2</sup> five layouts were required to include all the test surfaces. The basic action required in these experiments was to pass over a number of surfaces as if travelling through a normal street environment. This study was approved by UCL Ethics Committee (0410/005 – funded by Transport for London and 0410/006 – funded by Guide Dogs for the Blind Association).

The VI participants were positioned so that they were facing either perpendicular to the surface or approximately 45° to it. They were asked before starting each trial to stop if they encountered a change in surface, otherwise to walk towards the experimenter at their normal walking pace using the experimenter's voice to help with direction. The experimenter then went to the other side of the surface and asked the participant to walk towards them. The experimenter marked each trial according to whether the participant detected the surface or not. Once the participant had finished each trial they were asked to rate the surface in terms of their perception of how easy it was to detect on a Numerical Rating Scale between '0' and '10' : a score of '0' indicating that they had not detected any change in surface, '10' that they believed that there was definitely a delineator indicating a change of surface, and scores in-between indicating how much confidence they had that any difference in
