Proceedings of the 38th International Conference on Infrared, Millimeter and Terahertz Waves IRMMW-THz 2013

THz reflectometric imaging of medieval wall paintings

Abstract— Terahertz time-domain reflectometry has been applied to the investigation of a medieval Danish wall painting. The technique has been able to detect the presence of carbon-black layer on the surface of the wall painting and a buried insertion characterized by high reflectivity values has been found in depth of the lime-based historical plaster.

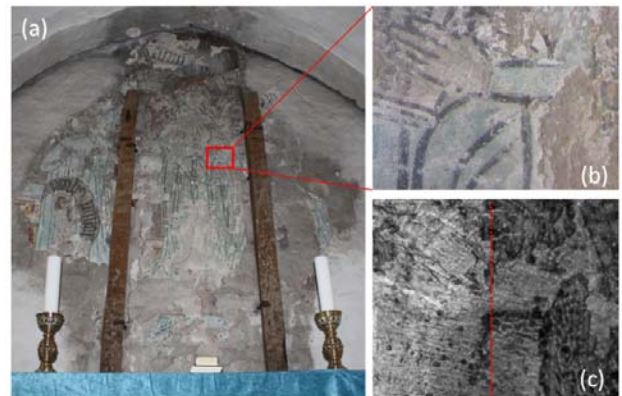
Fig. 1: (a) Apsidal wall painting in Nebbelunde Church - Rødby, Lolland, Denmark. (b) The relevant detail of the painting. (c) THz reflection image of the detail; the red line indicate the scan-line used to image the b-scan shown in Fig. 3.

Fig. 1(b) shows the investigated area and Fig. 1(c) the grayscale terahertz reflection image, plotted using the value of the difference between maximum and minimum of the temporal amplitude of the reflected terahertz signal. Despite the characteristic high reflectivity of carbon-based pigment in the terahertz range, the outlines of the figures, painted with carbon-black, are not always visible in the image due to strong scattering from the irregular surface. Regardless of this, it is possible to identify the carbon-black distribution in some painting details, including the outlines of Mary fingers (especially the index), the normal outlines which define the bottom of book (particularly the one of the open page) and, even if pale, the two curved outlines defining the draperies of the dress that falls to her knees.

The reflection image (Fig. 1(c)) clearly localizes the incisions made on the wet lime-based plaster by an awl as preparatory drawing of the Mary's fingers (specially marked for the pinky) before the pigment application, which do not always overlap with the final painted outlines. This proves that the artist has changed his mind as to the composition during the process of painting ("*pentimenti*"). All the surface scratches appear highlighted, with an effect similar to that of grazing visible light. The lower, middle part of Fig. 1(c) shows a dark "Γ" shape mark that has no counterpart in the visible image. 3D visualization of the time-of-flight of the signal reflected at the surface (Fig. 2) reveals that this mark is related to an abrupt depression of 2-3 mm of the wall at that point. The uncovered regions of the wall painting are characterized by a smooth appearance of the THz reflection image, whereas the regions still covered by lime wash appears much more uneven in the THz image. This correlates well with the visual appearance of the area.

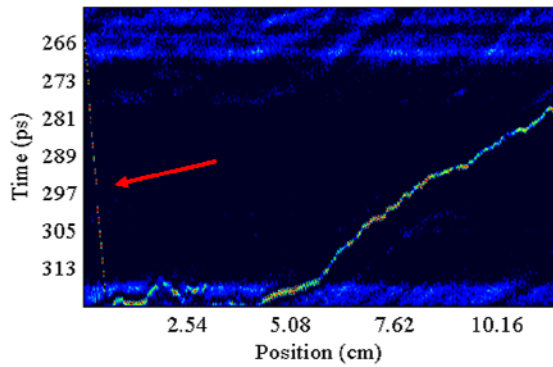
Fig. 3: b-scan along the red line in Fig. 1(c) revealing a subsurface structure, indicated by the red arrow.

B-scan images have been realized to represent non-invasive cross sections of the wall. The most interesting information arising from the b-scans is the presence of a hidden structure in depth in the plaster. Fig. 3 shows the b-scan image obtained by scanning the investigated area along the red line shown in Fig. 1(c), within the 260 - 320 picoseconds range.

Inside this temporal interval, at about 150 picoseconds after the arrival time of the main pulse, we note the presence of a thin insertion, transverse to the plaster, highlighted by the red arrow in Fig. 3. Due to the speed of light (c), 1 picosecond flight time (Δt) of the terahertz signal corresponds to 0.3 mm distance (Δx) in air. Assuming a mean index of refraction (n)

equal to 1.5 for the building material, it may be calculated that the insertion is located at about 1.5 cm from the surface ($\Delta x = c\Delta t/2n$, where the factor of 2 comes from the double-pass reflection geometry). Fig. 4(a) shows the 3D plot of the time time-of-flight of the signal reflected at the surface (green in the figure) and the time time-of-flight of the signal reflected within the 260 - 320 picoseconds interval (pink in the figure). We clearly identify a foil structure, inserted transversely into the wall. Detail of the insertion is shown in Fig. 4(b). The foil insertion is found to be in contact with a building element which may be attributed to a slab, given its characteristic texture (Fig. 4(c)). The concrete texture which can be observed in the 3D plot of the time time-of-flight of the signal reflected within the 260 - 320 picoseconds interval (Fig. 4(a)) is actually an echo image of the surface layer; it cannot be identified for the entire length of the scanned area since some part are located at times higher than 320 picoseconds (i.e. limit of the temporal window of the system).
